Northern Agency Tronox Mines

Removal Site Evaluation Report

October 10, 2019

Tetra Tech, Inc.

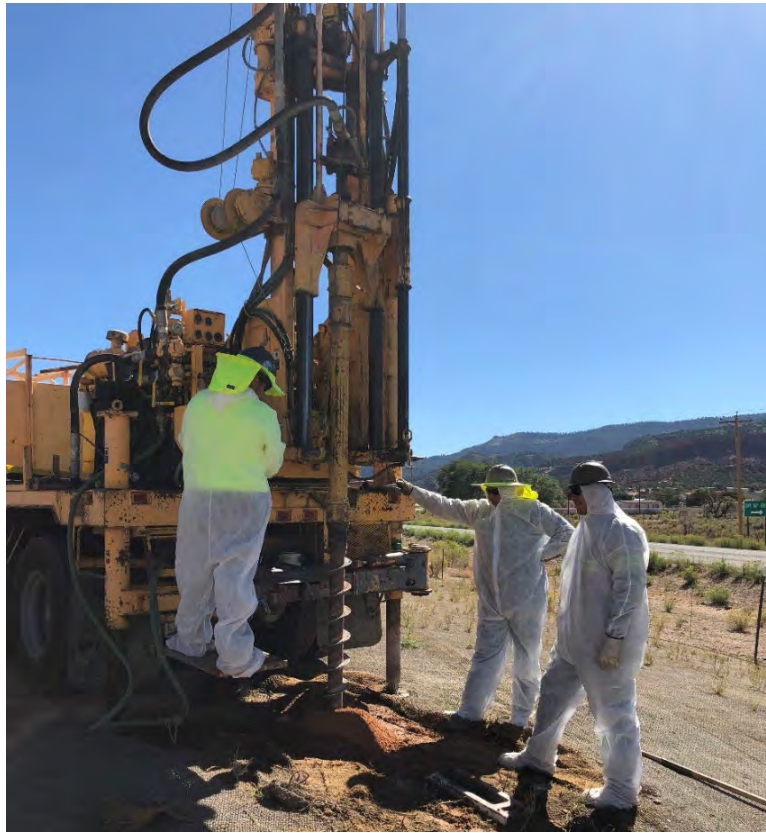
Figure 18. The Larger CME-75 Truck-Mounted Drill Rig

A mechanical subsurface drilling program occurred at seven sites. Results of the subsurface drilling program are summarized in individual SSRSE reports in Appendix H.

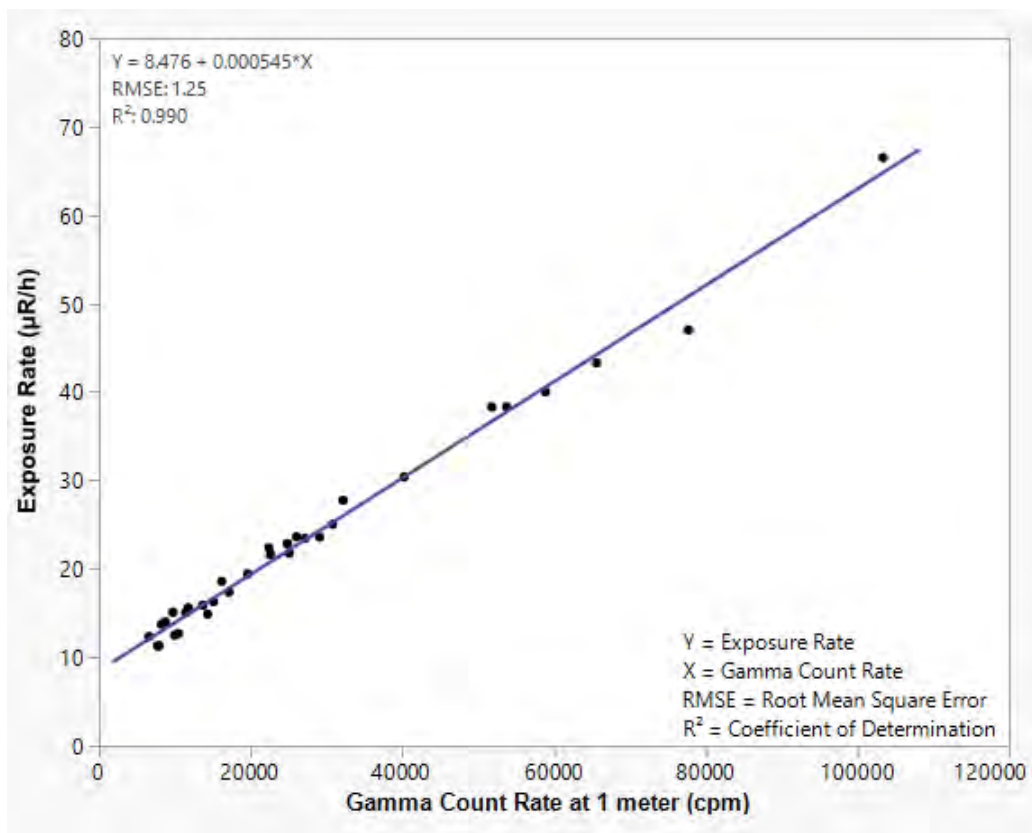
Figure 20. Gamma Count Rate (Counts per Minute) versus Exposure Rate (Microrentgens per Hour)

Where: Y is the gamma exposure rate
 X is the gamma count rate
 μR is microrentgens
 cpm is counts per minute

The development of the correlation between gross gamma count rate and gamma exposure rate is discussed in detail in Appendix C of the RSE report. [Attachment 2](#) to this report includes figures displaying gross gamma count rate measurements converted to gamma exposure rate in $\mu\text{R/hr}$. The intervals displayed on the figures in [Attachment 2](#) are related to a variety of gamma exposure rates found at various locations or other sources of radiation dose.

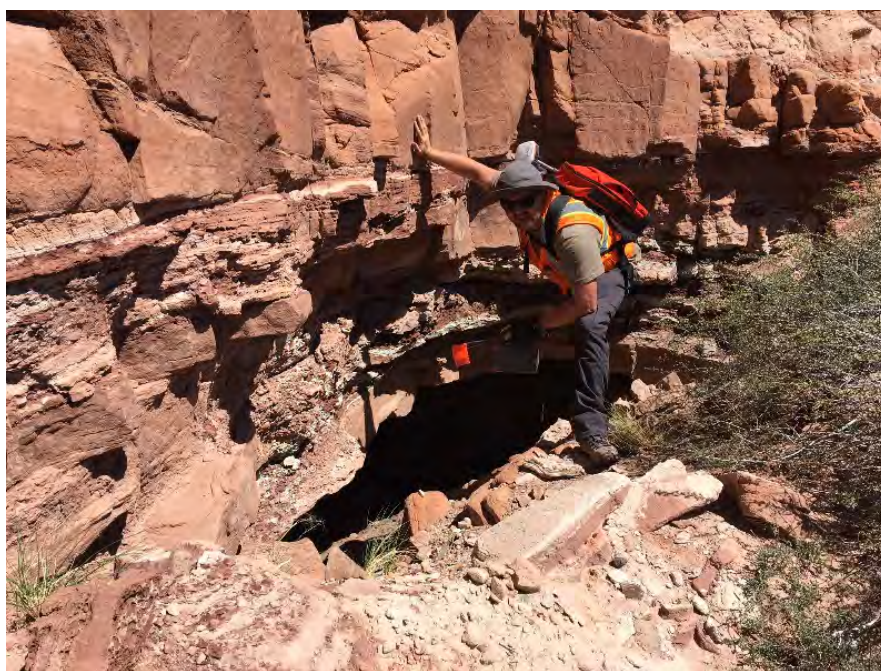
Figure 4. Open Portal noted on Mesa I Mine 12

- Noted potential spring as Mesa I Mine 13.
- EPA conducted site walk with TT Project Manager; on Mesa I Mine 10 and 13. EPA verified hazardous conditions at both mine sites which will limit 100% scan coverage in these areas.
