Minnesota Efforts to Reduce Nutrient Enrichment

Pam Anderson | Surface Water Monitoring Program Manager

February 4, 2020

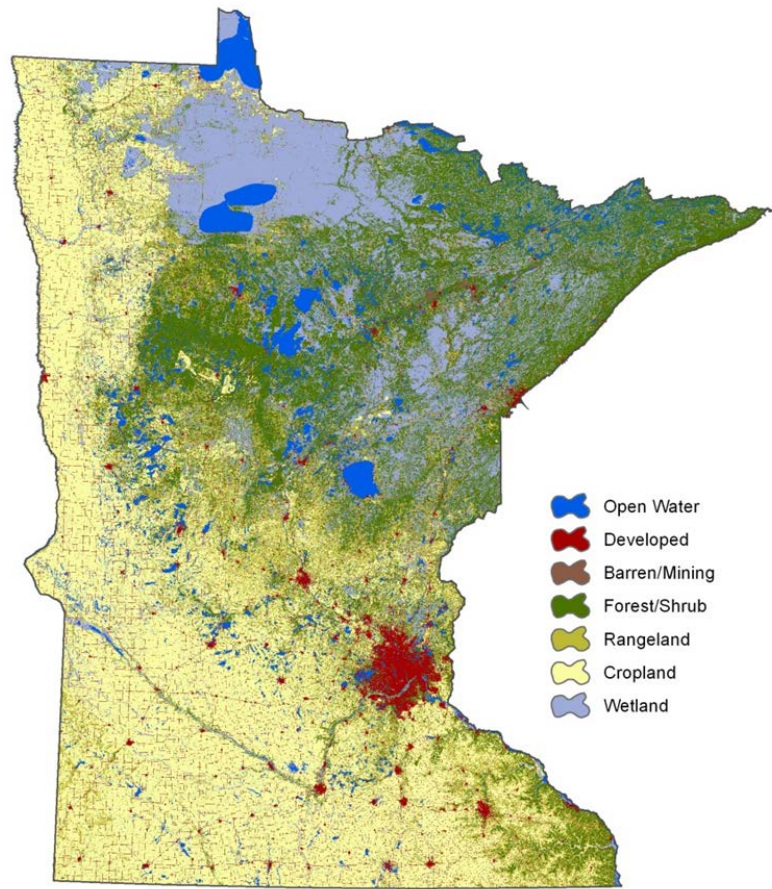
NLCD2006 (resampled to 120m)
US Geological Survey

- 12,200 lakes greater than 10 acres
- 92,000 miles of rivers/streams
- Drains to 3 basins
- Land Use:
 - Agriculture 44%
 - Grassland 13%
 - Forest 32%
 - Water 5%
 - Urban 6%

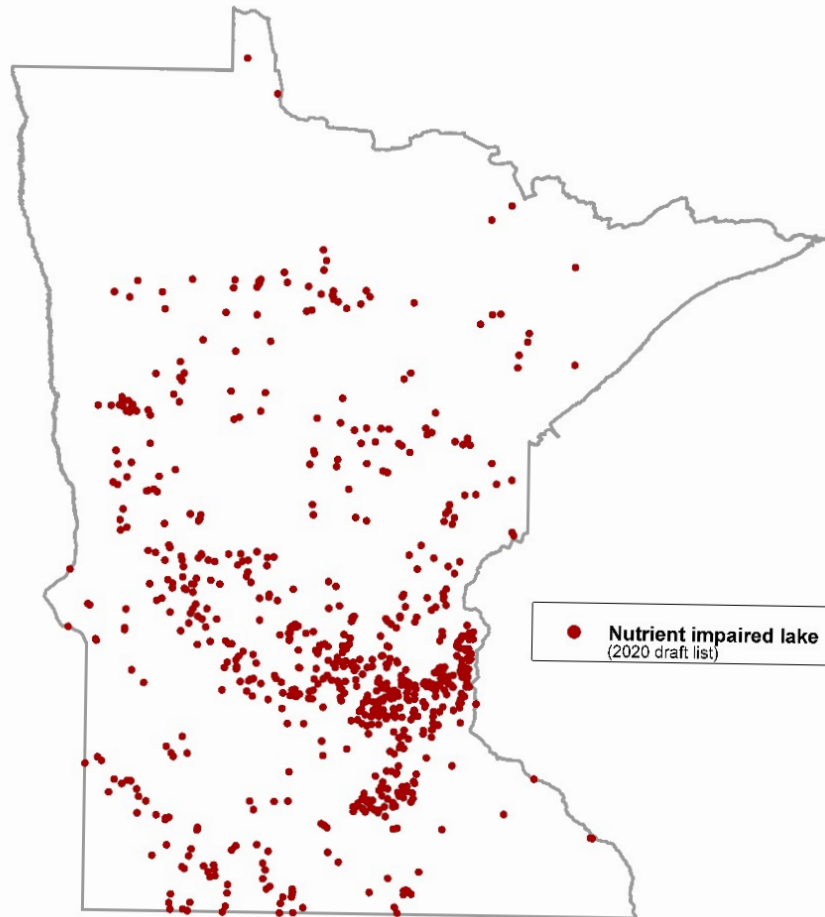
693 lakes impaired

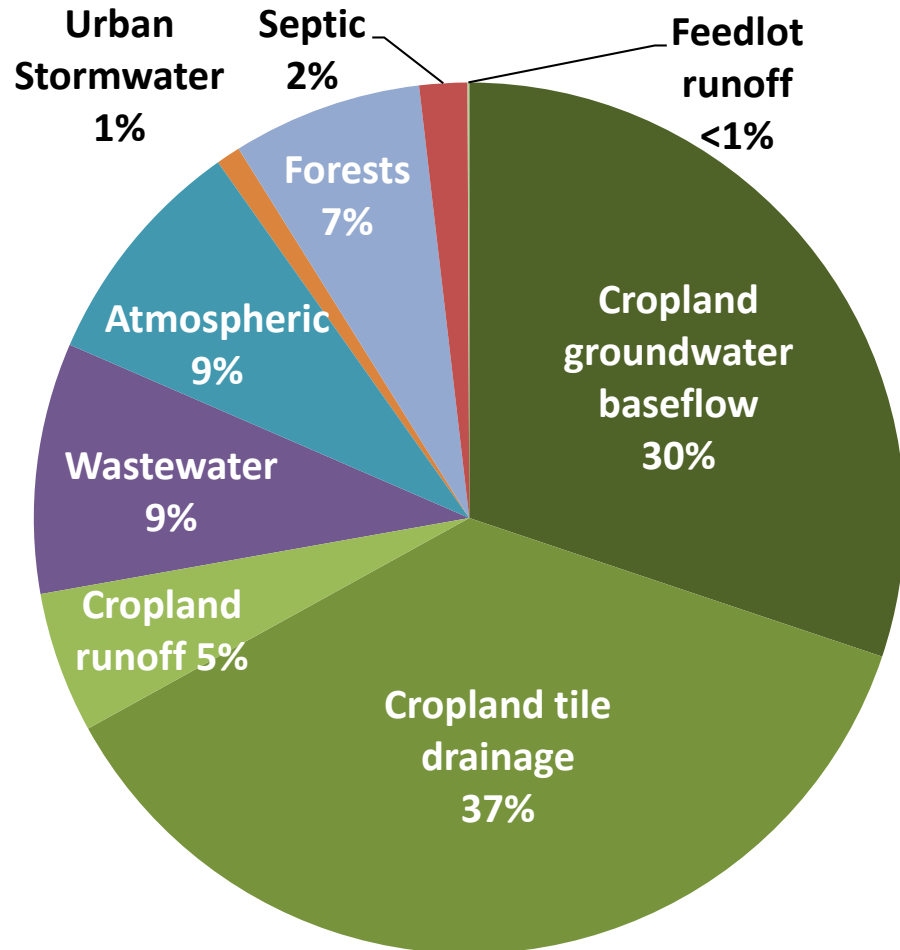
Nitrogen

Statewide sources of nitrogen & phosphorus to rivers

Source: MPCA & UMN 2013

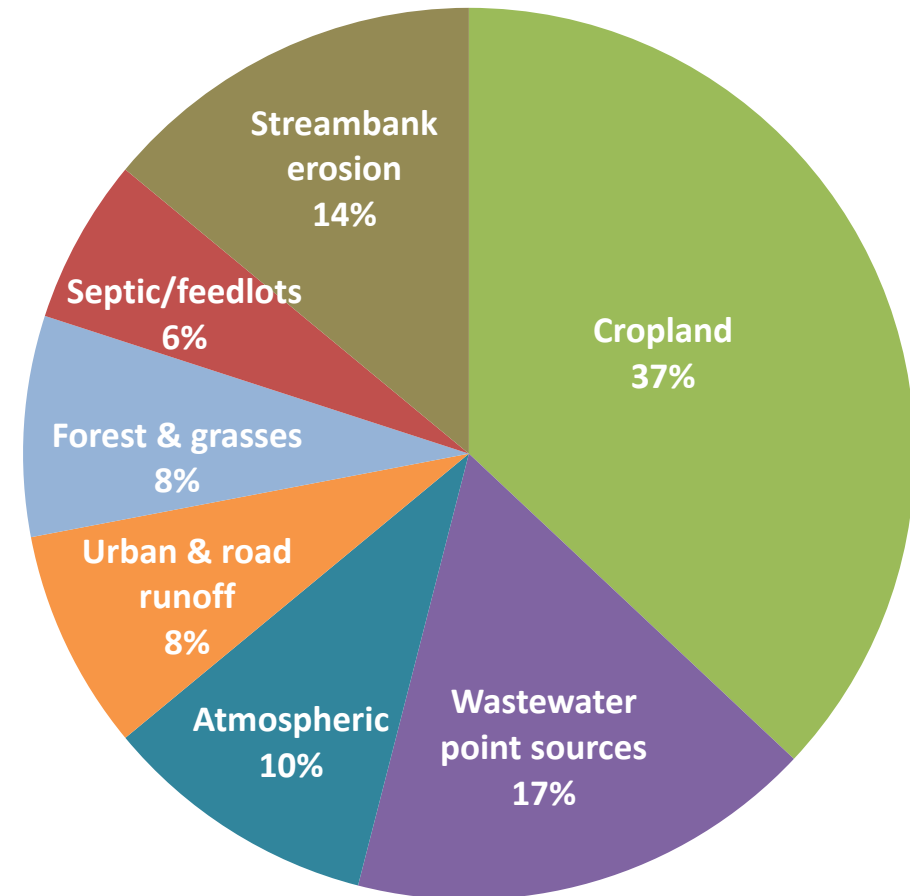
Phosphorus

Source: MPCA et al., 2014

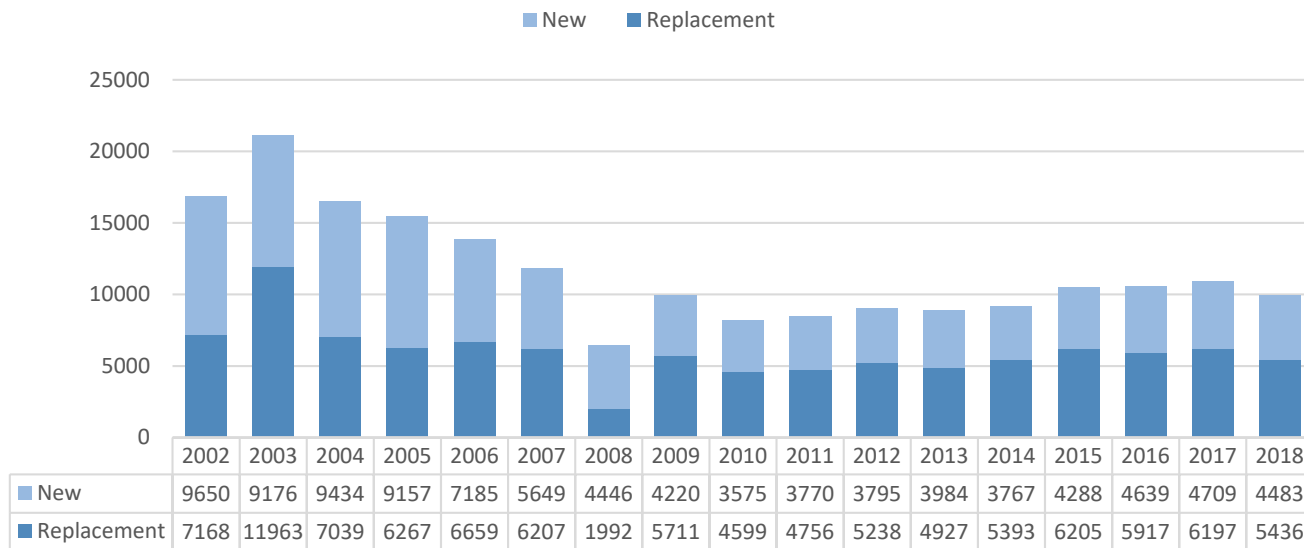
New & Replacement Septic Systems Over 17 Years

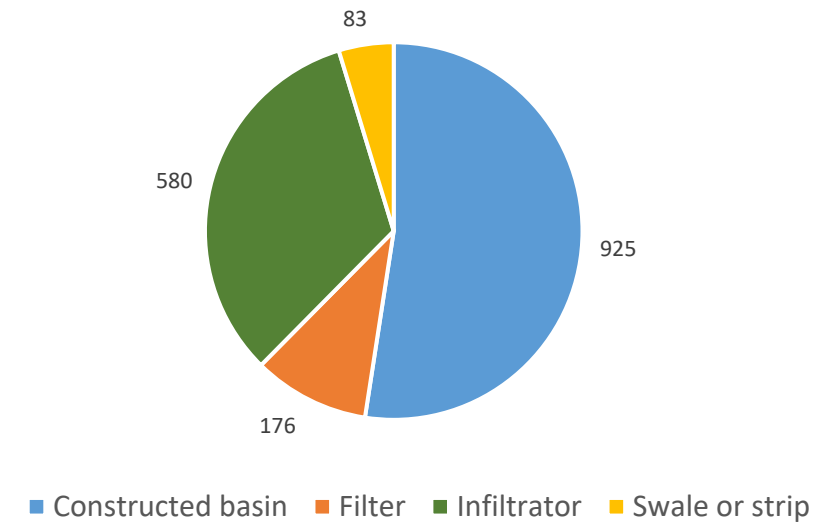
Total number of structural Stormwater BMPs implemented (2014-2018) at 78 MS4s
