An Update from the San Juan Bay Estuary Program

Urban Waters Meeting
June 9, 2017
EPA, Caribbean Office

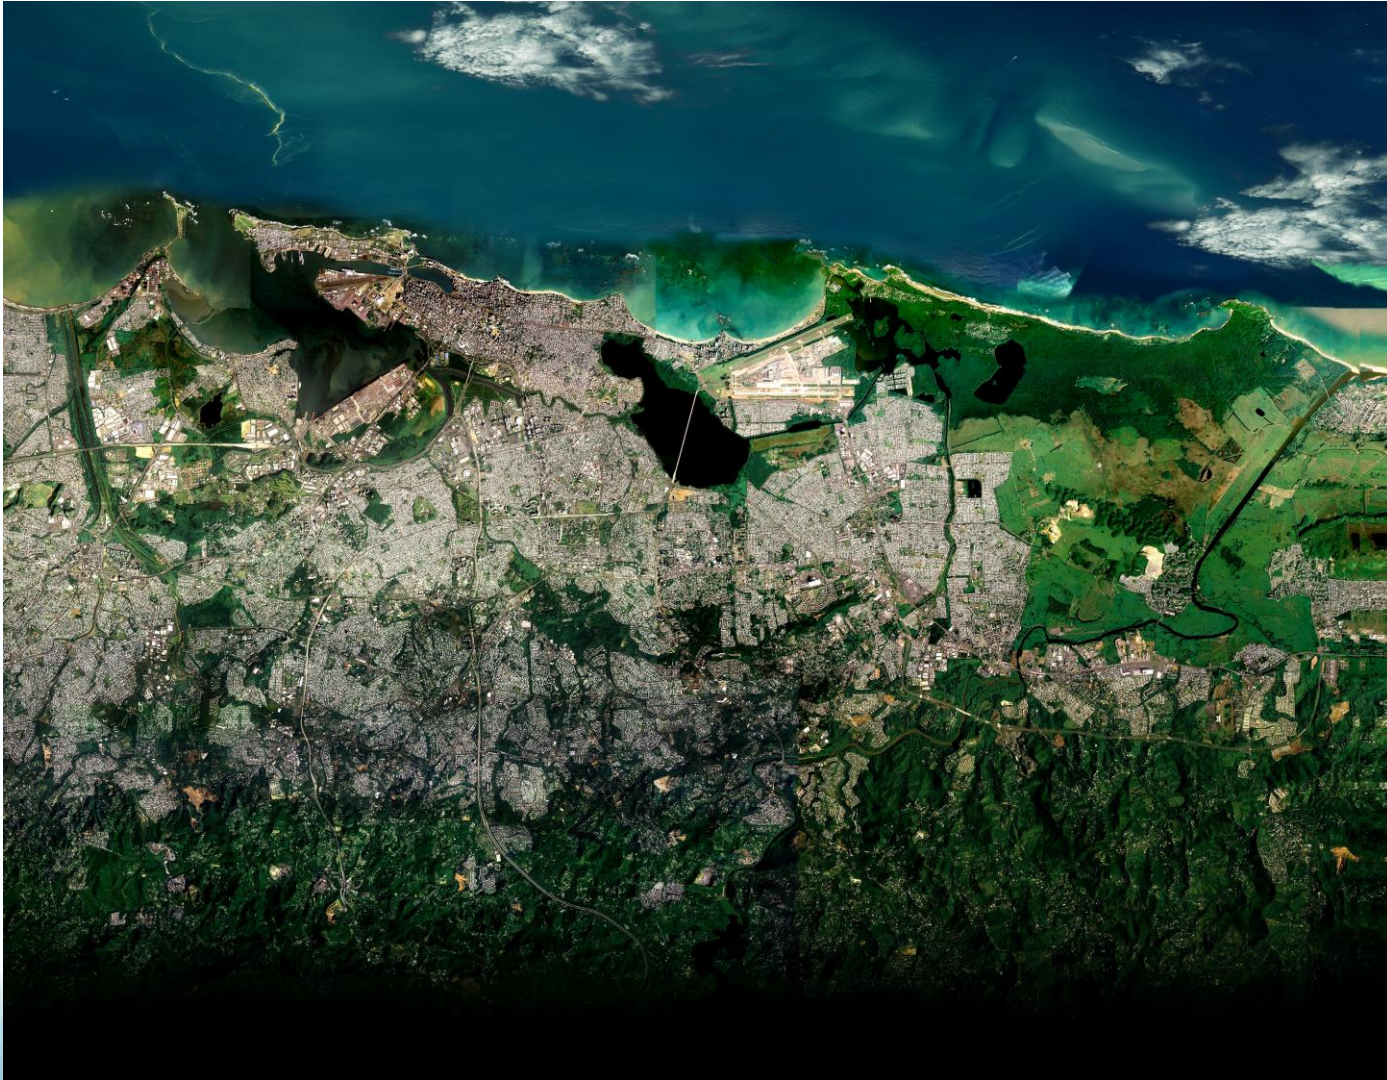
San Juan Bay Estuary Watershed

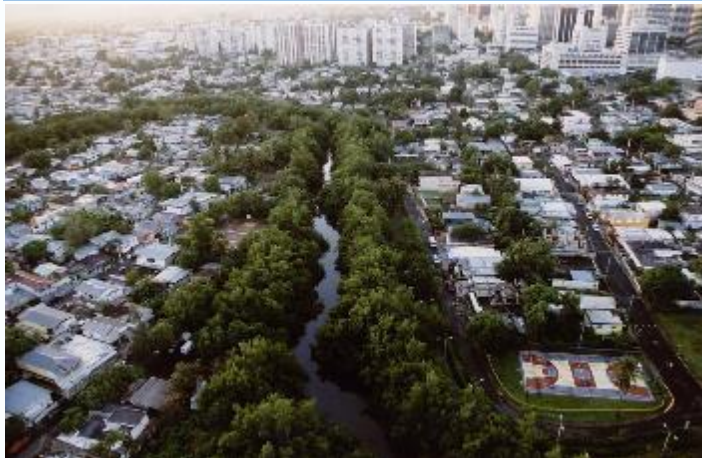
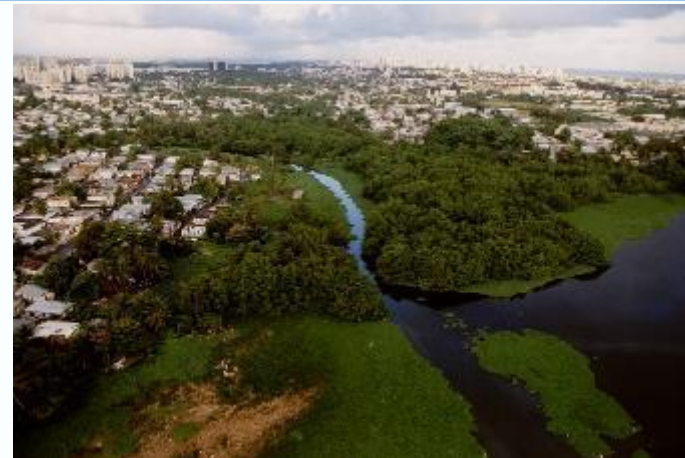
Caño Martín Peña Water Quality Status & Trends

Water Quality Index

MONITORING YEARS	WATER QUALITY INDEX SCORE	NOTE	DESCRIPTION
2008	19	F	VERY POOR
2009	14	F	VERY POOR
2010	40	F	VERY POOR
2011	23	F	VERY POOR
2012	29	F	VERY POOR
2013	33	F	VERY POOR
