Remedial Action Completion Report

Site 00019 – Former Derecktor Shipyard
Marine Sediment, Operable Unit 5

Naval Station Newport
Newport, Rhode Island

September 2019

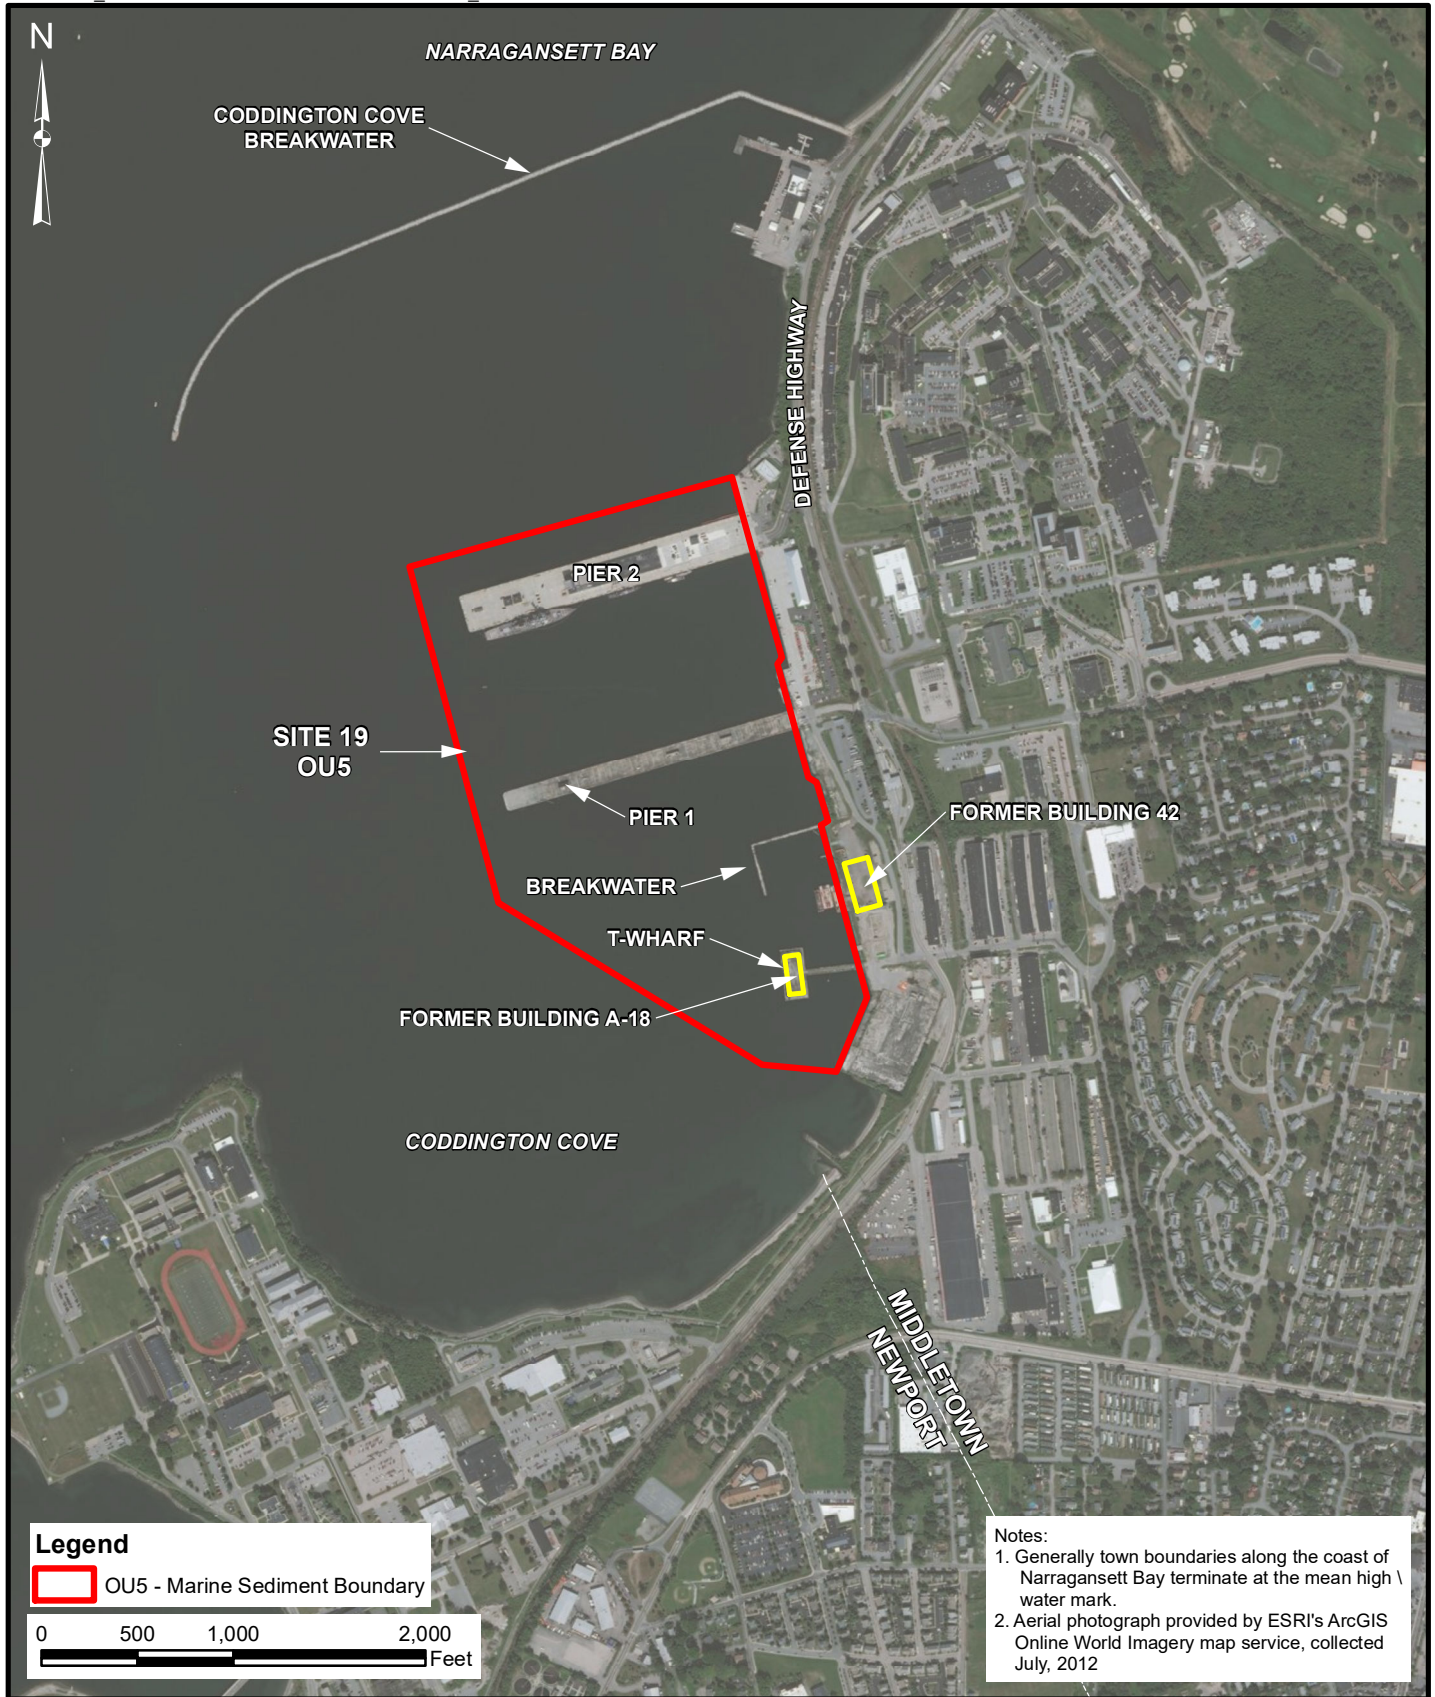
SCALE PER SCALE BAR	
FILE DER_SITE_PLAN.MXD	
REV 0	DATE 07/26/19
FIGURE NUMBER 1-2

SITE PLAN

Site 19 - Former Derecktor Shipyard is composed of approximately 41 acres of shoreline land (OU12) and approximately 110 acres of the adjacent deep water industrial port in Coddington Cove (OU5) that were formerly leased to Robert E. Derecktor Shipyards of Rhode Island, Inc. A site plan is provided as Figure 1-2.

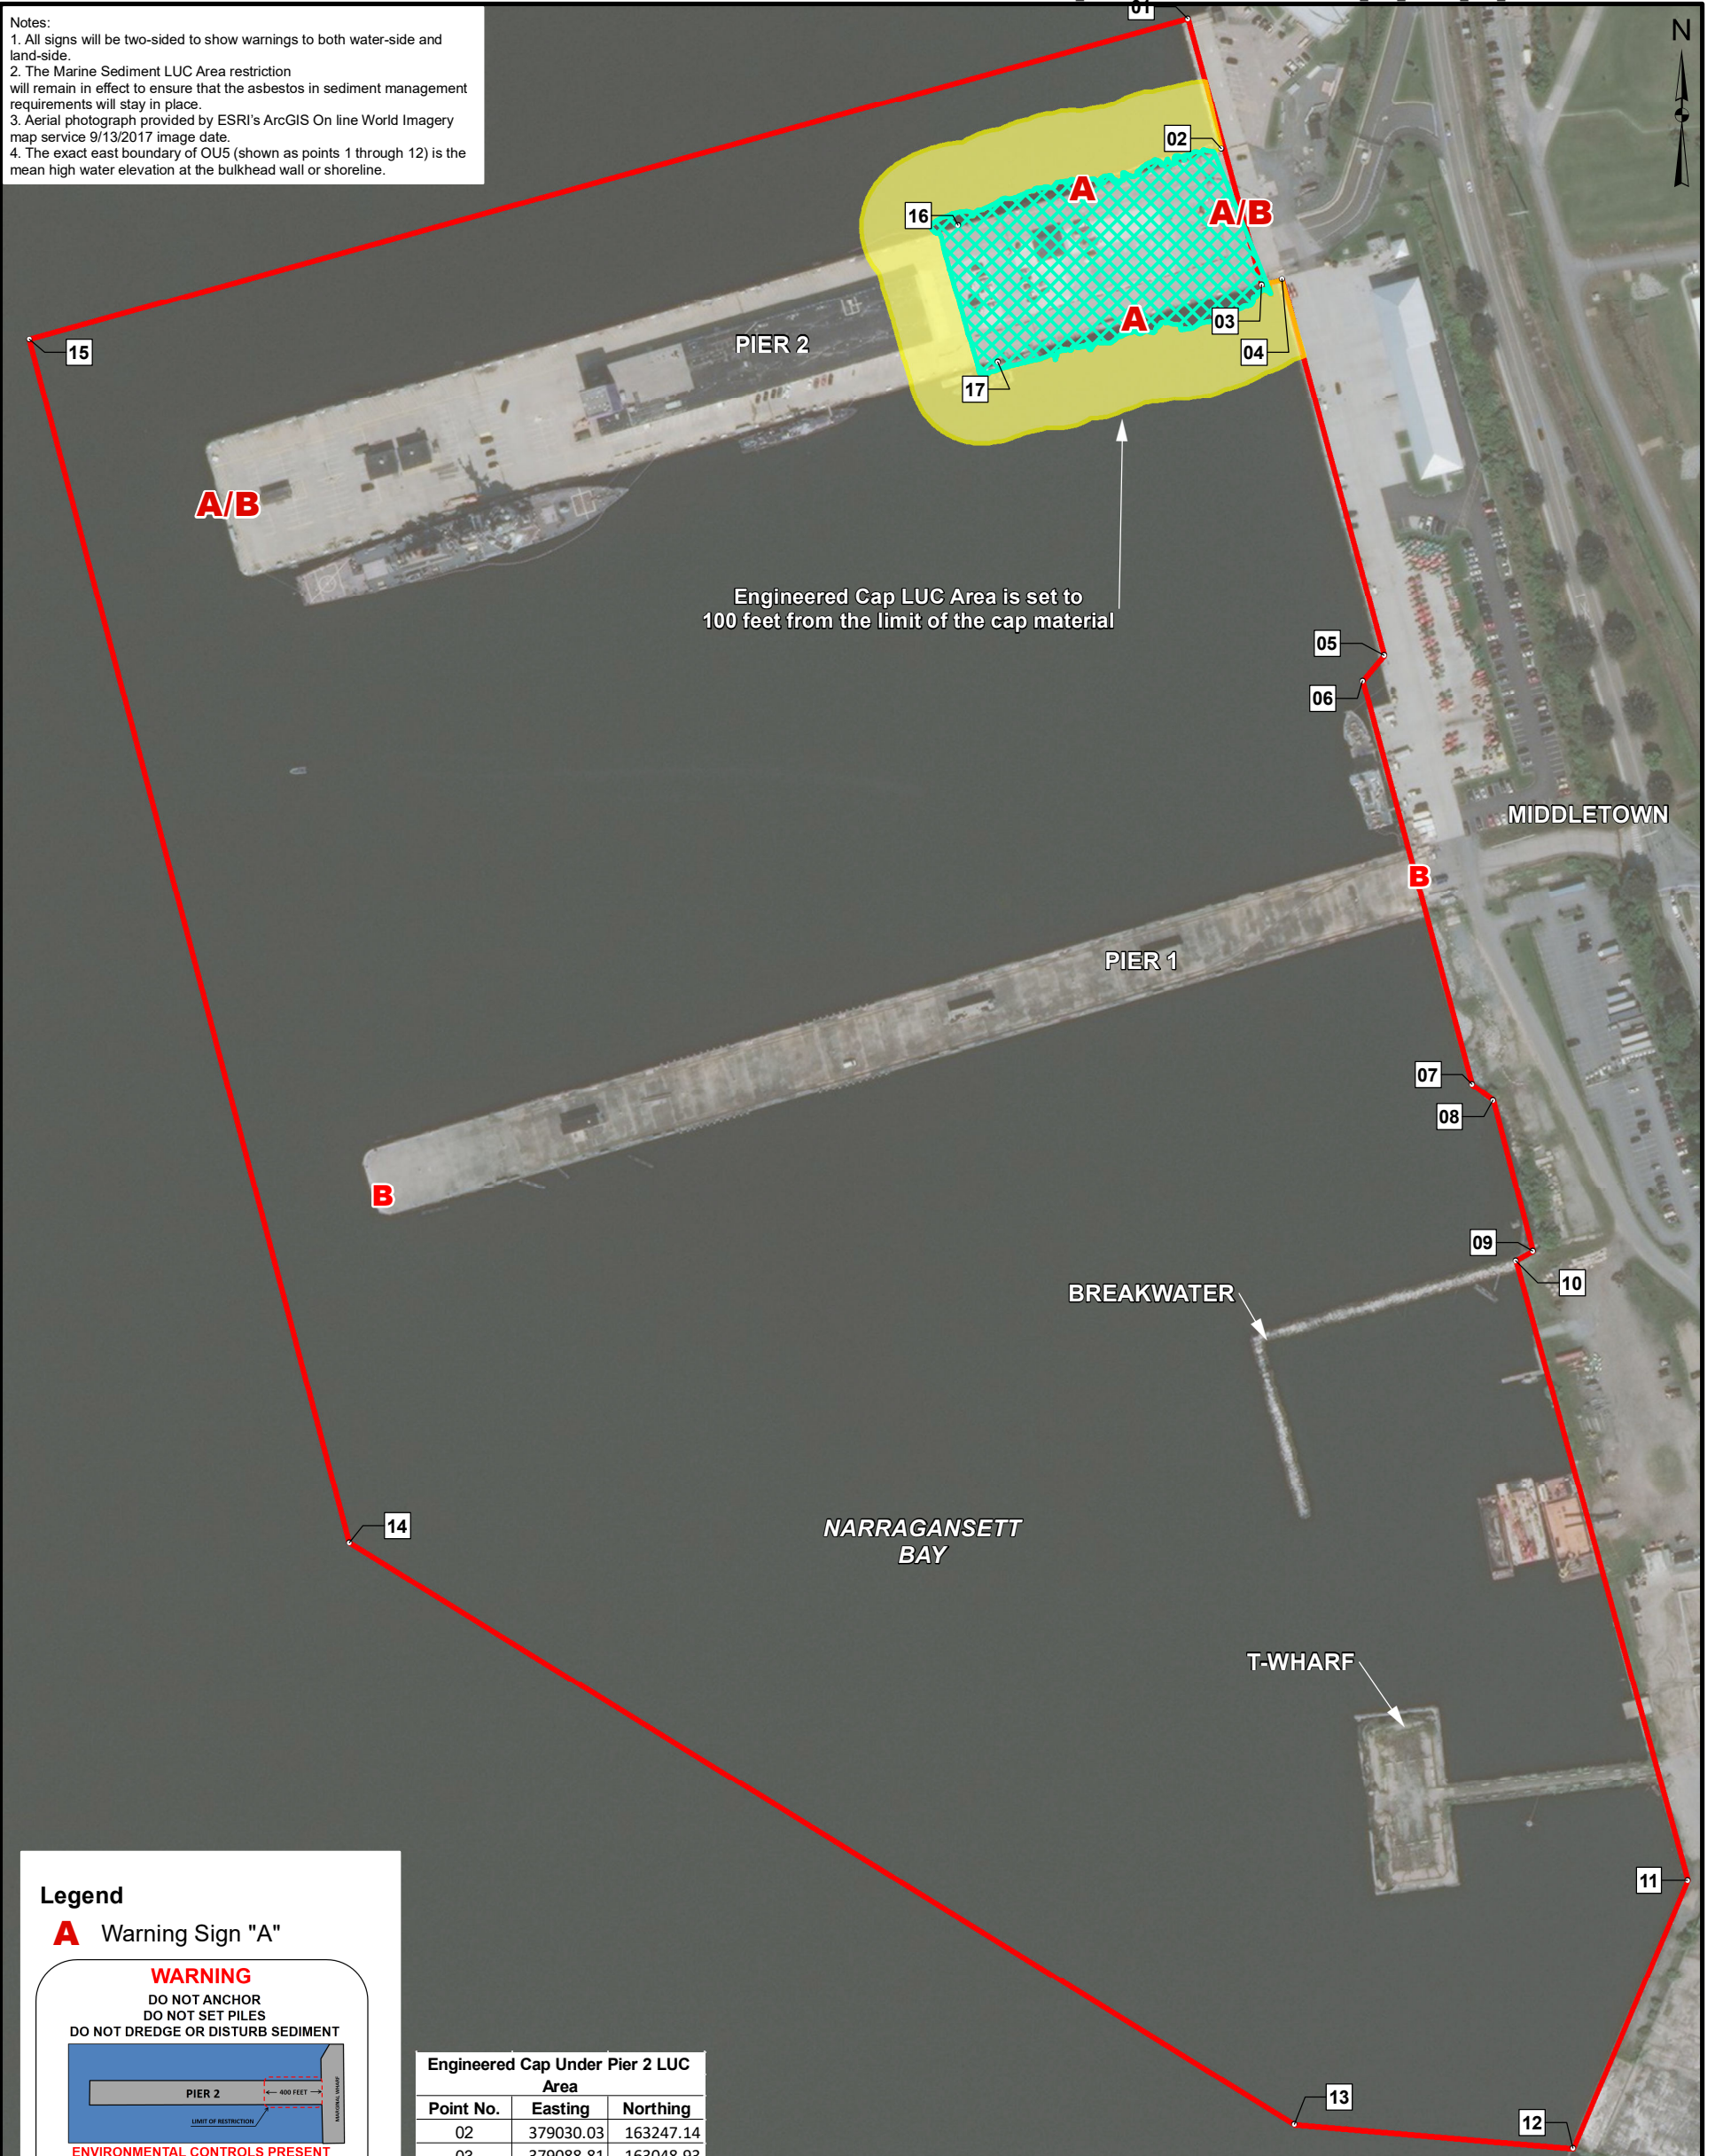
Notes:
 1. All signs will be two-sided to show warnings to both water-side and land-side.
 2. The Marine Sediment LUC Area restriction will remain in effect to ensure that the asbestos in sediment management requirements will stay in place.
 3. Aerial photograph provided by ESRI's ArcGIS On line World Imagery map service 9/13/2017 image date.
 4. The exact east boundary of OU5 (shown as points 1 through 12) is the mean high water elevation at the bulkhead wall or shoreline.

Engineered Cap LUC Area is set to 100 feet from the limit of the cap material

A Warning Sign "A"

B Warning Sign "B"

- Engineered Cap As-Built
- Engineered Cap LUC Area
- Site 19 OU5 Marine Sediment LUC Area

Engineered Cap Under Pier 2 LUC Area

The two-foot thick engineered barrier (in-situ cap) was placed within two target areas, G-25 and G-29 (see Figure 3-3), beneath the east end of Pier 2 between September 25, 2017 and April 4, 2018. The in-situ cap was constructed of 11,950.15 tons of D50 = 1.5-inch aggregate (American Association of State Highway and Transportation Officials M43-50) and placed throughout a 136,000-square foot area. The in-situ cap material was selected based on the conclusions and recommendations specified in the Sediment Cap Geotechnical Recommendations technical memorandum (TtEC, 2017), provided as Appendix I to the CCR.
