# **Northern Agency Tronox Mines**

## **DRAFT FINAL Appendix K Access Road Report**

**Submitted to  
U.S. Environmental Protection Agency**

**Submitted by  
Tetra Tech, Inc.  
1999 Harrison Street, Suite 500  
Oakland, CA 94612**

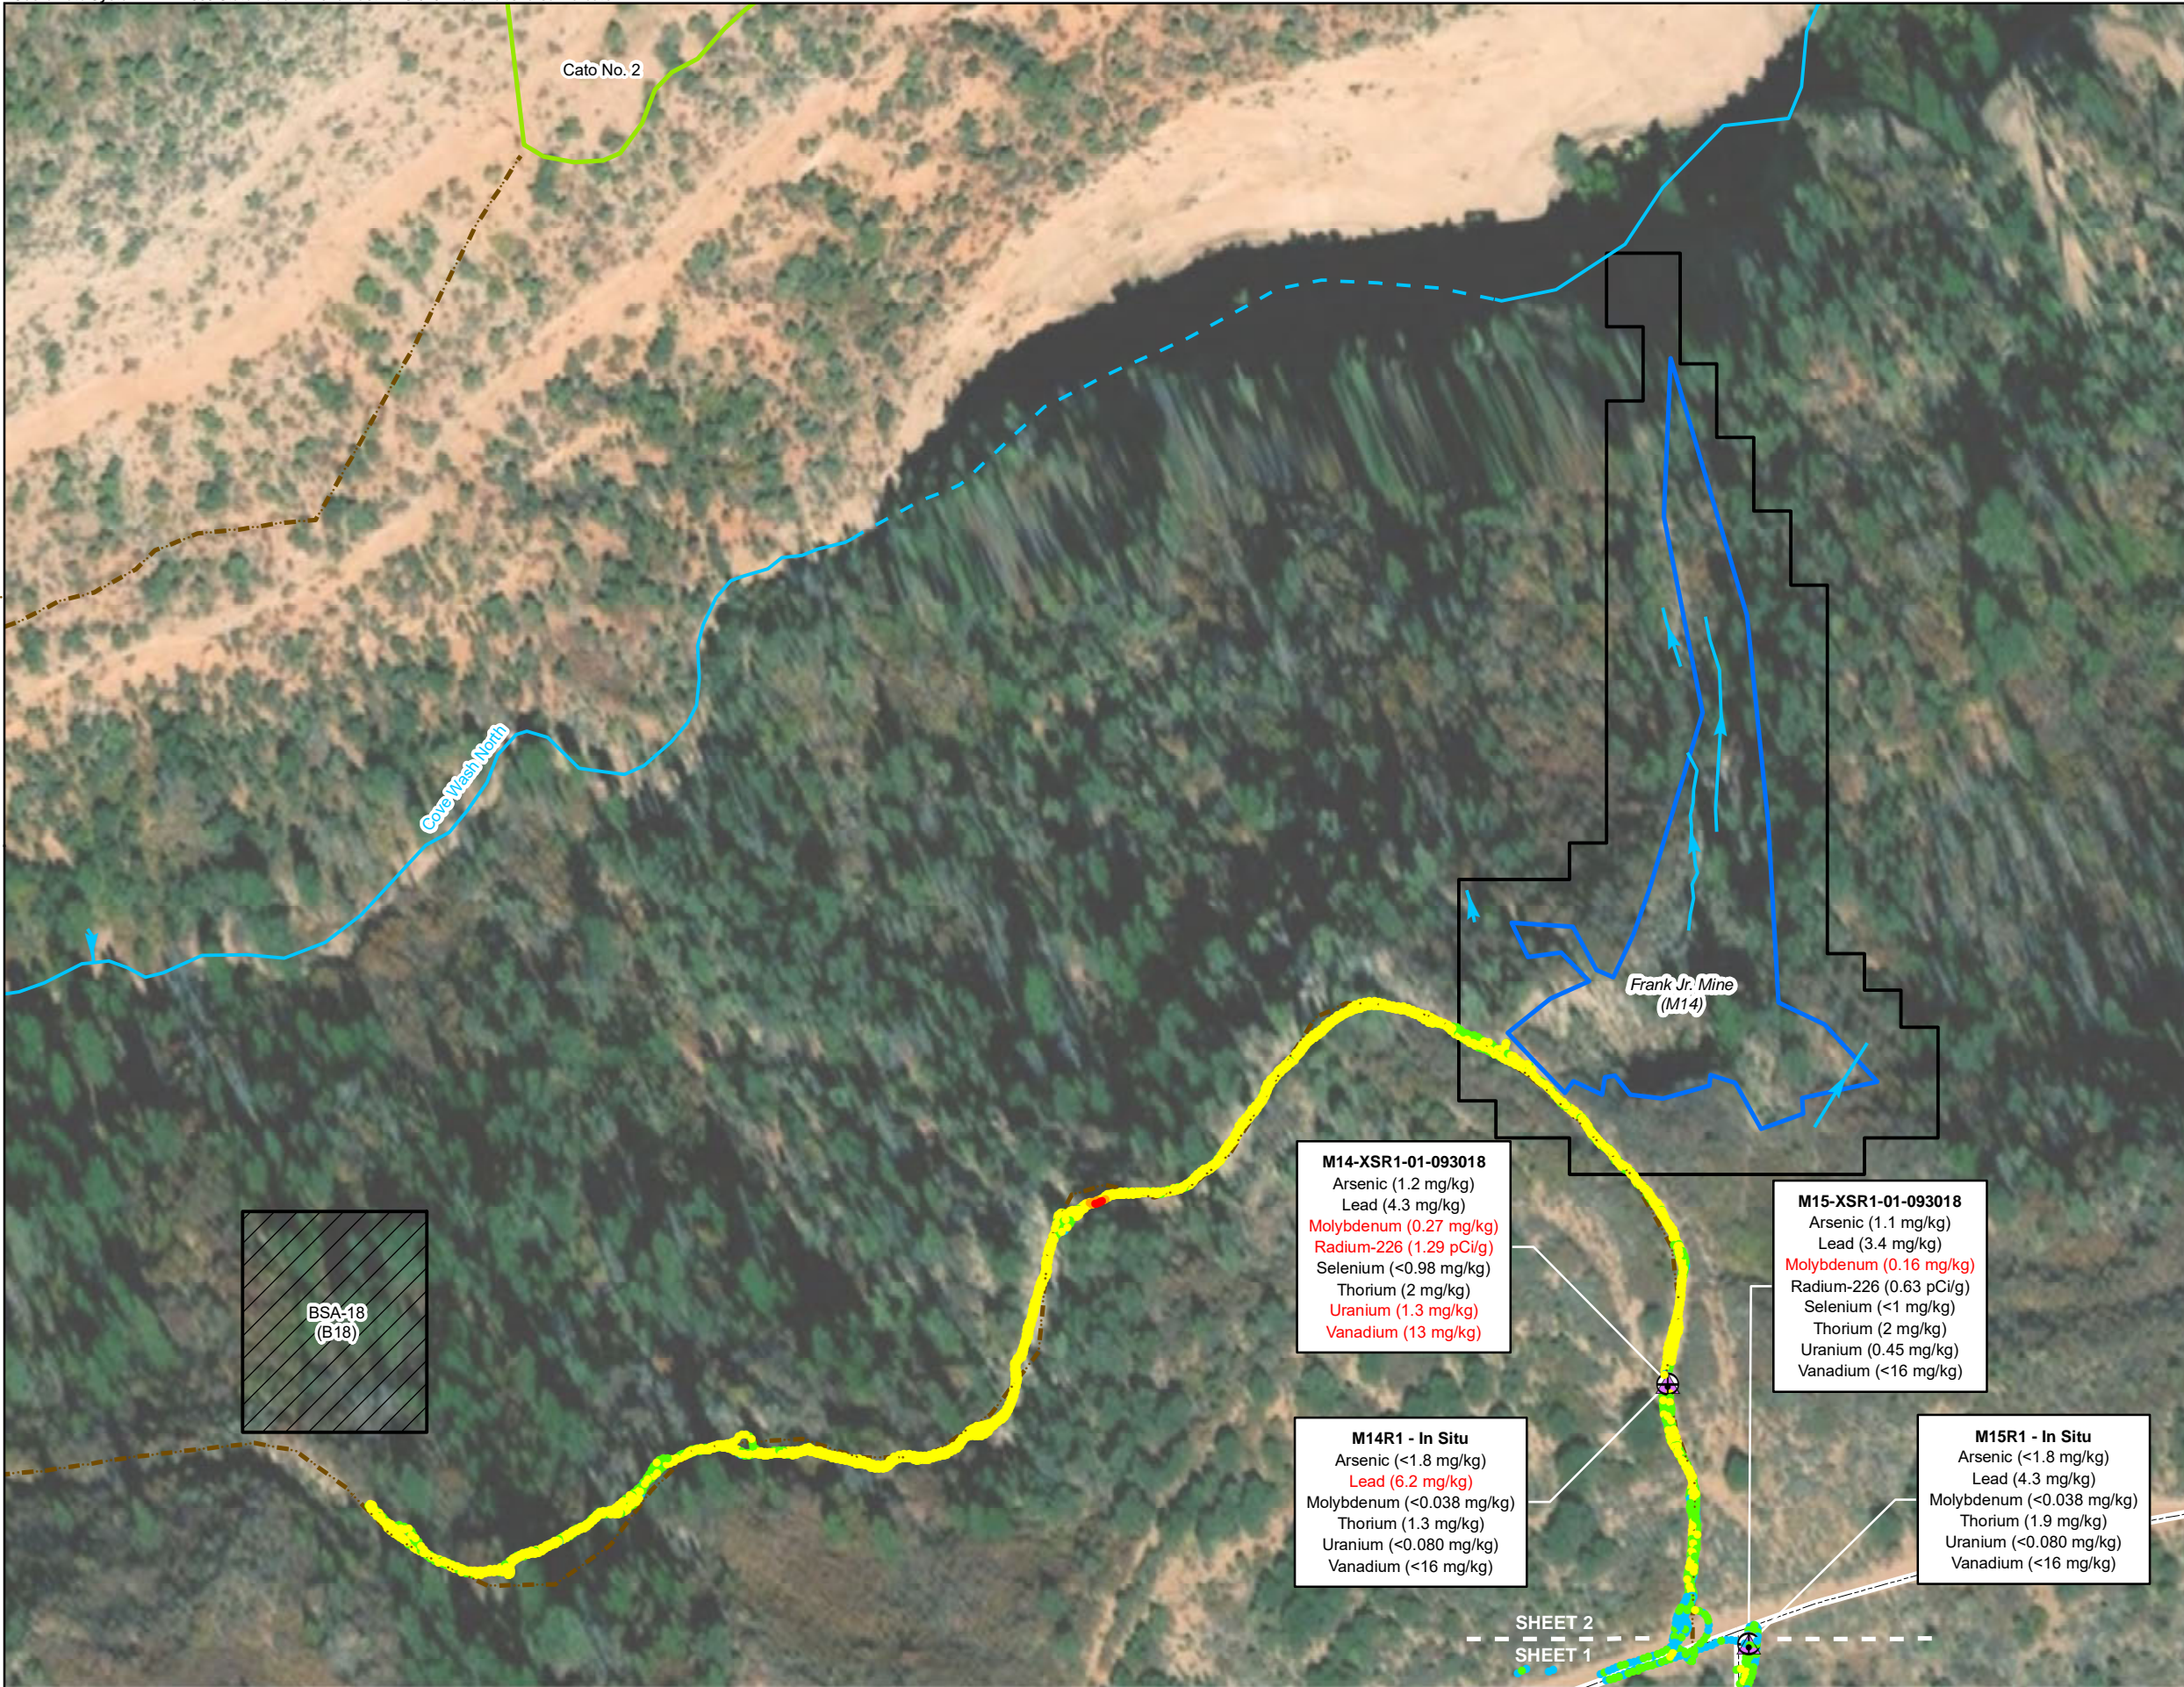
Figure No.:  
**K-9**

Notes:  
<sup>2</sup>The applied gamma BTV is 11,319 cpm derived from BSA-19 as presented in Appendix A. Avg. BG: Average value of the background data set.

▲ XRF Confirmation Soil Sample<sup>1</sup>  
 ⊕ In Situ XRF Measurement<sup>1</sup>  
**Gamma Reading (cpm)<sup>2</sup>**  
 ● ≤ 9,560 ≤ Avg. BG  
 ● 9,560 - 11,319 Avg. BG - 1 x BTV  
 ● 11,319 - 22,638 1 x BTV - 2 x BTV  
 ● 22,638 - 33,957 2 x BTV - 3 x BTV  
 ● 33,957 - 45,276 3 x BTV - 4 x BTV  
 ● 45,276 - 113,190 4 x BTV - 10 x BTV  
 ● ≥ 113,190 ≥ 10 x BTV  
 □ AUM Site Boundary  
 □ Survey Area Boundary  
 ▨ Background Location  
 □ Non-Tronox AUM Site  
 - - - Access Route - Foot  
 - - - Access Route - Vehicular  
 - - - Drainage - Estimated Path  
 - - - Drainage - Field Mapped

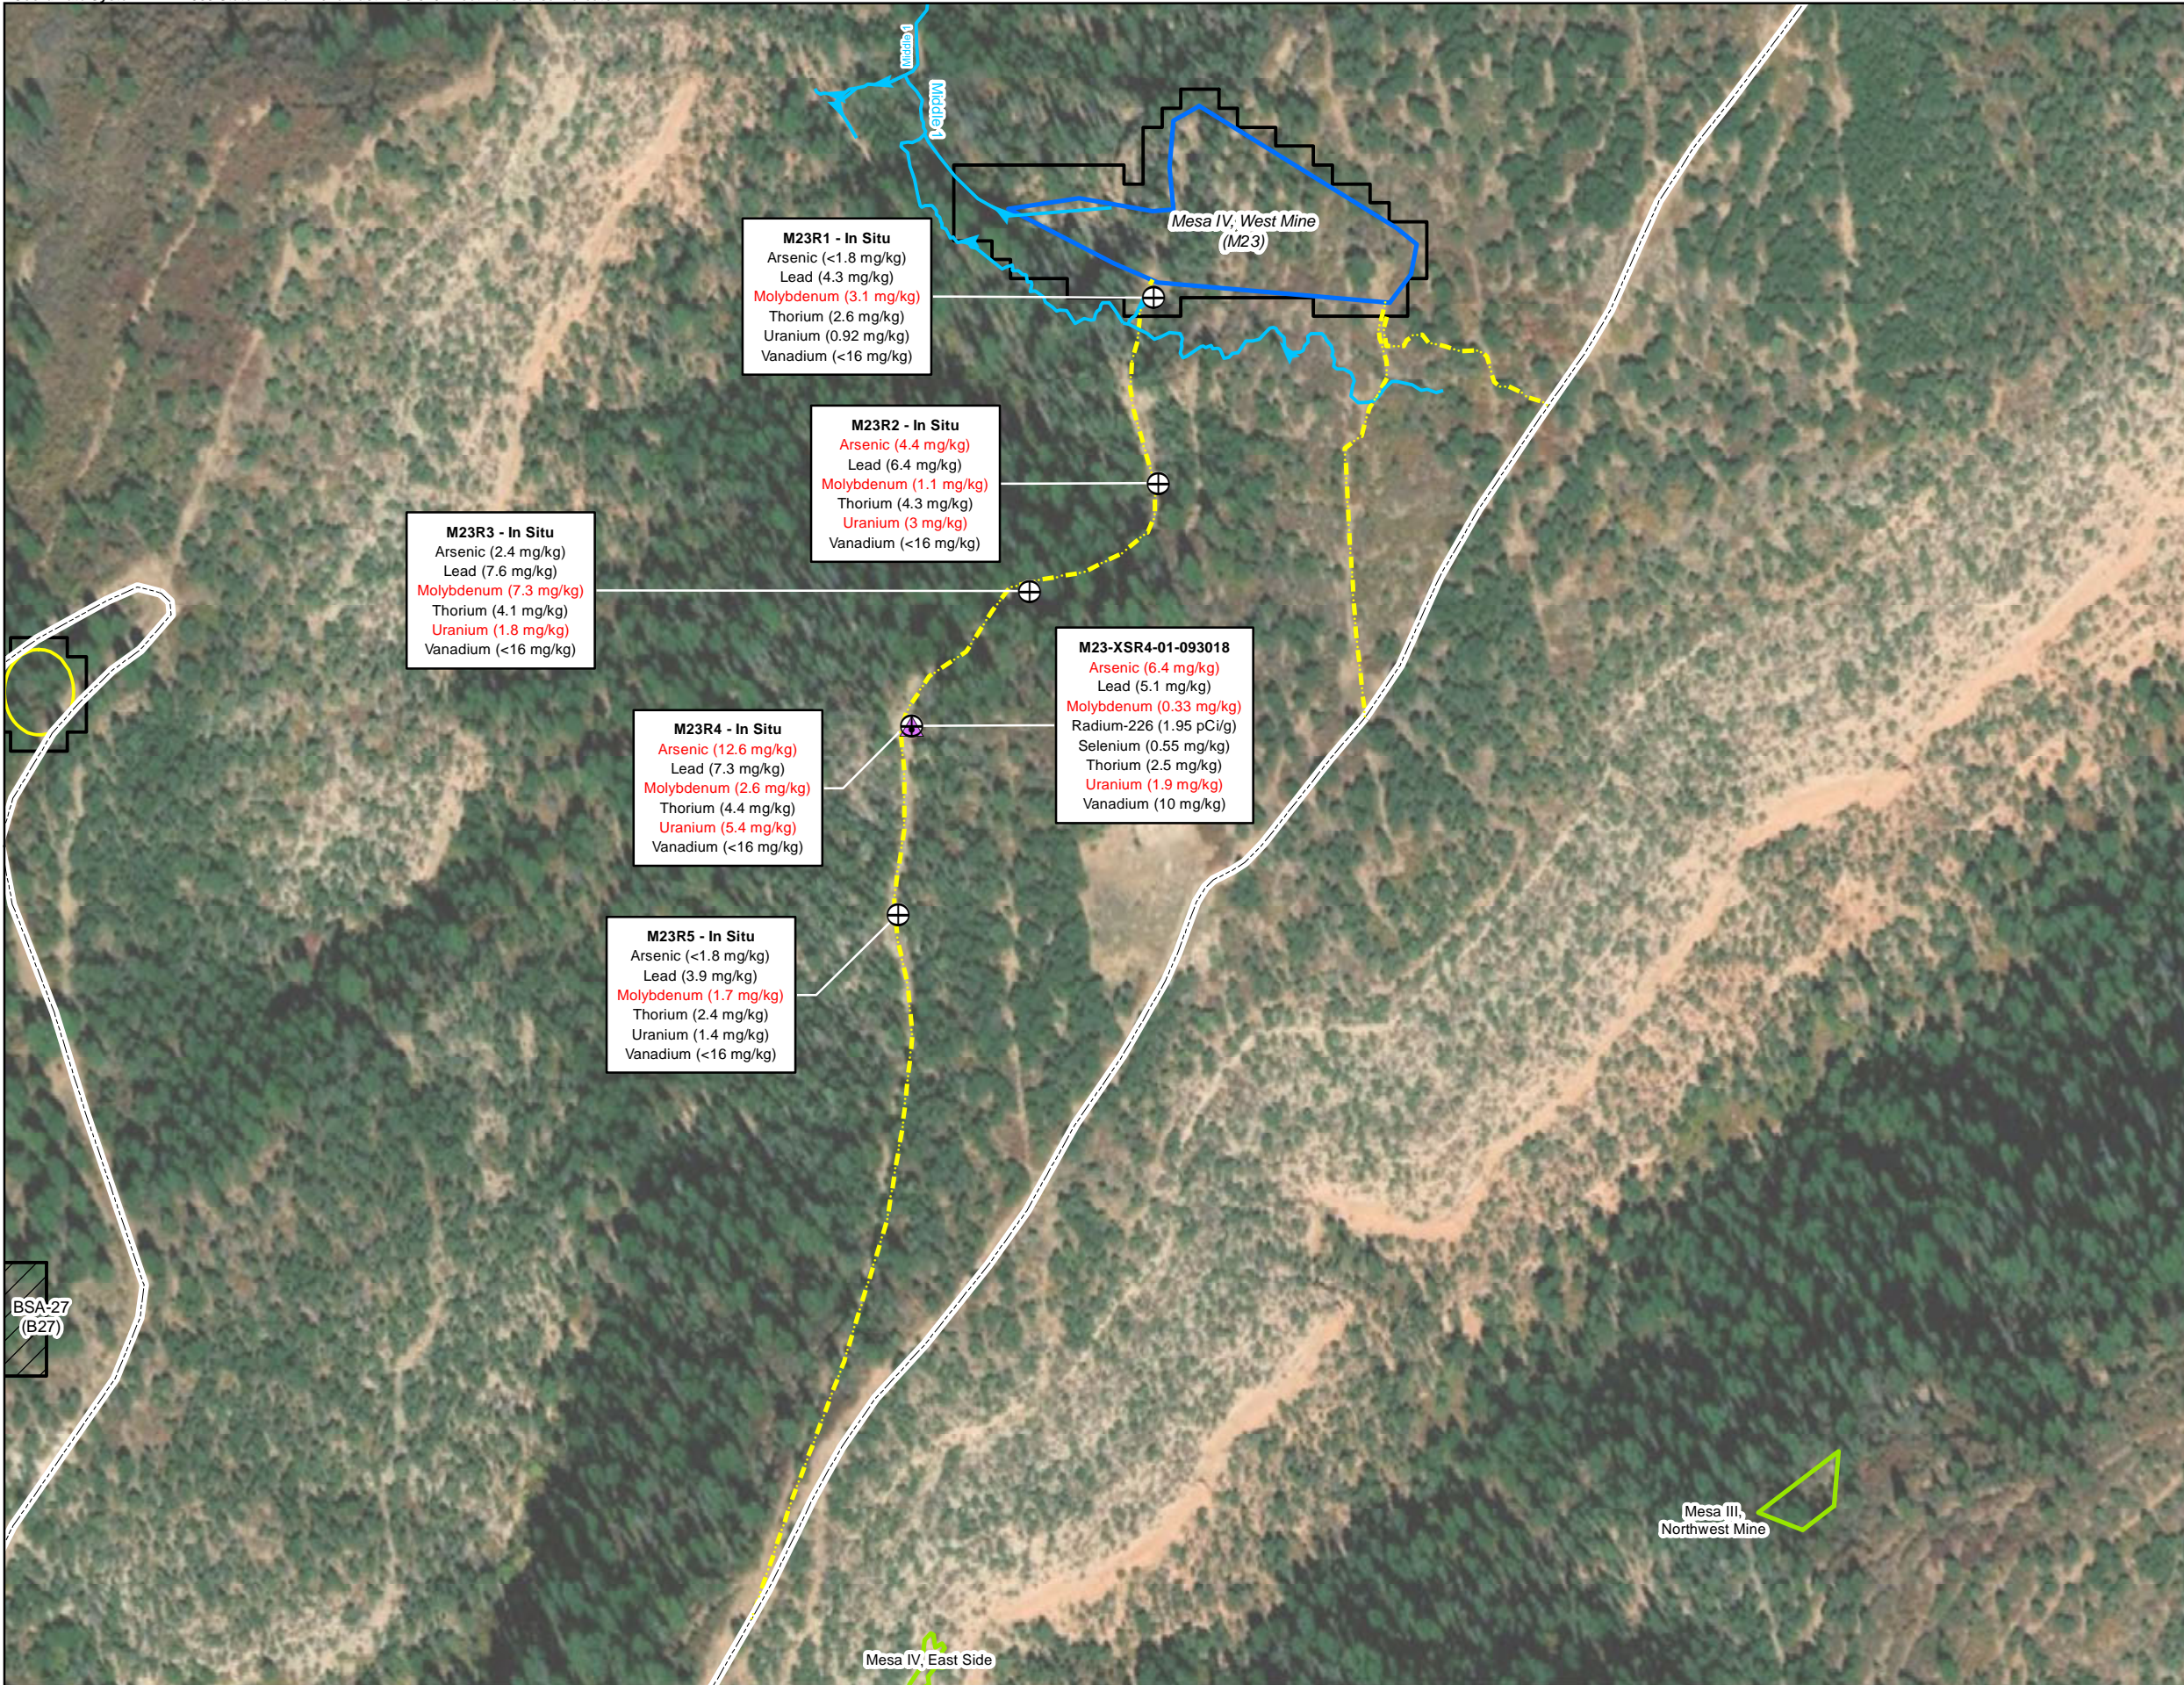
▲ XRF Confirmation Soil Sample\*  
 ⊕ In Situ XRF Measurement\*  
 [Blue Outline] AUM Site Boundary  
 [Yellow Outline] Non-AUM Target Site Boundary  
 [Black Outline] Survey Area Boundary  
 [Hatched Box] Background Location  
 [Green Outline] Non-Tronox AUM Site  
 [Dashed Yellow Line] Access Route - Foot  
 [Dashed White Line] Access Route - Vehicular  
 [Blue Arrow] Drainage - Field Mapped

Note: Gamma survey data not available.

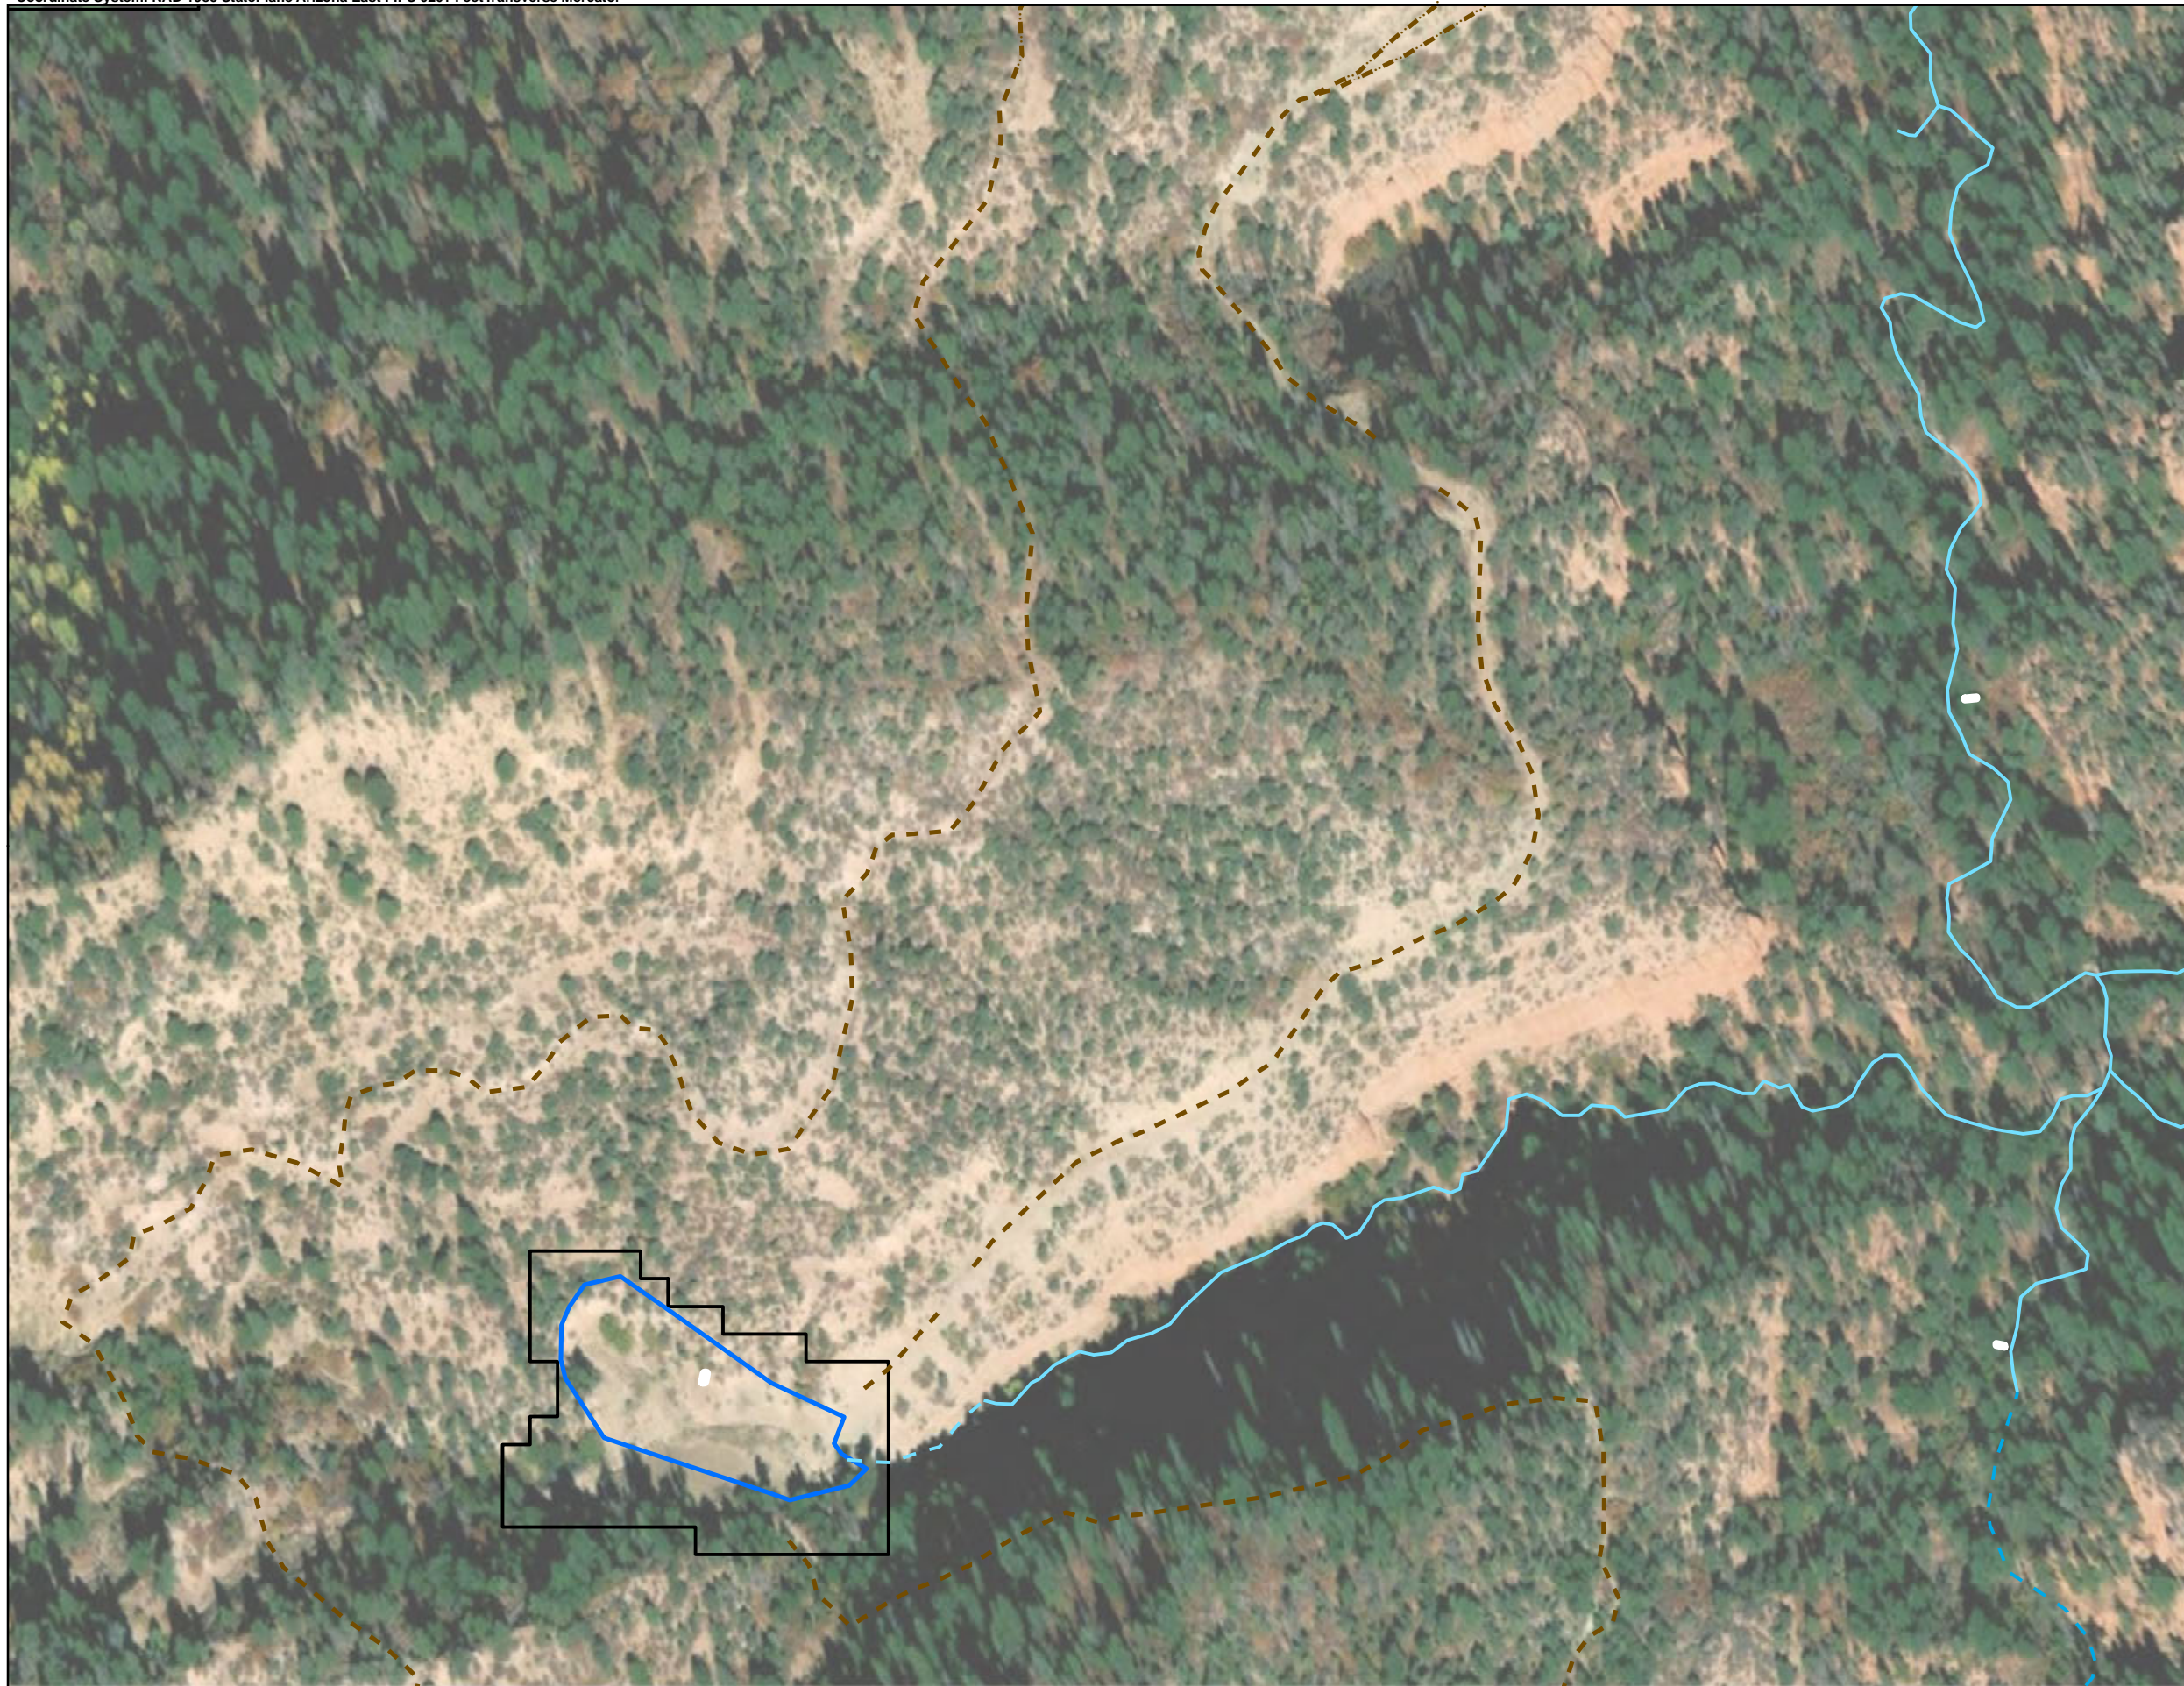
MESA I 3/4 INCLINE  
 ACCESS ROAD GAMMA RADIATION SURVEY

The gamma radiation survey results indicate that Mesa I 3/4 Incline access road does not appear to be impacted, because the median gamma measurement is approximately equal to the applied BTV, and none of the measurements exceeded two times the applied BTV.

Note:  
 In situ XRF and XRF confirmation sample data not available.  
<sup>1</sup>The applied gamma BTV is 11,378 cpm derived from BSA-30 as presented in Appendix A. Avg. BG: Average value of the background data set.
