# Acid Brook Sampling Update

May 2, 2012  
Environmental CAG Mtg.

# Acid Brook Sampling Round 1

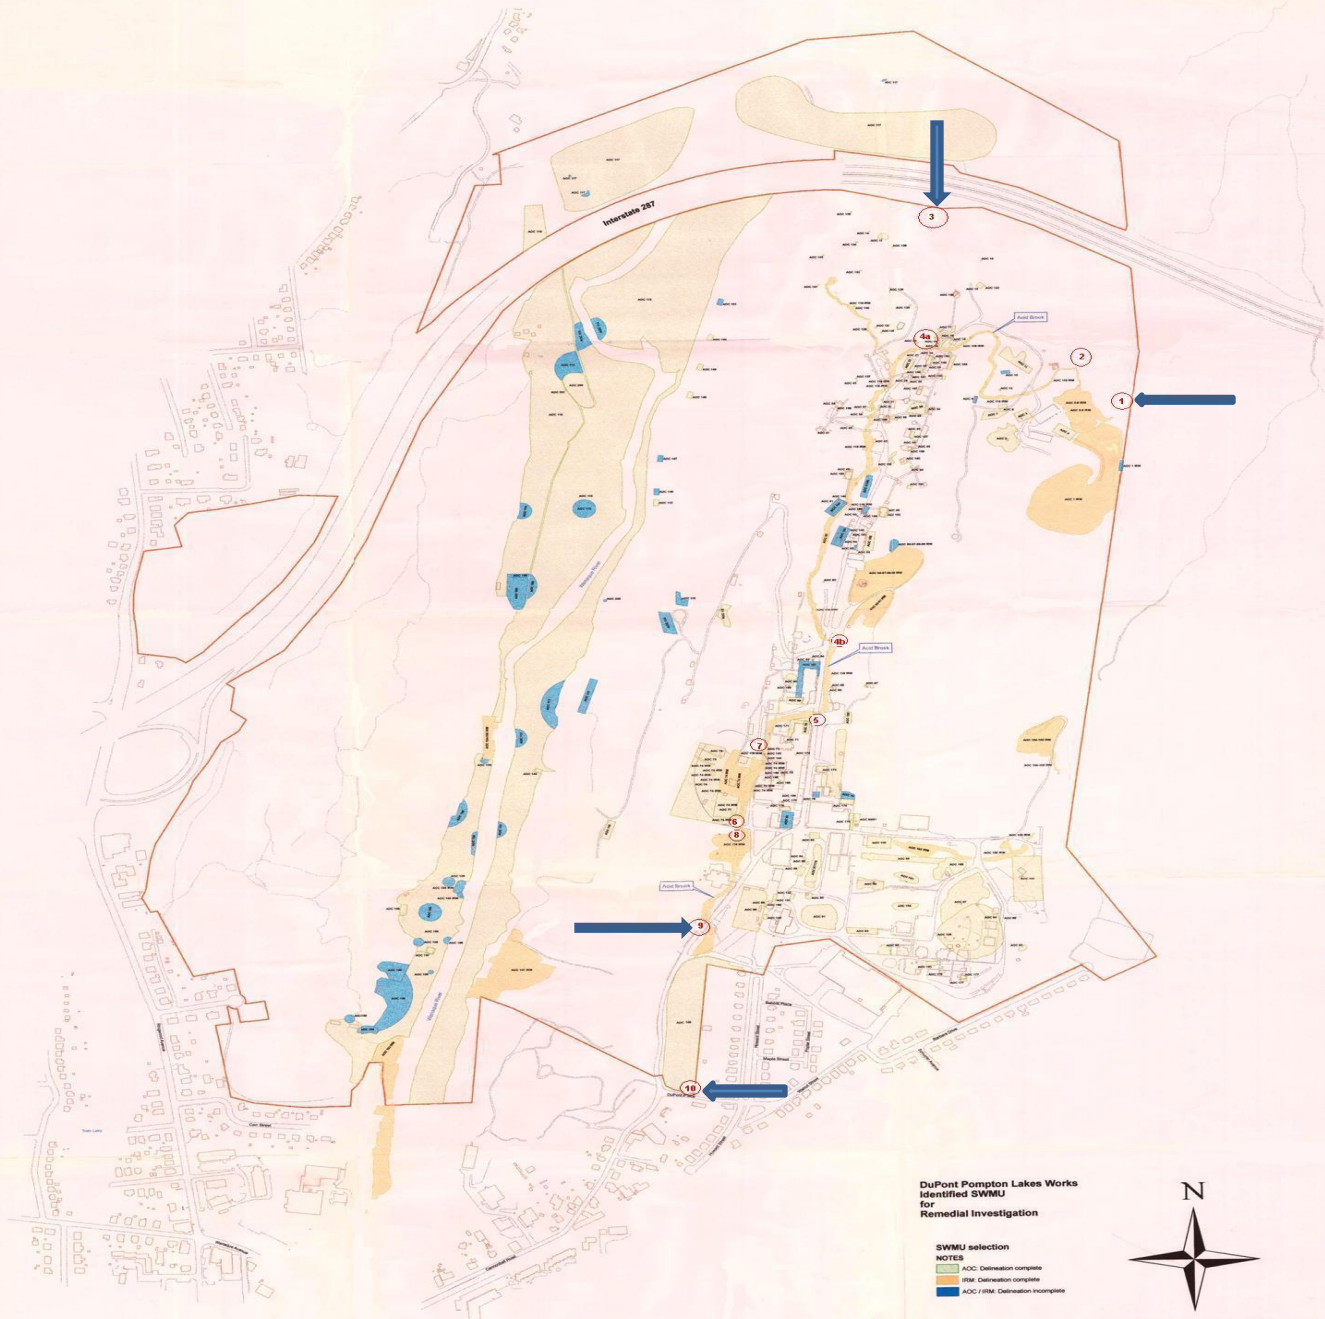
**DuPont Pompton Lakes Works  
Identified SWMU  
for Remedial Investigation**

**SWMU selection**  
 NOTES  
 ACC: Detention complete  
 IRM: Detention complete  
 ACC / IRM: Detention incomplete

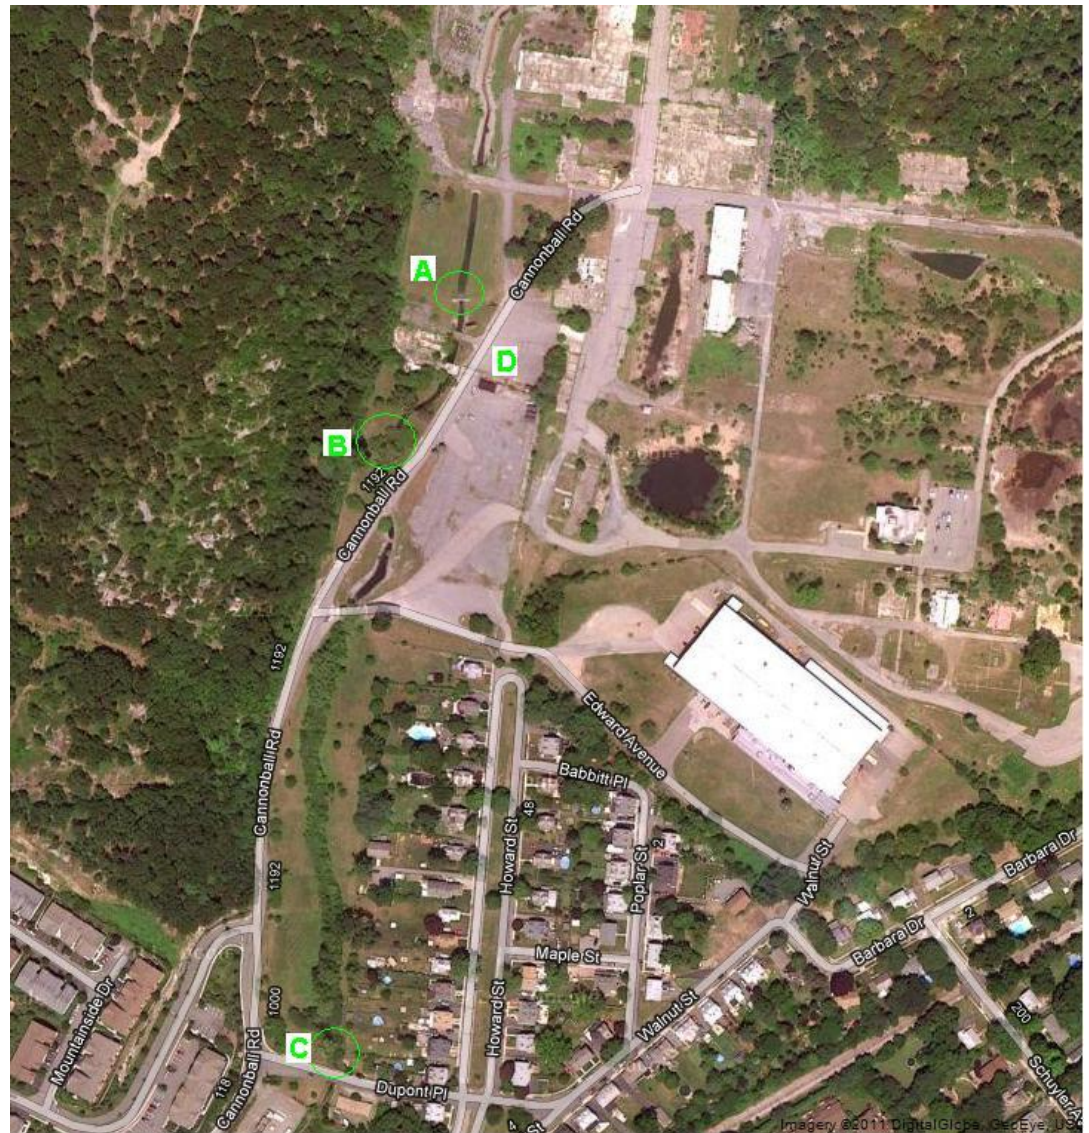
# Sampling Locations 9 and 10

- A - Spillway for Retention Pond
- B - **Location 9** (Weir to measure water flow)
- C - **Location 10** (DuPont Pl) --  
A spillway for retention pond above vegetated area before culvert that is present below DuPont Place
- D - Parking Lot with Security Office  
Entrance to DuPont Facility

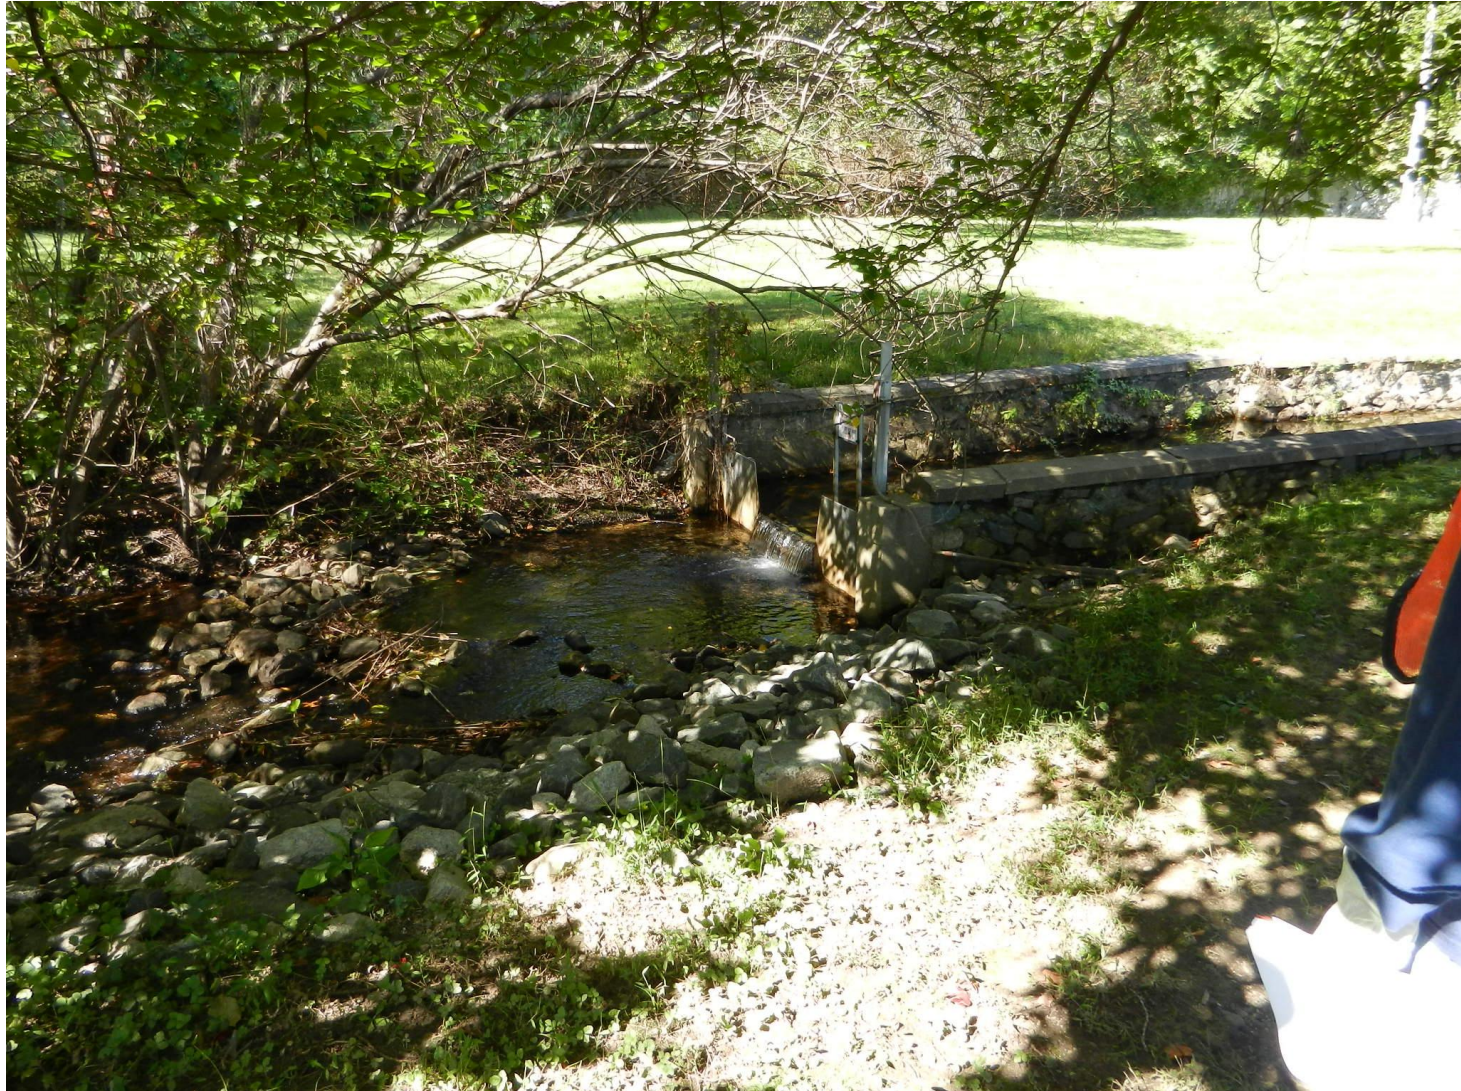
# Sampling Location 09 (weir)

**Location 9** (weir) -- Location 9 (weir to measure water flow) [aqueous and sediment]

- **EPA believes that there is very little potential for Acid Brook sediment to re-contaminate Pompton Lake because of a lack of a significant sediment source in Acid Brook**
  - Operations at the site ceased in April 1994
  - Interim remedial measures (IRM) have been implemented to address impacted portions of the Acid Brook (on-site and off-site)
  - Measures include: excavation, backfilling with clean fill, installation of geotextile, silt curtain, and rip-rap
  - Plant run-on/run-off control was also improved to prevent impact to Acid Brook.
- **DuPont will evaluate alternatives to address the mercury/sediment results**
  - DuPont will address Location 9 and Location 10 area in an IRM

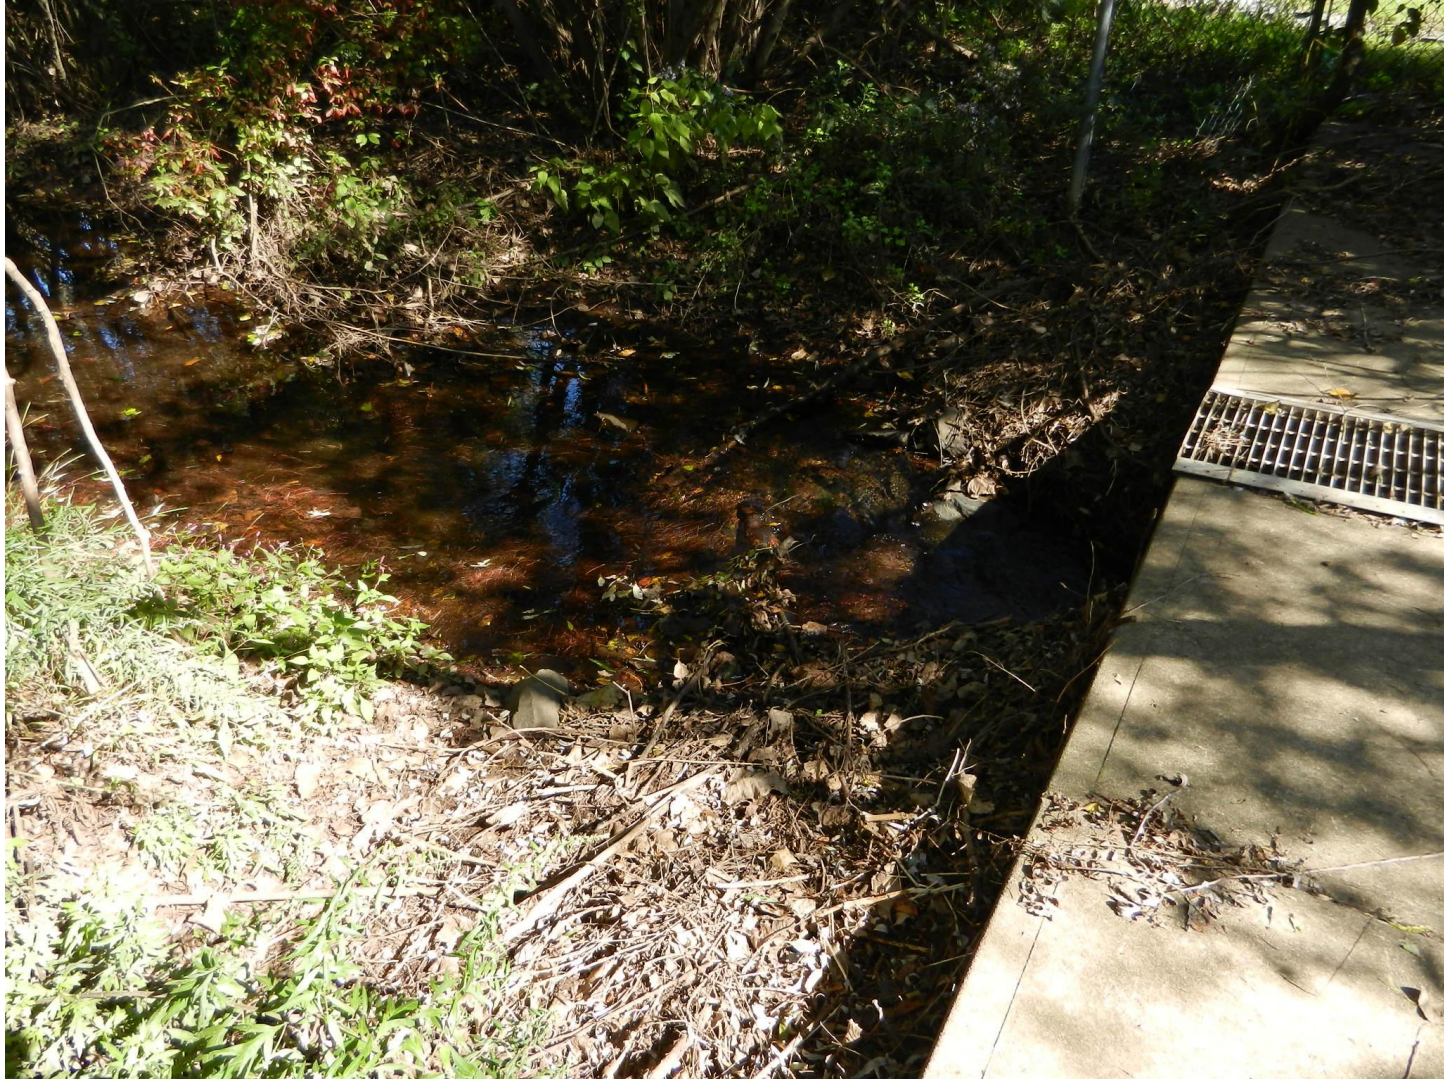
# Sampling Location 10 (DuPont Pl)

**Location 10** (DuPont PI) – Although still on DuPont property, this spillway is adjacent to Valbruna and residents. [aqueous and sediment]

- **Exception: a single sample (SITE10-SD-02) and a single contaminant (mercury)**
  - **The mercury sediment concentration of 29 mg/kg in sample SITE10-SD-02 was marginally above the risk-based remediation goal of 23 mg/kg.**
  - **However, when considered along with the rest of the mercury sediment sampling results, it does not pose a significant risk (mean mercury concentration equals 6.6 mg/kg).**
- **Individually, or collectively, from a risk-based perspective the surface water and sediment contaminants in the Acid Brook do not pose a significant risk to an individual exposed under the conservative conditions outlined above**

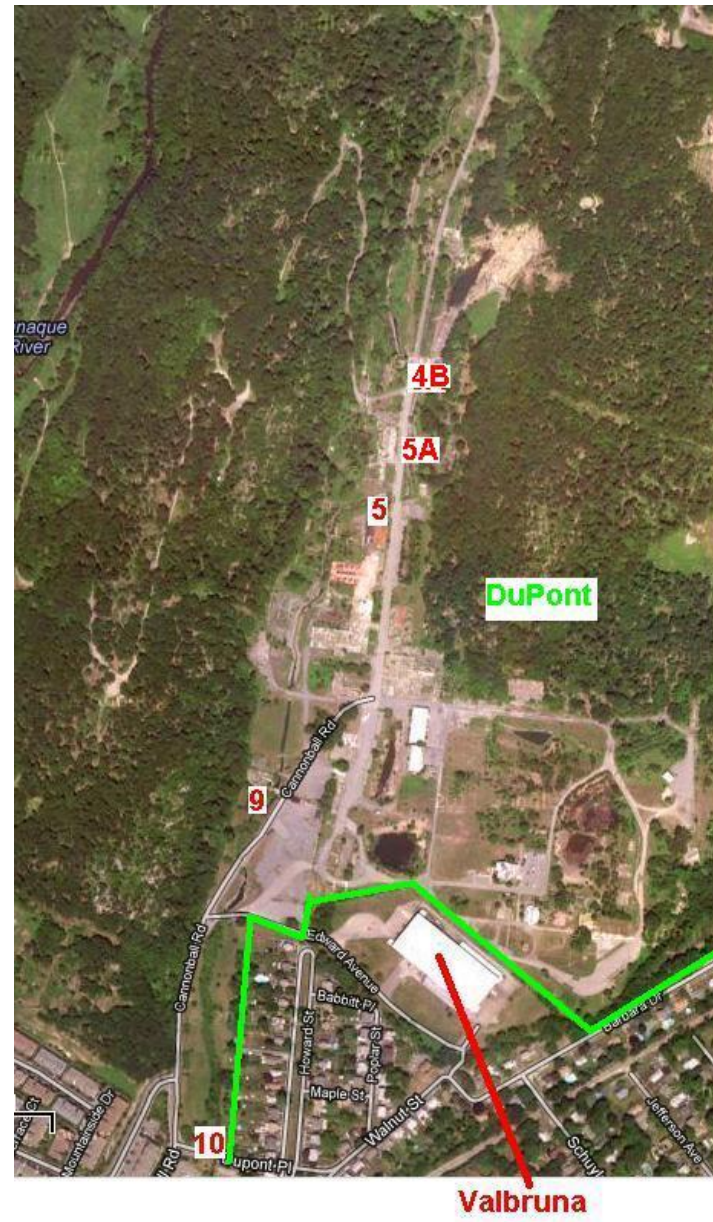
## Sampling locations at the Acid Brook (on-site at DuPont Property)

**Location 5A** – Up-gradient of Well #13 area. [aqueous only]

**Location 5** (Well #13) – known groundwater plume at Well #13 area; [aqueous only]

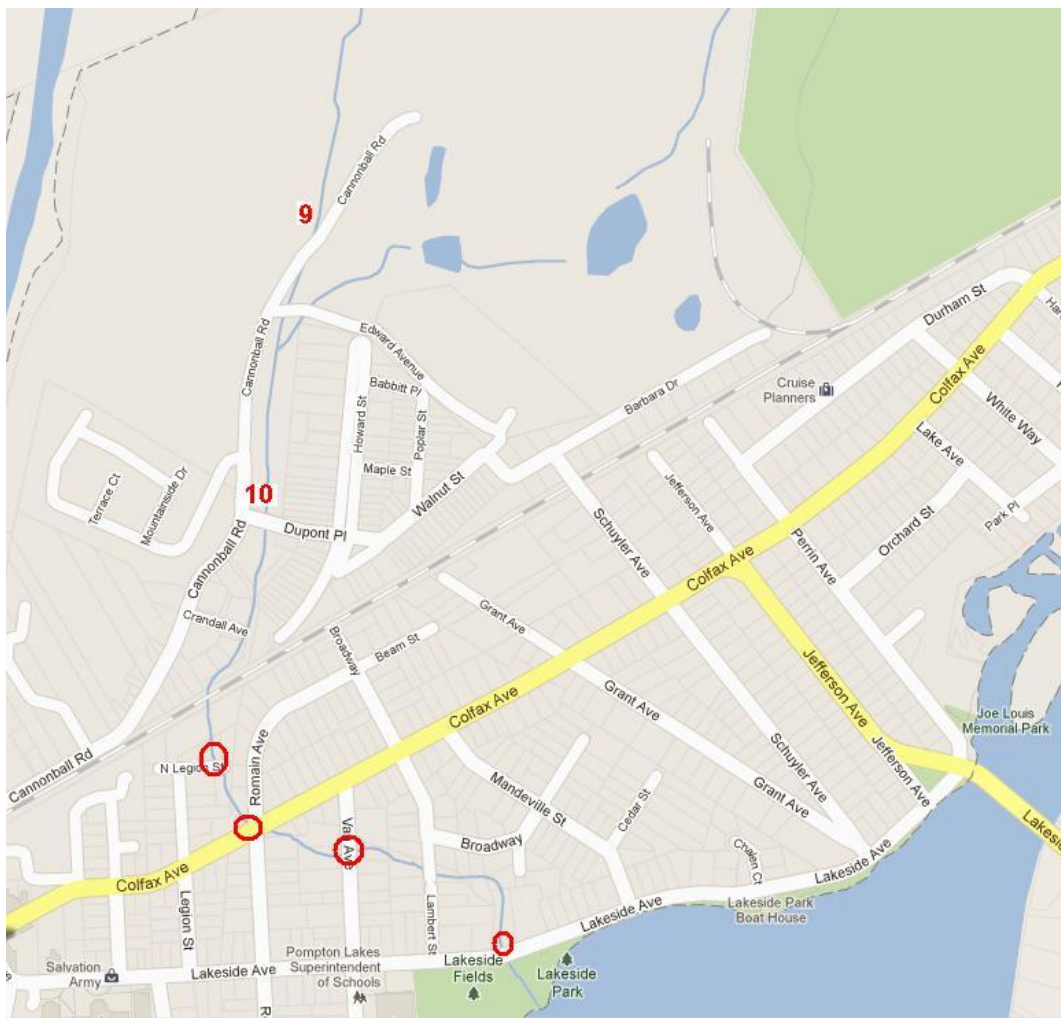
## Samples locations at the Acid Brook (off-site)

N. Legion Ave. -- aqueous only;  
VOC's only.

Colfax Ave. -- aqueous and sediment

Vann Ave. -- aqueous and sediment

Lakeside Ave. -- aqueous and  
sediment
