**Final Second Five-Year Review Report for
the
Hudson River PCBs Superfund Site**

**APPENDIX 7
CAPPING EVALUATION**

Prepared by:
Louis Berger US, Inc.

April 2019

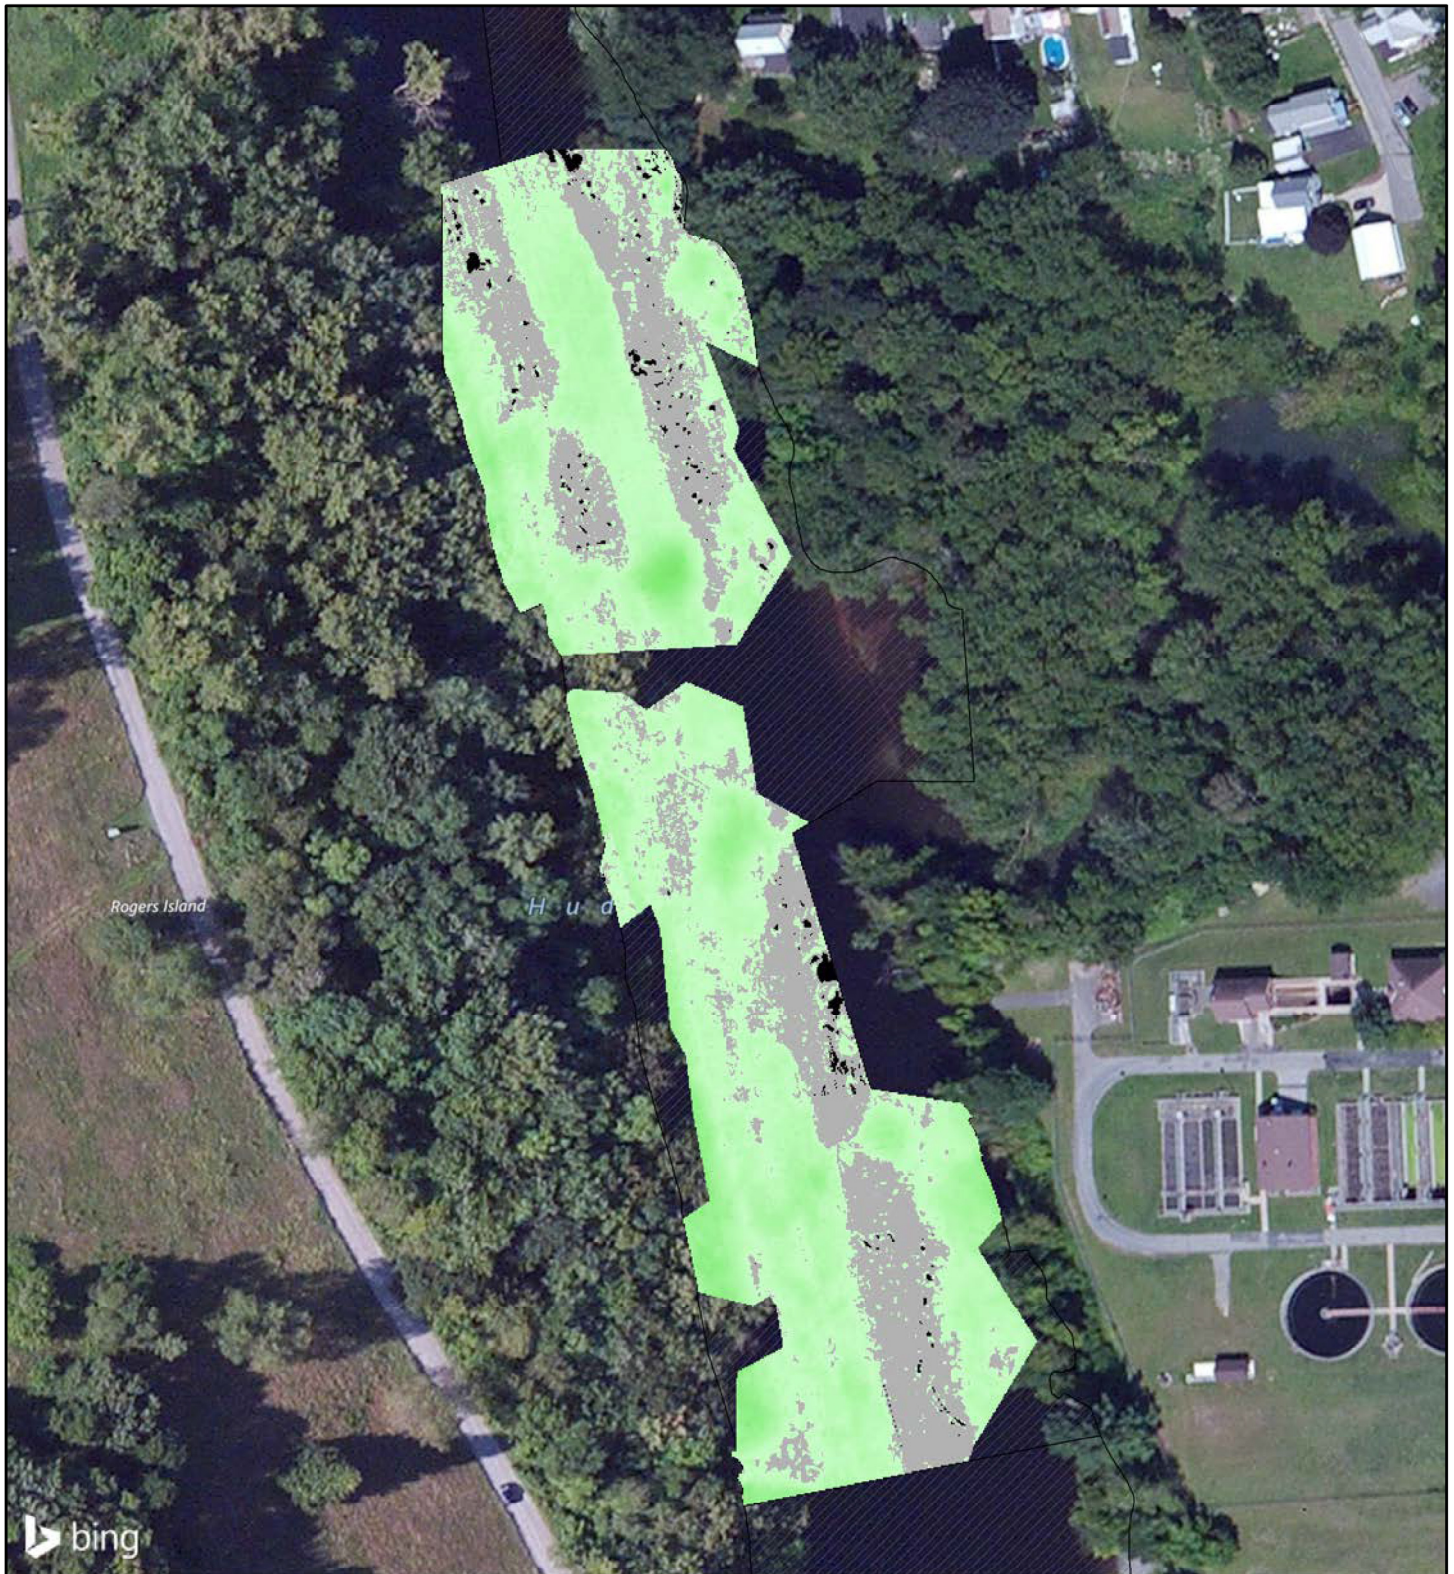
**Figure A7-1b. CU-2
 Bathymetric Comparison
 2009 Cap Reference Survey
 vs.
 2011 High Flow Survey**

Total area capped: 3.43 acres
 Area capped with >3" deposition: 70%
 Area capped with >3" erosion: 1%

No Measurable Loss in CU-2

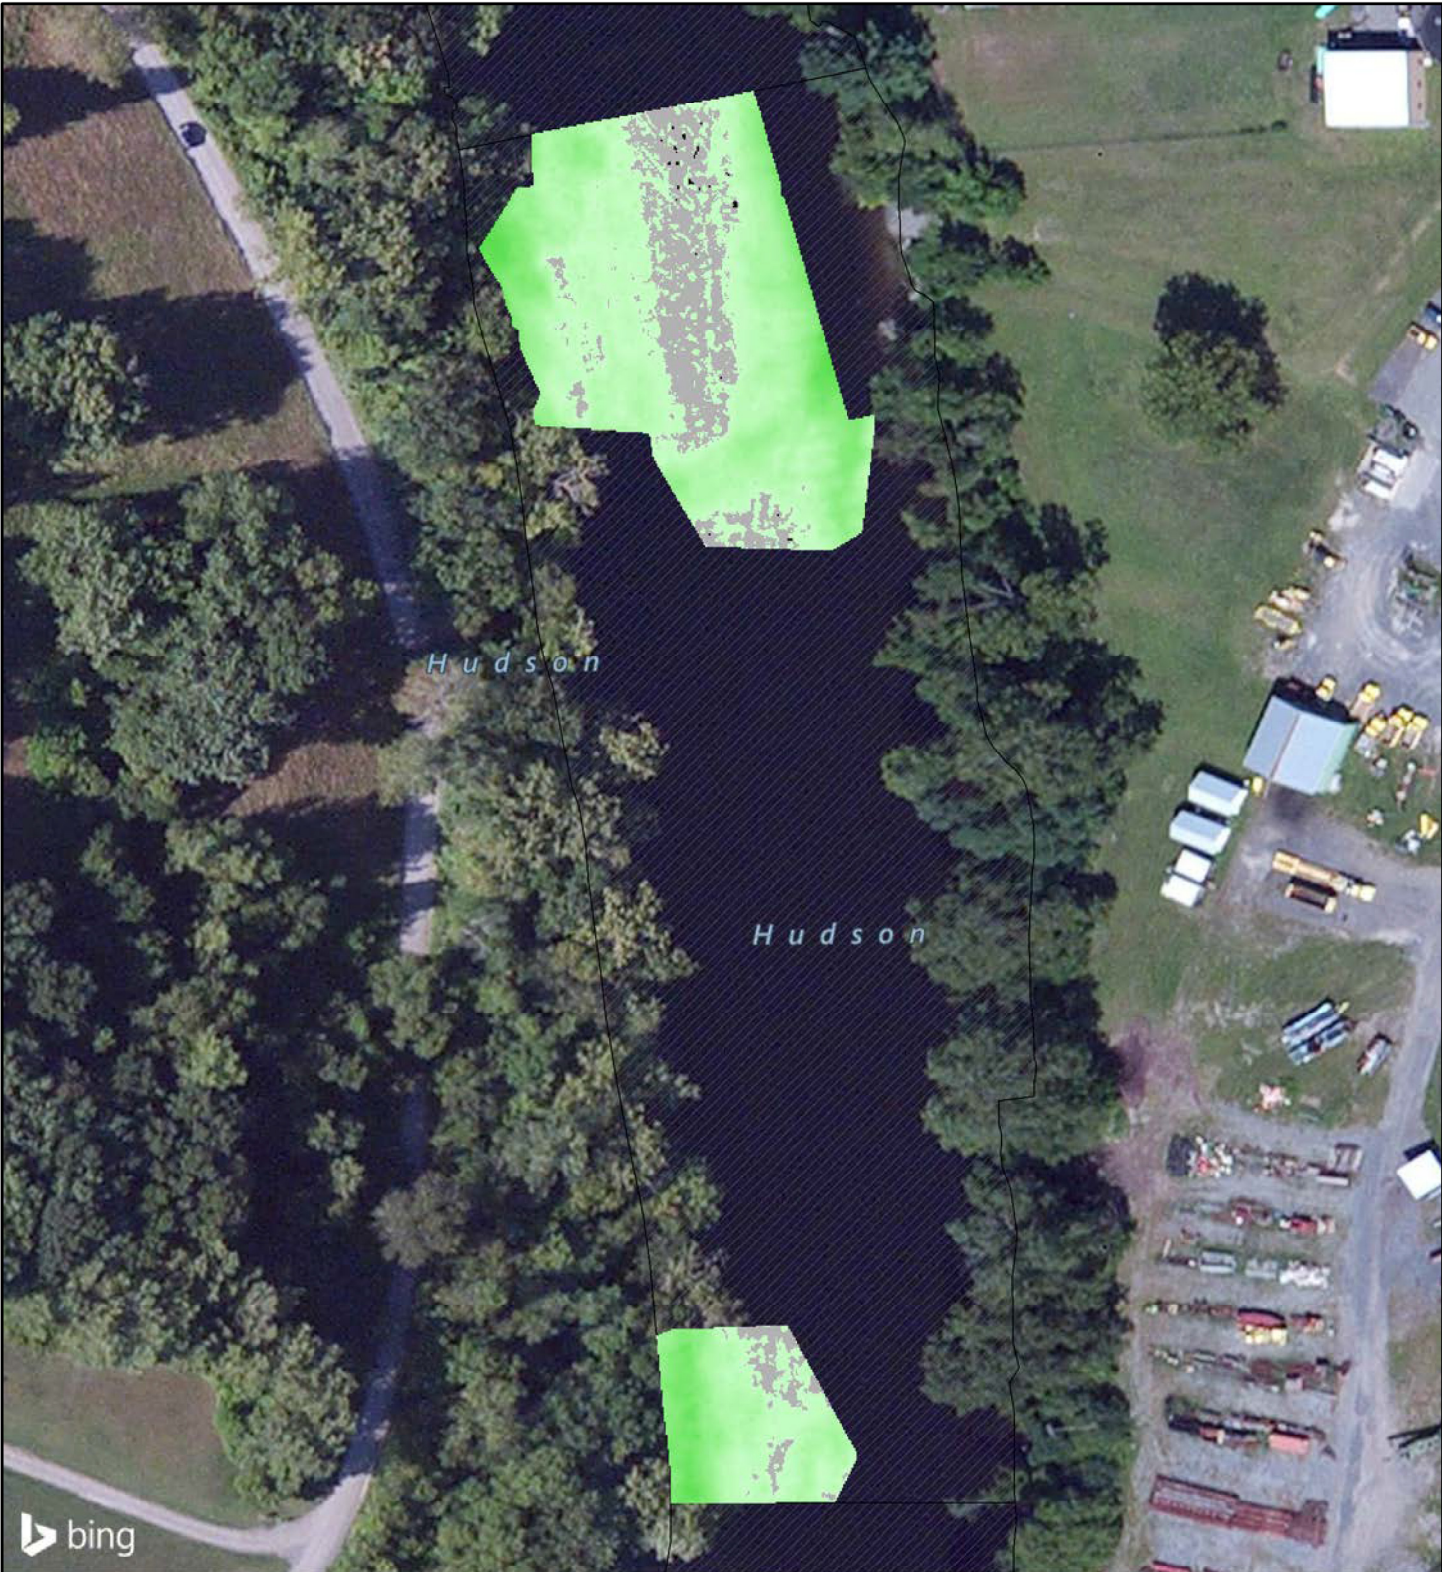
**Figure A7-1c. CU-3
 Bathymetric Comparison
 2009 Cap Reference Survey
 vs.
 2011 High Flow Survey**

Total area capped: 1.22 acres
 Area capped with >3" deposition: 83%
 Area capped with >3" erosion: <1%

No Measurable Loss in CU-3

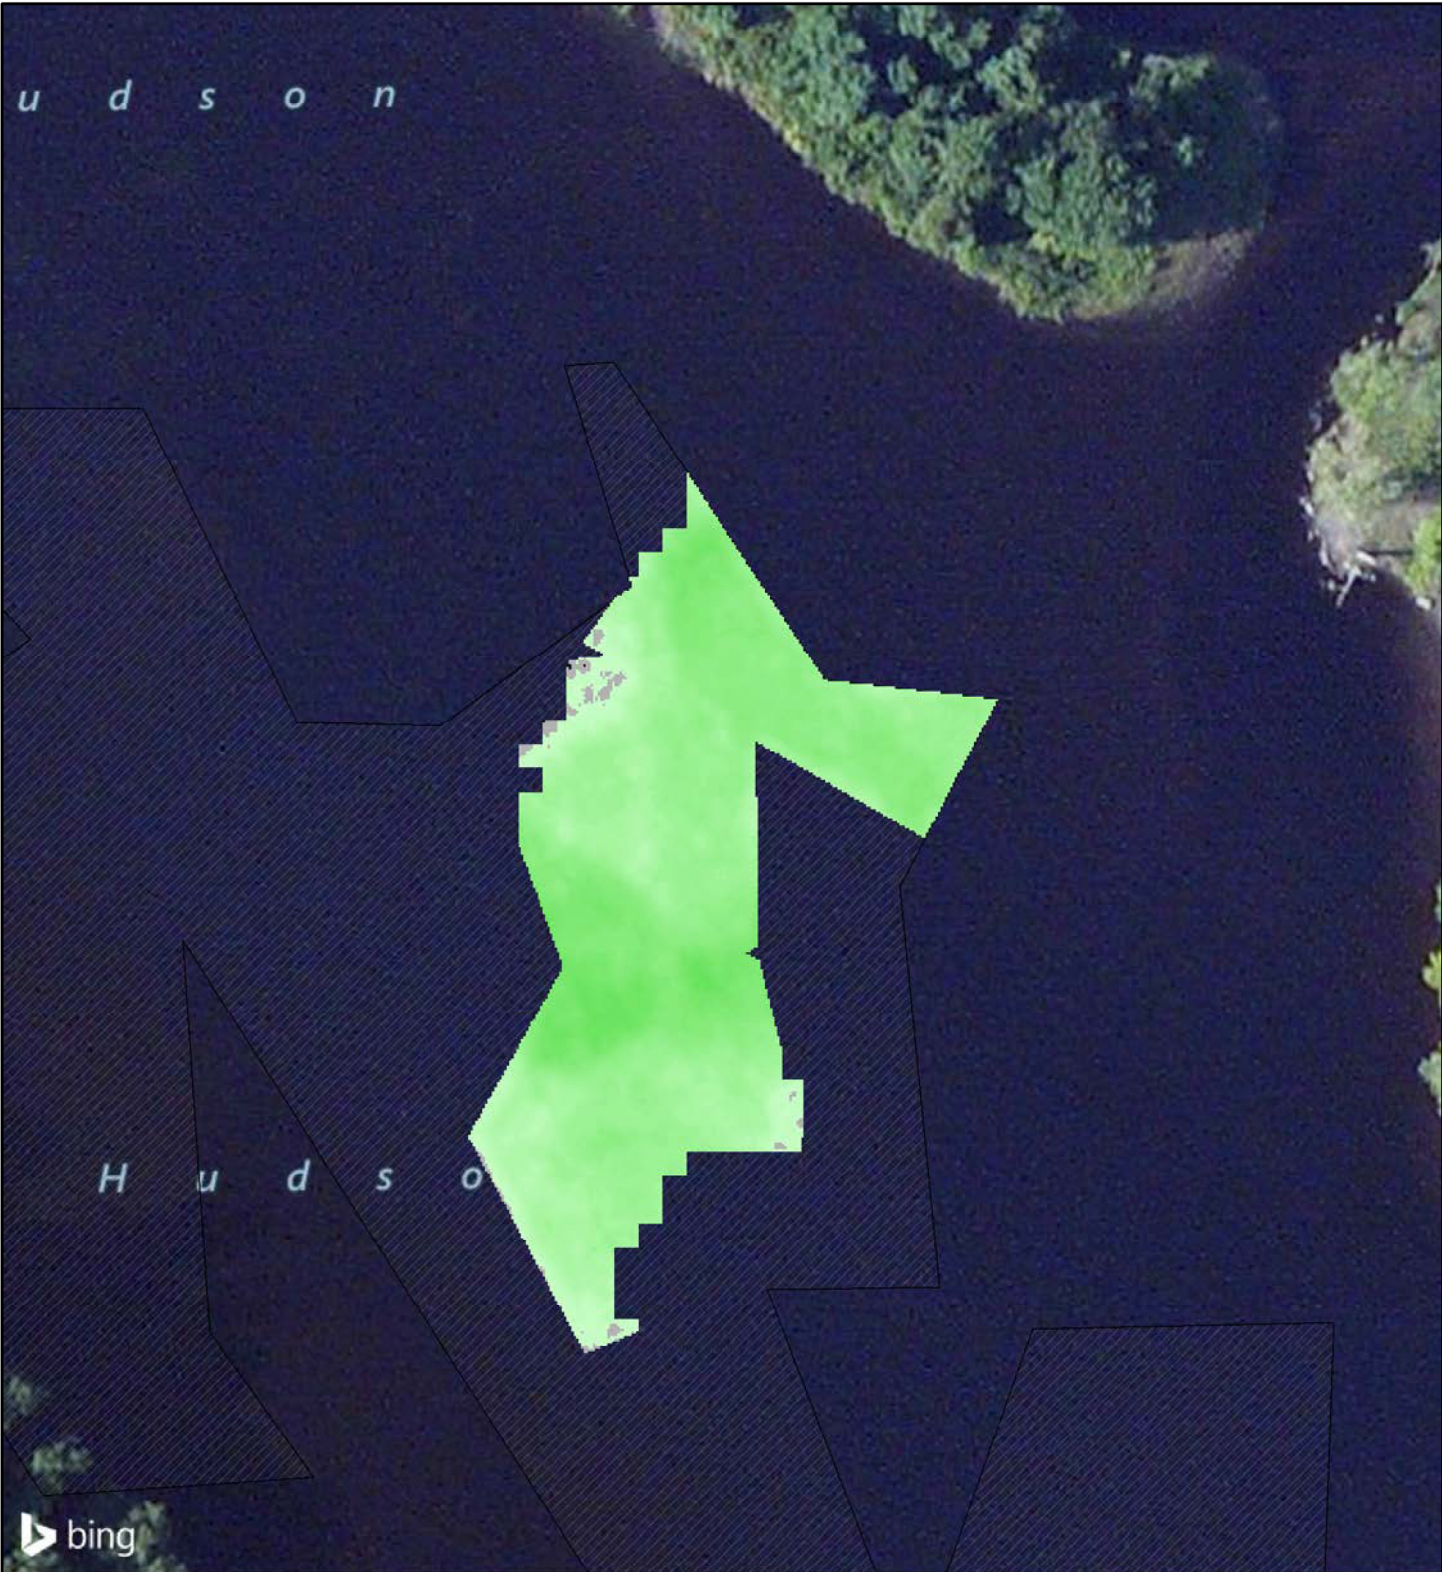
**Figure A7-1e. CU-5
 Bathymetric Comparison
 2009 Cap Reference Survey
 vs.
 2011 High Flow Survey**

Total area capped: 0.7 acres
 Area capped with >3" deposition: 99%
 Area capped with >3" erosion: <1%

No Measurable Loss in CU-5

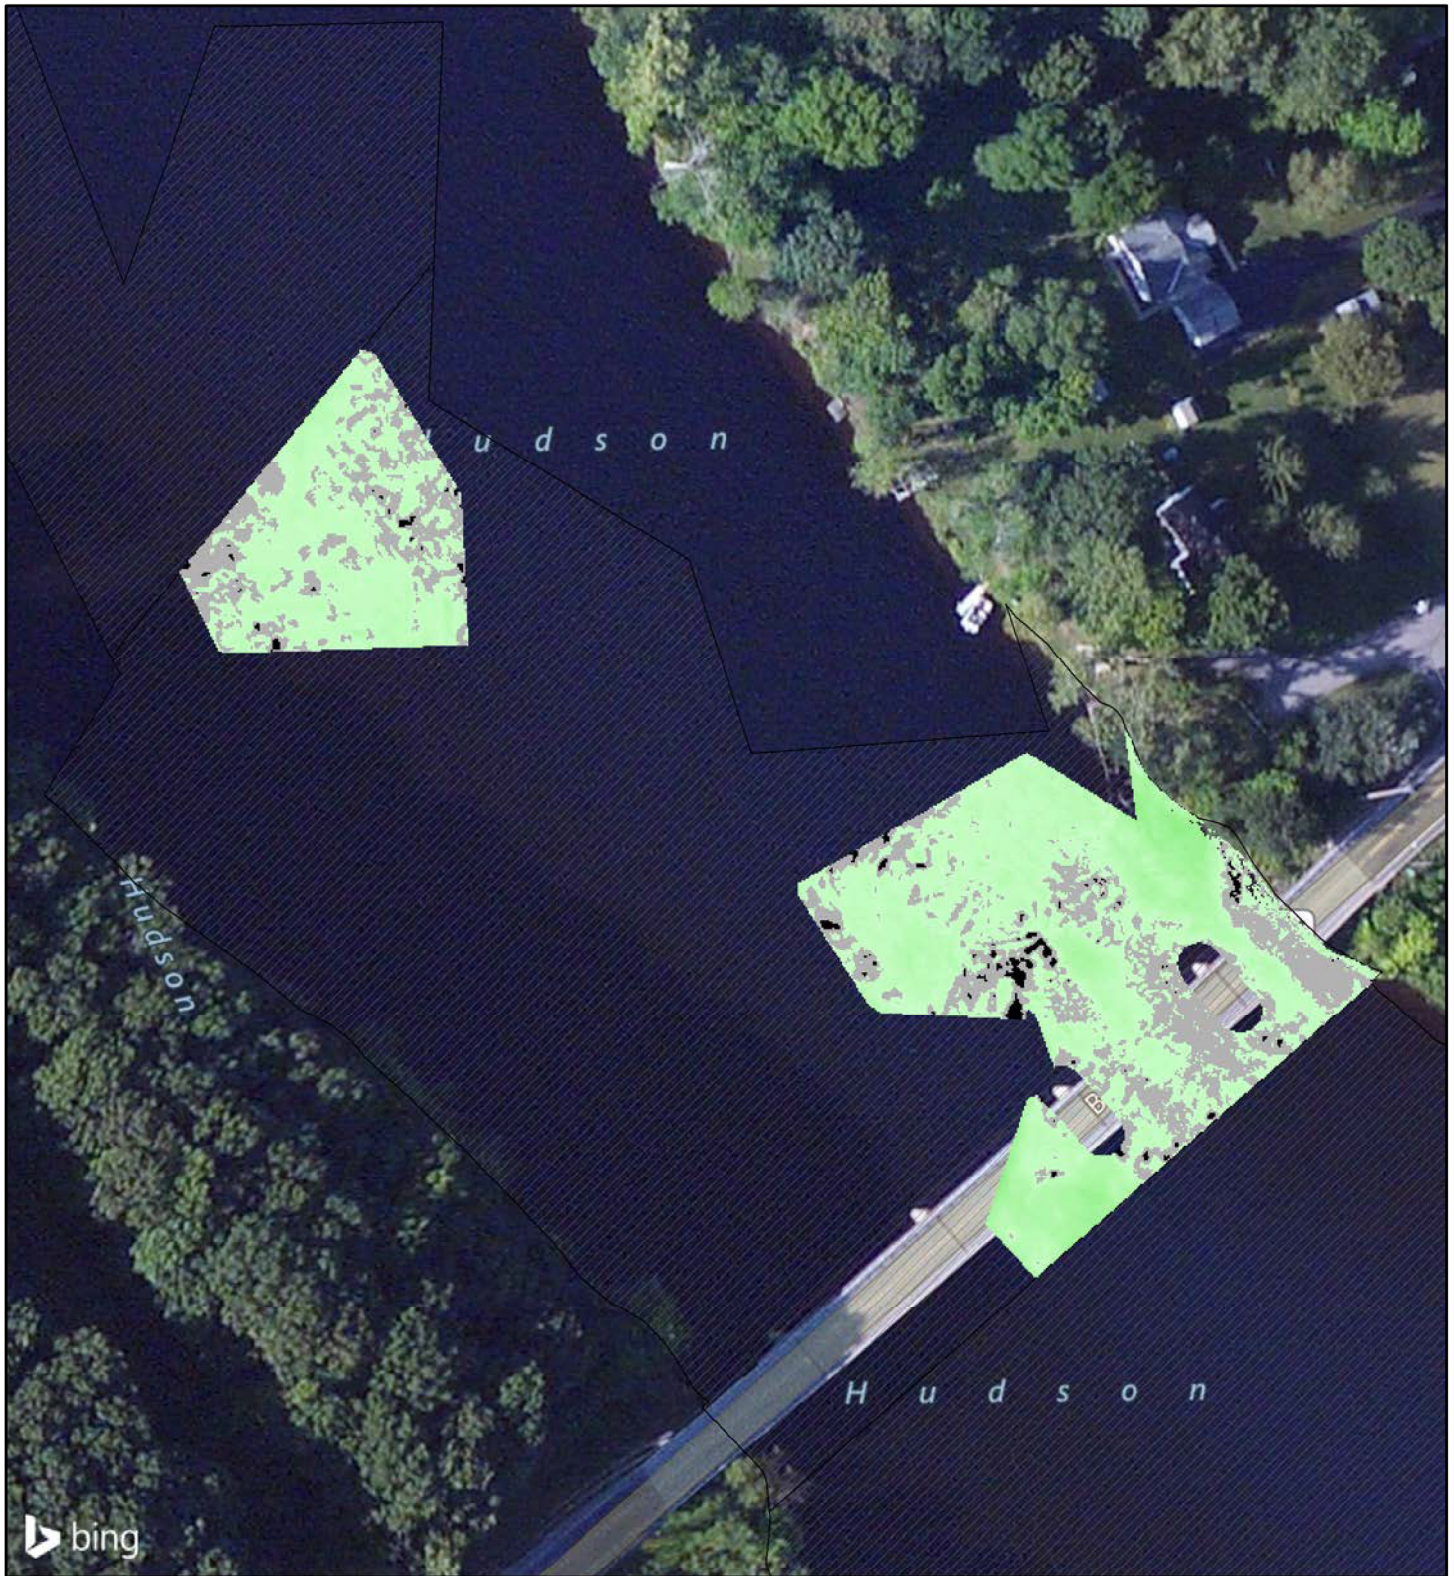
**Figure A7-1f. CU-6
 Bathymetric Comparison
 2009 Cap Reference Survey
 vs.
 2011 High Flow Survey**

Total area capped: 1.33 acres
 Area capped with >3" deposition: 72%
 Area capped with >3" erosion: 1%

No Measurable Loss in CU-6

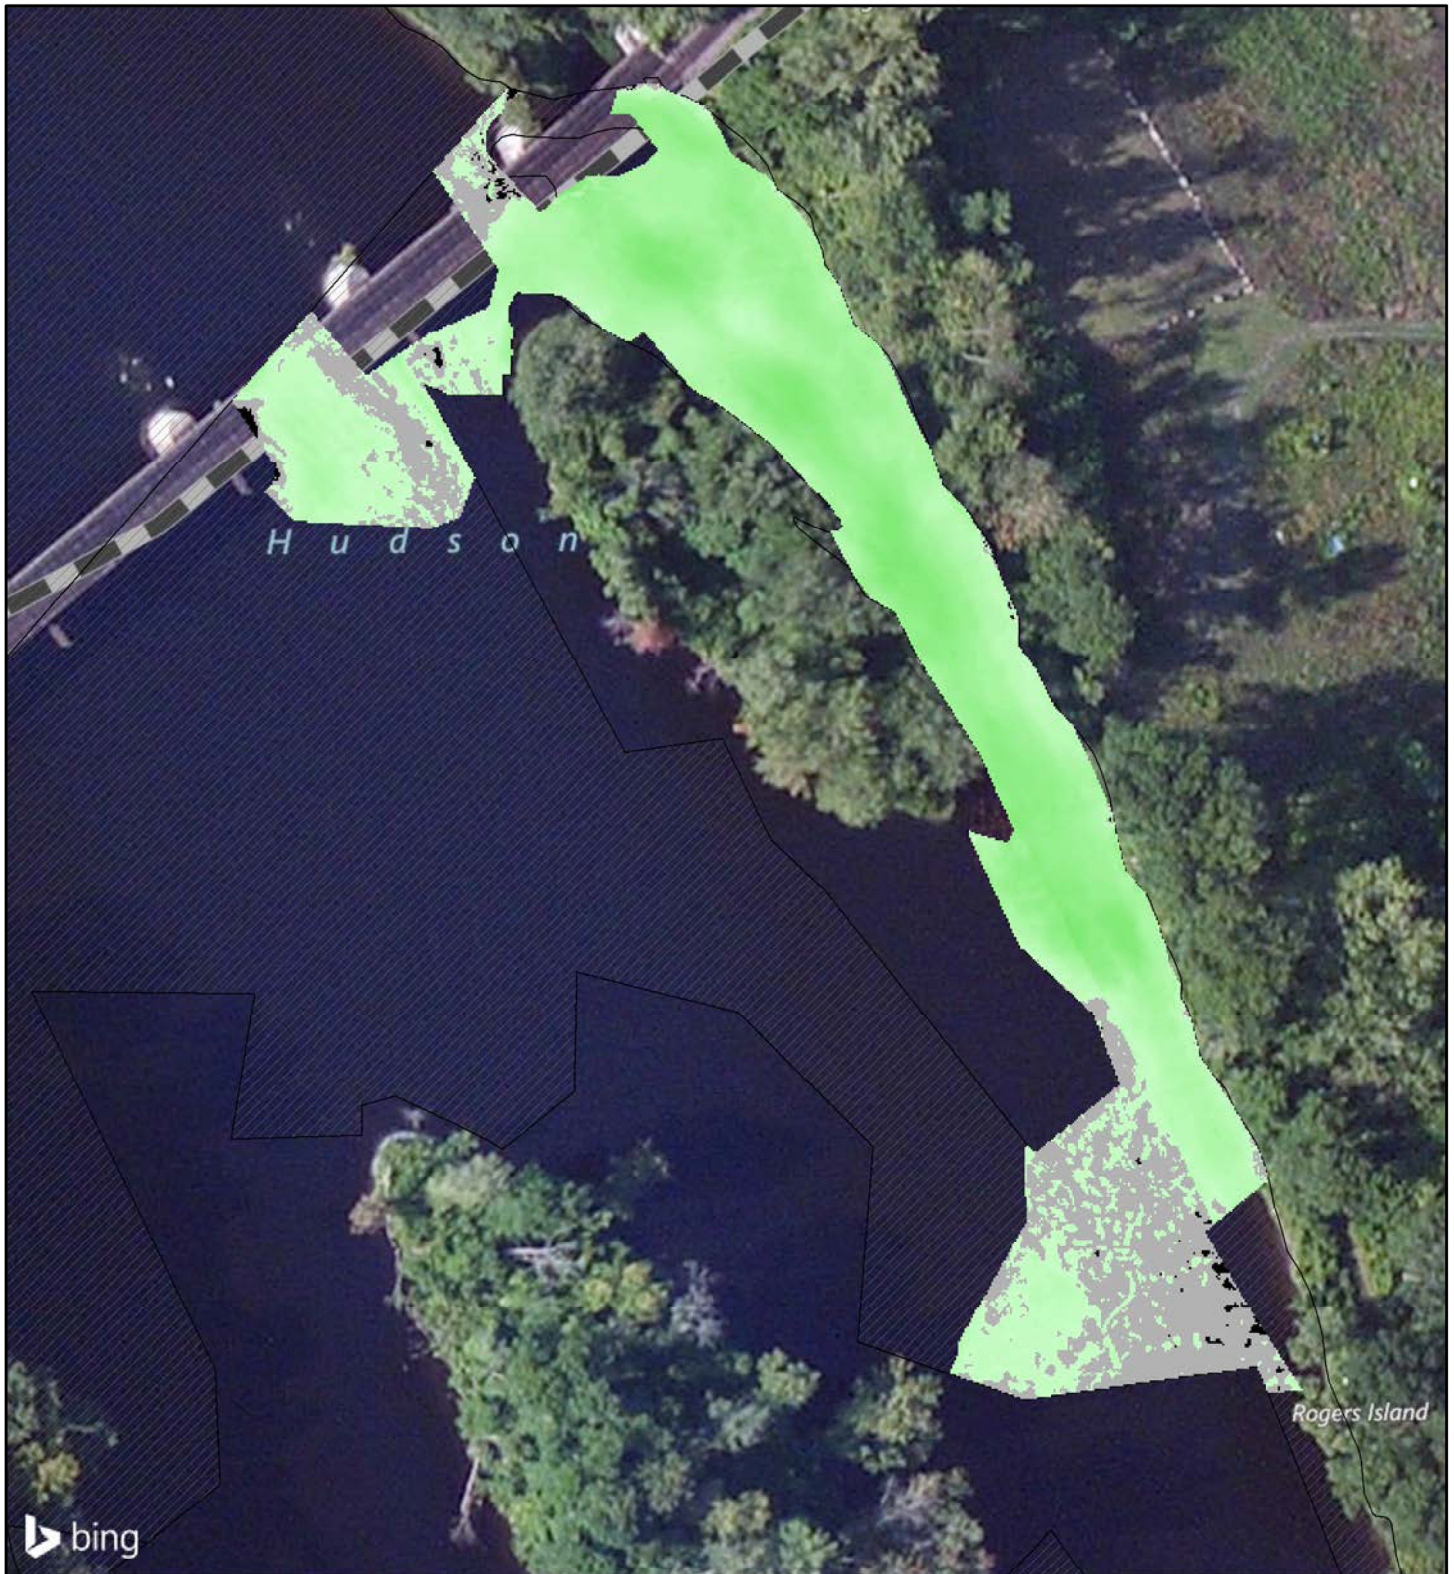
**Figure A7-1h. CU-8
 Bathymetric Comparison
 2009 Cap Reference Survey
 vs.
 2011 High Flow Survey**

Total area capped: 1.47 acres
 Area capped with >3" deposition: 79%
 Area capped with >3" erosion: 1%

No Measurable Loss in CU-8

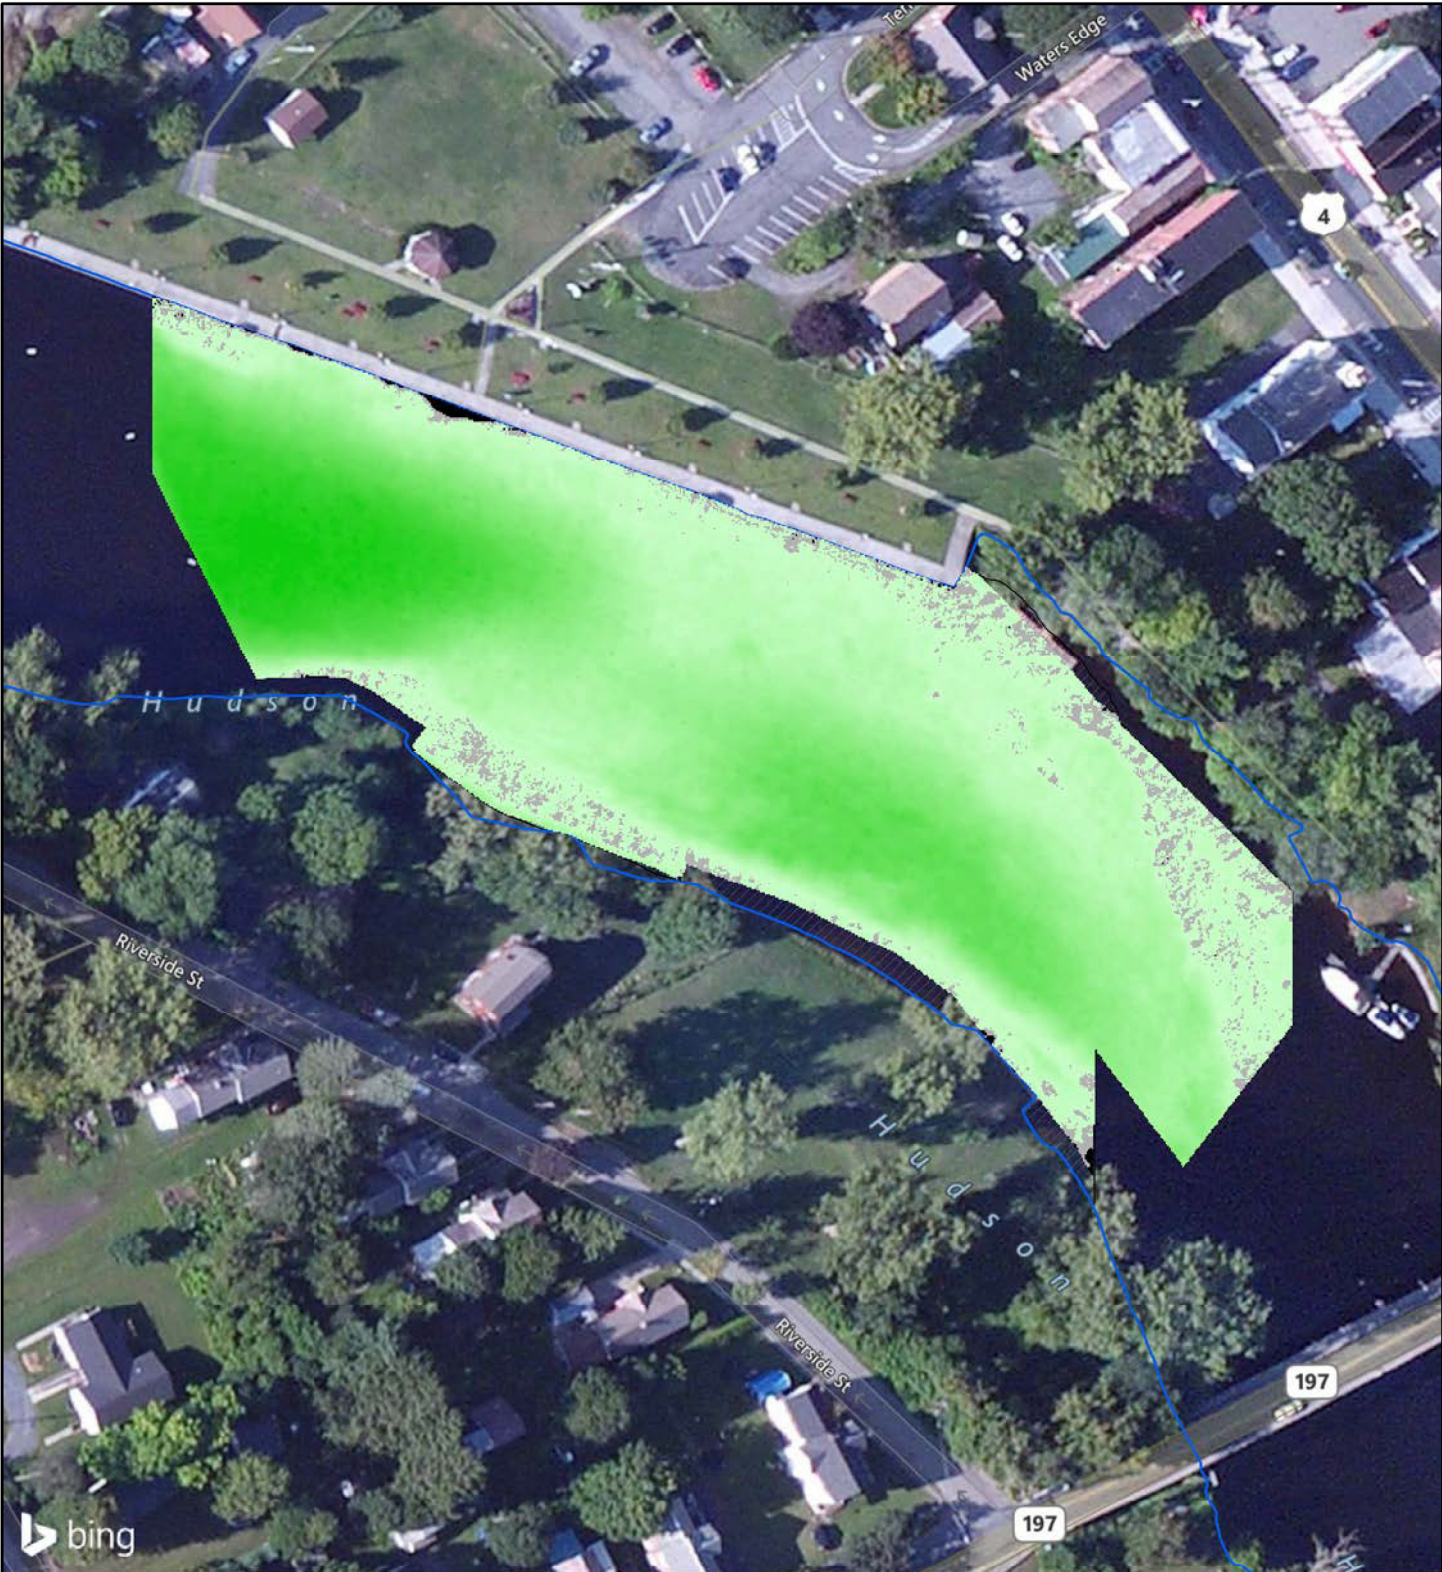
**Figure A7-2a. CU-1
 Bathymetric Comparison
 2009 Cap Reference Survey
 vs.
 2014 Five-Year Tier 1 Survey**

Total area capped: 3.31 acres
 Area capped with >3" deposition: 95%
 Area capped with >3" erosion: <1%

No Measurable Loss in CU-1

While the bathymetric data for the 2016 Tier 1 survey have not been finalized by GE, the 2014 Phase 1 5-year Tier 1 bathymetric survey results were available for evaluation. As noted above, comparison of the 2014 Tier 1 bathymetry and the 2009 post-placement bathymetry for Phase 1 capped areas provides the longest time period over which to assess the stability of the caps. A comparison of the 2009 baseline elevations and the 2014 Tier 1 elevations indicated that the Phase 1 area caps have remained intact and have been net depositional in nature (Table A7-3 and Figures A7-2a-i). Bathymetric change analysis in the Phase 1 capped areas indicates recent deposition of sediment occurred on the cap surfaces, and confirmed that the Phase 1 capped areas have not experienced Measurable Loss of cap material as defined in the OM&M documents.

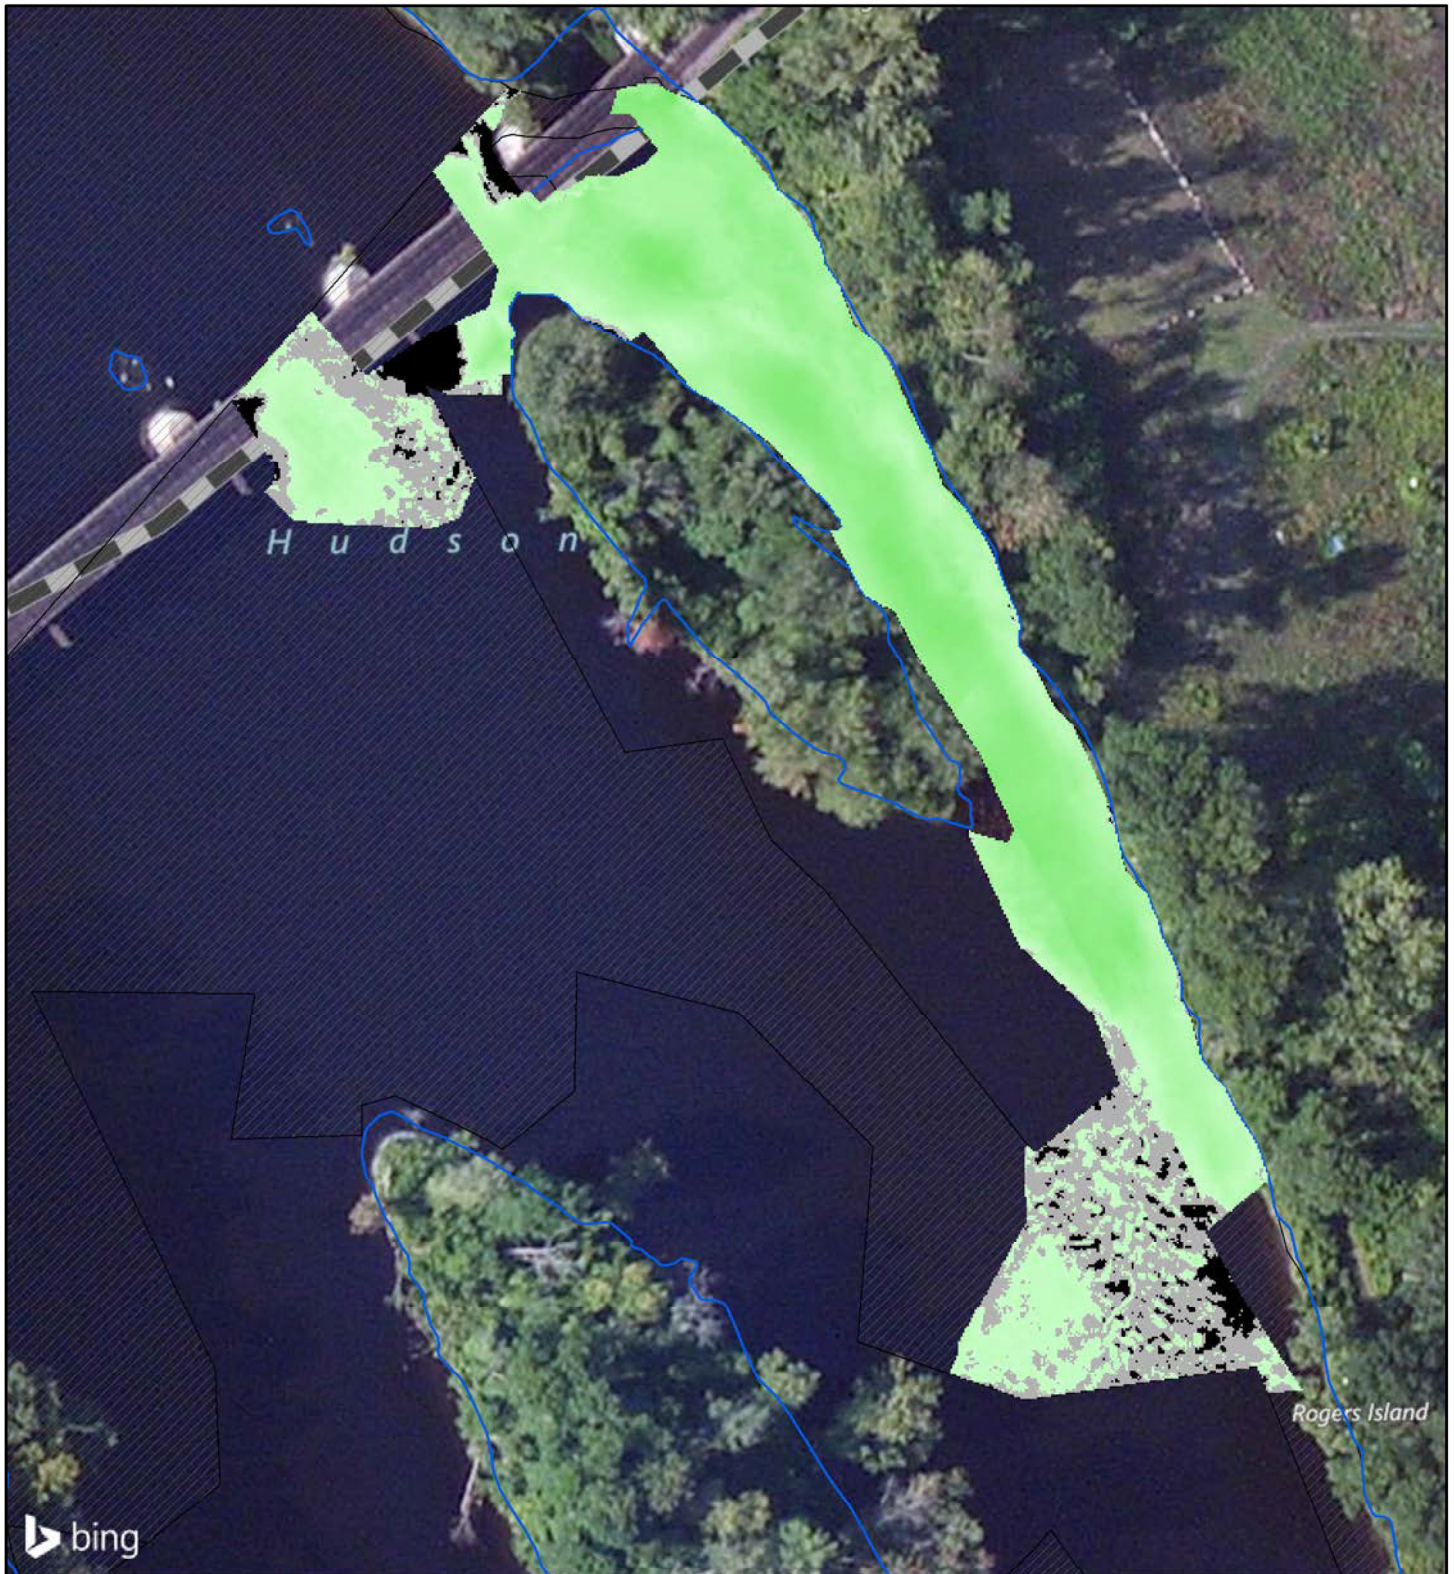
Total area capped: 1.47 acres
 Area capped with >3" deposition: 78%
 Area capped with >3" erosion: 5%

No Measurable Loss in CU-8
