RE: Great Pond Alternative Restoration Plan

The Maine Department of Environmental Protection (DEP) is pleased to submit the Great Pond Watershed-Based Management Plan (2021) as an Alternative Restoration Plan (ARP) as part of its 303(d) Vision.

MARCH 2021

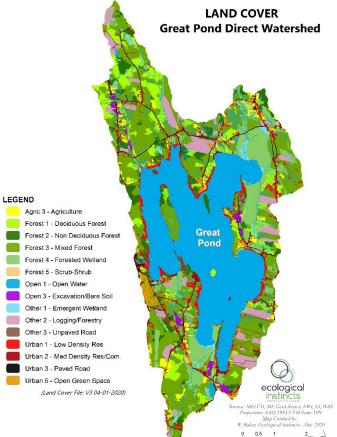
Figure 5. Updated land-cover map for Great Pond.

The resulting updated land-cover file provides a more accurate representation of current land cover within the Great Pond watershed (Figure 5, Table 2). The most significant changes to land cover were the addition of low- and mid-density residential and commercial development throughout the watershed (Figure 6). These data are foundational in the watershed model used to estimate phosphorus loading in Great Pond (Section 4). In the model, a phosphorus export coefficient is assigned to each land-cover type to represent typical concentrations of phosphorus in runoff from those land-cover types. Unmanaged forested land, for example, tends to deliver very little phosphorus downstream when it rains, while row crops and high-density urban land export significantly more phosphorus due to fertilizer use, soil erosion, car and factory exhaust, pet waste, and many other sources. Smaller amounts of phosphorus are also exported to lakes and streams during dry weather under base flow conditions. A breakdown of land-cover types by area and contributing phosphorus loads to the lake is presented in Section 4.

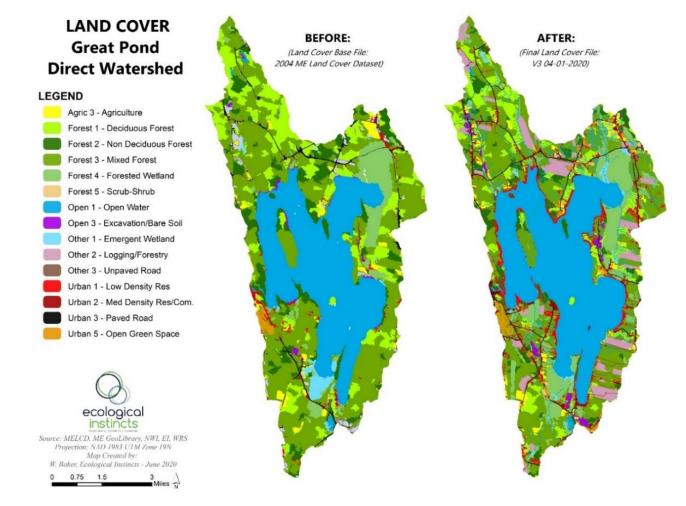
Figure 6. "Before" (left) and "After" (right) land-cover file modifications.

between the aerials and the MELCD file were found, changes were made by manually editing polygons. The State road layer (NG911 roads), stream layer, and an NWI wetlands layer were overlaid on the updated land-cover layer and relabeled appropriately.
