Providence Stormwater Innovation Center

TRAINING MONITORING PUBLIC OUTREACH

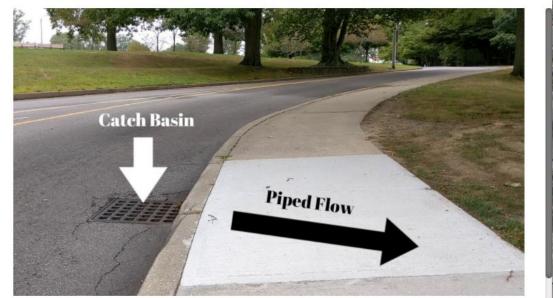
1 BMP 15

Inlet controls manage runoff into a stormwater STU.

INLET TYPE: Catch Basin and Piped Flow Entrance

Inlet structures may be used to capture runoff, slow runoff velocities, settle solids and convey runoff to a downstream STU. A deep-sump catch basin is an example of an inlet structure.

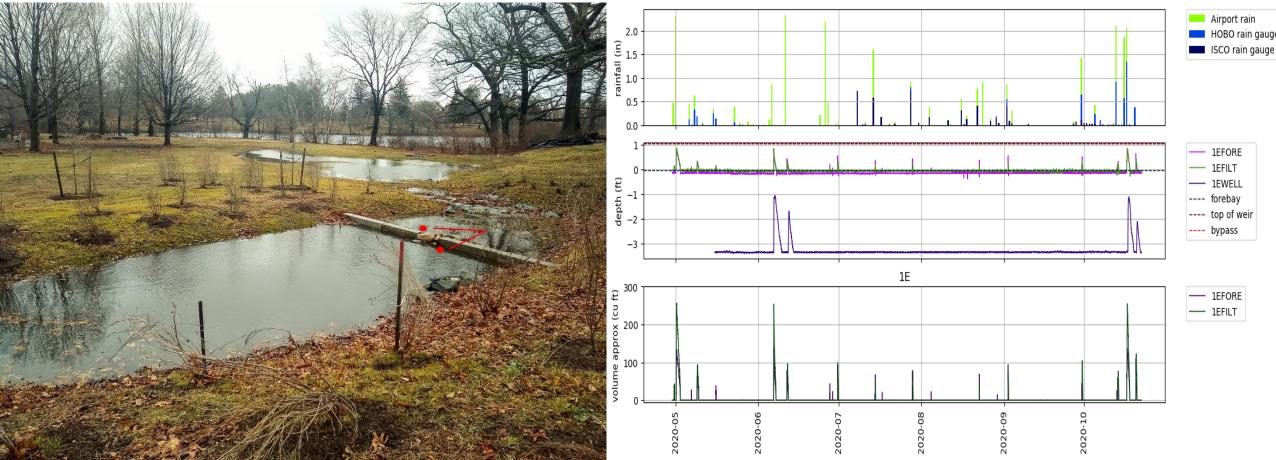
BMP Performance and Function

- Logging pressure transducers in forebay, treatment area a
- Survey the systems
- Compute volume of water entering the system
- Verify vs modeled volumes for a specific sized rain event
- Rotate tranducers between BMPs twice per year

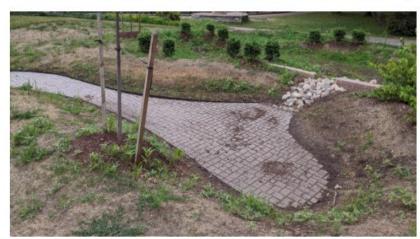
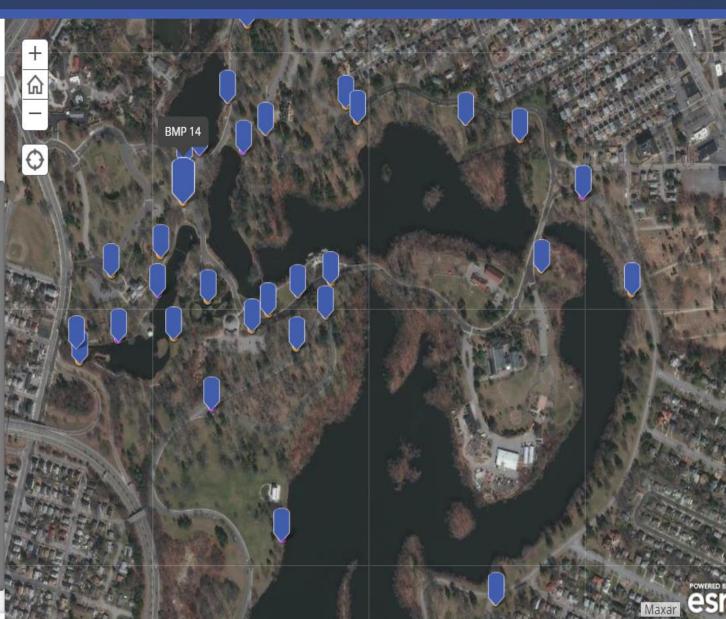
TYPE: Infiltration Basin

PHOSPHOROUS REDUCTION: 0.356 lbs/yr

PLANTINGS: Tulip Tree, Green Luster Japanese Holly, Mariesii Double-file Viburnum ,Compact Japanese Andromeda

CONSTRUCTION COST: \$27,535.73

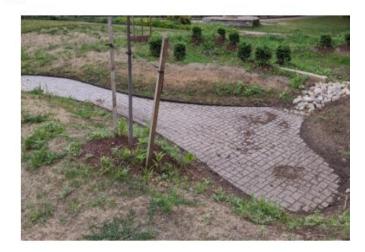
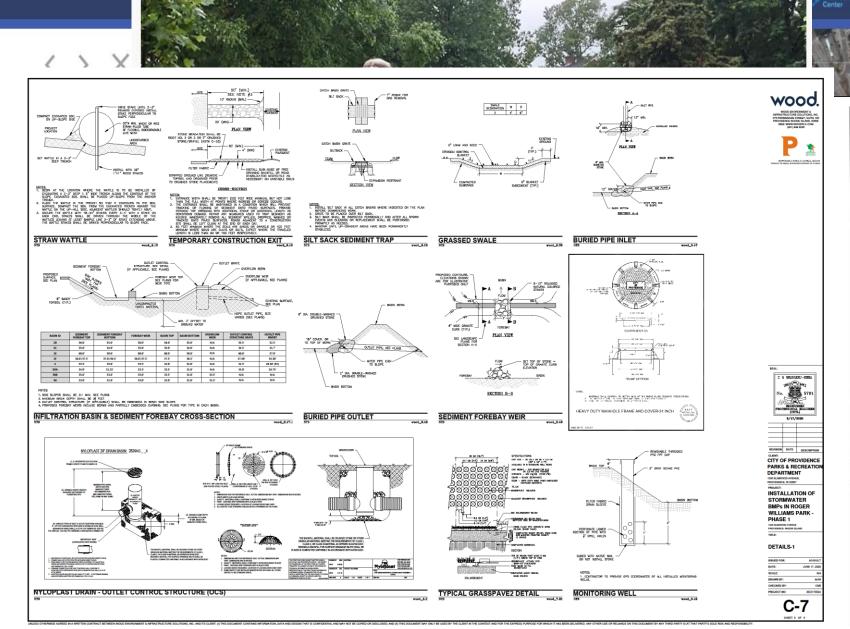
BMP 14

TYPE: Infiltration Basin

PHOSPHOROUS REDUCTION: 0.356 lbs/yr

PLANTINGS: Tulip Tree, Green Luster Japanese Holly, Mariesii Double-Japanese Andromeda

CONSTRUCTION COST: \$27,535.73
