CLEANUP OF BALL FIELDS 5-8 FINISHED

Under the U.S. Environmental Protection Agency's (EPA) oversight, the New York City Department of Parks and Recreation (NYC Parks) has finished the cleanup of Red Hook Park Ball Fields 5-8. The ball fields were contaminated with lead from a former secondary lead smelting facility known as Columbia Smelting and Refining Works, which once stood atop what is now Ball Field 7.

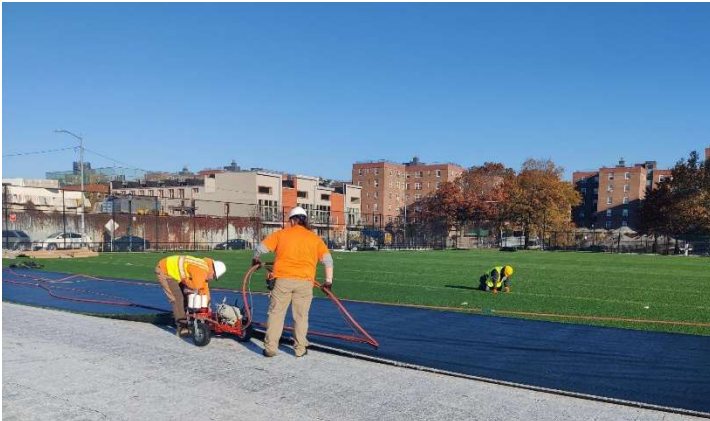
Contractors installing artificial turf on Ball Fields 5 - 8

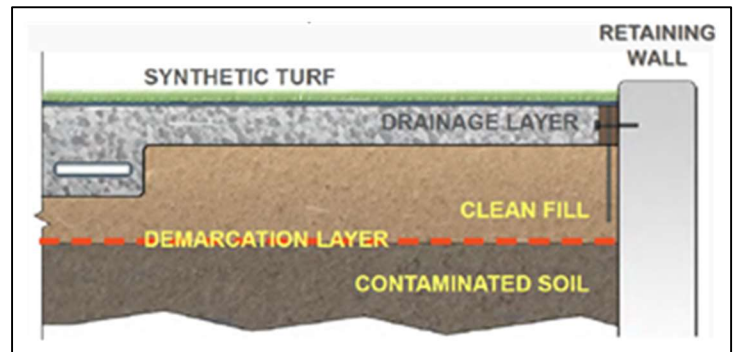
Contractors placed brightly colored plastic fencing as a visual barrier, labeled in the graphic below as a demarcation layer, over the deeper contaminated soil. This visual barrier was covered with at least one foot of clean soil or other material. NYC Parks then installed artificial turf over all of the ball fields. This barrier system permanently reduces the chance of people coming into contact with contaminated soil on these fields, and will be inspected routinely. A bioswale (planted areas along the fields that collect stormwater that runs off the fields when it rains), new trees, and other improvements were also added.

NYC Parks layout of barrier and cover for Red Hook Park Ball Fields

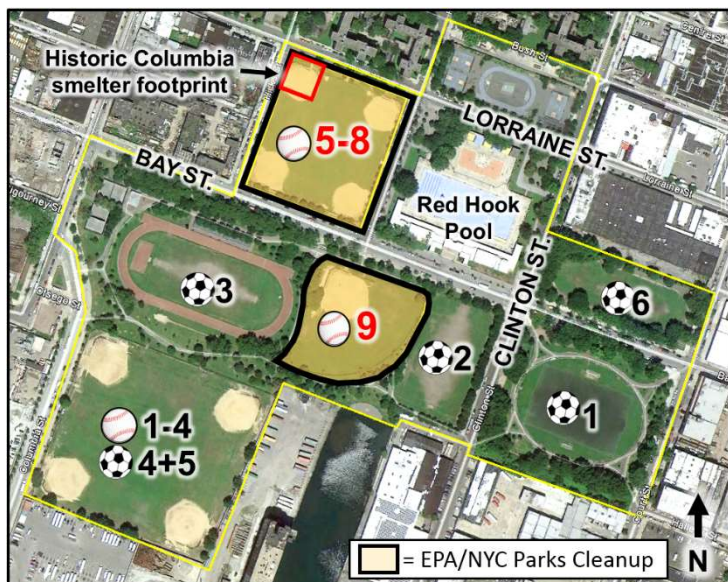
Red Hook Park Ball Fields to be cleaned up by NYC Parks under EPA oversight

As part of an investigation of the former Columbia smelting plant, EPA and NYC Parks sampled soil throughout all areas of Red Hook Park. Sampling showed elevated lead levels from the former Columbia facility in surface soil across Ball Fields 5, 6, 7, 8 and 9. As a result, Ball Fields 5-8 were closed in Spring 2015 and remained closed until the cleanup was completed in December 2021. At Ball Field 9, elevated lead levels were found only in deeper soil samples. Ball Field 9 remained open for public use until cleanup work began in September 2019.
