Long-Term Stewardship Assessment Report

Safety-Kleen Systems, Incorporated

EPA ID #: WVD981034101

Assessment Date: March 14, 2019

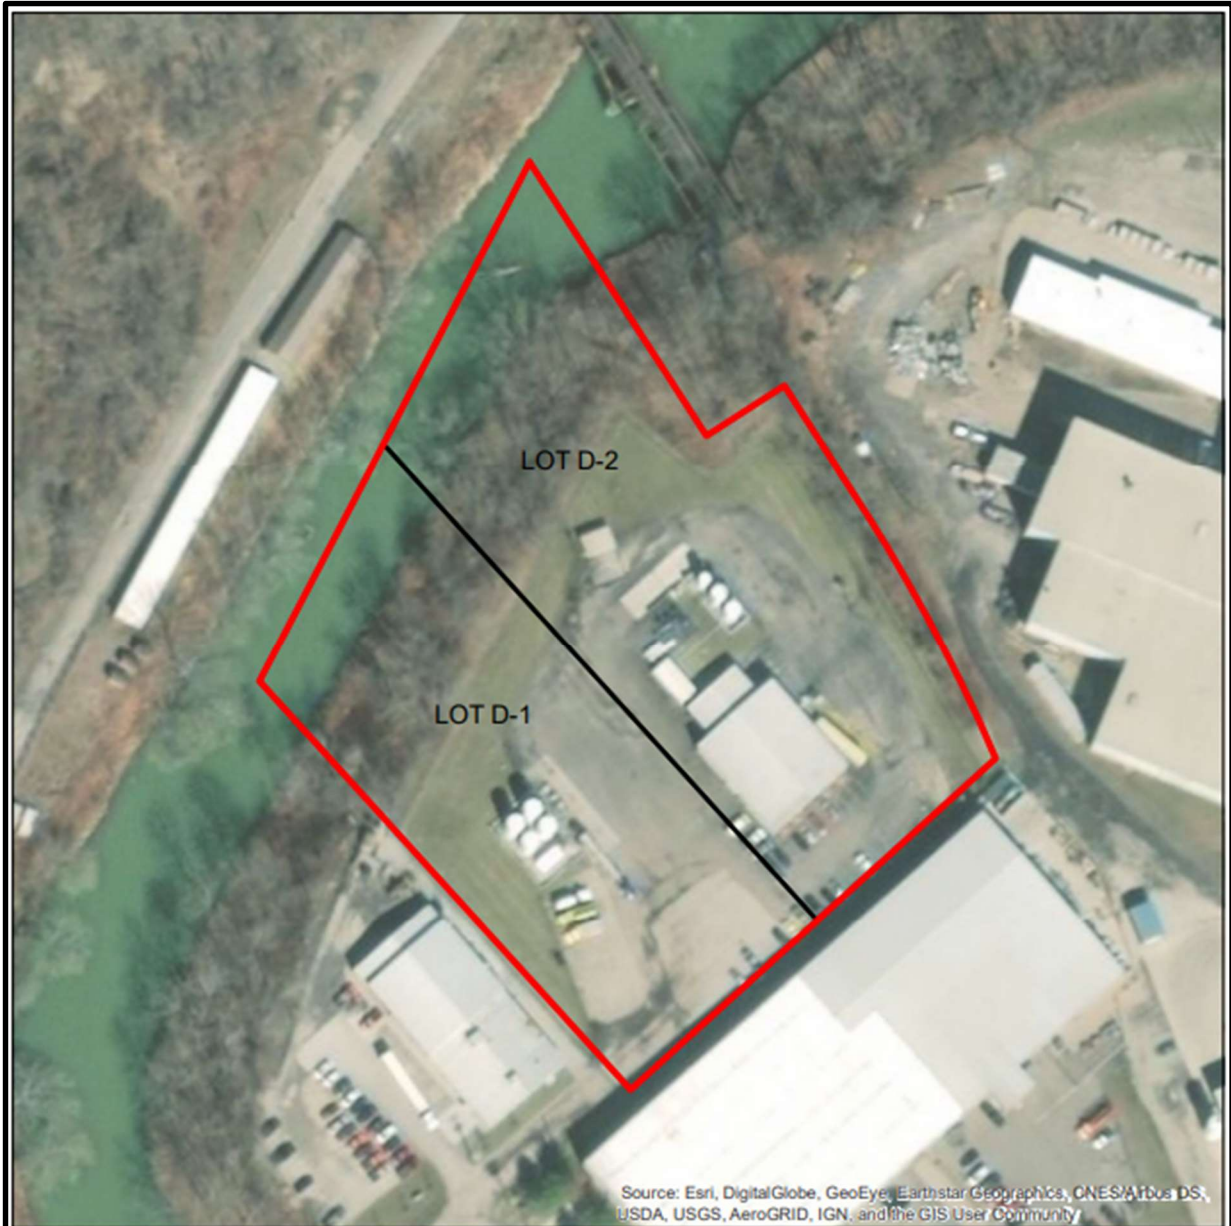
Figure 1: Aerial Map of Safety-Kleen, Incorporated

Environmental Covenant: The Covenant is the method for implementing institutional controls required as a condition of the Statement of Basis and Final Decision. The following ICs apply to the Safety-Kleen facility, shown on Figure 1:

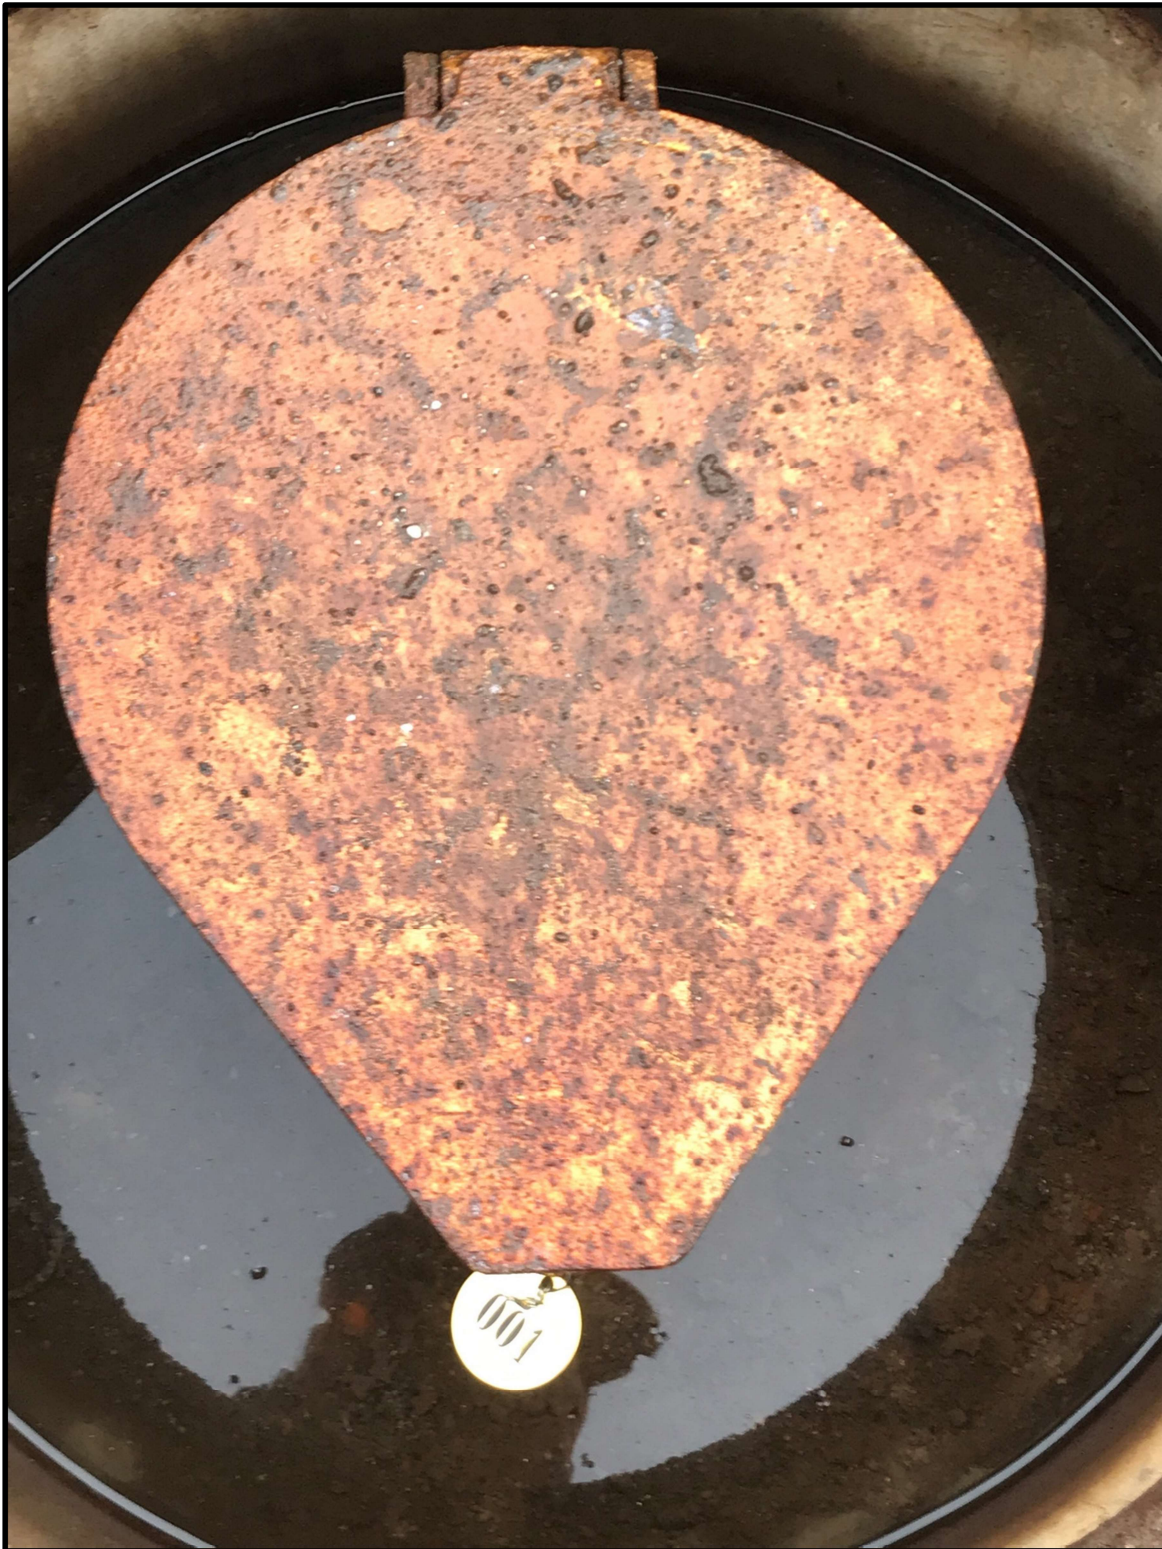
Picture 1: Monitoring Well MW-1

Monitored Natural Attenuation: Nine (9) onsite groundwater monitoring wells are gauged and sampled semi-annually, during May and November, at the Facility. All wells are sampled and analyzed for VOCs, primarily tetrachloroethylene (PCE) and trichloroethylene (TCE). Groundwater at well MW-3 was not sampled during the May 2018 due to insufficient water volume.

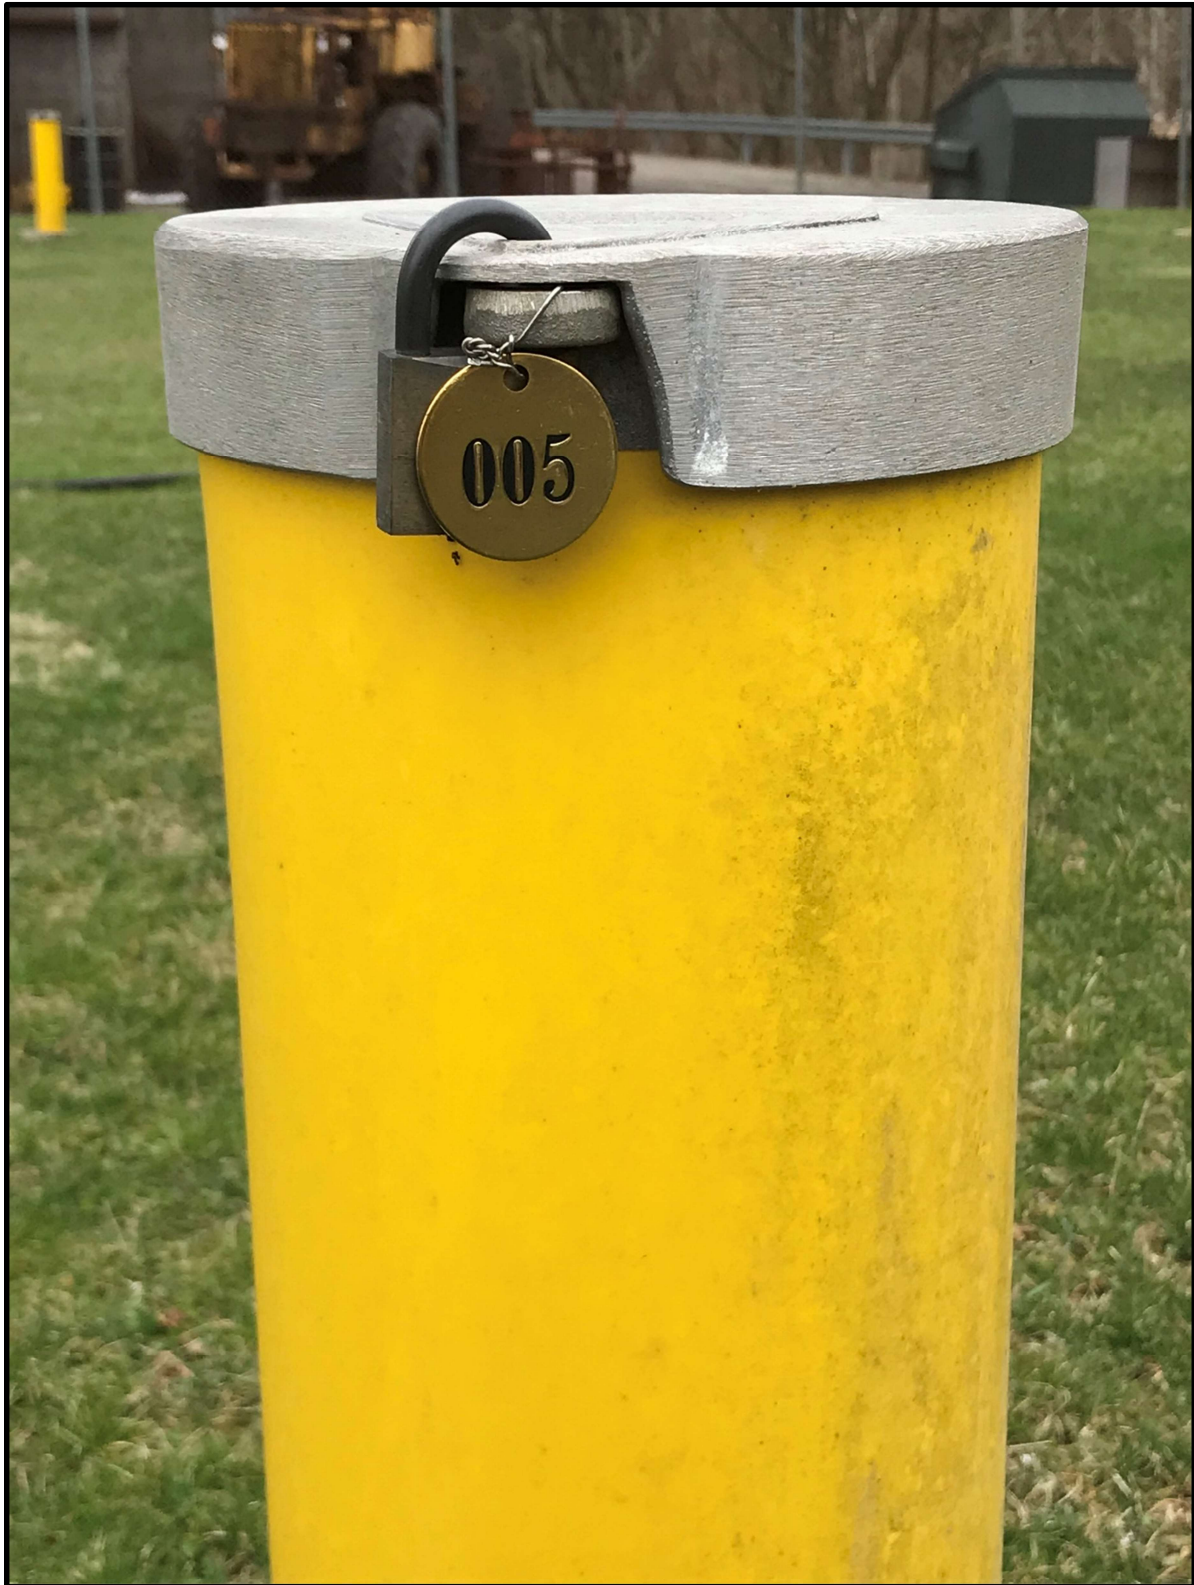
Picture 5: Monitoring Well MW-5

Concentrations of PCE and TCE were detected above the West Virginia Groundwater Quality Standards in samples collected from Monitoring Wells MW-5, MW-6, MW-7, MW-8, and MW-9, with MW-5 exhibiting the highest dissolved phase concentrations.

Monitoring wells with elevated PCE and TCE concentrations in groundwater are located near the western boundary of the adjacent to the Facility's tank farm. The highest contaminant concentrations were observed at monitoring well MW-5, which consistent with historical data. The most recent sampling events show that PCE and TCE groundwater concentrations are stable. Safety-Kleen will continue to monitor Facility groundwater on a semi-annual basis.

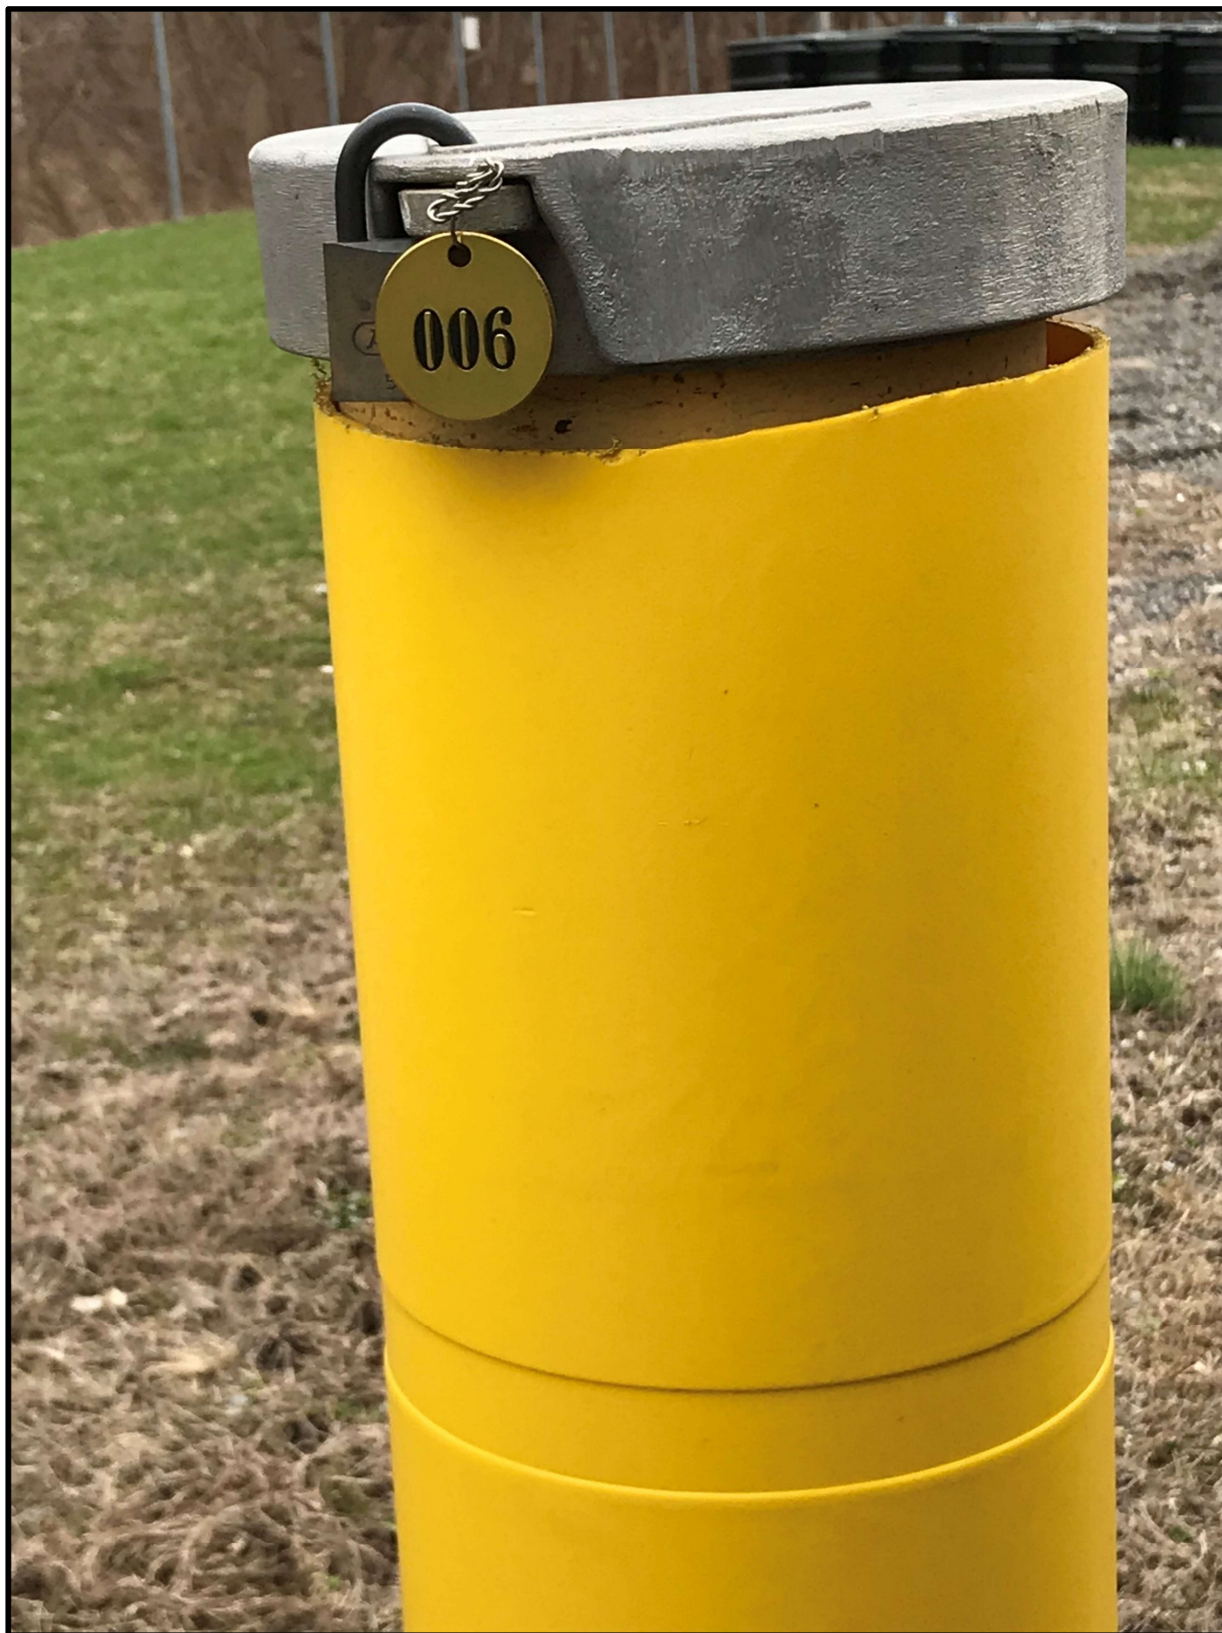
Picture 6: Monitoring Well MW-6

Groundwater monitoring results are screened in comparison to West Virginia Groundwater Quality Standards (WVGWQS) which are equivalent to EPA Maximum Contaminant Levels. During the latest sampling event in May 2018, PCE concentrations in groundwater observed at five (5) of eight (8) monitoring wells exceeded the WVGWQS of 5 ug/L, with detected concentrations ranging from 31 ug/L in MW-8 to 440 ug/L in MW-5. TCE concentrations in groundwater observed at four (4) of eight (8) monitoring wells exceeded the MCL of 5 ug/L, with detected concentrations ranging from 8.9 ug/L in MW-9 to 20 ug/L in MW-6.

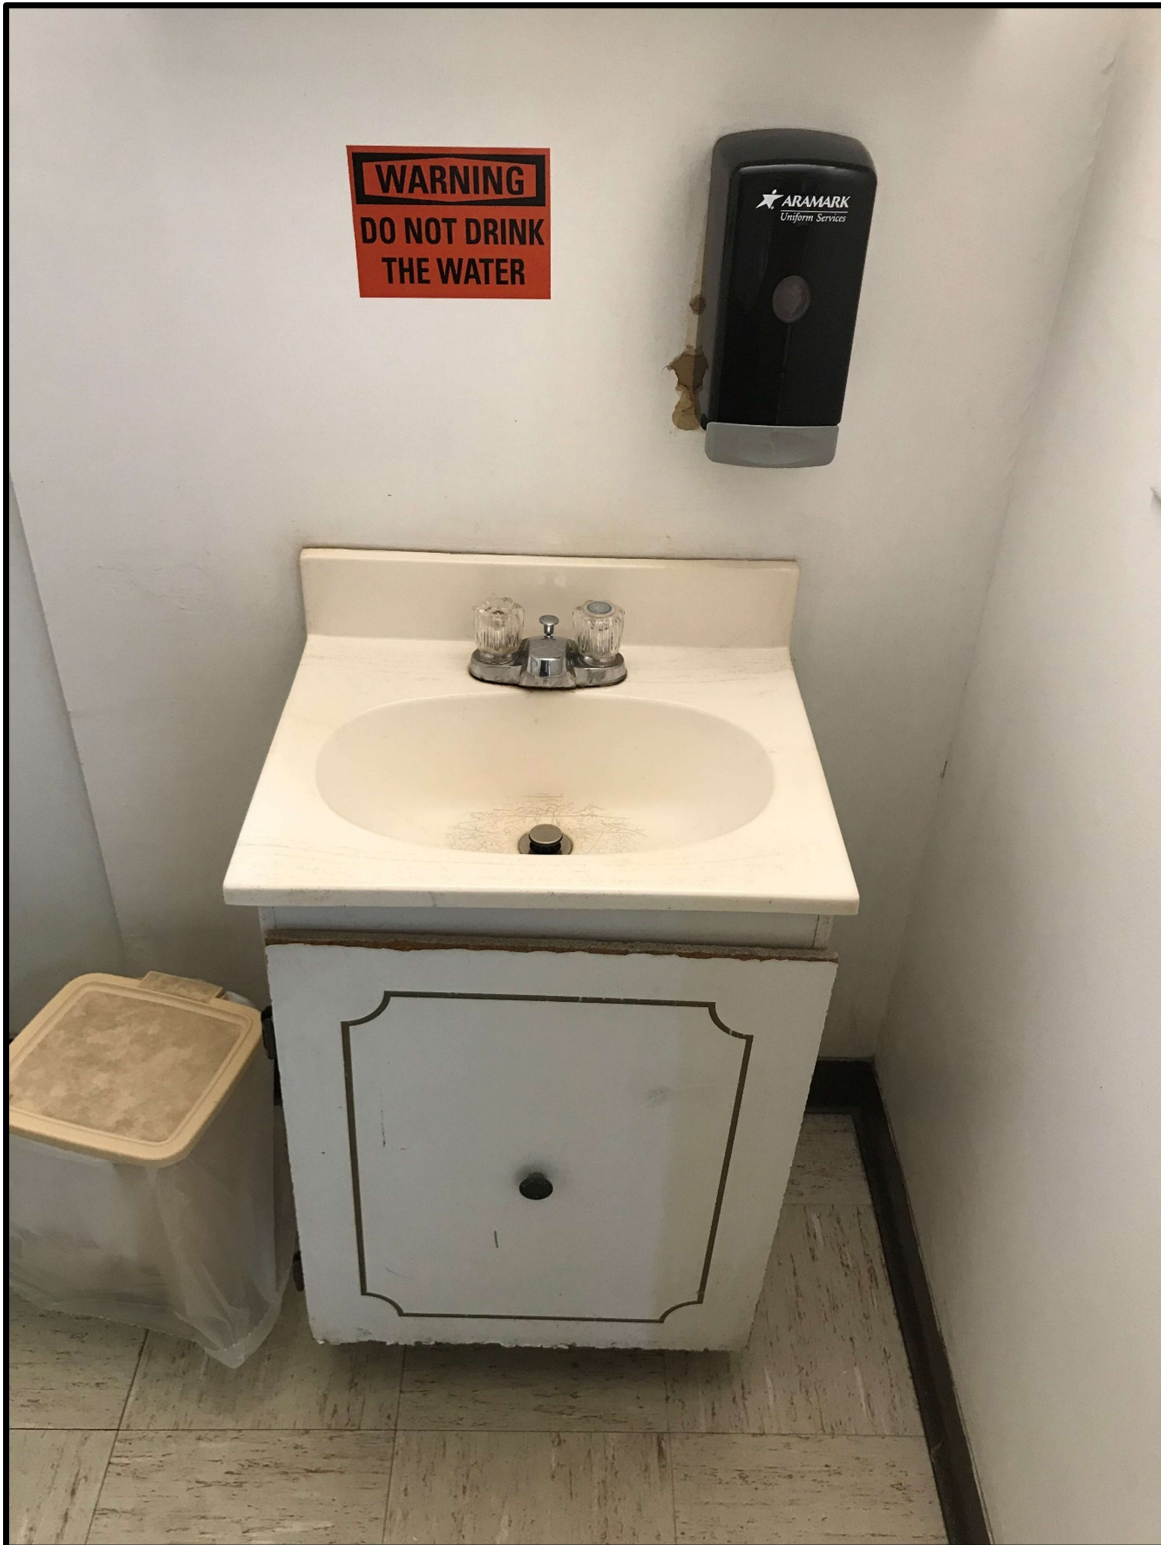
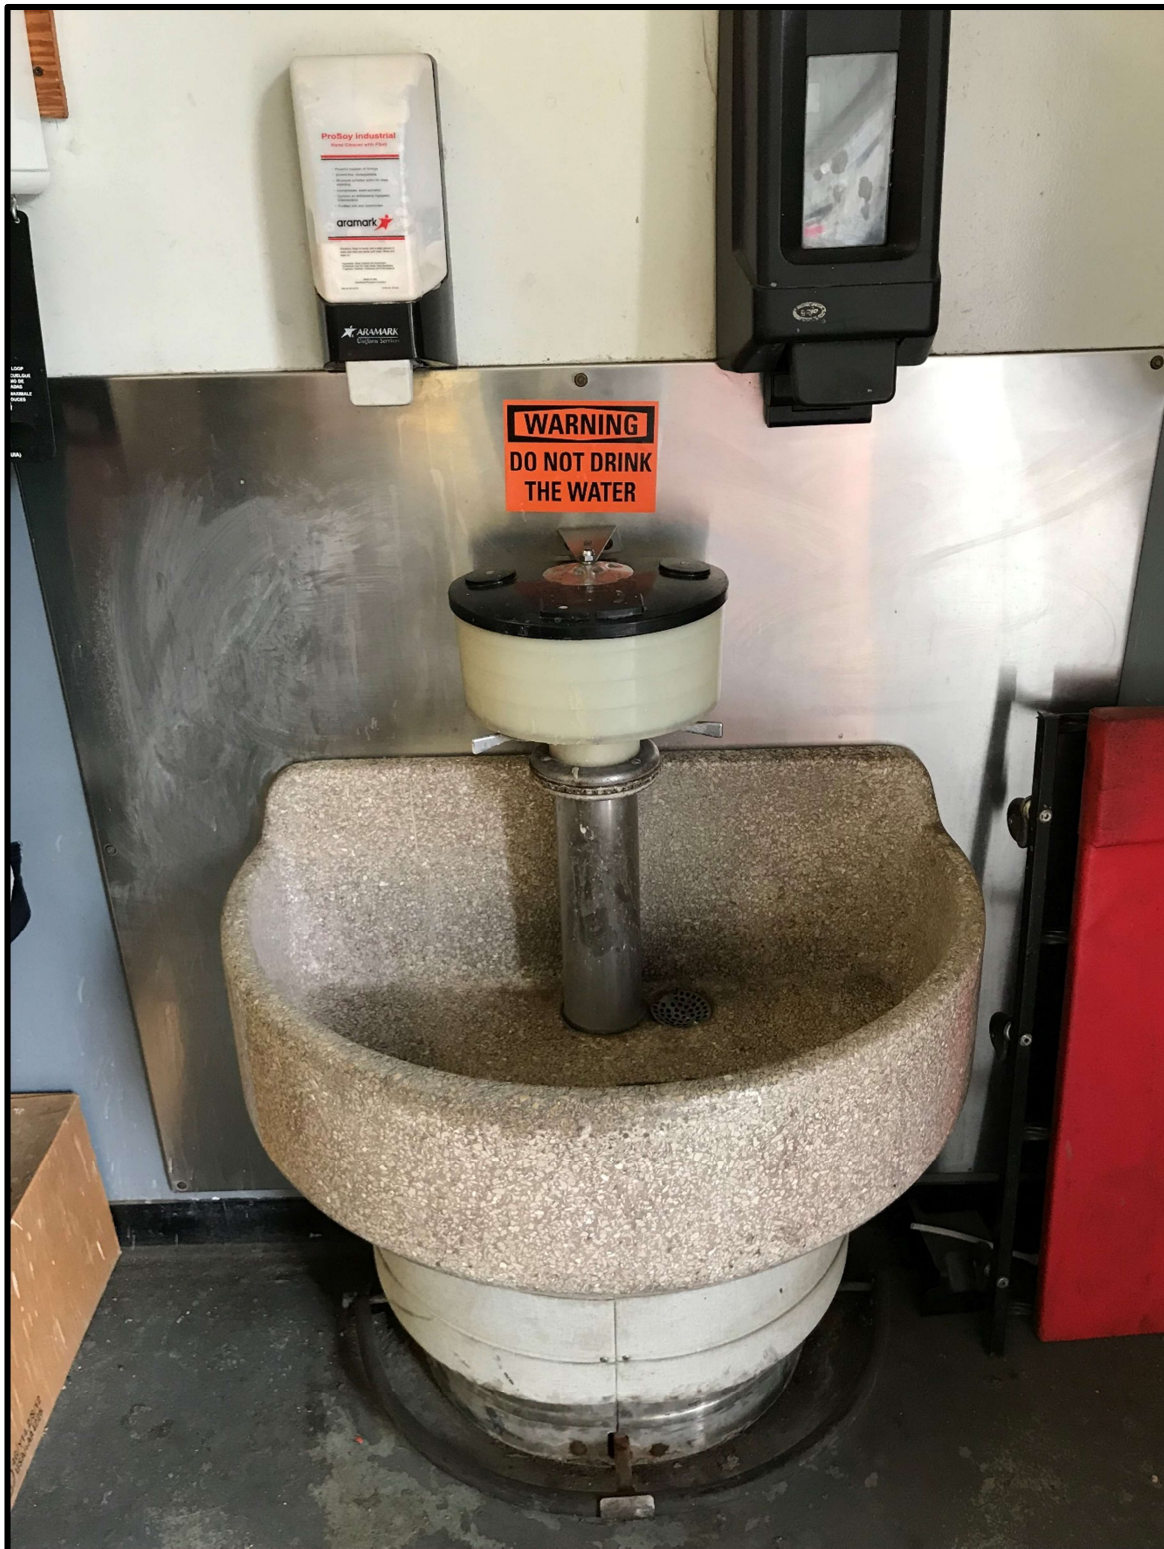
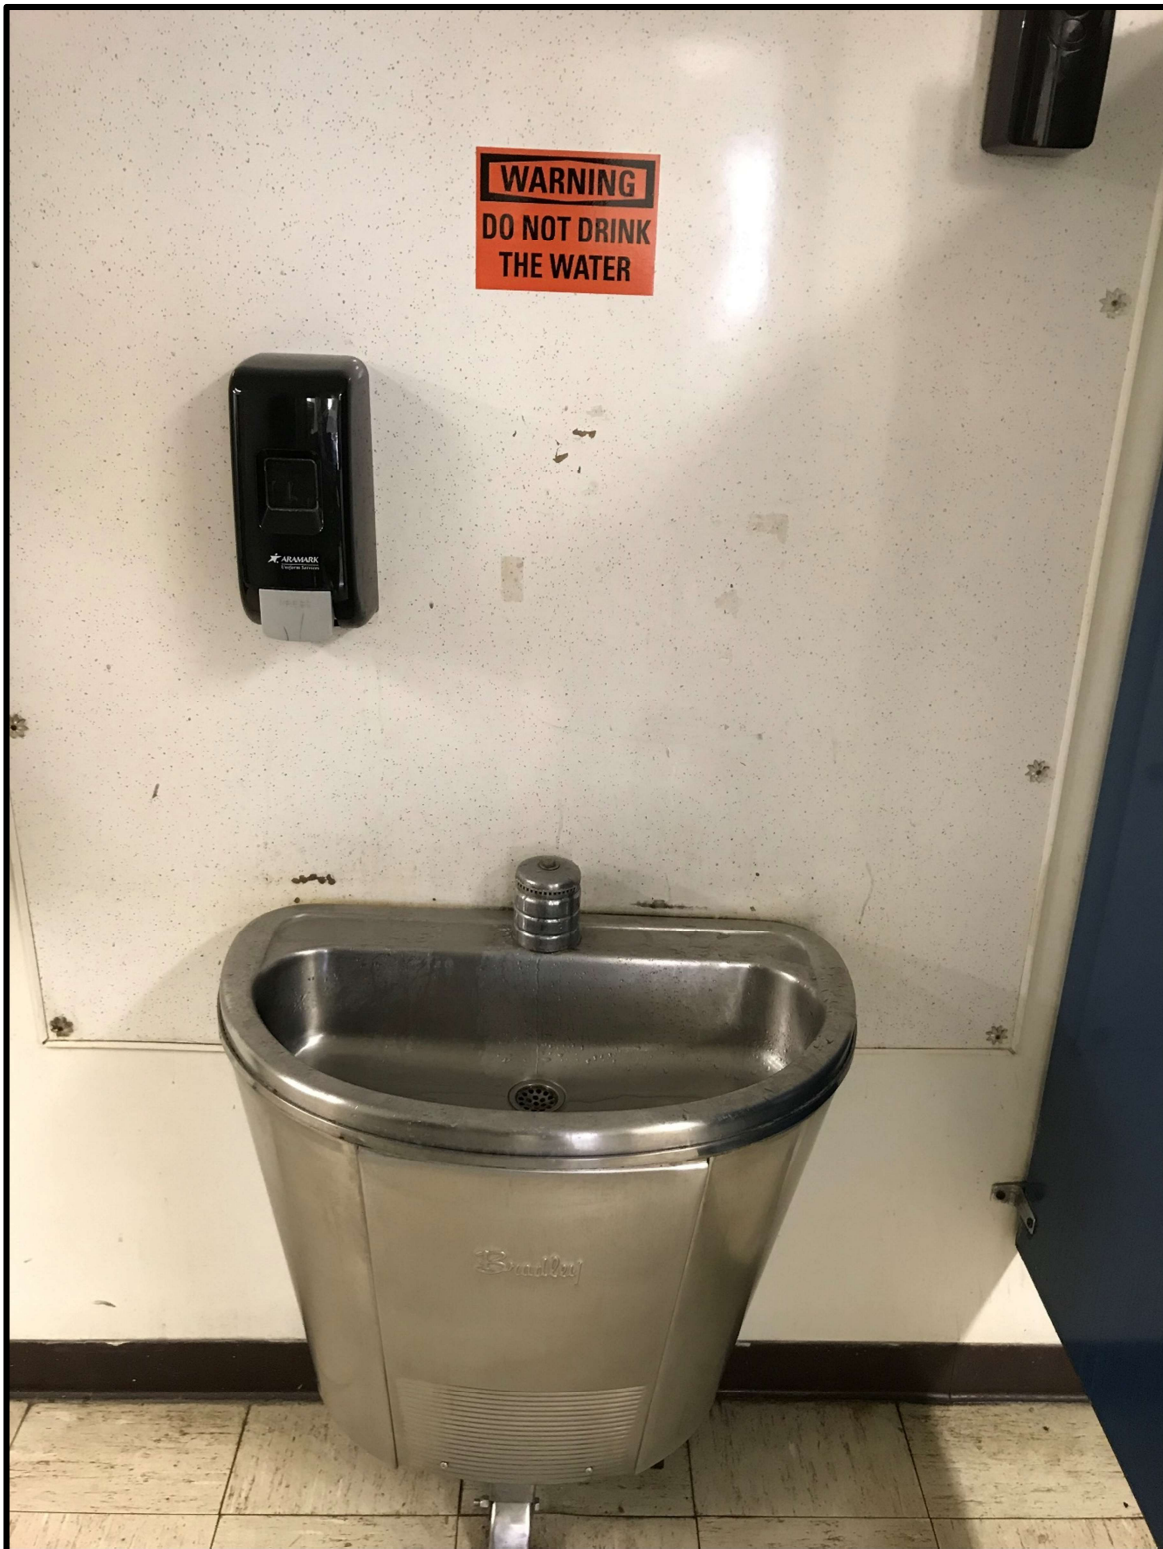
Picture 10: Informational Sign in Facility Restroom #1

Groundwater Use Restriction: Groundwater at the Facility property shall not be used for any purpose other than the monitoring or remediation activities required by WVDEP and EPA. Via email on May 28, 2018, Safety-Kleen representative Mr. Stephen Fleming confirmed that the City of Wheeling Water Department provides potable water to the Facility. There is one onsite well that provides non-potable water to the Facility. Warning signs which read “Do not drink the water” were observed in Facility restrooms.
