# Mitigating Environmental Impacts of the Abandoned Interstate 95 Embankment across Rumney Marsh

EPA Publication 901-R22-001

Edward Reiner, Senior Wetland Scientist,  
US EPA New England,  
Boston, Massachusetts.

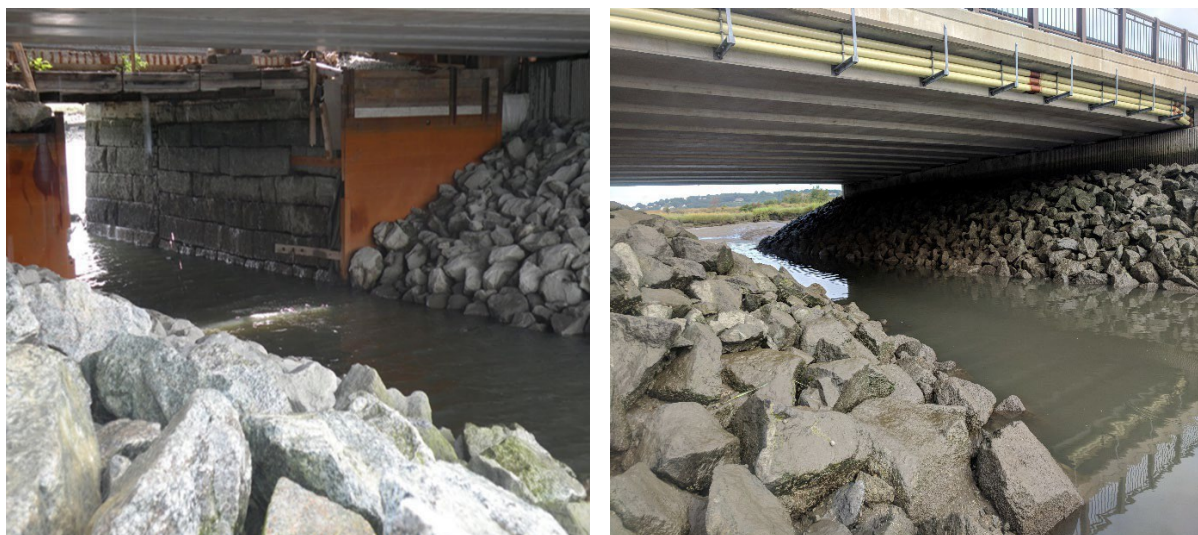
**Figure 9.** During and after construction photographs of the East Branch Pines River bridge S-5-3 crossing show how the vertical walls of the former bridge were changed to a riprap slope, which increased channel conveyance. Photo credit Ed Reiner.

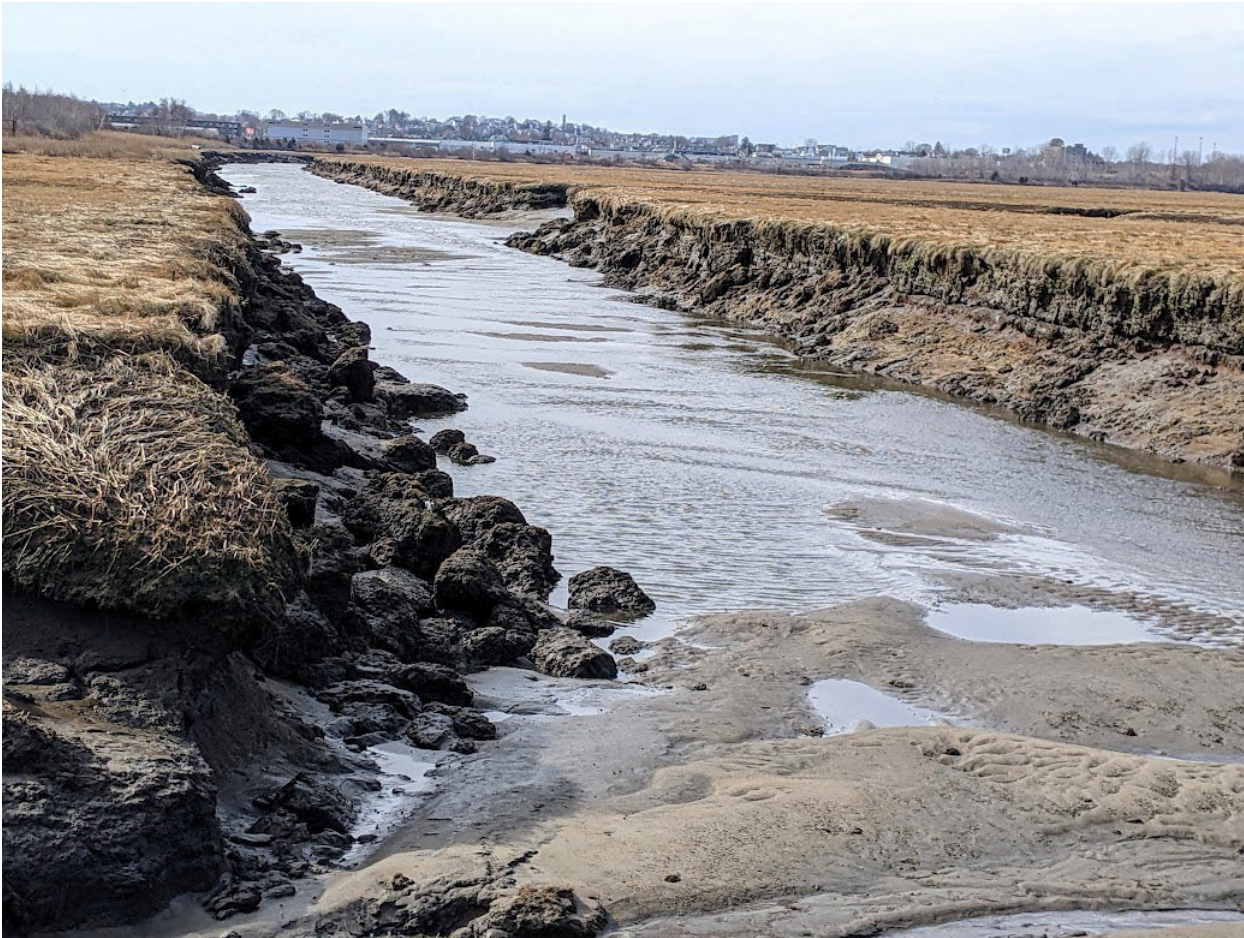
**Figure 13.** Photograph of the constructed “temporary” drainage channel in East Saugus looking south toward Revere taken February 23, 2022. The channel in some places is more than twice the original constructed width due to erosion of the salt marsh peat banks. Photo credit Ed Reiner.

Our study also showed the depth along the constructed drainage channel on the west side of the abandoned I-95 embankment became shallower with the distance from the relocated Pines River channel. The channel becomes narrower and eventually was shallow enough to support *Spartina alterniflora*. During our investigation, we observed significant erosion of the salt marsh along the constructed drainage channel (Figure 13).

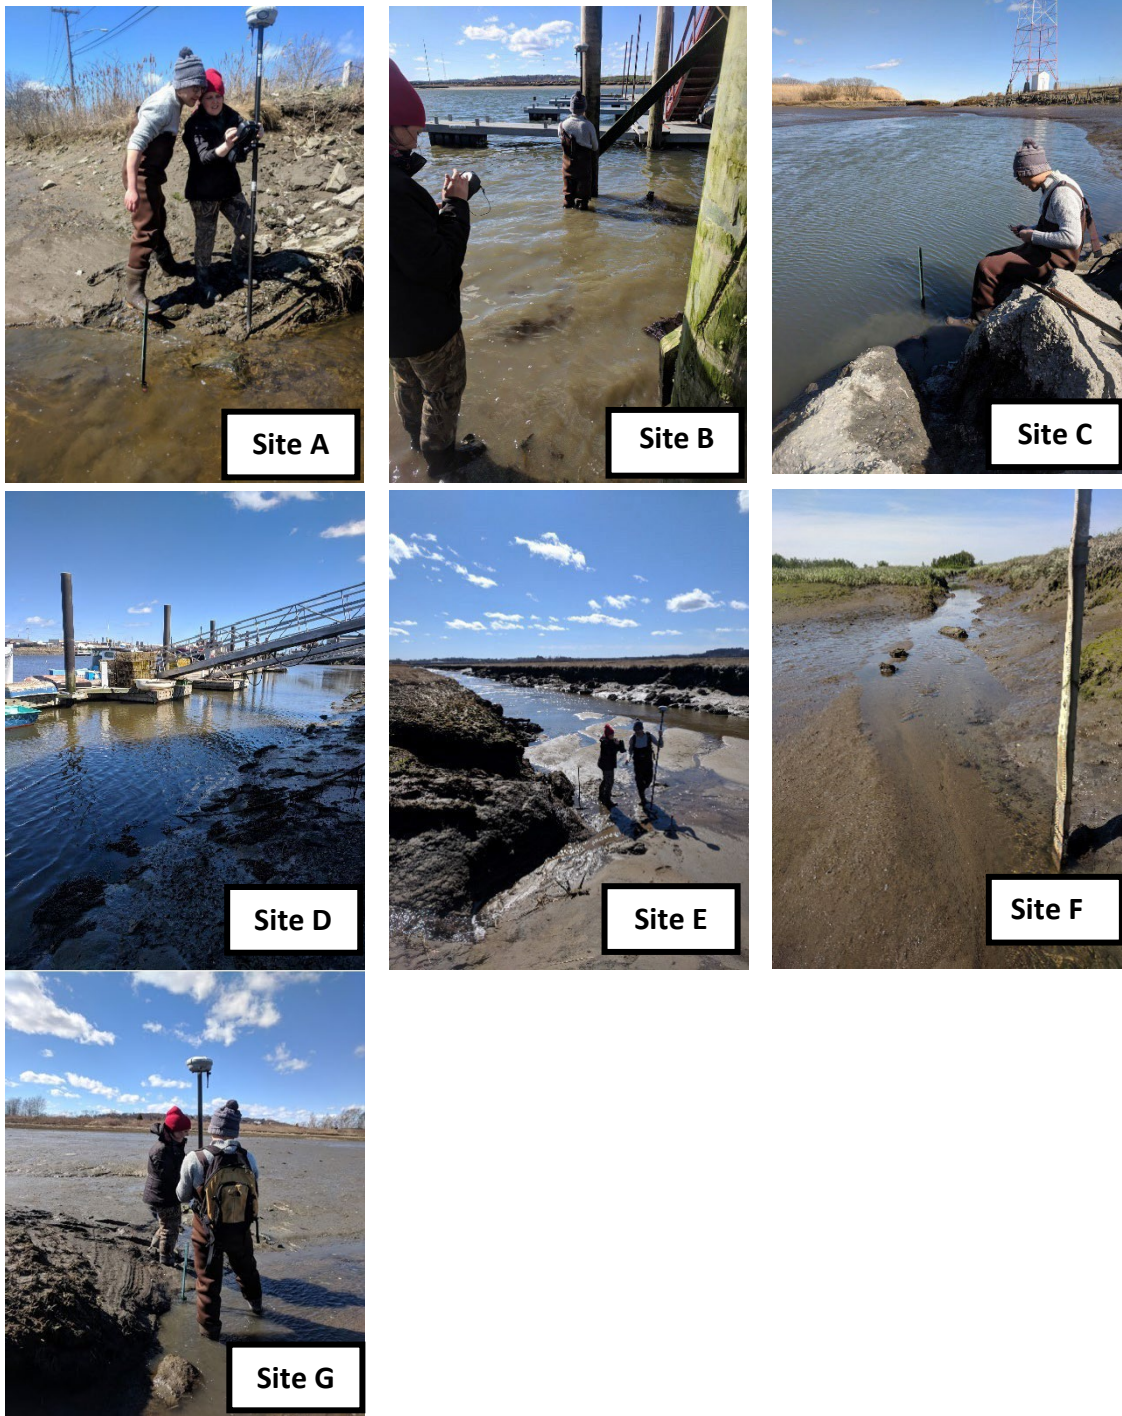
**Figure 17.** Photographs of the pressure transducer installations at sites A – Ballard Street, B – Lower Pines River, C – Upstream Railroad, D – Saugus River, E – Upstream I-95, F – East Saugus, and G – Upstream 107. Photo credit Ed Reiner.

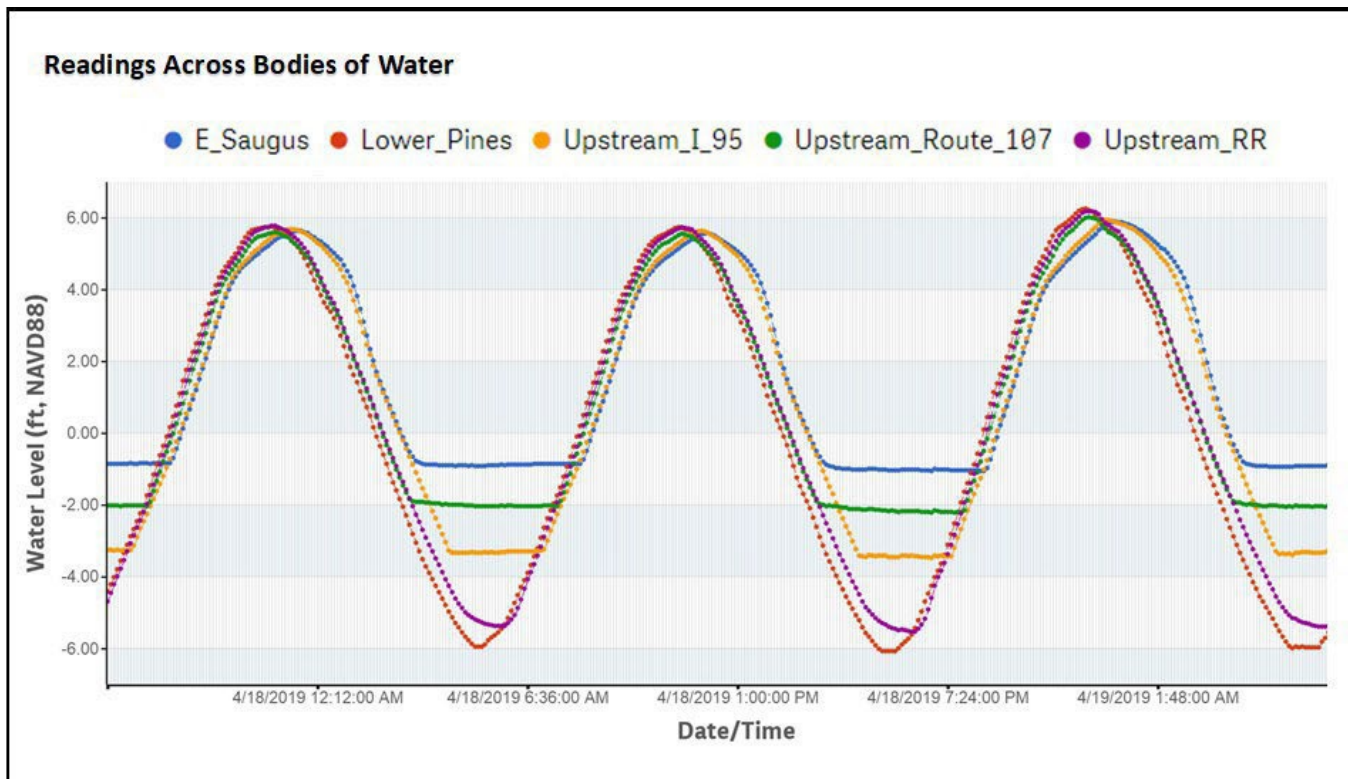
**Figure 23.** Daily tidal water elevations during spring tide conditions April 18-19, 2019, depict the tidal phase delay and slightly lower peak tidal height above the abandoned I-95 embankment caused by the downstream bridges.

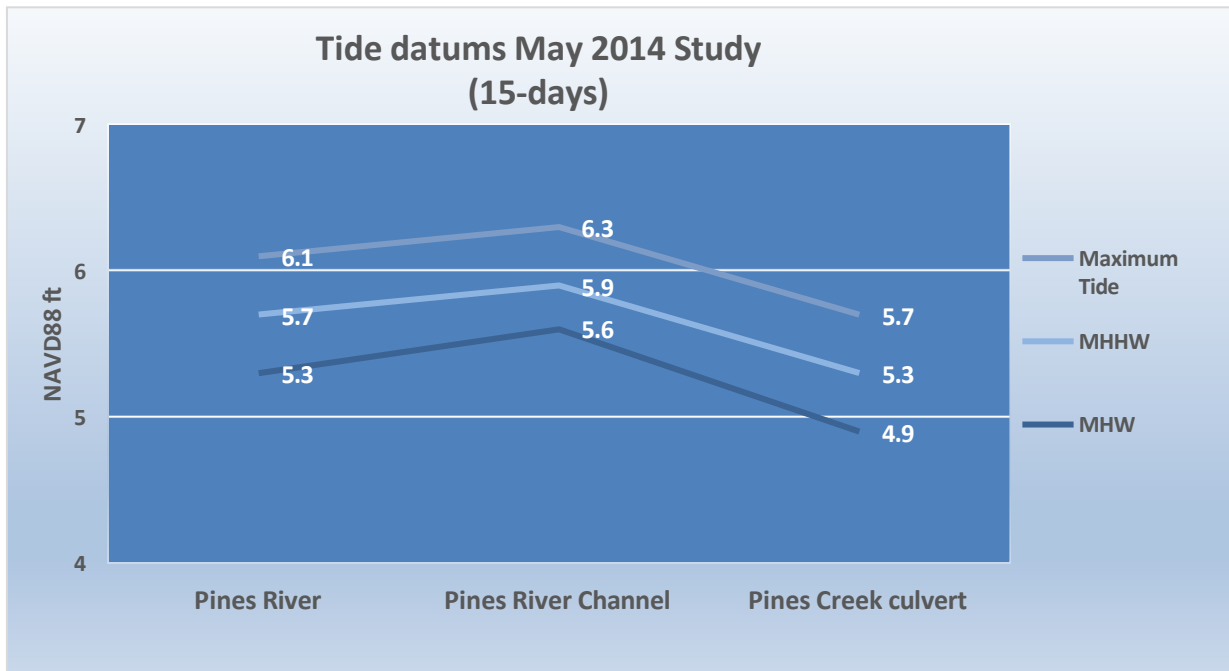
**Figure 26.** Tidal datums computed from the 15-day records collected Pines River marsh system in May 2014. Datum elevations are in feet NAVD88. Data from ACRE 2015.

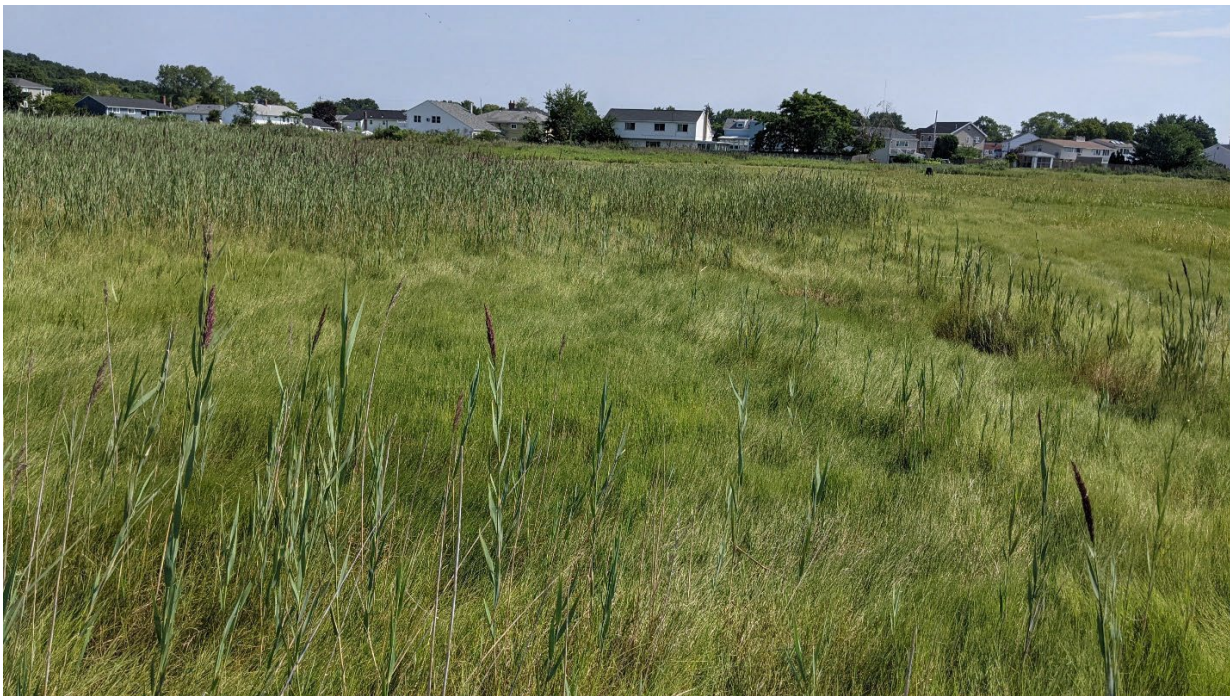
**Figure 29.** Stunted Phragmites is less than two feet tall in this area of the East Saugus Marsh due to the increased tides. Photo credit Ed Reiner.

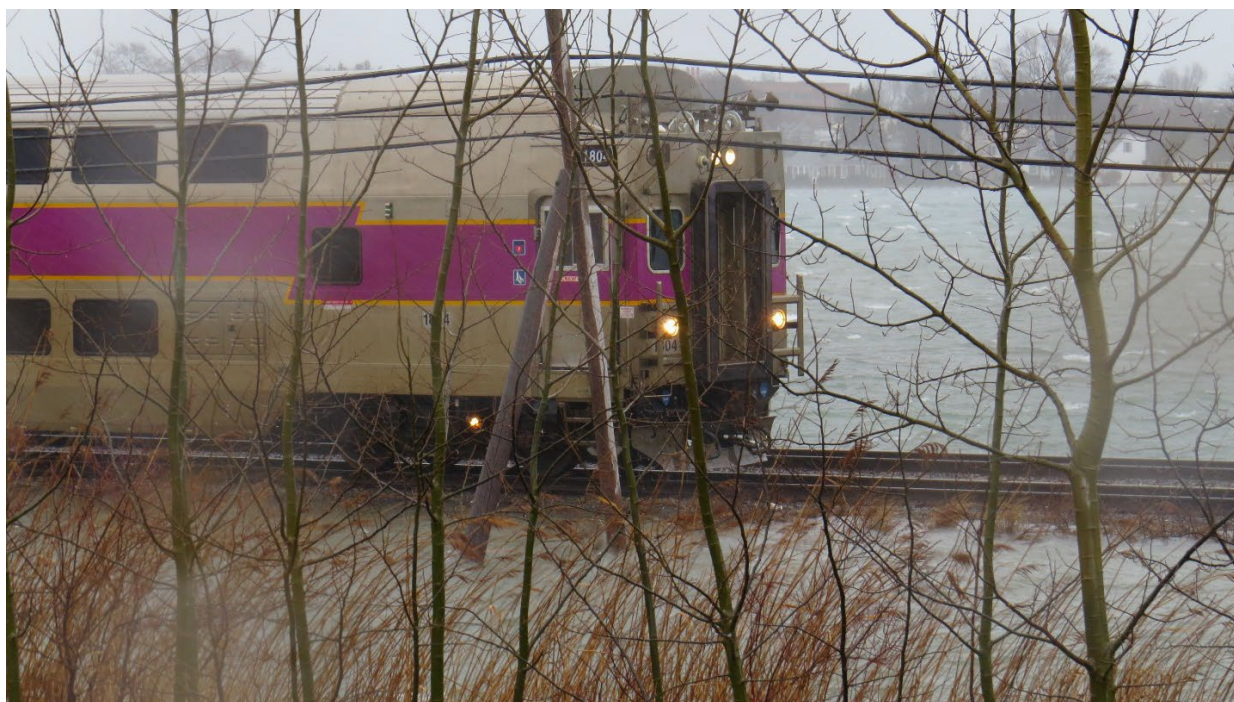
**Figure 32.** Photograph taken March 3, 2018, shows tidal water levels approaching the top of the railroad embankment at Rumney Marsh. Photo credit, Geoffrey Wilson, Northeast Wetland Restoration.

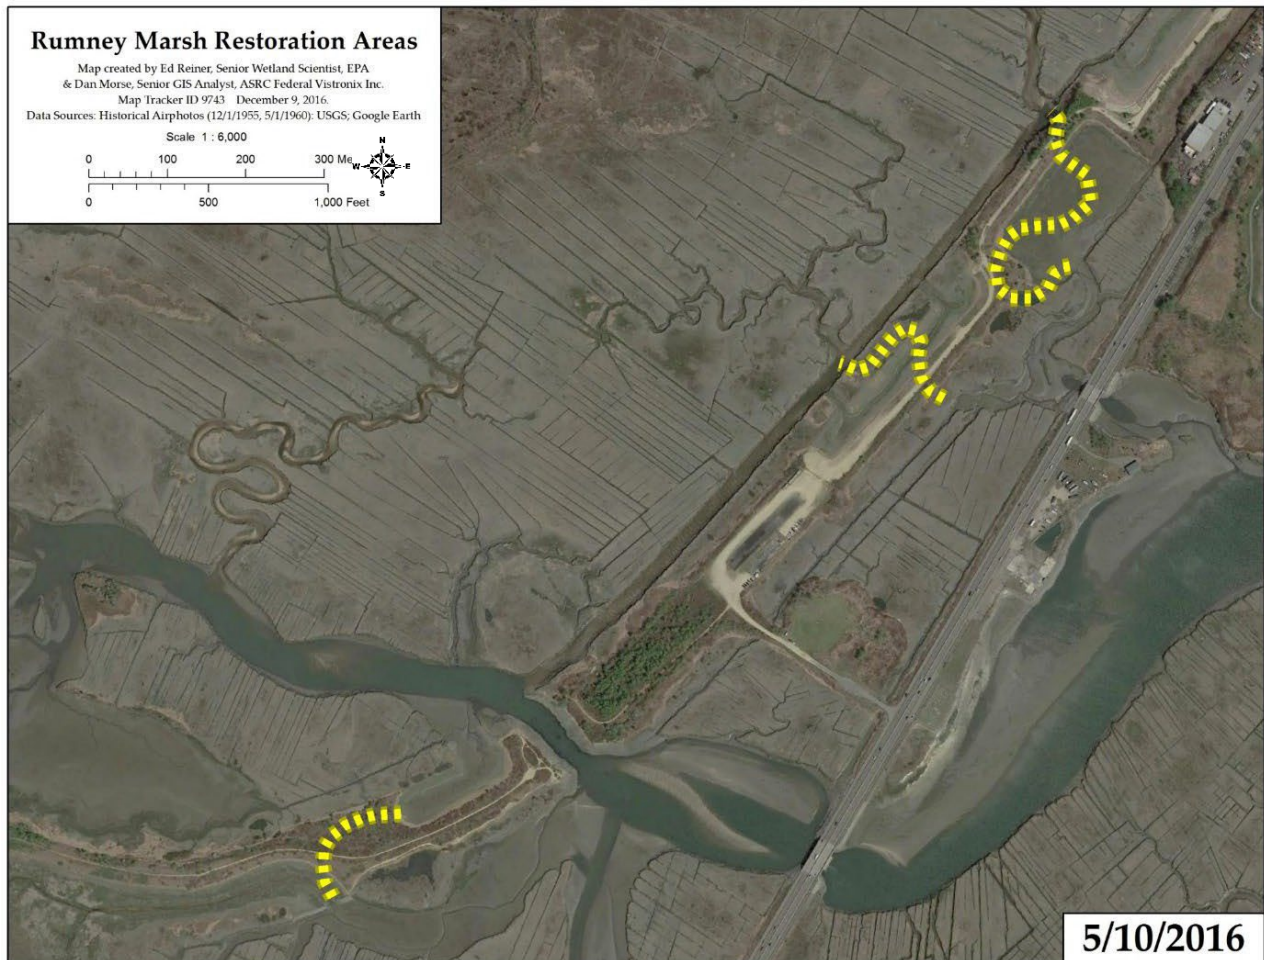
**Figure 33.** Aerial photo taken May 10, 2016, highlighting the locations of former channels which were filled along the abandoned I-95 embankment in Revere and Saugus, Massachusetts.

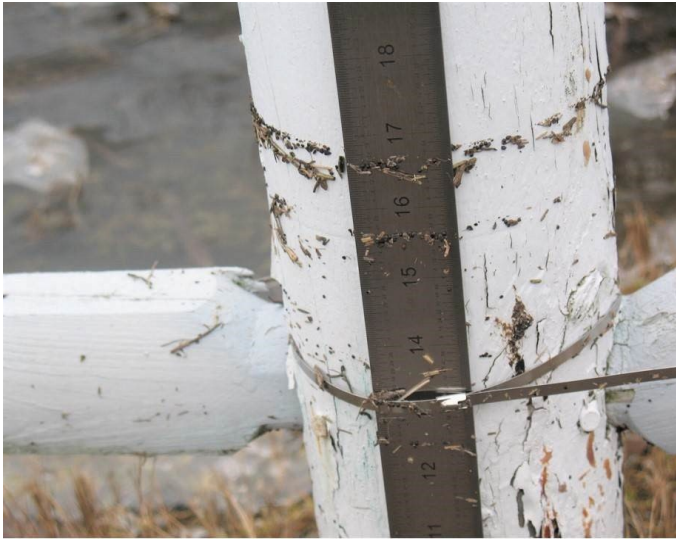
**Figure C-2.** High tide debris from January 2, 2022, storm surge measures 16.5 inches from ground level or elevation 7.0 feet NAVD88. Photo credit Fae Saulenas.
