UNITED STATES ENVIRONMENTAL PROTECTION AGENCY

Region 9 Enforcement and Compliance Assurance Division
75 Hawthorne Street
San Francisco, CA 94105
RCRA INSPECTION REPORT

Inspection Date(s):	6/23/2021	Inspection Announced: Yes
Time:	Entry: 9:00 am	
Regulatory Program(s)	RCRA Subtitle C (Hazardous Waste)	
Company Name:	Evoqua Water Technologies	
Facility/Site Physical Location:	2523 Mutahar Street	
(city, state, zip code)	Parker, AZ 85344	
Geographic Coordinates:	34.13249, -114.27262	
County	La Paz	
Facility/Site Contact:	Russell Smith	Plant Manager
	Russell.smith@evoqua.com	(928) 669-5758 ext. 17
Facility/Site Identifier:	AZD982441263	
Generator Status	Permitted Treatment, Storage & Disposal Facility (TSDF) Large Quantity Generator (LQG)	
NAICS:	562211 – Hazardous Waste Treatment & Disposal	
Facility/Site Personnel Participating in Inspection:		
Russell Smith	Evoqua Water Technologies	Plant Manager
Don Breaux	Evoqua Water Technologies	Senior Supervisor of Production
Matthew Myers	Evoqua Water Technologies	Corporate Environmental Manager
Monte McCue	Evoqua Water Technologies	Executive Consultant

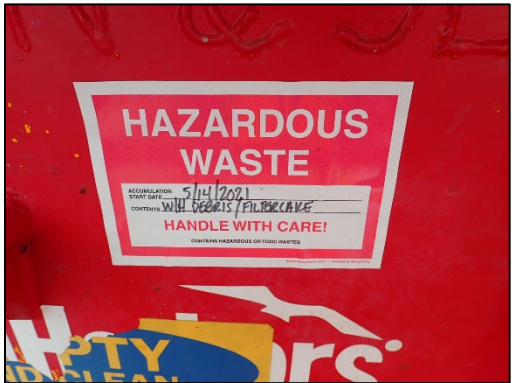
NO	OBSERVATION	PHOTOGRAPH	Regulatory Area of Concern
1	The inspectors observed that a label on the roll-off bin of debris with filter cake (D018, F001, F002, F003, F004, F005) was not marked with an indication of the hazards of the contents.

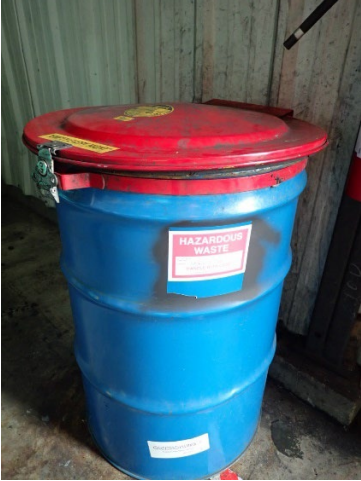
NO	OBSERVATION	PHOTOGRAPH	Regulatory Area of Concern
2	The inspectors observed that a satellite accumulation container (SAA) of hazardous warehouse debris was not marked with an indication of the hazards of the contents.
