Date: June 22, 2023
Refer To: N3B-2023-0209

Subject: Submittal of the Response to the U.S. Environmental Protection Agency National Pollutant Discharge Elimination System Permit No. NM0030759 Los Alamos National Laboratory Stormwater Individual Permit Comments on 2022 Annual Sampling Implementation Plan

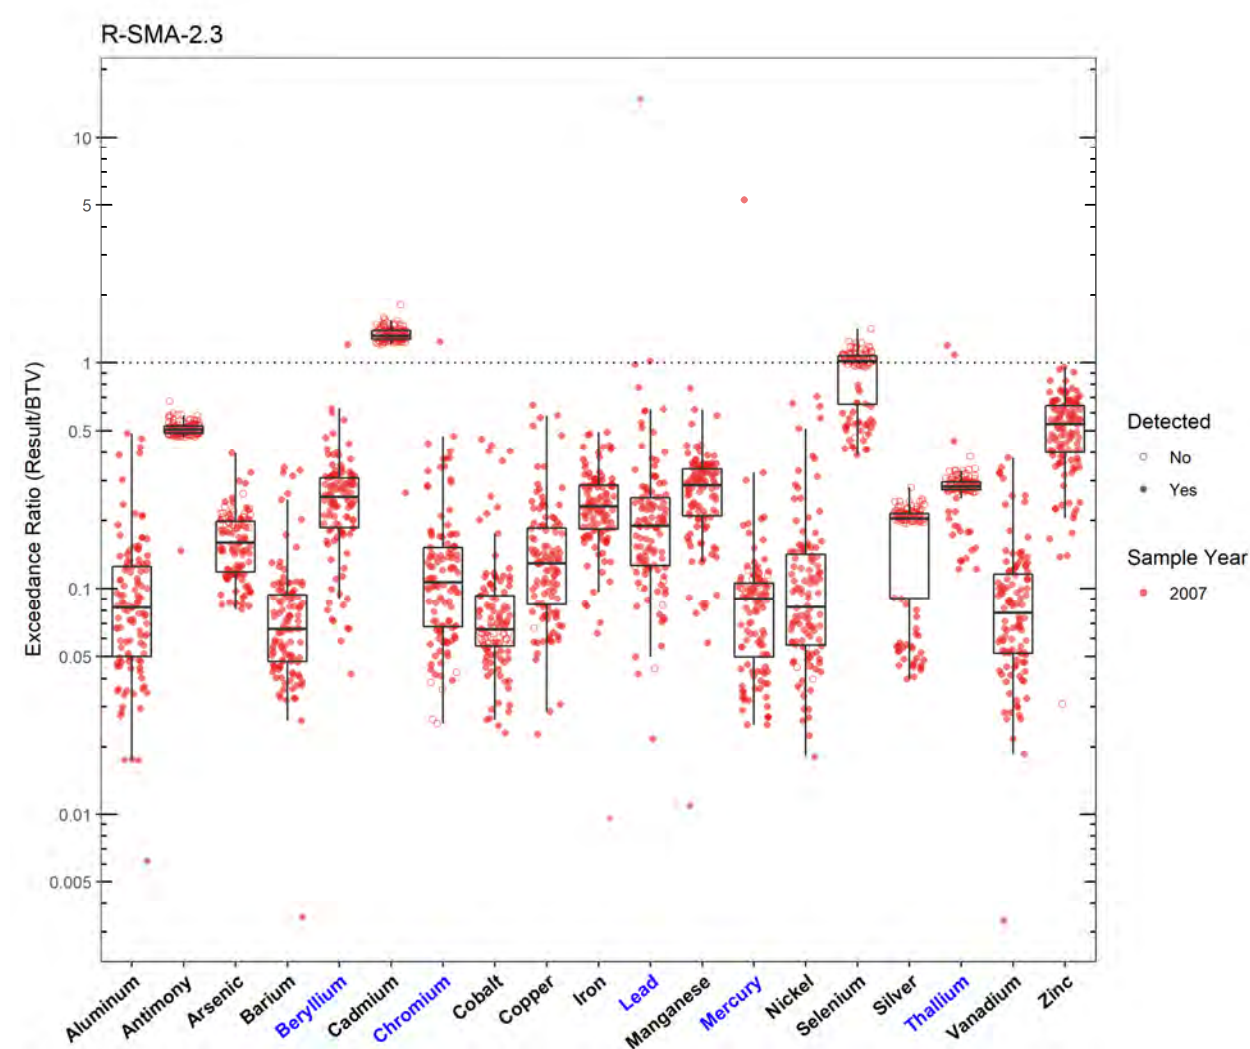
Figure 3.3-1 Inorganics Analytical Results from Soil Samples Associated with R-SMA-2.3

Decision-level data for SWMU 00-011(e) consist of results for samples collected in 2007. Analytical results from those samples are presented in Figures 3.3-1 through 3.3-3. The approved IR (LANL 2007, 099954) concluded that the lateral and vertical extent of all detected chemicals are defined.
