# Climax Transfer Station

## Removal Site Evaluation Report

July 2022

Cyprus Amax Minerals Company

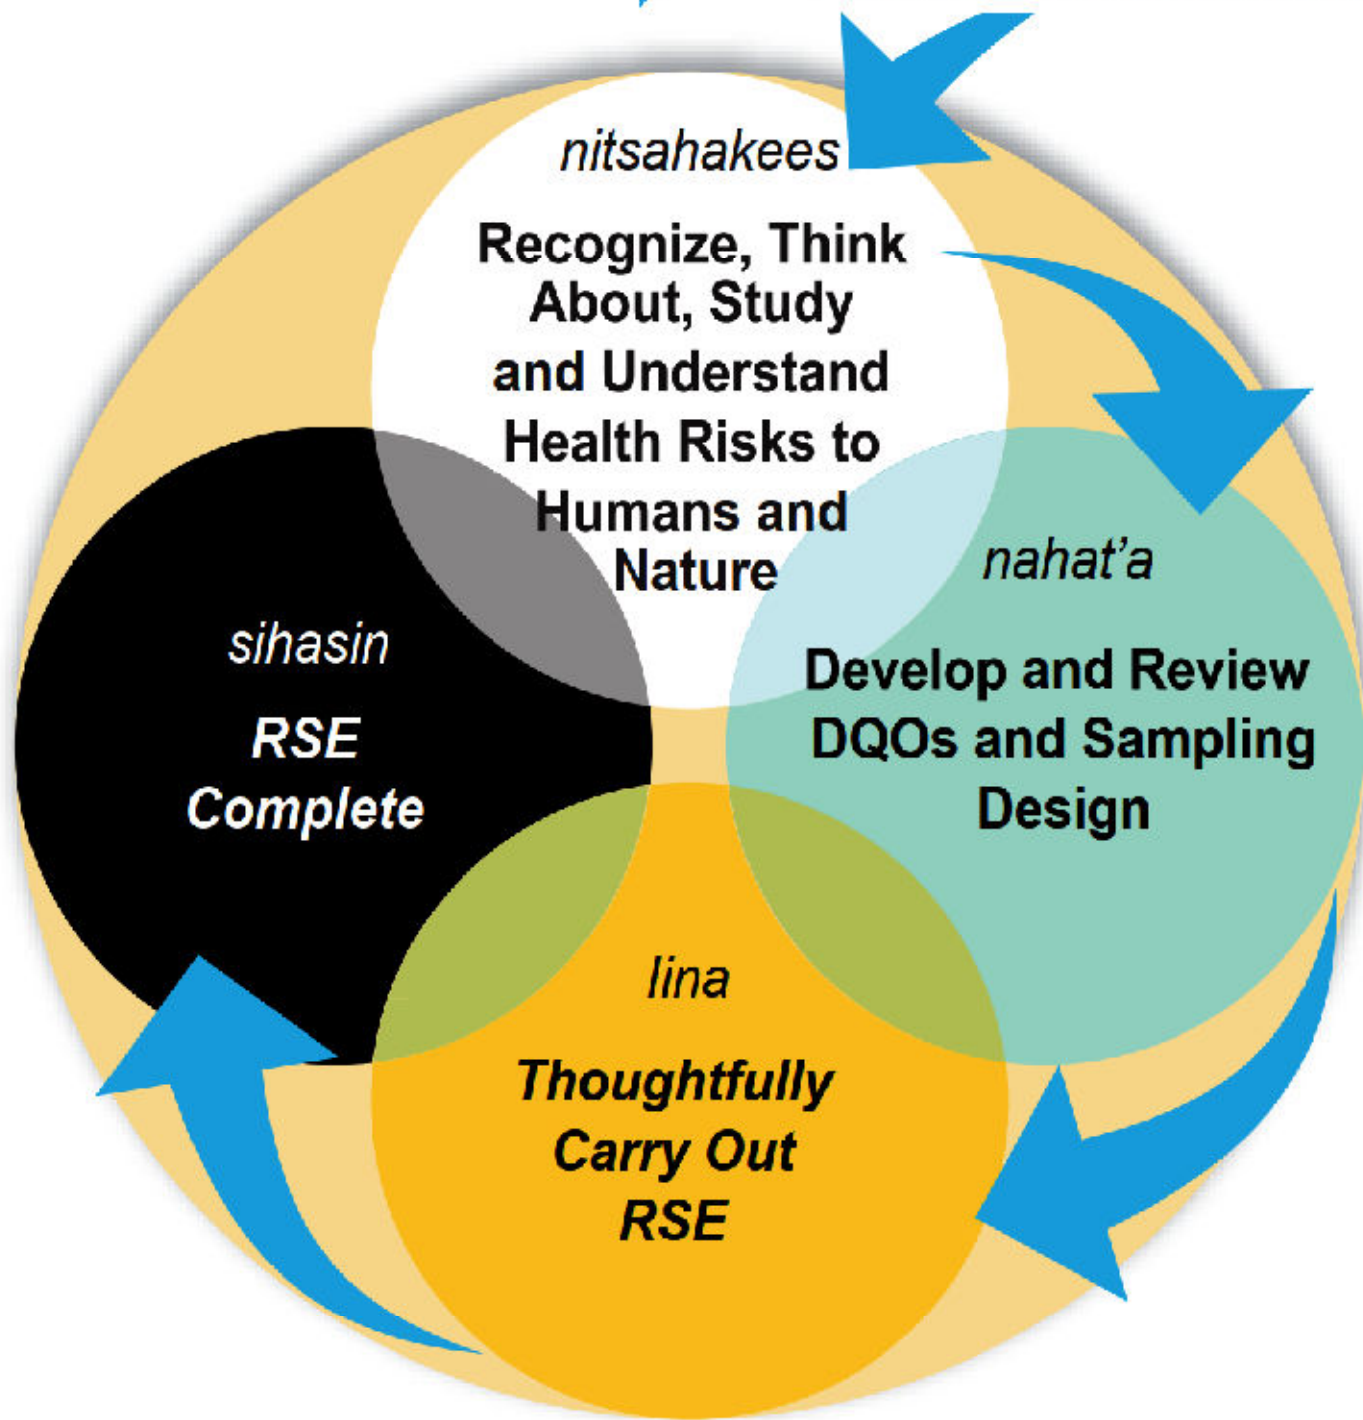
Figure 1-2. Decision Process  
Climax Transfer Station  
Removal Site Evaluation Report

results (sihasin) (Figure 1-2)<sup>3</sup>. The stages of the Diné problem-solving process flows in an ongoing, circular clockwise direction (Sha Bikehgo) that begins in the east and moves through to the south, west, and north. Diné problem solving is ongoing with the application of mutual cooperation and kinship. The activities and results of the investigation to characterize chemical and radiological conditions at the Transfer Station, as summarized in this RSE Report, will be used by U.S. EPA and NNEPA along with a risk assessment and EE/CA, if warranted, as they are thinking (nitsahakees) prior to any necessary remedial or removal action for the Transfer Station.

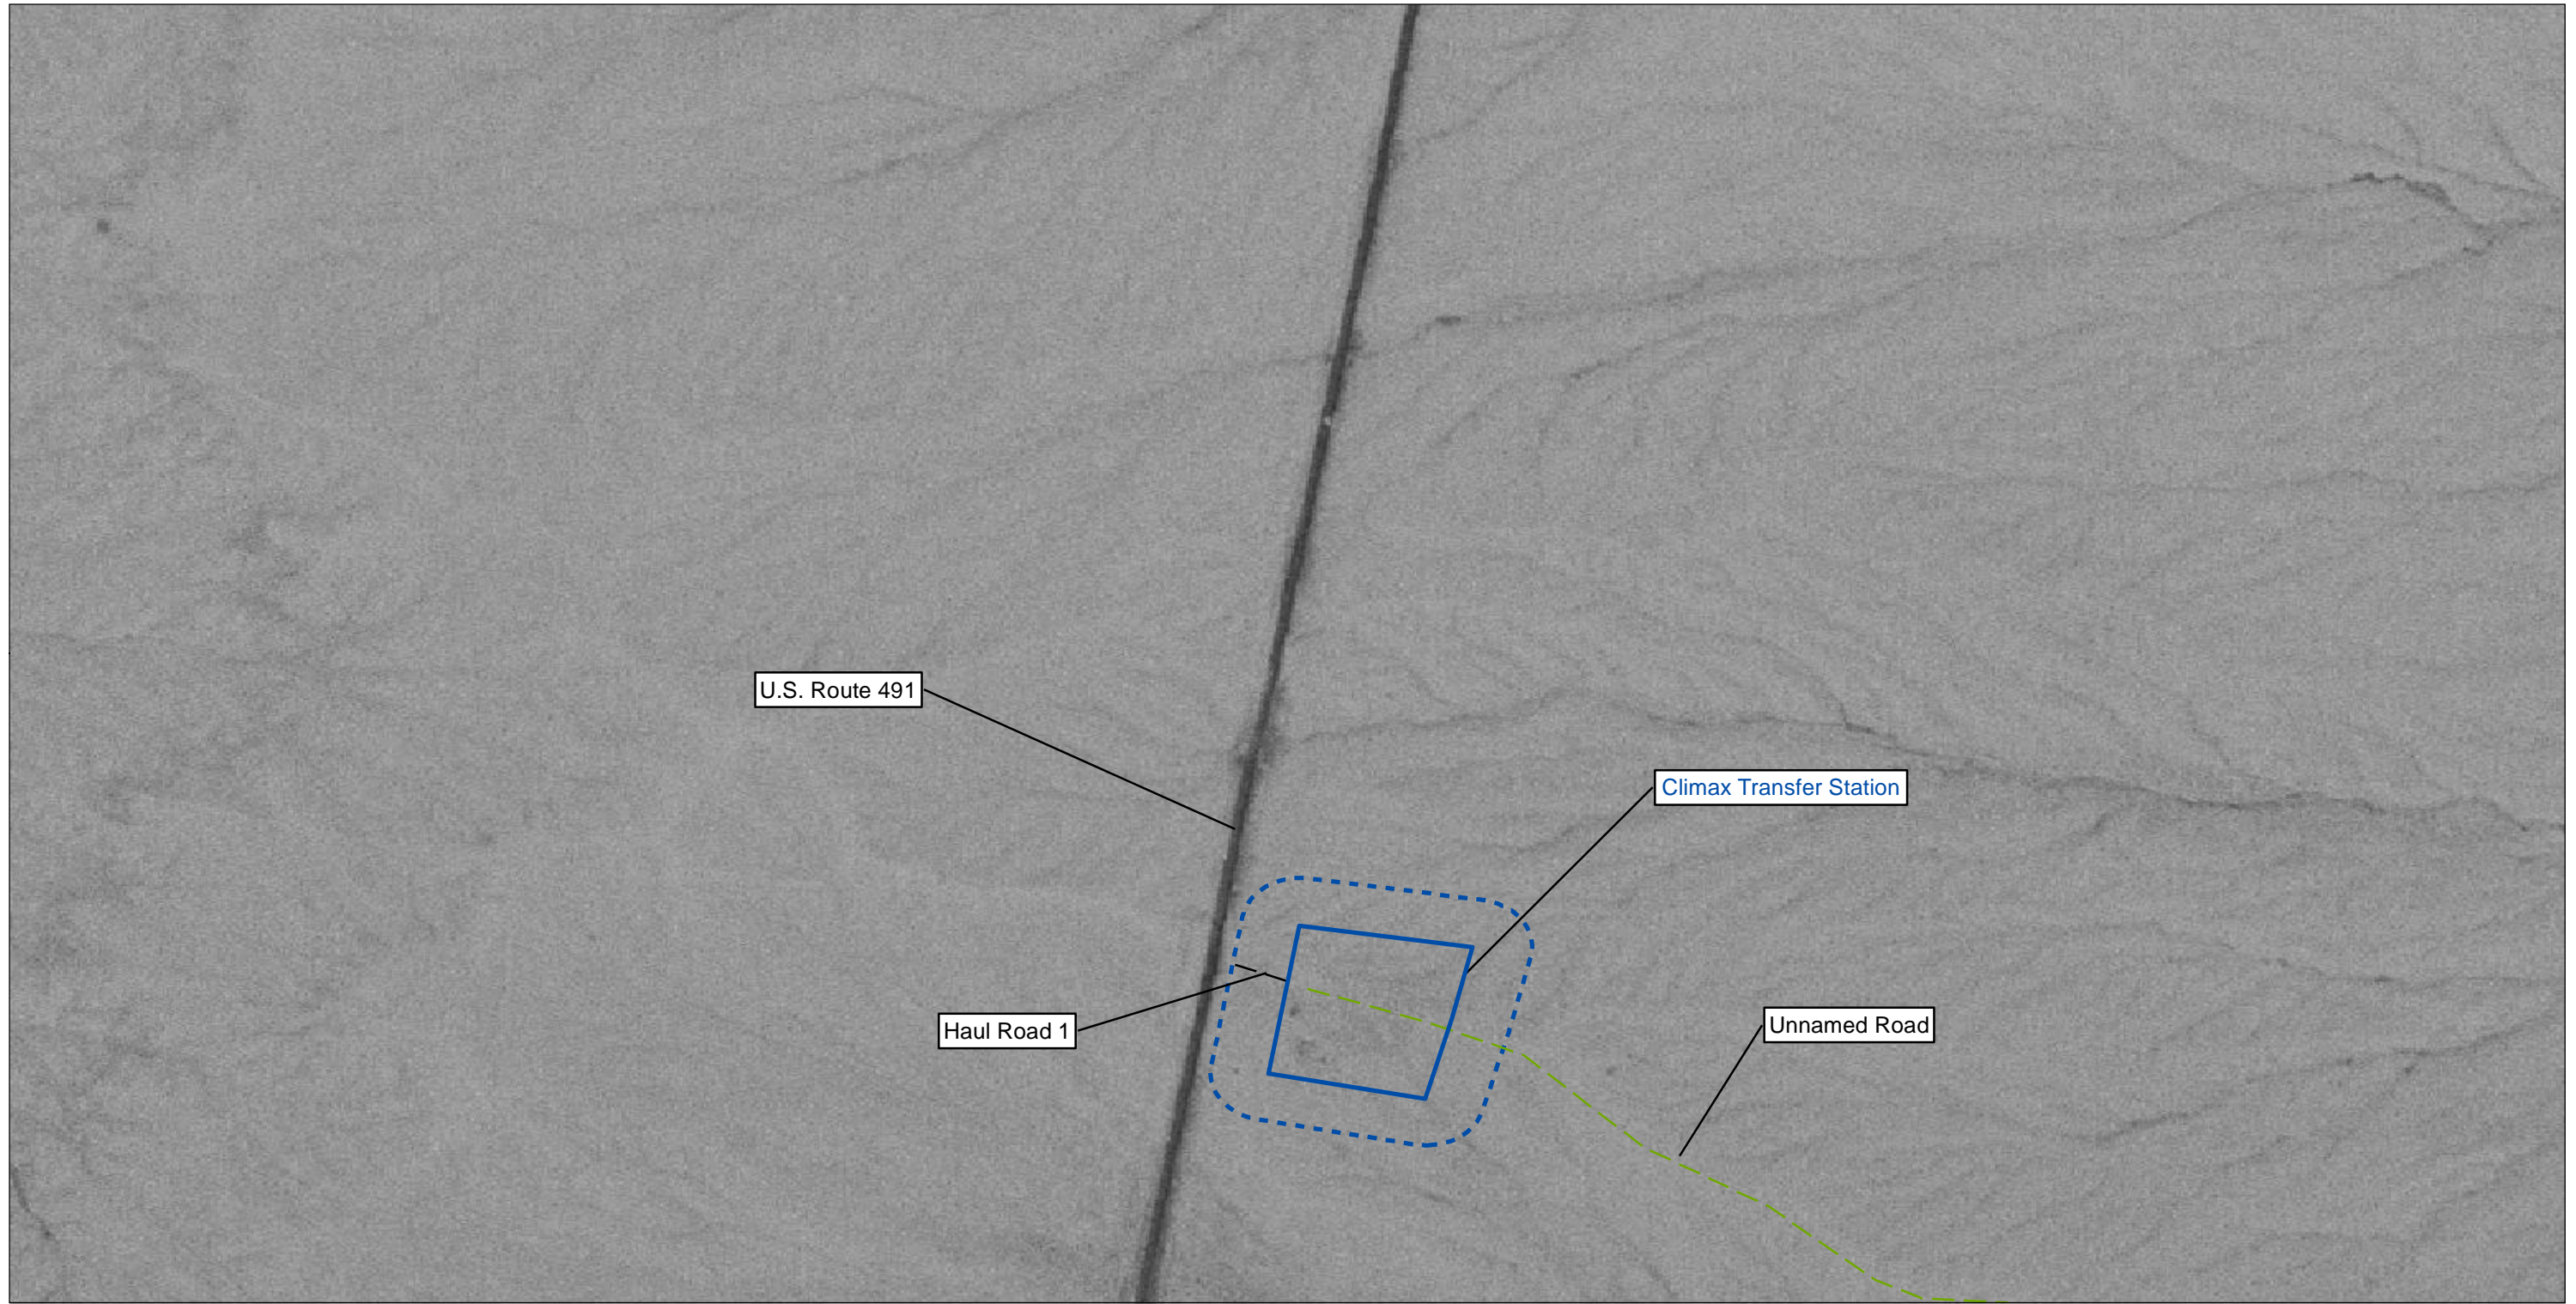
Figure 2-2b. Historical Aerial Photo from 1965  
Climax Transfer Station  
Removal Site Evaluation Report

- The 1965 aerial image (Figure 2-2b) is of poor quality; however, Haul Road 1 is visible and bisects the Transfer Station.
- Because of the poor image quality of the 1978 aerial image (Figure 2-2c), no discernable site features can be observed except for U.S. Route 491.

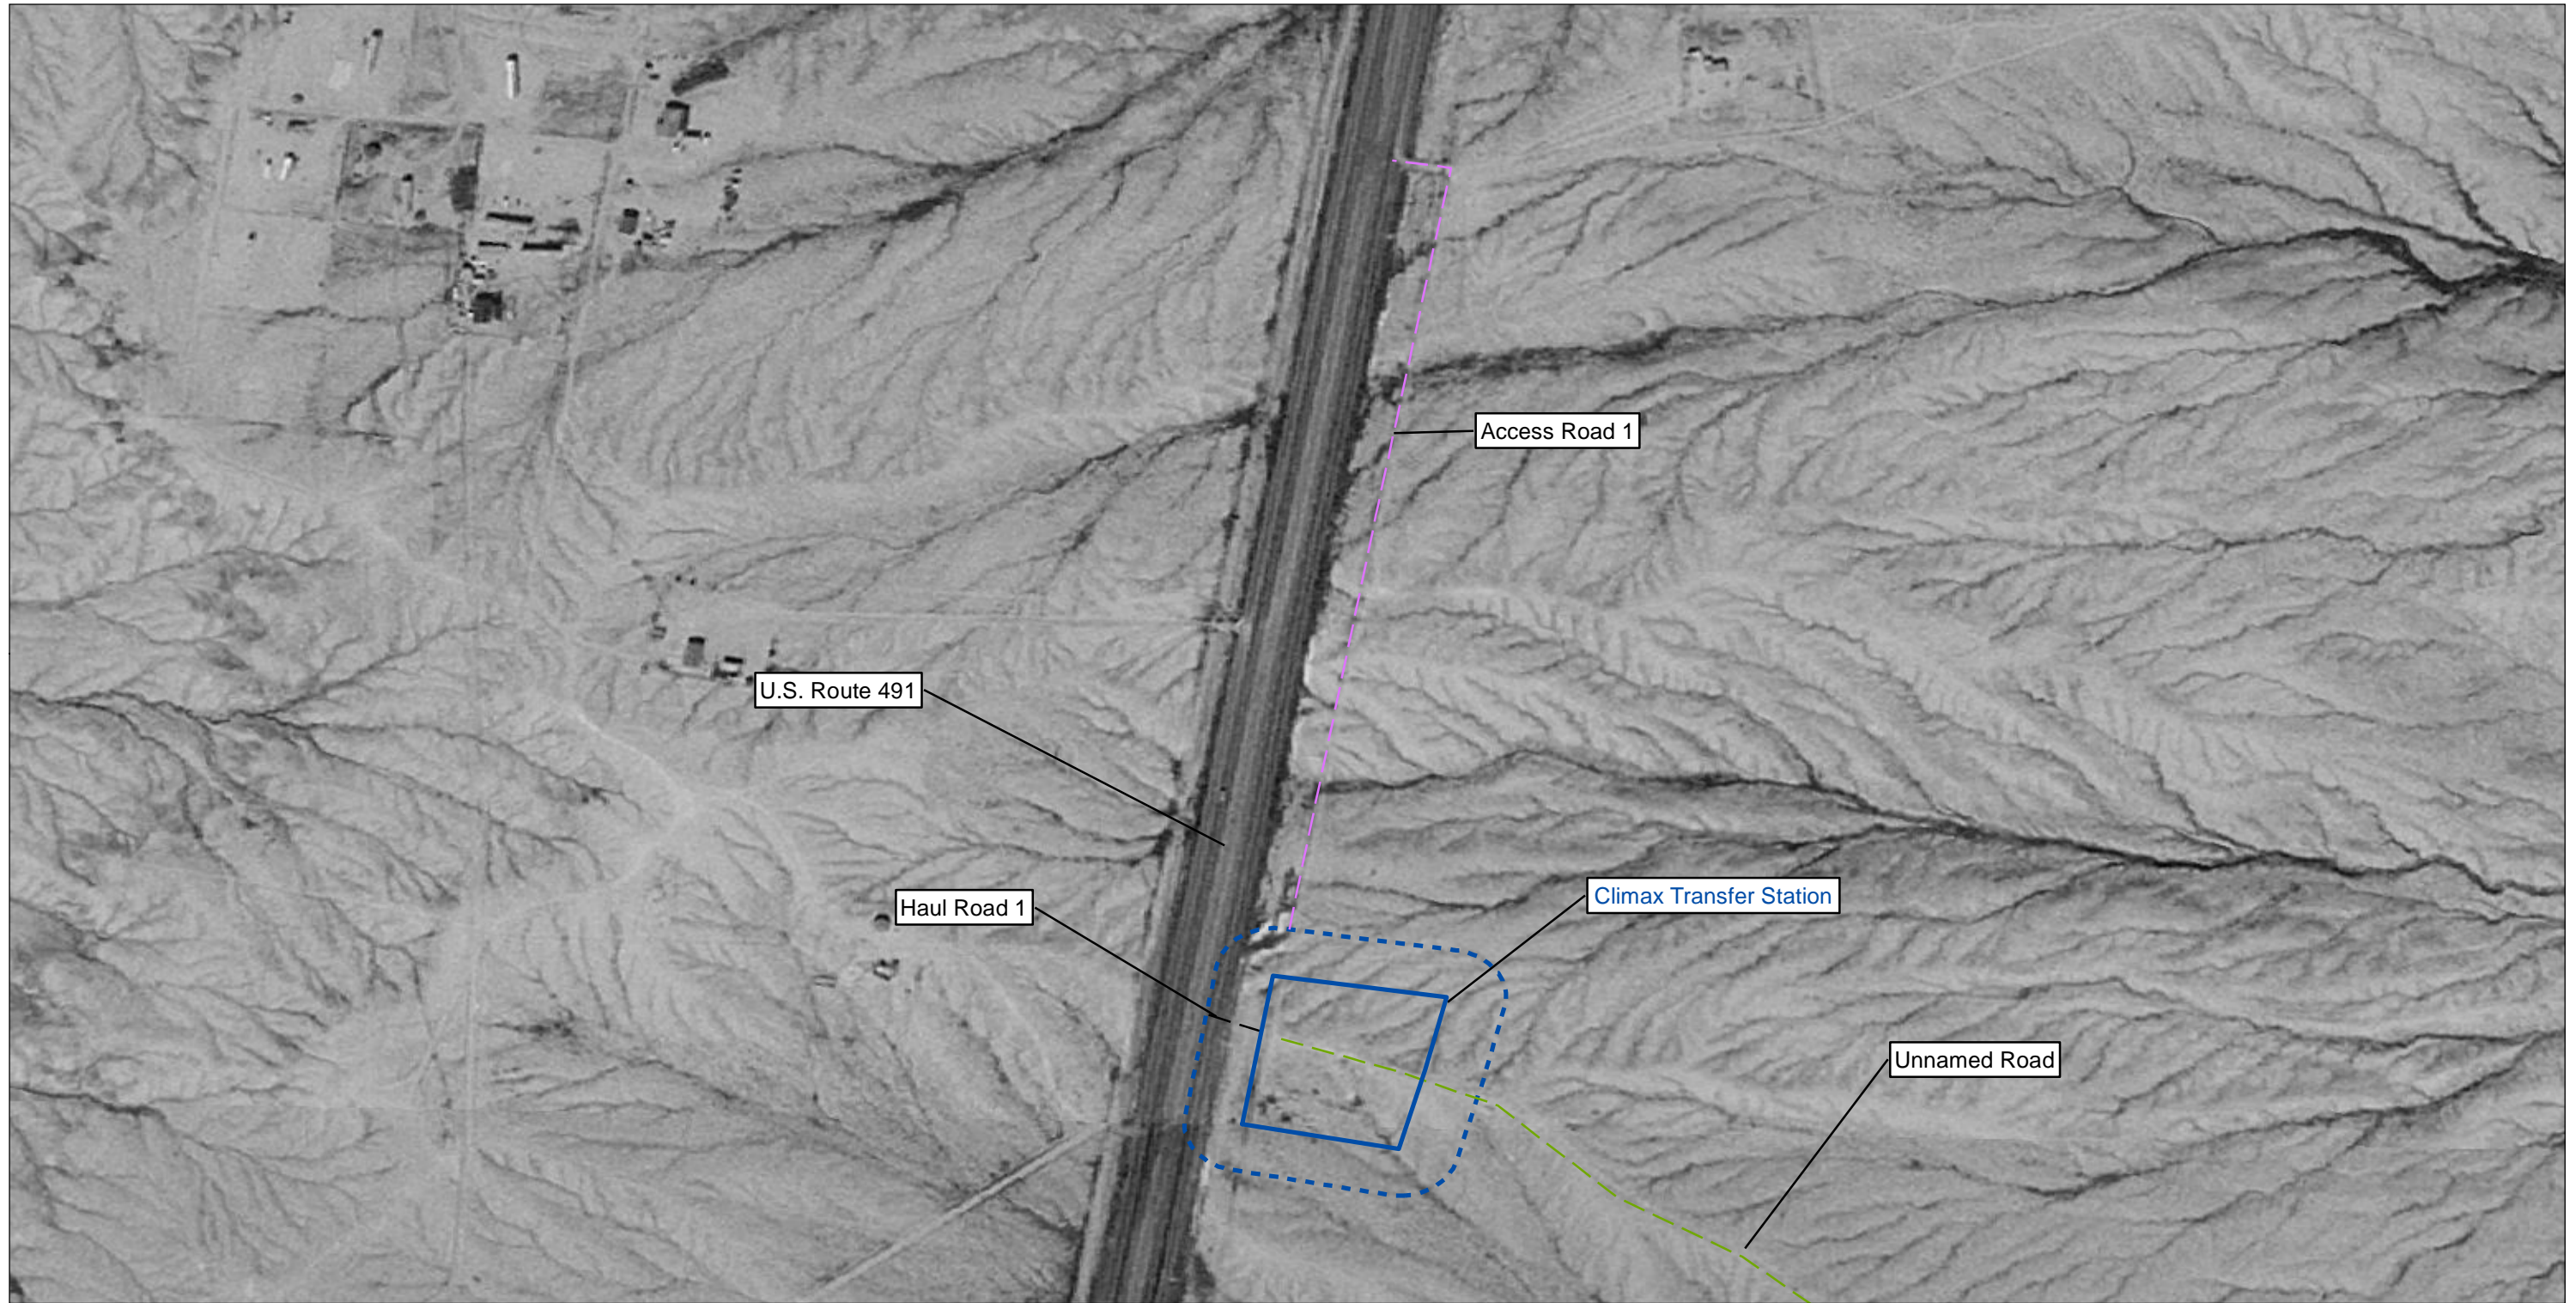
Figure 2-2d. Historical Aerial Photo from 1997  
 Climax Transfer Station  
 Removal Site Evaluation Report

- The 1997 and 2019 historical aerial images (Figure 2-2d and Figure 2-2e) show increased development near the Transfer Station. Specifically, U.S. Route 491 has been widened and the ROW for a gas line running parallel to the east of U.S. Route 491 is observed. In addition, buildings are apparent approximately to the north and west of the Transfer Station in 1997, and more development is apparent in the 2019 aerial image. Access Road 1 is visible traversing north from the Transfer Station.
