LAKE WINNISQUAM WATERSHED-BASED PLAN

PREPARED BY FB ENVIRONMENTAL ASSOCIATES & HORSLEY WITTEN GROUP
*in cooperation with the Winnisquam Watershed Network, the New Hampshire Department of
Environmental Services, and the US Environmental Protection Agency*

JULY 2022 | **FINAL**

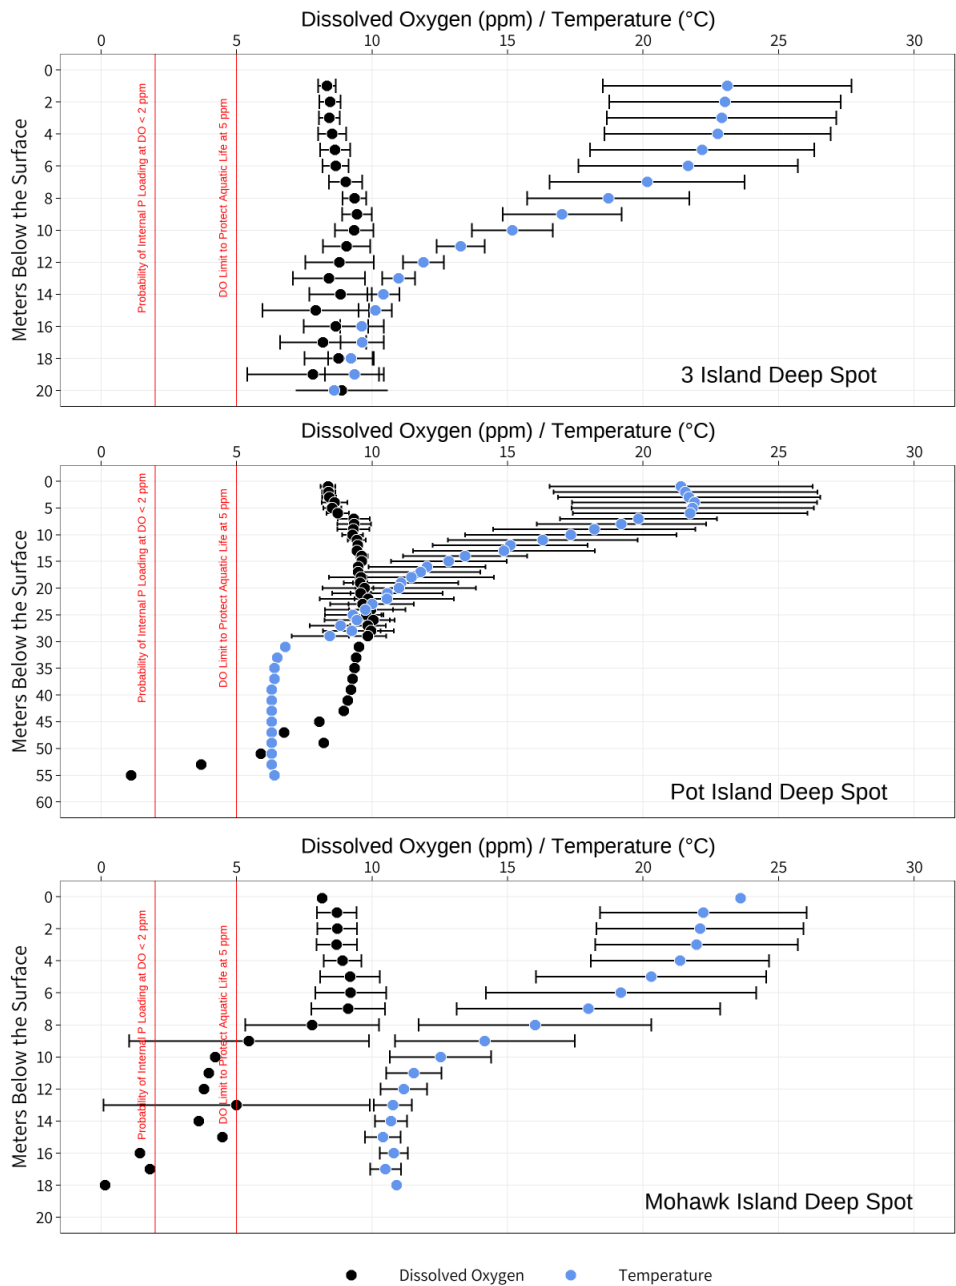
Figure 5. Dissolved oxygen (black) and temperature (blue) depth profiles for three deep spot stations on Lake Winnisquam (ordered from upstream to downstream): Three Island (TOP), Pot Island (MIDDLE), and Mohawk Island (BOTTOM). Profiles were measured once in 2012, 2013, 2016, 2017, and 2018, and twice in 2020 during thermal stratification in summer. Dots represent average values across sampling dates for each respective depth. Error bars represent standard deviation.

A common occurrence in many New England lakes is the depletion of dissolved oxygen in the deepest part of lakes throughout the summer months, a natural phenomenon in some **dimictic** lakes that is made more severe by human disturbance. Chemical and biological processes occurring in bottom waters deplete the available oxygen throughout the summer, and because these waters are colder and denser, the

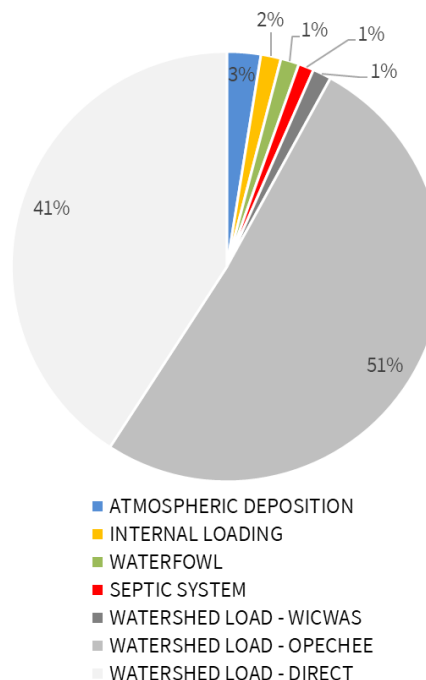
Figure 8. Summary of total phosphorus loading by major source for Lake Winnisquam. Refer to Table 6 for a breakdown.

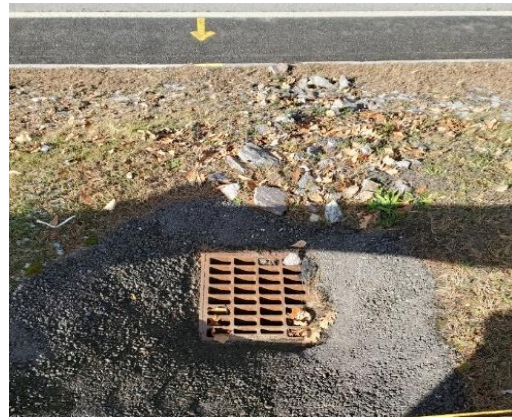
(2) SEDIMENT/GRAVEL DUMP SITE ON OLD STATE ROAD

Recommendations: Remove sand and sediment from the site. Install erosion control measures along bank, such as an increased buffer and silt fences.

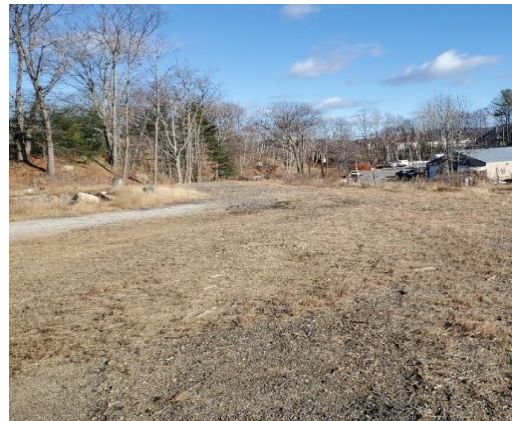
(3) OLD STATE ROAD

Recommendations: Enhance buffer and erosion controls on both sides of road. Improve stormwater runoff treatment.

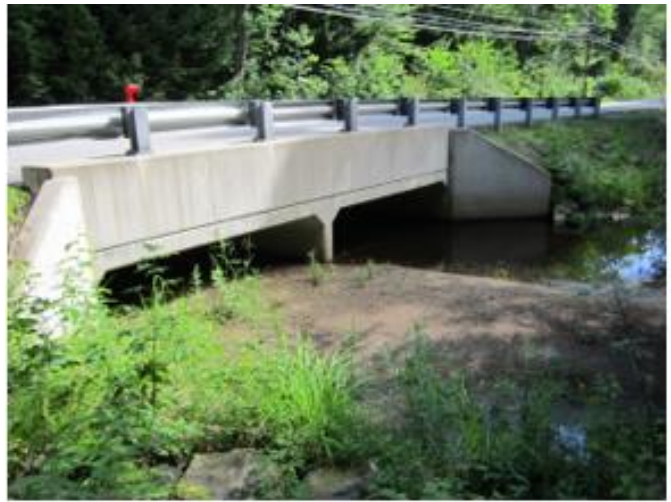
Sedimentation evident at a new box culvert along Black Brook at the Black Brook Rd crossing. Photo courtesy of Lang (2021).

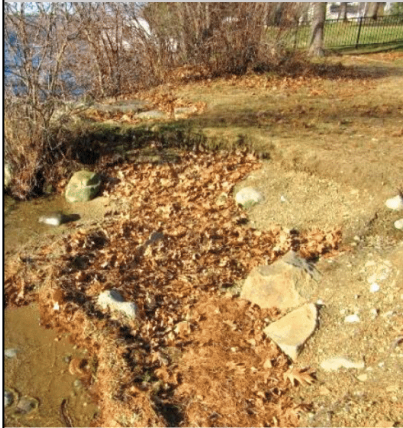
Shoreline of Gale Ave Park.

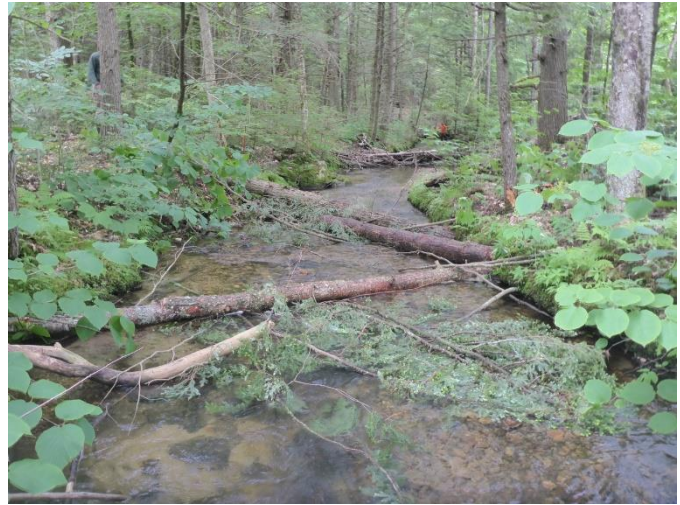
The felling of large woody material was completed in a one mile segment of Black Brook as part of a stream habitat restoration project in 2021 by the BCCD and Trout Unlimited.
