Updates to the Rhode Island Statewide Total Maximum Daily Load (TMDL) for Bacteria Impaired Waters

**Final Report
September 2023**

**RHODE ISLAND DEPARTMENT OF ENVIRONMENTAL MANAGEMENT
OFFICE OF WATER RESOURCES
235 PROMENADE STREET
PROVIDENCE, RI 02908**

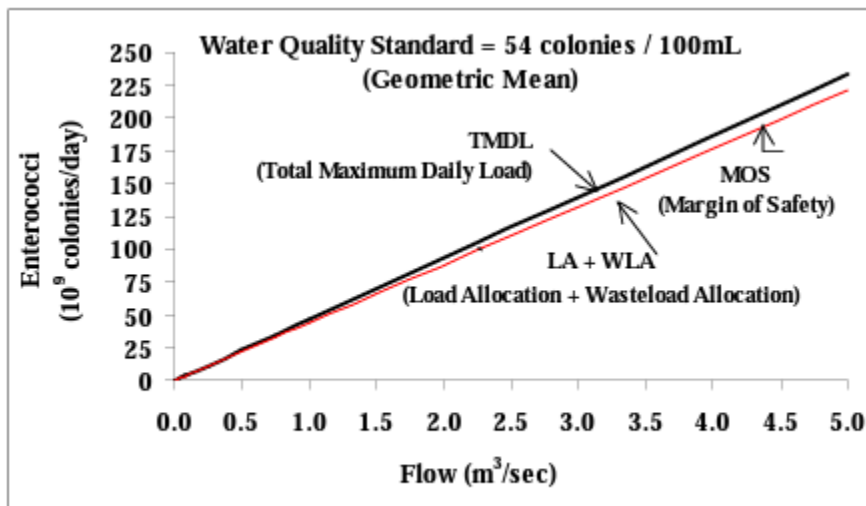
Figure 1: Enterococci Freshwater Rivers and Streams Daily Loads

Additionally, in the Statewide Bacteria Core Document, Appendix M provides a means to express the concentration targets as daily loads. Figure 1 and Table 1 from Appendix M (reproduced below) provide a general cross-walk for flows between 0.0 and 5.0 m³/sec. For flows >5 m³/sec Formula 1 (reproduced below on next page) can be used. Full details are documented in Appendix M³.

Bacteria TMDLs use concentration data rather than loading data to determine allocations and what is necessary to achieve criteria. As stated in the Statewide Bacteria Core Document, expressing bacteria TMDLs in terms of concentration provides a direct link between existing water quality and numeric water quality criteria, consistent with water quality standards which apply for a range of flow and environmental conditions, and loads for bacteria can difficult to interpret.
