Quaker Creek

Watershed Description

UPDATE TO THE RHODE ISLAND STATEWIDE TMDL FOR BACTERIA IMPAIRED WATERS – QUAKER CREEK- SEPTEMBER 2023

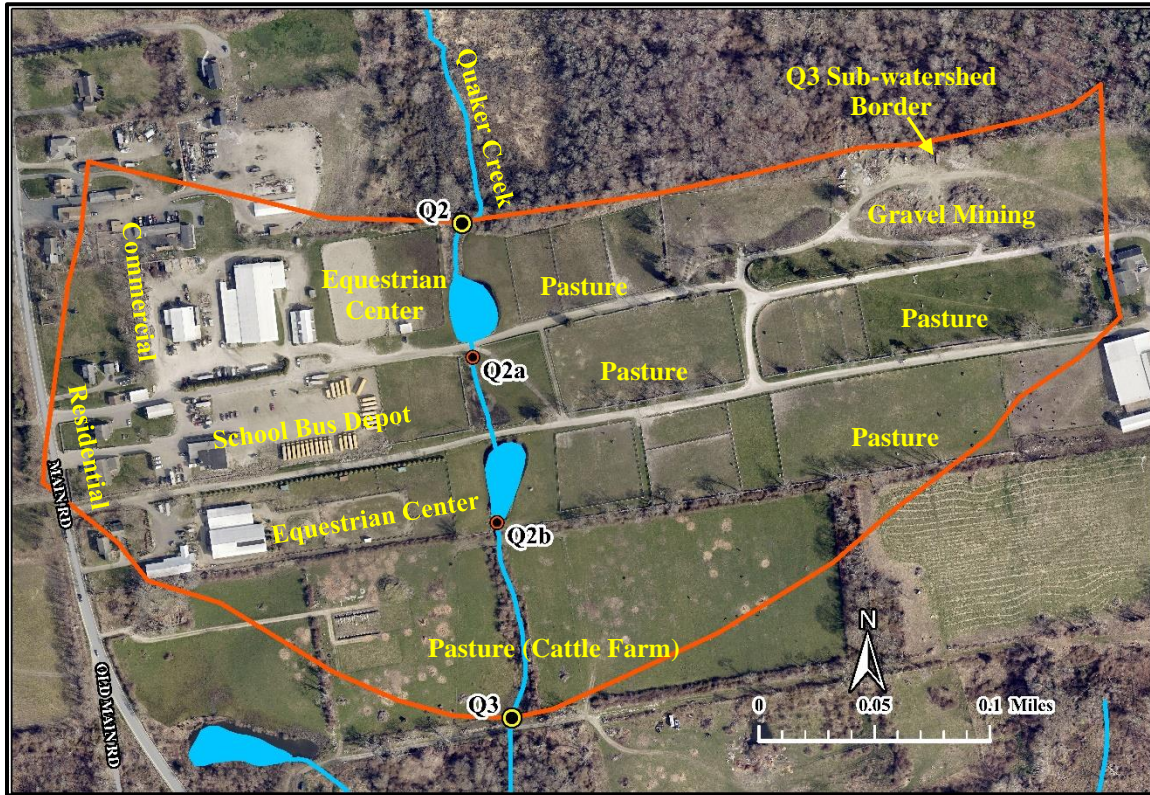
Figure 4. Quaker Creek Sub-watershed Q3 Station Locations for Targeted Wet Weather Sampling Event

enterococci data were not used in the geometric mean calculations for this TMDL. During this sampling event, two additional stations were added between Station Q2 and Q3 to more help bracket potential pollutant sources. Station Q2a was located at the outlet of the upstream farm pond, and Station Q2b was located at the outlet of the downstream farm pond within the sub-watershed for Q3. The location of these stations is shown in Figure 4, and the results of the sampling event are shown in Table 2. As mentioned above, there was a potential for areas around the farm ponds to become flooded during wet weather events. The areas around the ponds and the stream segments between the ponds are slightly elevated in relation to the streambed. As mentioned earlier in the document, fences have been constructed to contain the farm animals and prevent them from having direct access to the stream area, but the potential still exists for stormwater to be a transport mechanism for pollutant runoff from the pasture areas near the ponds where livestock do have access.

Table 2 shows that there was a decrease in the enterococci concentrations from Station Q2 to Q2a, which may be attributed to settling within the upper farm pond. However, the enterococci values doubled between Stations Q2a and Q2b where livestock have direct access to the lower farm pond and the stream segment between the two ponds. Station Q3 was below the 10 MPN/100ml detection limit for enterococci during this targeted sampling event. Overall, the geometric means for this stream segment during this event was 191 MPN/100ml.
