Tributary to Nonquit Pond

Assessment Unit Facts (RI0010031R-20)

$\begin{tabular}{ll} \textbf{UPDATE TO THE RHODE ISLAND STATEWIDE TMDL FOR BACTERIA IMPAIRED WATERS - TRIBUTARY TO NONQUIT POND - SEPTEMBER 2023 \end{tabular}$

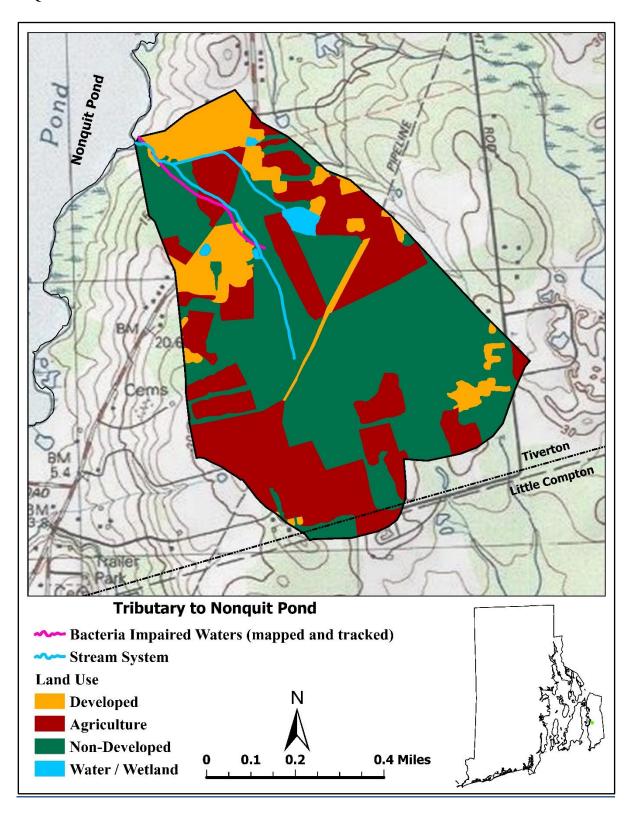
Figure 1. Unnamed Tributaries to Nonquit Pond with Land Cover and Impaired Waters

The unnamed tributary to Nonquit Pond is a stream system that measures 1.80 miles, of which 0.38 miles are mapped and tracked for assessment purposes. The unnamed tributary stream system to Nonquit Pond is composed of two forks. The northeastern fork originates from a wetland area, located within a cow pasture. The stream flows past a couple of residences before crossing Main Road, where it skirts the northern edge of a crop field. The northeastern fork then flows along the rear edge of several residential lawns, prior to its confluence with the southwestern fork of the unnamed tributary (Figure 1, Figure 2).

The southwestern fork of the unnamed tributary to Nonquit Pond originates from a large linear wetland. Upland forest as well as hay fields border the wetland corridor. As it exits the wetland, the southwestern fork flows along the rear of a lawn associated with a large-lot residential property. Downstream of Main Road, the southwest fork bisects a crop field, prior to its confluence with the northeast fork of the tributary, just upstream of the cul-de-sac at the end of Peaceful Way (Figure 1, Figure 3).

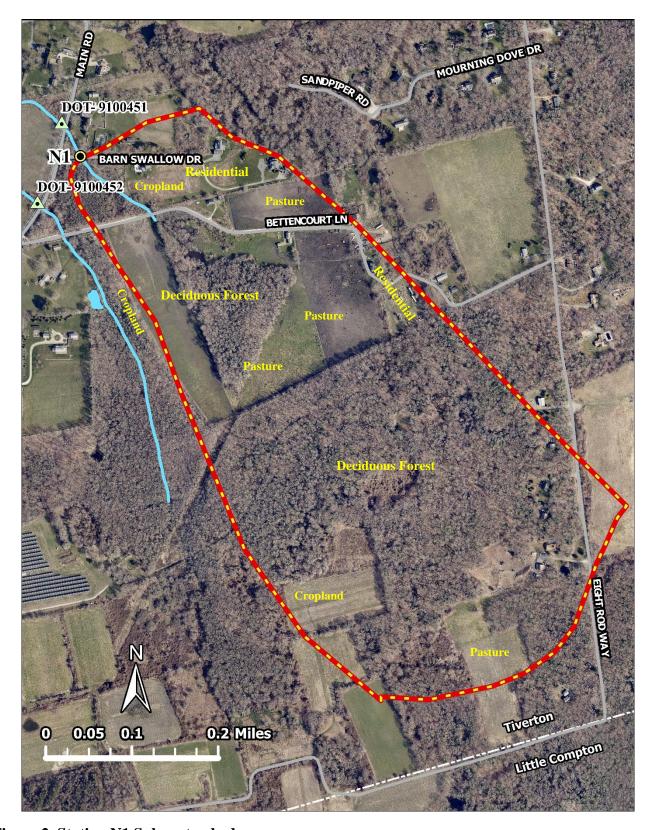
Figure 2. Station N1 Sub-watershed

Station N1 (Figure 2) is located at Barn Swallow Drive, on the northeast fork of the unnamed tributary to Nonquit Pond. The stream originates from a wetland, south of Bettencourt Lane and flows past the northeast corner of a pasture, just south of Bettencourt Lane. It then flows through a small wetland area and upland forest.

Inspection of aerial photographs as well as field observations in 2018 revealed that cows graze within the wetland at the headwaters of the stream. Cattle have access to saturated and flooded areas along much of the perimeter of the wetland. There is an earthen berm, along the perimeter of the corner of the wetland, where it lies closest to the eastern pasture. During most of the year, cattle graze within the wetland, particularly in a significant area of standing water to the north of the forested portion of the wetland, including a small farm pond. Cows also graze in wet meadows on the southeastern side of the

There were two sampling stations located on the unnamed tributary to Nonquit Pond. One station (Station N1) is located near the headwaters of the northeast fork of the stream where the stream passes under Barn Swallow Drive (Figure 2). The other sampling station (Station N2) is located at the cul-desac of Peaceful Way, immediately downstream of the confluence of the northeast fork and the southwest forks of the stream (Figure 3).

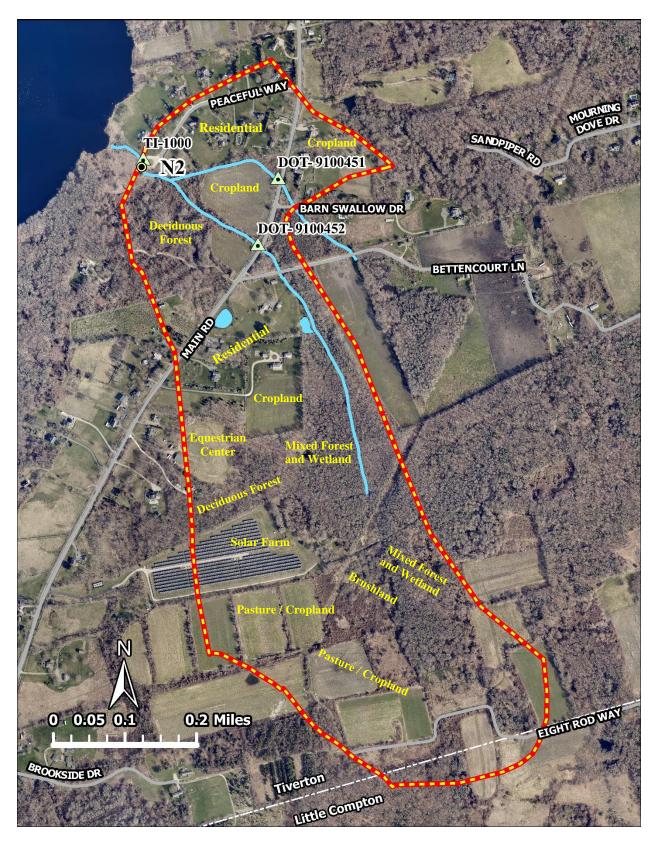
Figure 3. Station N2 Sub-watershed

The southwest fork of the unnamed tributary to Nonquit Pond arises from a large linear wetland (Figure 3). Except for a residential area to the immediate south of Bettencourt Lane, the stream flows through a wetland corridor, which is bordered mainly by upland forest.

Downstream of Station N1, the northeast fork of the unnamed tributary flows along the edge of a residential lawn before passing under Main Road. The stream continues along the northern edge of a crop field with 0 - 15 ft. of vegetated buffer. The stream then flows across a stone wall, forming a property boundary between the crop field and residential lots. The tributary continues parallel to the stone wall, at the rear of several residential lots. Except for one residential lot with a 50-ft. vegetative buffer, the remaining lots have lawns that extend to the bank of the tributary. Turbid runoff was observed in an erosional swale at the northern edge of the cornfield, which discharges to the tributary near the confluence of its two forks. The two forks of the unnamed tributary converge just upstream of Station N2, which is located approximately 400 ft. upstream of Nonquit Pond.
