**RCRA CORRECTIVE ACTION  
LONG-TERM STEWARDSHIP INSPECTION**

**FACILITY:** INV Performance Materials, LLC (Invista)  
25876 DuPont Road  
Seaford, Delaware 19973

**DATE OF INSPECTION:** October 10, 2023

**DATE OF REPORT:** November 30, 2023

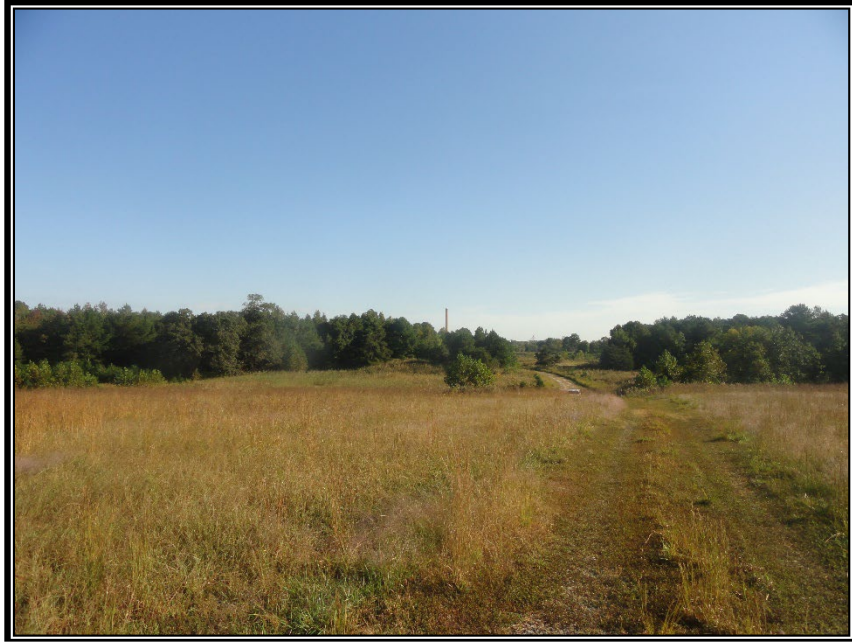
The AOC/ROD describes SWMU 13 as "Solid Waste Landfill C" (Photograph Nos. 1 and 2).

Security fencing, as required by DRGHW, and a protective soil cover, as required by the AOC/ROD, comprise the EngCs at SWMU 13. Facility conditions reported by Mr. Mastaw, as well as those observed by DNREC personnel, strongly suggest Invista is in compliance with DRGHW security requirements. Observations made while traversing accessible portions of SWMU 13 on foot and by vehicle did not

reveal any exposed debris such as concrete, bricks, wood, etc. SWMU 13 appeared highly vegetated. Based upon observed conditions, Invista appears to have implemented and sufficiently maintained a protective soils cover at SWMU 13.

**Photograph No. 1:** From SWMU 17, northerly view of SWMUs 13 and 16 where no evidence of residential development, land disturbance, groundwater withdrawal (other than for environmental monitoring), or exposed debris was observed.

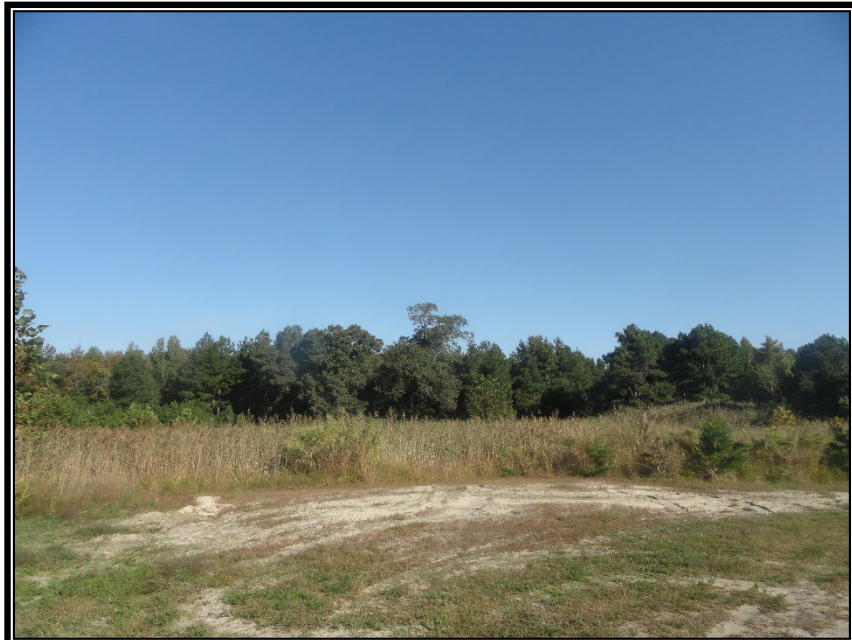
**Photograph No. 2:** Westerly view of SWMUs 13 and 16 where no evidence of residential development, land-disturbing activities, groundwater withdrawal (other than environmental monitoring), or exposed debris was observed.

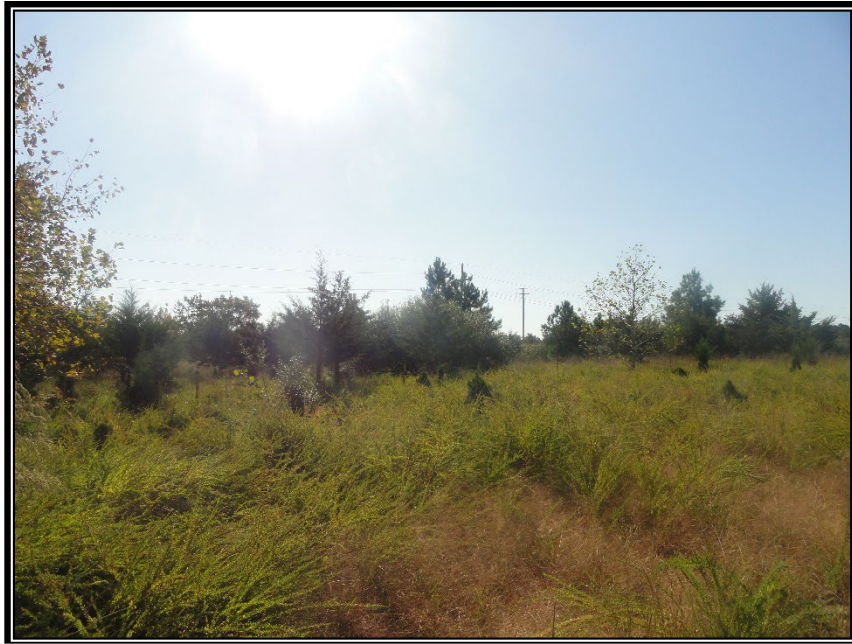
The AOC/ROD describes SWMU 1 as “Solid Waste Landfill A” (Photograph No. 3).

During the inspection, DNREC personnel did not observe any development, residential or otherwise, at SWMU 1. No evidence of digging, drilling, excavating, grading, constructing, earth moving, or any other land disturbing activities at depths greater than two feet were observed within SWMU 1 by DNREC personnel during the inspection. Groundwater withdrawal from SWMU 1 was not observed during the inspection.

**Photograph No. 3:** Southeasterly view of SWMU 1 where no evidence of residential development, land-disturbing activities, or groundwater withdrawal was observed.

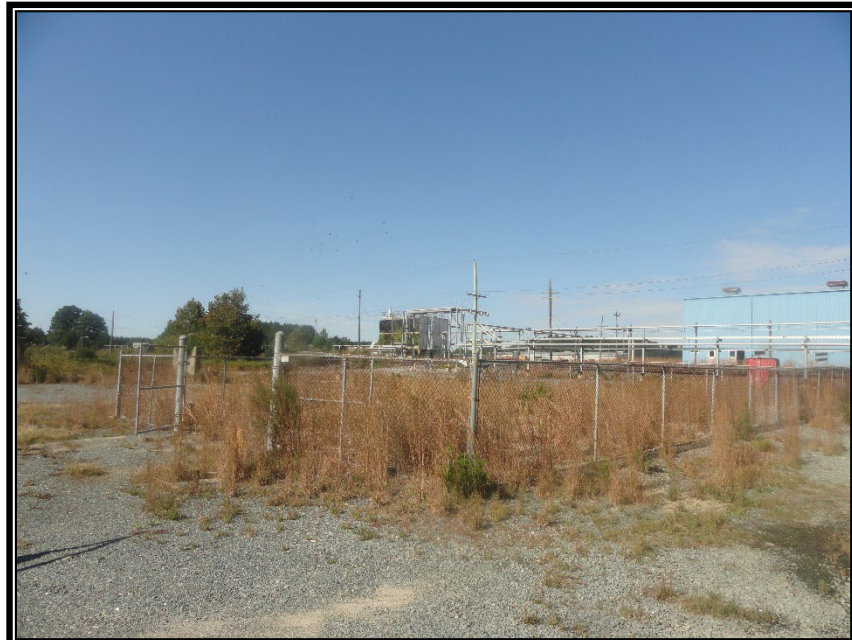
The AOC/ROD describes SWMU 6 as “Solid Waste Landfill B” (Photograph Nos. 4 and 5) and SWMU 19 as a “Former Coal Ash Disposal Area” (Photographs Nos. 6 and 7).

**Photograph No. 4:** Westerly view of the northern portion of SWMU 6, where no evidence of residential development or land-disturbing activities was observed.

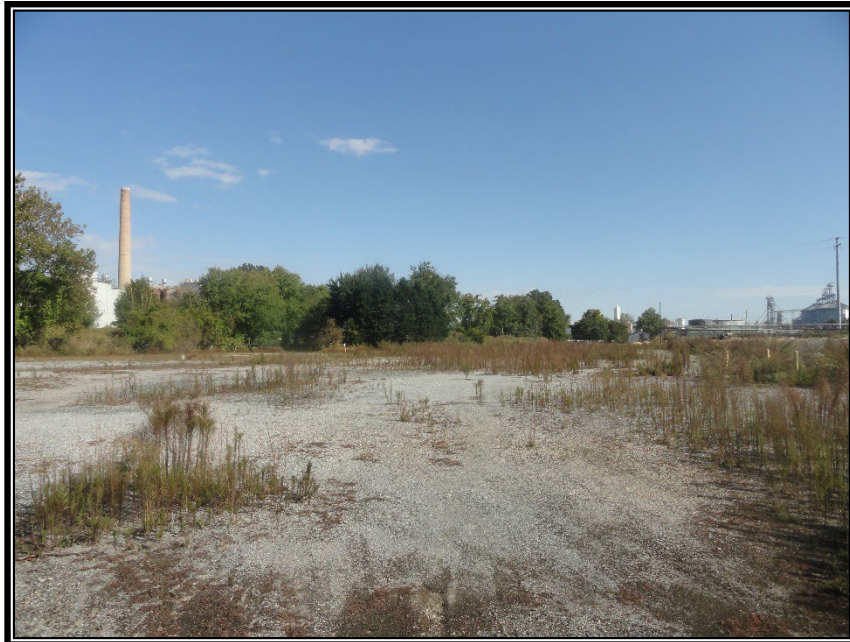
**Photograph No. 5:** Northerly view of the southern portion of SWMU 6, where no evidence of residential development or land-disturbing activities was observed.

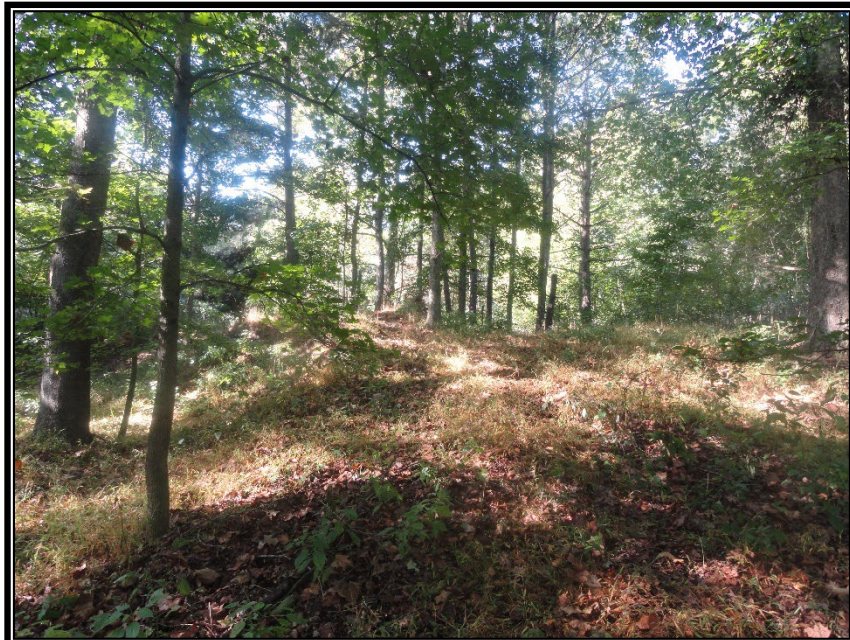
**Photograph No. 6:** Southeasterly view of the northern extent of SWMU 19, where no evidence of residential development or land-disturbing activities was observed.

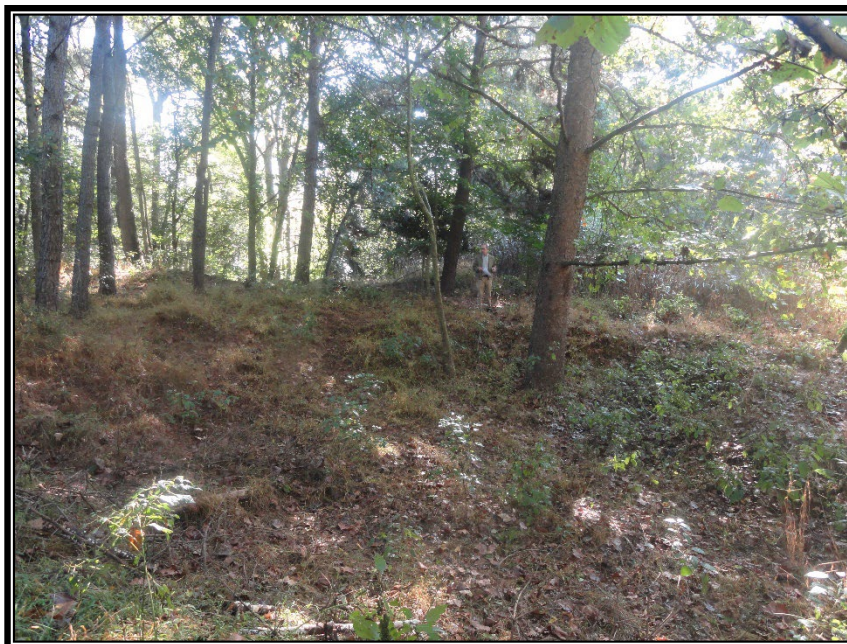
**Photograph No. 7:** Easterly view of interior portions of SWMU 19, where no evidence of residential development or land-disturbing activities was observed.

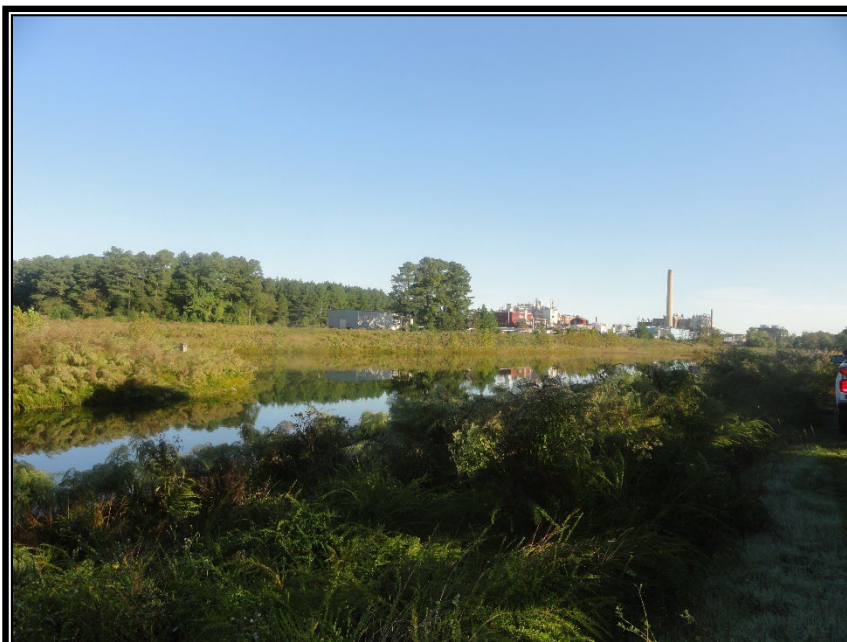
The AOC/ROD describes SWMU 7 as the “Utility Ash Settling Ponds” (Photograph No. 8) and SWMU 12 as “Retention Ponds” (Photograph No.9).

**Photograph No. 8:** Northerly view across the southern portion of SWMU 7, where no evidence of groundwater withdrawal (other than for environmental monitoring) was observed.

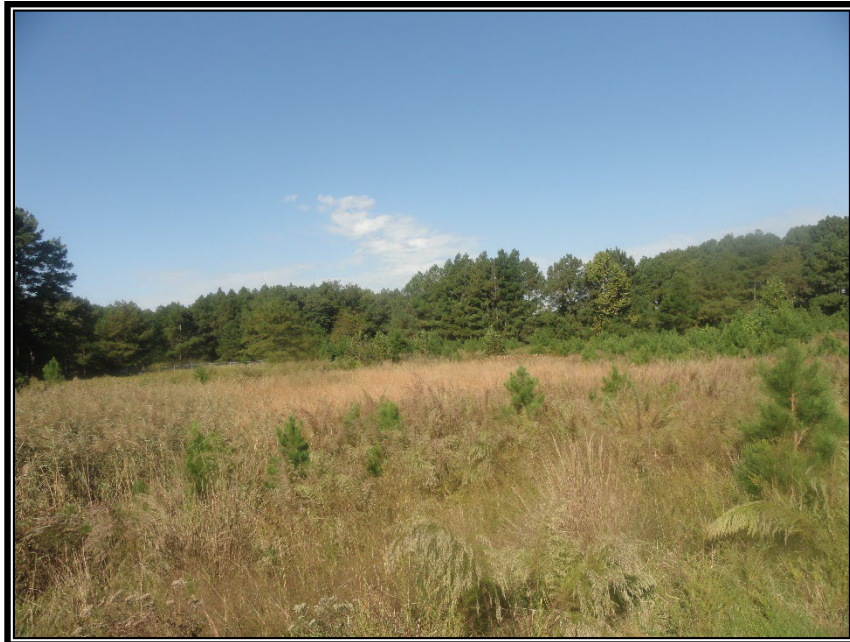
**Photograph No. 9:** Westerly view of SWMU 12 where no evidence of groundwater withdrawal (other than for environmental monitoring) was observed.

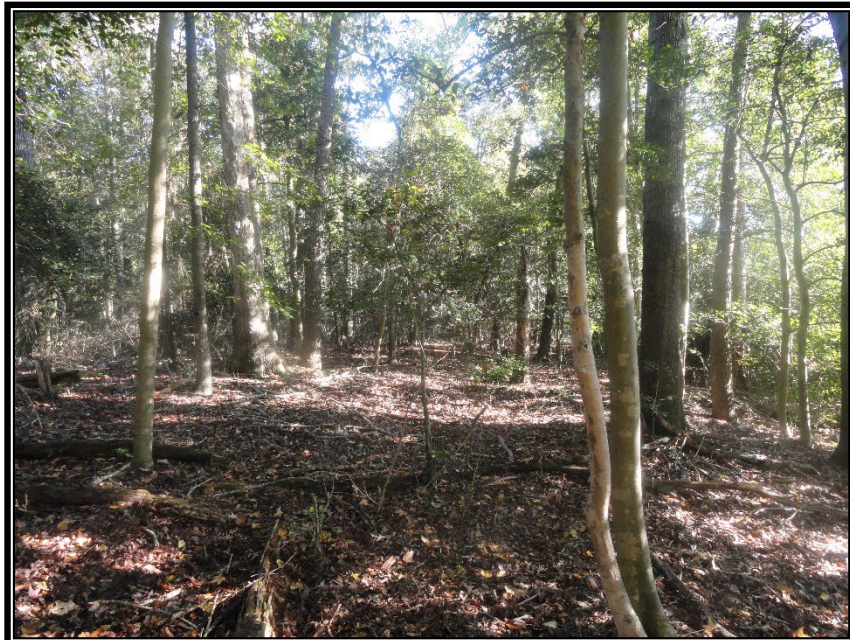
The AOC/ROD describes SWMU 16 as a “Trade Waste Retention Pond” (Photograph Nos. 1, 2, 10, 11, and 12) and SWMU 17 as “Coal Ash Landfill” (Photograph Nos. 1, 12, and 13) The Coal Ash Landfill is primarily regulated as a solid waste unit under Solid Waste Post-Closure Permit SW-09/01

Security fencing and a protective soil cover comprise the EngCs at SWMUs 16 and 17. Facility conditions reported by Mr. Mastaw, as well as those observed by DNREC personnel, strongly suggest Invista is in compliance with DRGHW security requirements. Observations made while traversing accessible portions of SWMUs 16 and 17 on foot and by vehicle did not reveal any exposed debris such as concrete, bricks, wood, etc. SWMU 16 appeared highly vegetated; vegetation at SWMU 17 is regularly managed in accordance with Solid Waste Post-Closure Permit SW-09/01. Based upon observed conditions, Invista appears to have implemented and sufficiently maintained a protective soils cover at SWMUs 16 and 17.

**Photograph No. 10:** Northerly view of a northern portion of SWMU 16, where no evidence of residential development, land-disturbing activities, or exposed debris was observed.

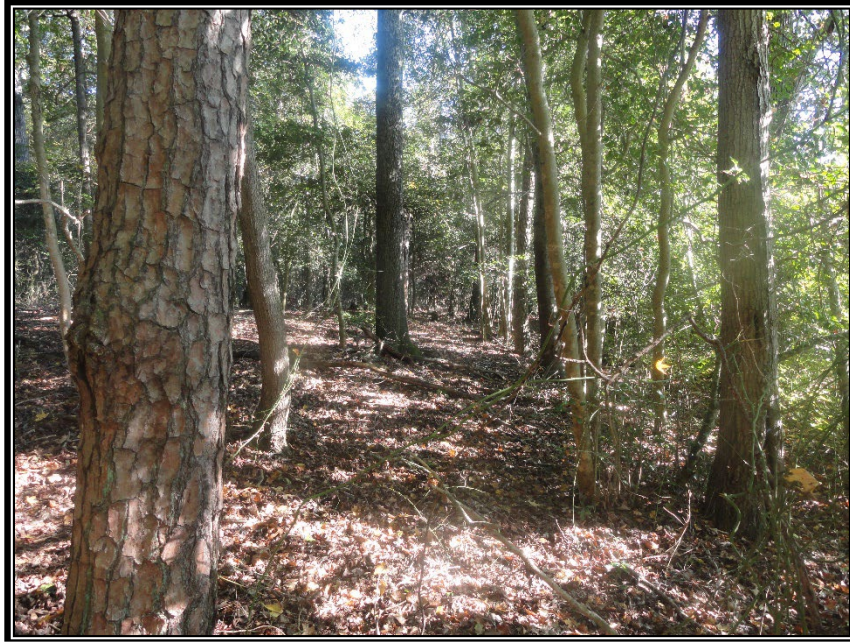
**Photograph No. 11:** Southerly view of a northern portion of SWMU 16, where no evidence of residential development, land disturbing activities, or exposed debris was observed.

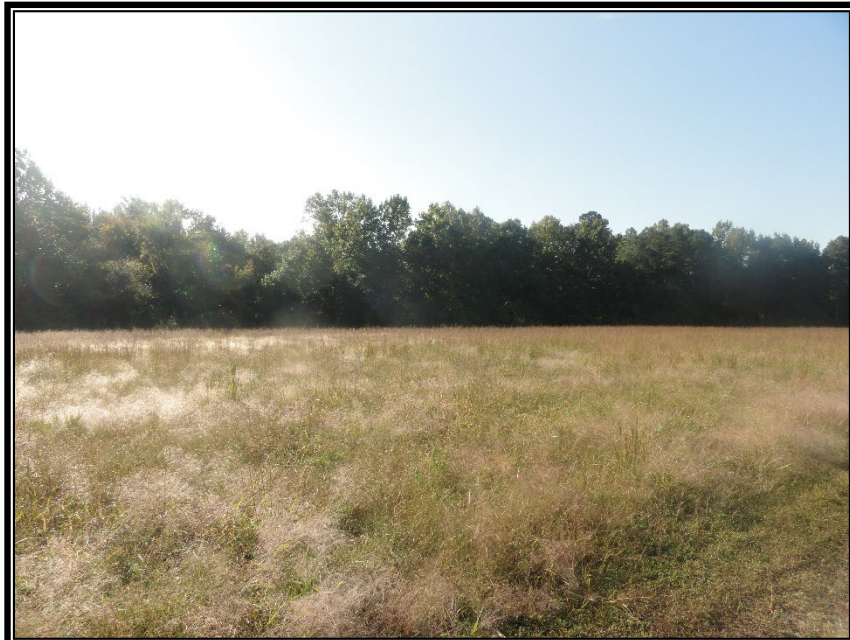
**Photograph No. 12:** Westerly view across SWMU 17 into SWMU 16, where residential development, land disturbance, groundwater use (other than environmental monitoring), or exposed debris was not observed.

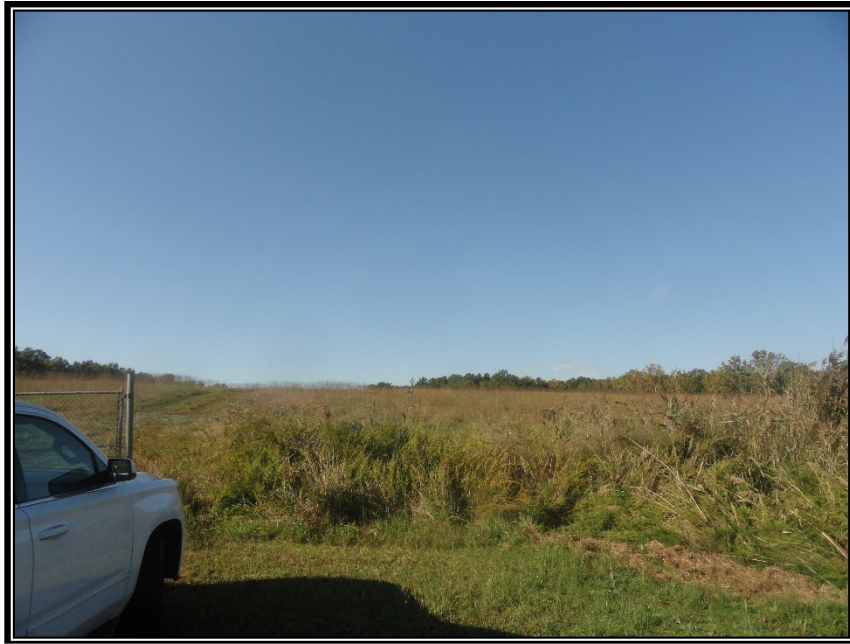
**Photograph No. 13:** Southerly view of SWMU 17, a landfill with a solid waste permit, where no evidence of residential development, land disturbance, groundwater use (other than environmental monitoring), or exposed debris was observed.

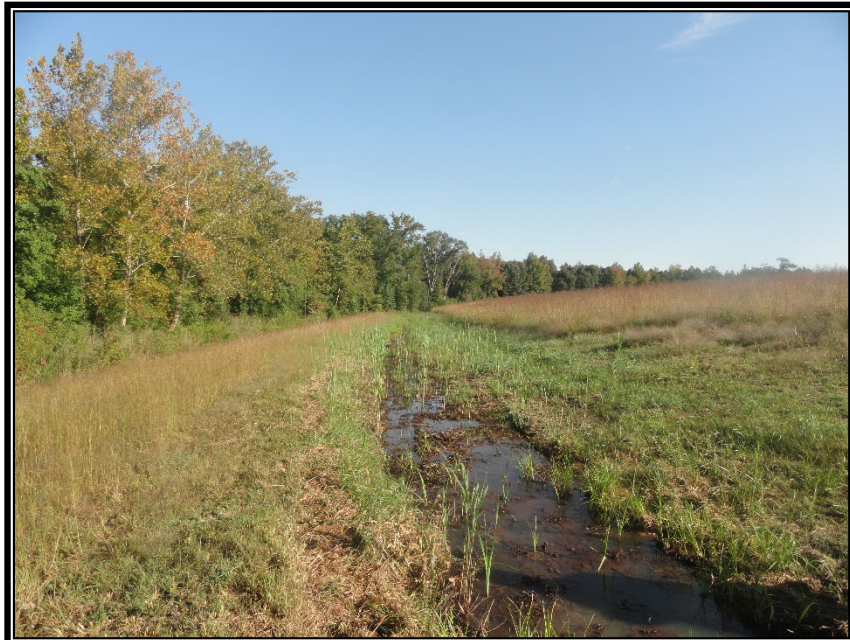
While walking the Coal Ash Landfill, stormwater was observed ponded within the northwesterly stormwater conveyance swale (Photograph No. 14). The quantity of ponded stormwater was not excessive, but was not insignificant. This violation of Invista’s solid waste post-closure permit for the Coal Ash Landfill is being managed as such, a violation of the their solid waste permit rather than non-compliance with DRGHW, the AOC/ROD, or the Invista EC.

**Photograph No. 14:** Northerly view of ponding in a stormwater swale along the northwesterly margin of SWMU 17, a coal ash landfill. The ponding was addressed as non-conformance with Solid Waste Post-Closure Permit SW-09/01.

Based upon the observed and reported conditions of the specific SWMUIs discussed herein, Invista appears to have appropriately implemented EngCs and ICs, and EngCs appear to have been sufficiently maintained to sustain effectiveness. A single non-compliant condition was observed consisting of ponding within the Coal Ash Landfill stormwater conveyance swales, which has been and continues to be addressed under the purview of Delaware’s *Regulations Governing Solid Waste* (DRGSW). No recommendations with regard to Invista’s EngCs and ICs are warranted at this time based upon conditions observed.

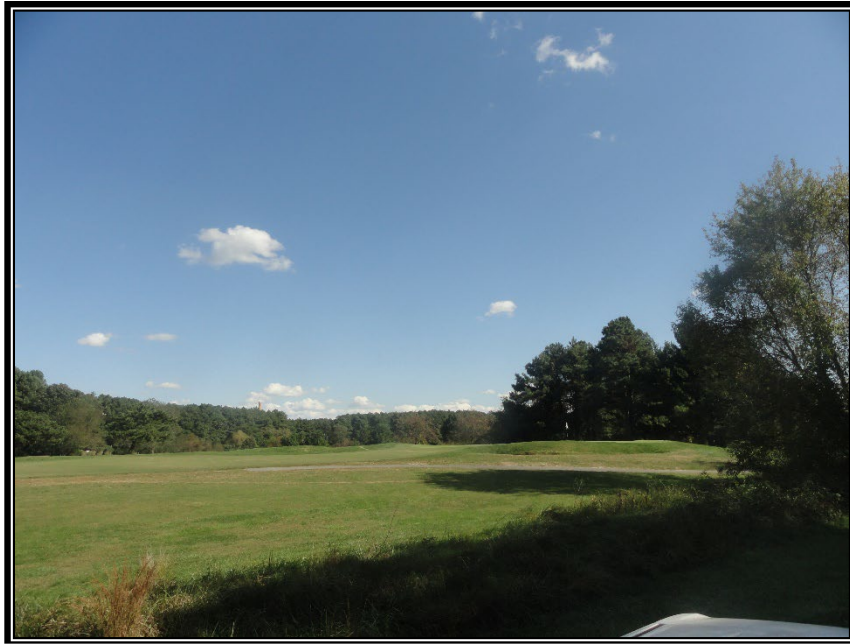
The EC establishes restrictions upon “the coal ash beneath the golf course expansion area” (Photograph No.15) as depicted on the included Restriction Locations map.

The westerly portion of the golf course, the portion reported to be underlain by coal ash, was observed from Woodland Road. During the inspection, DNREC personnel did not observe any residential development at the golf course. No evidence of digging, drilling, excavating, grading, constructing, earth moving, or any other land disturbing activities were observed at the golf course by DNREC personnel during the inspection.

**Photograph No. 15:** Easterly view of the portion of the Hooper's Landing Golf Course underlain by coal ash where no evidence of residential development or land-disturbing activities was observed.
