File Number: 24TA007	Entity Name: ACCEL Schools – Steam Academy of Warren	Inspection Address, City, State, Zip Code: 261 Elm Road Northeast, Warren, Ohio 44483
Date of Inspection: April 4, 2024	Inspector-Photographer: Brandon Brewster	Number of Photographs Taken: 75
Camera Used: SY2376	Digital Recording Media: SD CARD	Notes:

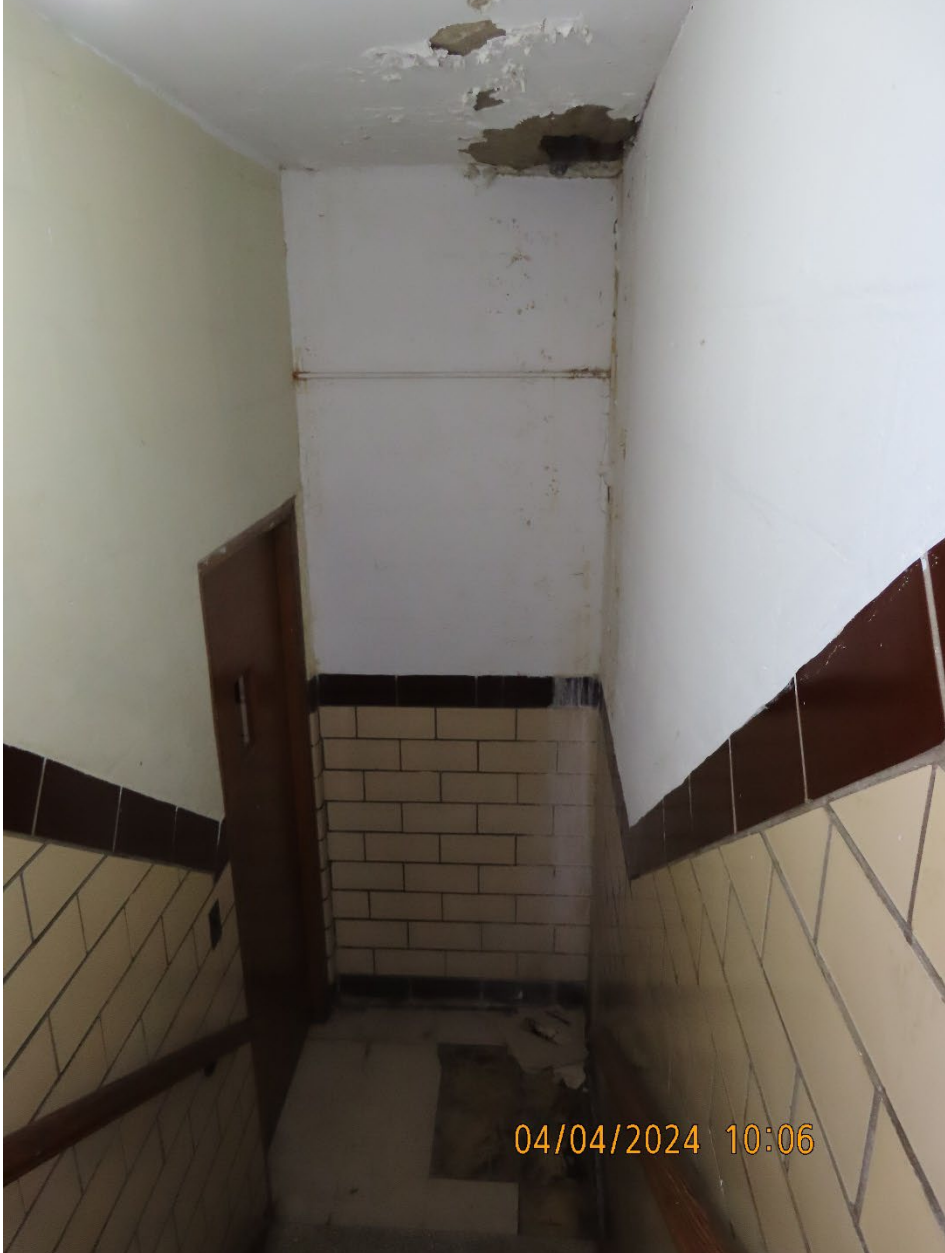
5.	Date Taken: 04/04/2024	Time Taken: 10:06 AM ET

Sample No.: IMG_0594		
	Description of Digital Image: Main Level – Gymnasium: Stage right northern stairwell crumbling ceiling plaster, flaking paint, broken and loose floor tile.		
Modifications: Reduced scale of photo for the purpose of inspection report.

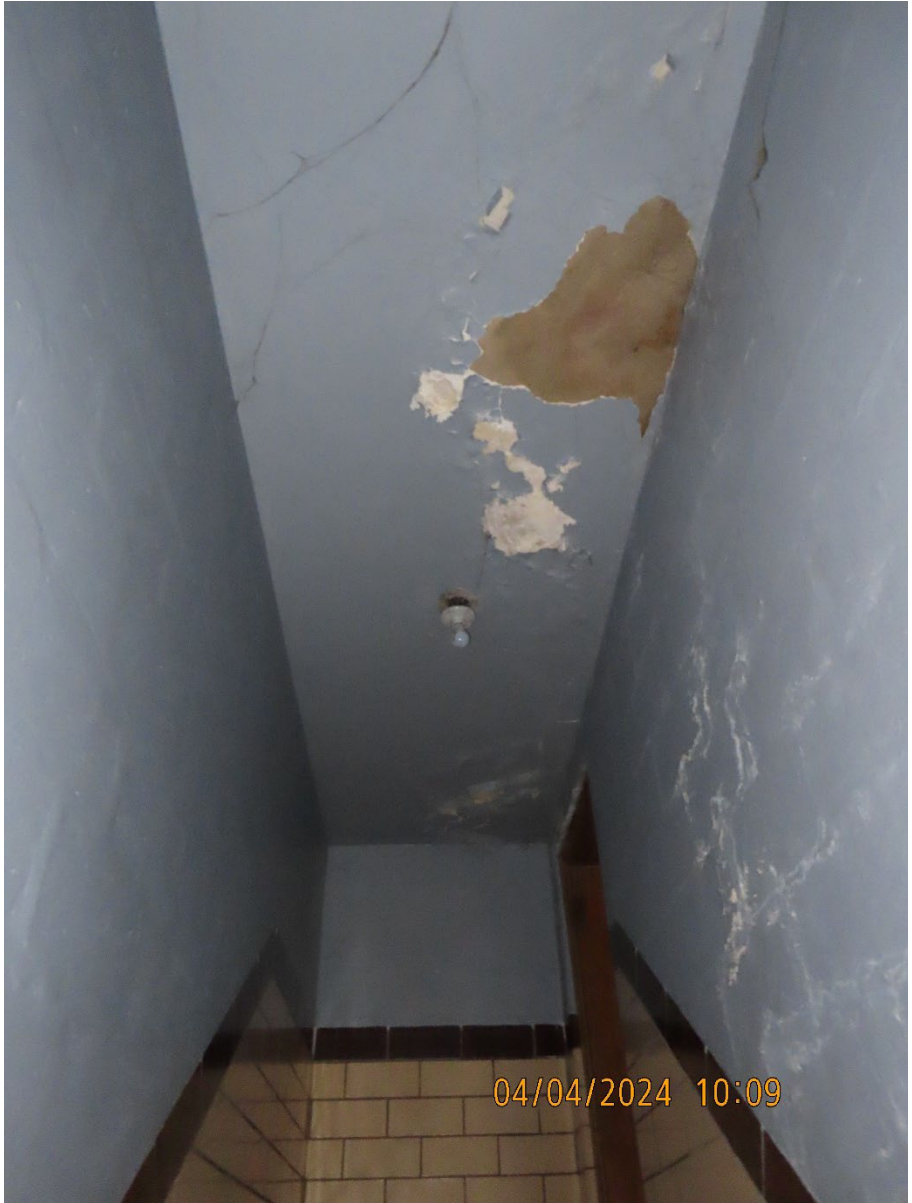
6.	Date Taken: 04/04/2024	Time Taken: 10:09 AM ET

Sample No.: IMG_0595		
	Description of Digital Image: Main Level – Gymnasium: Stage left southern stairwell crumbling ceiling and wall plaster with flaking paint.		
	Modifications: Reduced scale of photo for the purpose of inspection report.

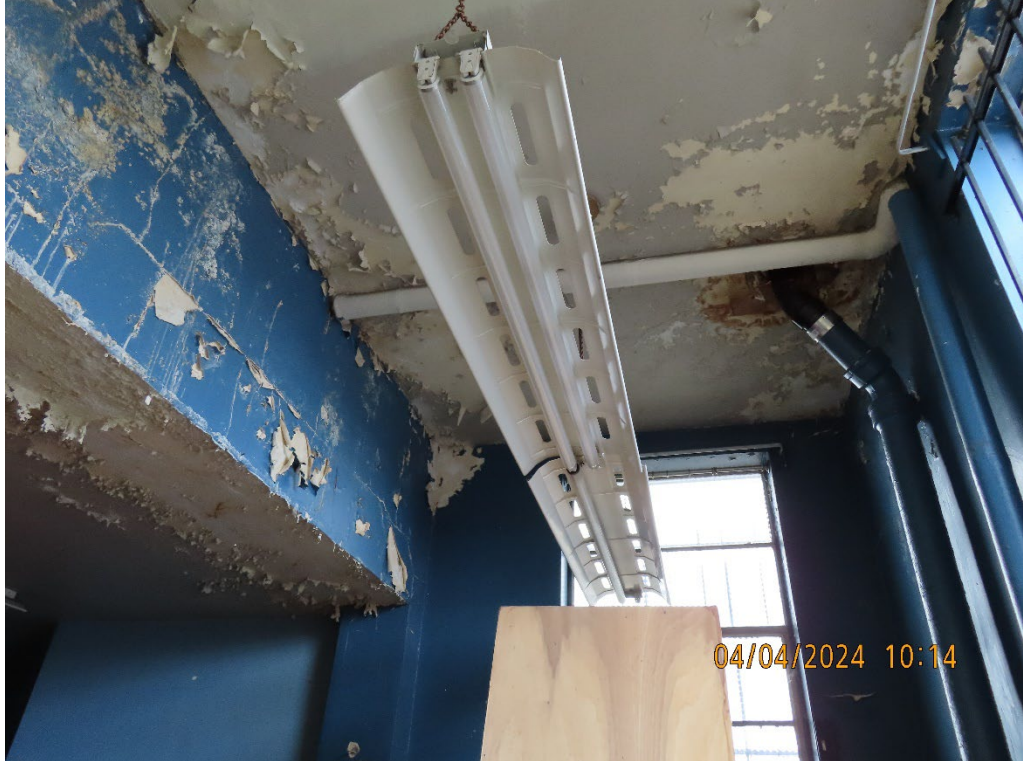
8.	Date Taken: 04/04/2024	Time Taken: 10:14 AM ET

Sample No.: IMG_0597		
	Description of Digital Image: Main Level – Gymnasium: Southeastern storage closet, crumbling ceiling and wall painted plaster with new and old piping, debris covered floor. Close up of ceiling.		
	Modifications: Reduced scale of photo for the purpose of inspection report.

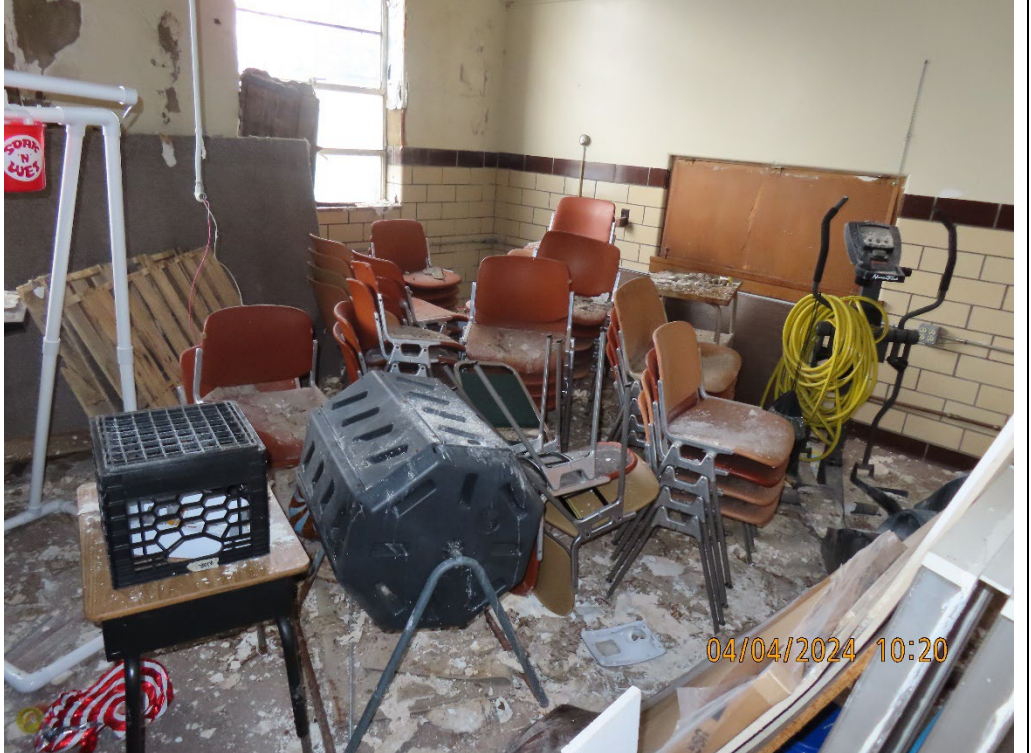
14.	Date Taken: 04/04/2024	Time Taken: 10:20 AM ET

Sample No.: IMG_0603		
	Description of Digital Image: Main Level – Northwest gym closet/storage room ceiling and building material debris covering the room and stored school supplies.		
Modifications: Reduced scale of photo for the purpose of inspection report.

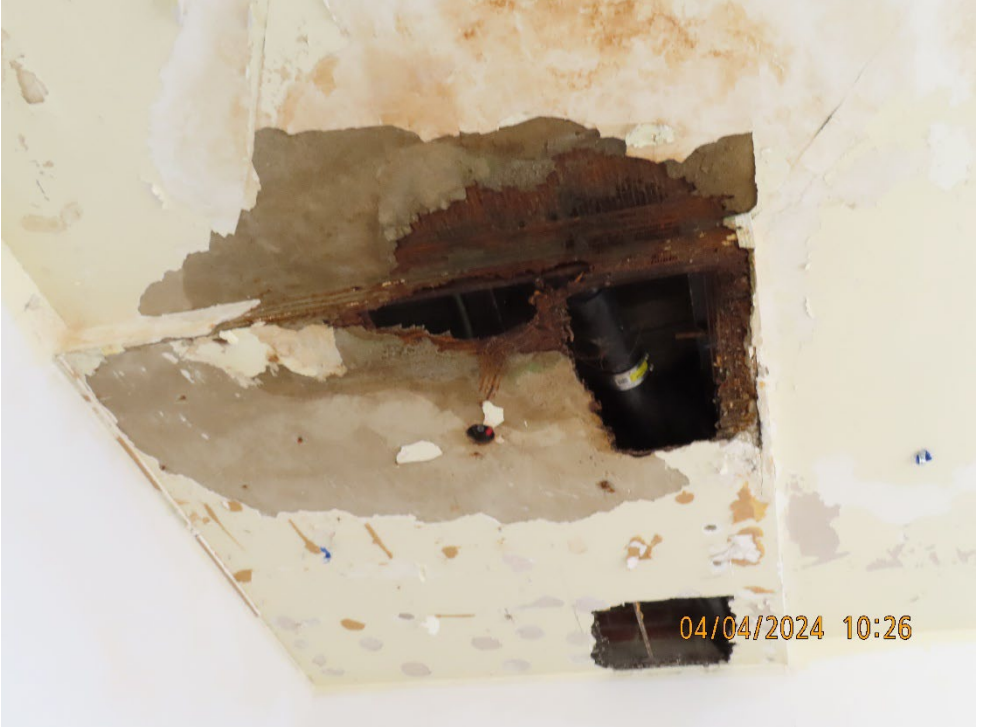
18.	Date Taken: 04/04/2024	Time Taken: 10:26 AM ET

Sample No.: IMG_0607		
	Description of Digital Image: Main Level – Southwest Storage room/kitchen ceiling leak, glue, and paint damage.		
	Modifications: Reduced scale of photo for the purpose of inspection report.

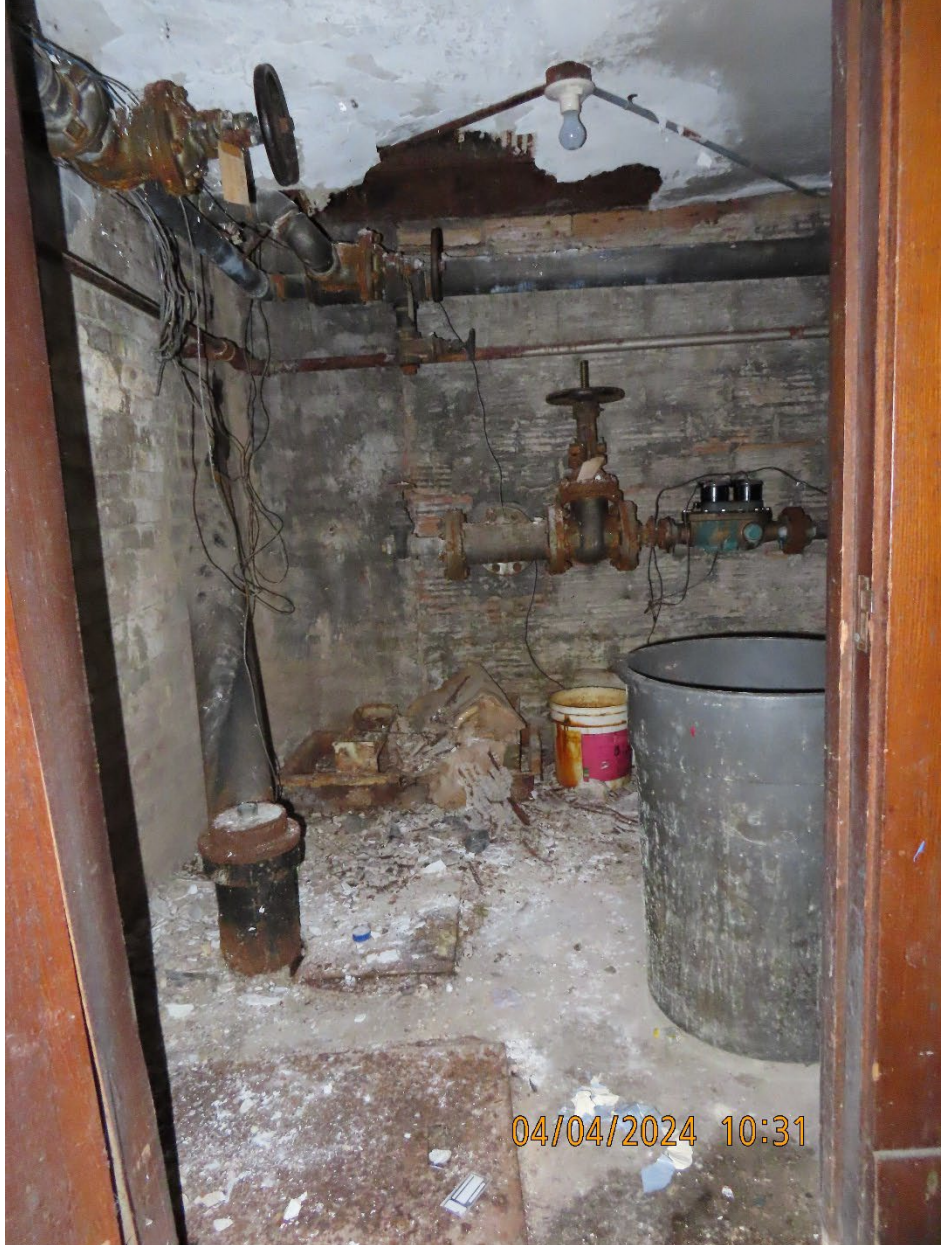
22.	Date Taken: 04/04/2024	Time Taken: 10:31 AM ET

<p style="text-align: right; color: orange;">04/04/2024 10:31</p>
	Sample No.: IMG_0611		
	Description of Digital Image: Lower Level – Southwest Stairway to Lower-Level Water meter room: ceiling plaster/paint debris covering the floor.		
Modifications: Reduced scale of photo for the purpose of inspection report.

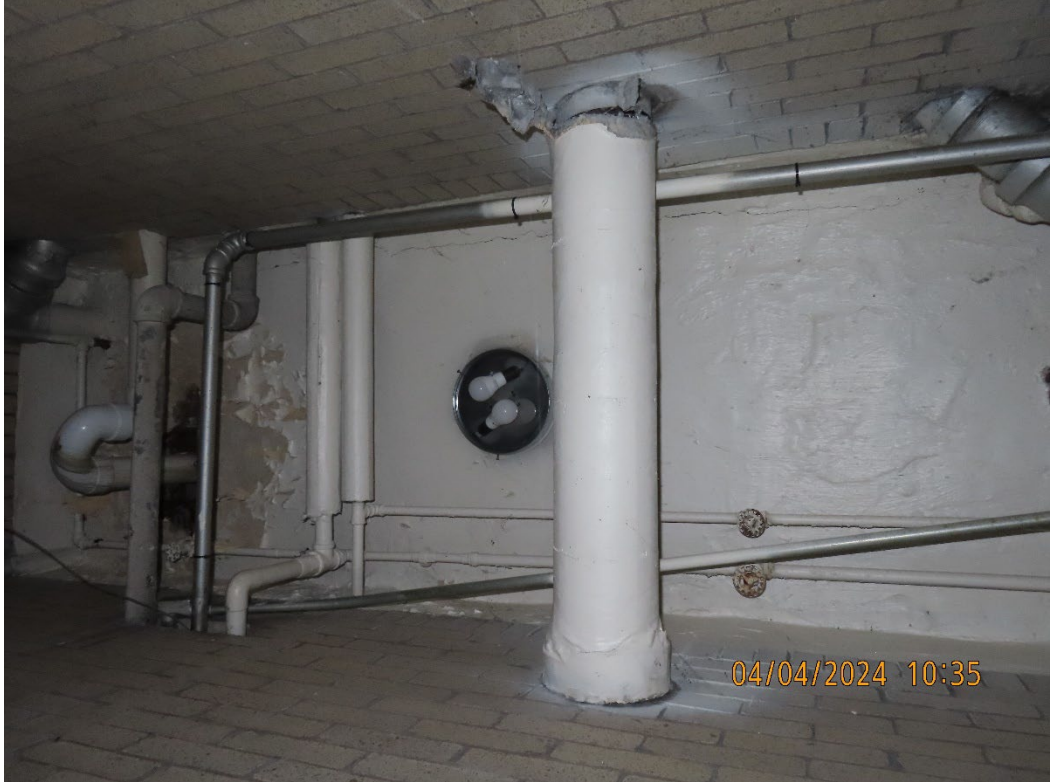
23.	Date Taken: 04/04/2024	Time Taken: 10:35 AM ET

Sample No.: IMG_0612		
	Description of Digital Image: Lower Level – Custodial Closet/Abandoned Bathroom: View of the ceiling at the entrance of the custodial closet. Significantly damaged flaking painted ceiling material and possible asbestos containing thermal system insulation (TSI) aerosol was observed		
	Modifications: Reduced scale of photo for the purpose of inspection report.

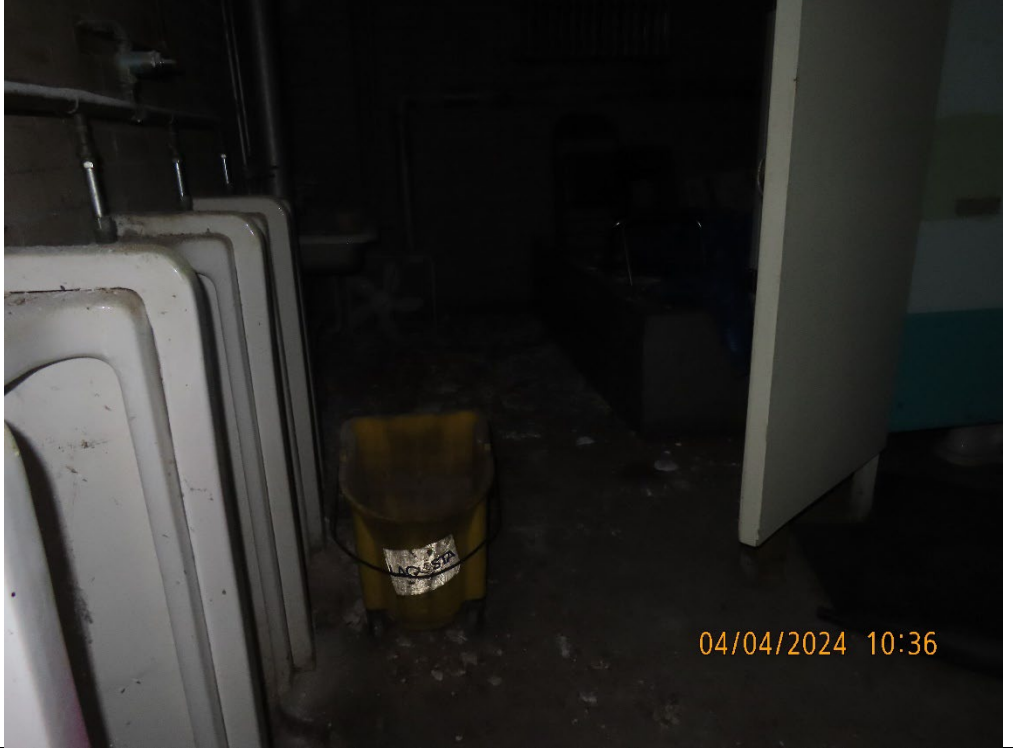
25.	Date Taken: 04/04/2024	Time Taken: 10:36 AM ET

Sample No.: IMG_0614		
	Description of Digital Image: Lower Level – Custodial Closet/Abandoned Bathroom: ceiling debris covering the floor.		
	Modifications: Reduced scale of photo for the purpose of inspection report.

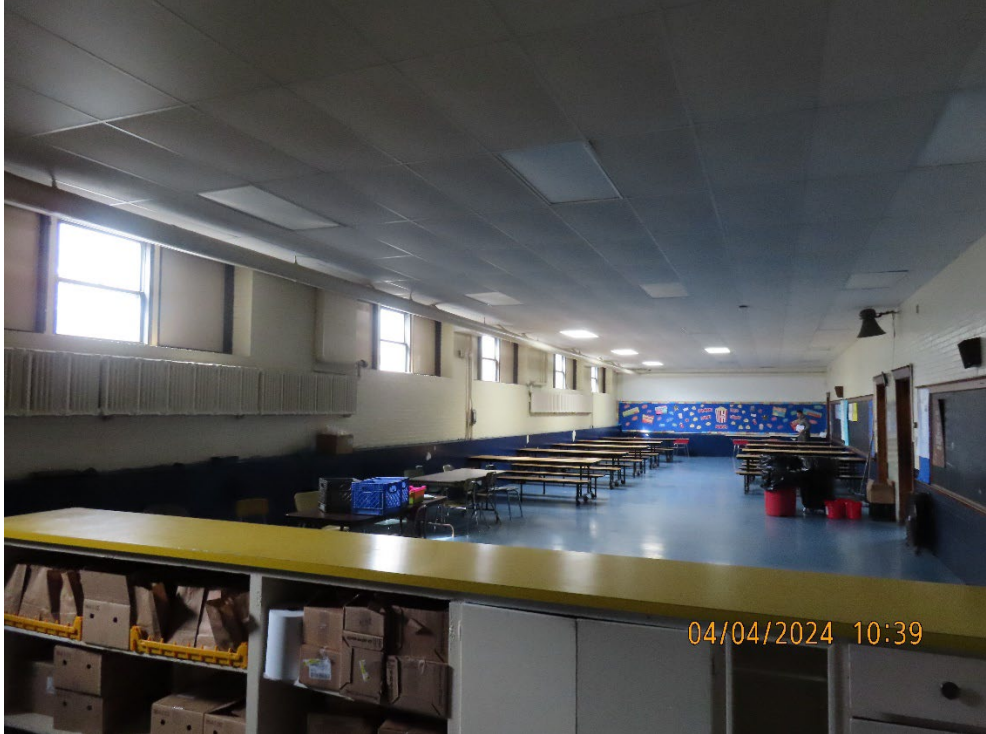
27.	Date Taken: 04/04/2024	Time Taken: 10:39 AM ET

Sample No.: IMG_0616		
	Description of Digital Image: Lower Level – Cafeteria: The cafeteria contained blue 9”x9” floor tile in fair condition. The cafeteria’s 2’x4’ ceiling tile appeared to be new and a 4” horizontal line with minor damage spanned the southern wall hung from the ceiling.		
	Modifications: Reduced scale of photo for the purpose of inspection report.

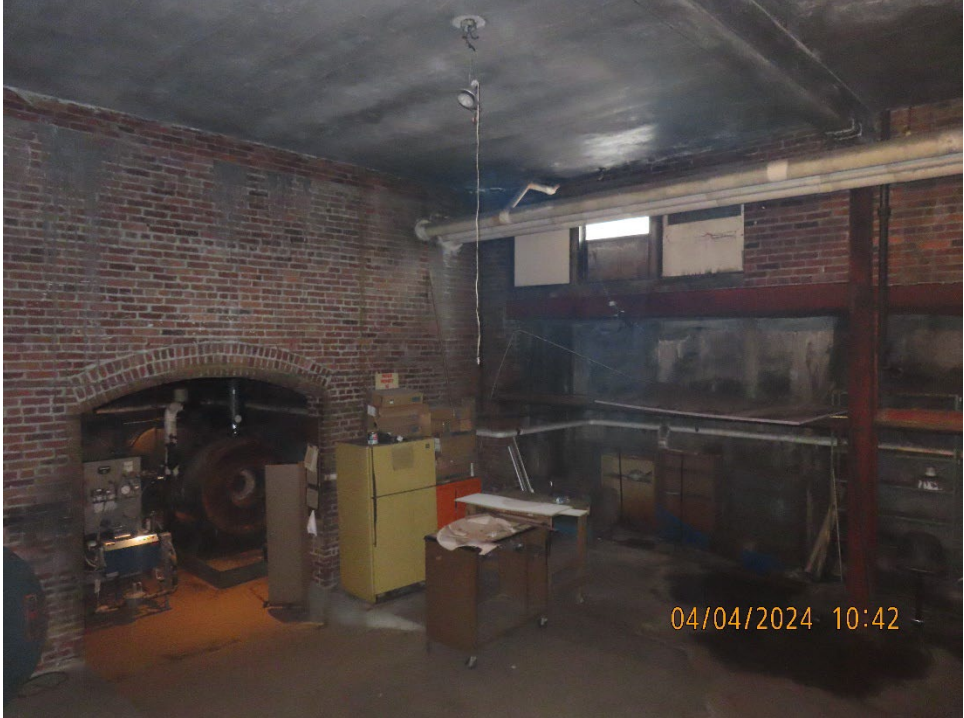
28.	Date Taken: 04/04/2024	Time Taken: 10:42 AM ET

Sample No.: IMG_0617		
	Description of Digital Image: Lower Level – Boiler room: Full frame photo of boiler room. In the first room, two cracked/damaged boiler gaskets from the old boilers are laid on the cart table in the center and against the brick wall in the bottom left of the photo.		
	Modifications: Reduced scale of photo for the purpose of inspection report.

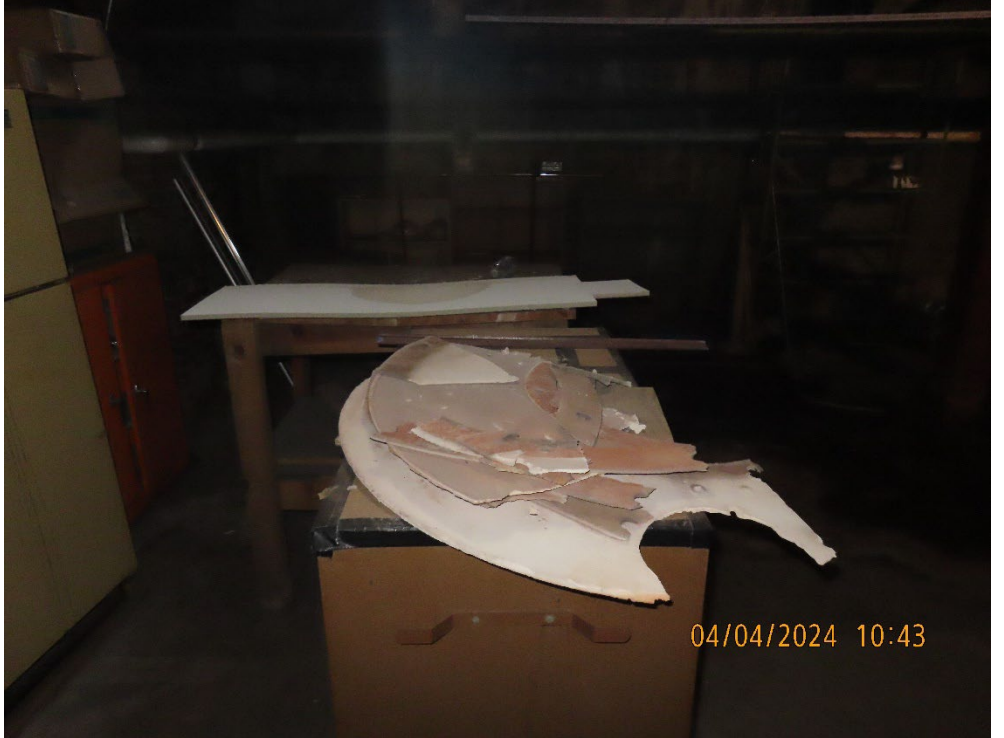
29.	Date Taken: 04/04/2024	Time Taken: 10:43 AM ET

Sample No.: IMG_0618		
	Description of Digital Image: Lower Level – Boiler room: Close up photo of a removed broken up boiler gasket on roller cart.		
	Modifications: Reduced scale of photo for the purpose of inspection report.

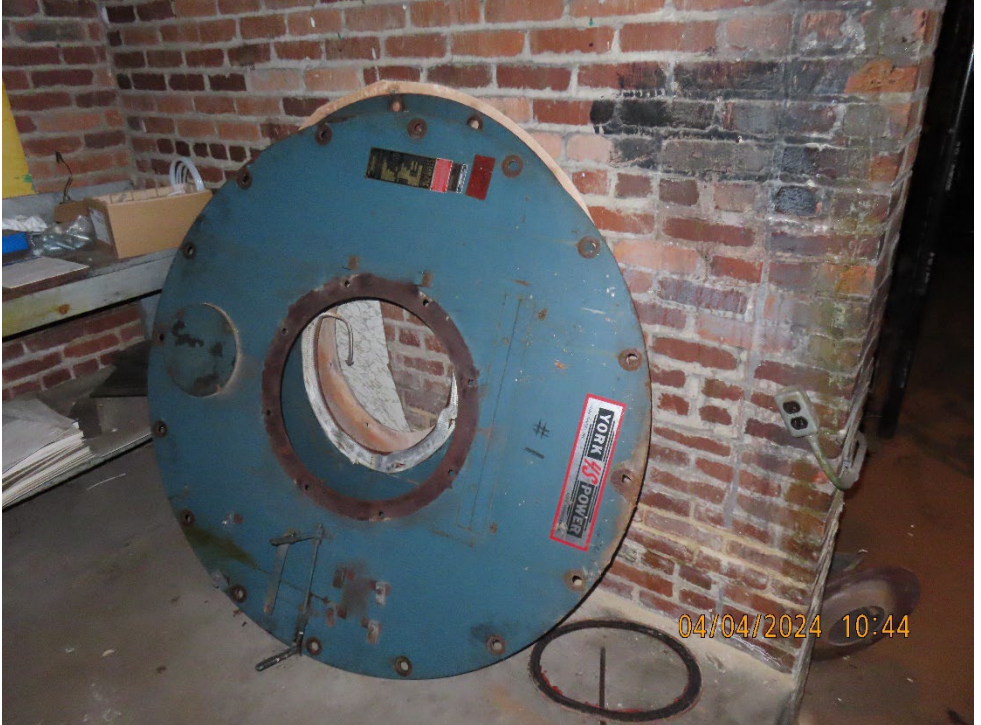
31.	Date Taken: 04/04/2024	Time Taken: 10:44 AM ET

Sample No.: IMG_0620		
	Description of Digital Image: Lower Level – Boiler room: Close up photo of a removed damaged gasket stored against the brick wall.		
	Modifications: Reduced scale of photo for the purpose of inspection report.

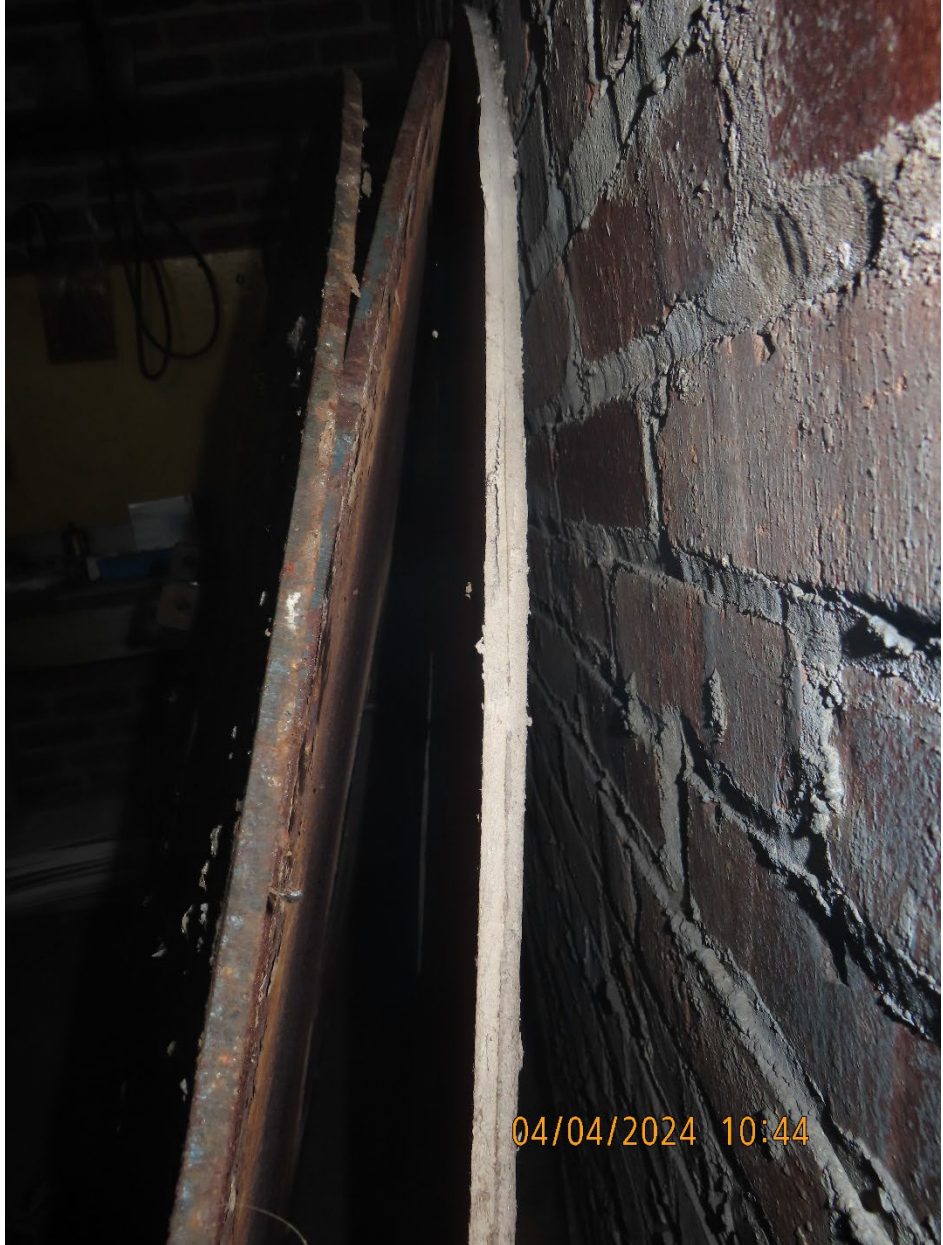
32.	Date Taken: 04/04/2024	Time Taken: 10:44 AM ET

Sample No.: IMG_0621		
	Description of Digital Image: Lower Level – Boiler room: Side profile close up photo of a removed broken up boiler gasket stored against the brick wall.		
Modifications: Reduced scale of photo for the purpose of inspection report.

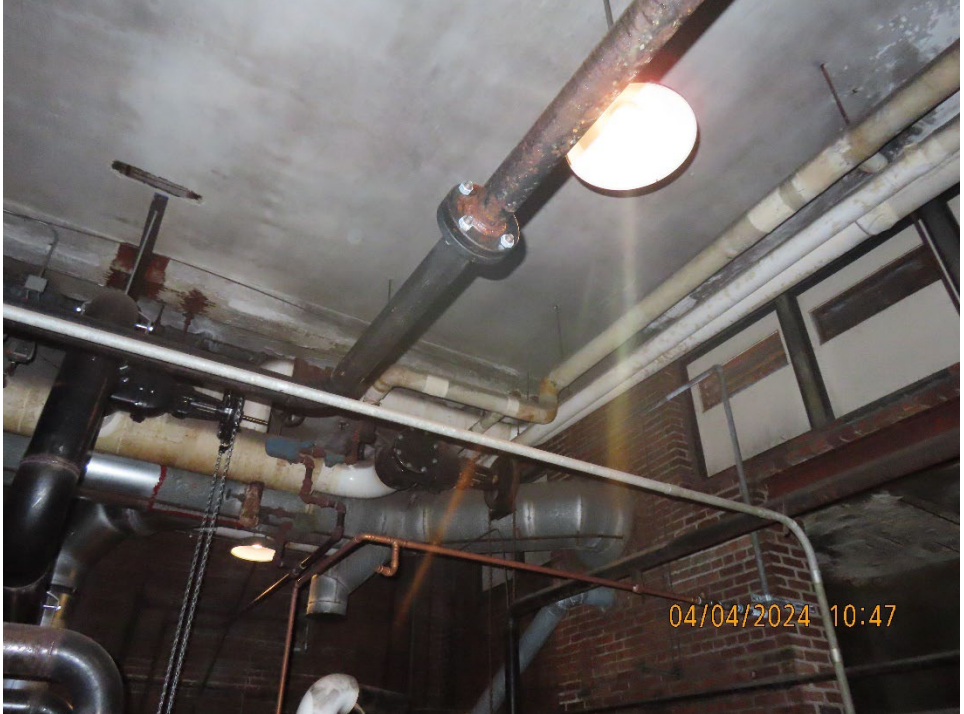
35.	Date Taken: 04/04/2024	Time Taken: 10:47 AM ET

Sample No.: IMG_0624		
	Description of Digital Image: Lower Level – Boiler room: Damaged TSI throughout the boiler room.		
	Modifications: Reduced scale of photo for the purpose of inspection report.

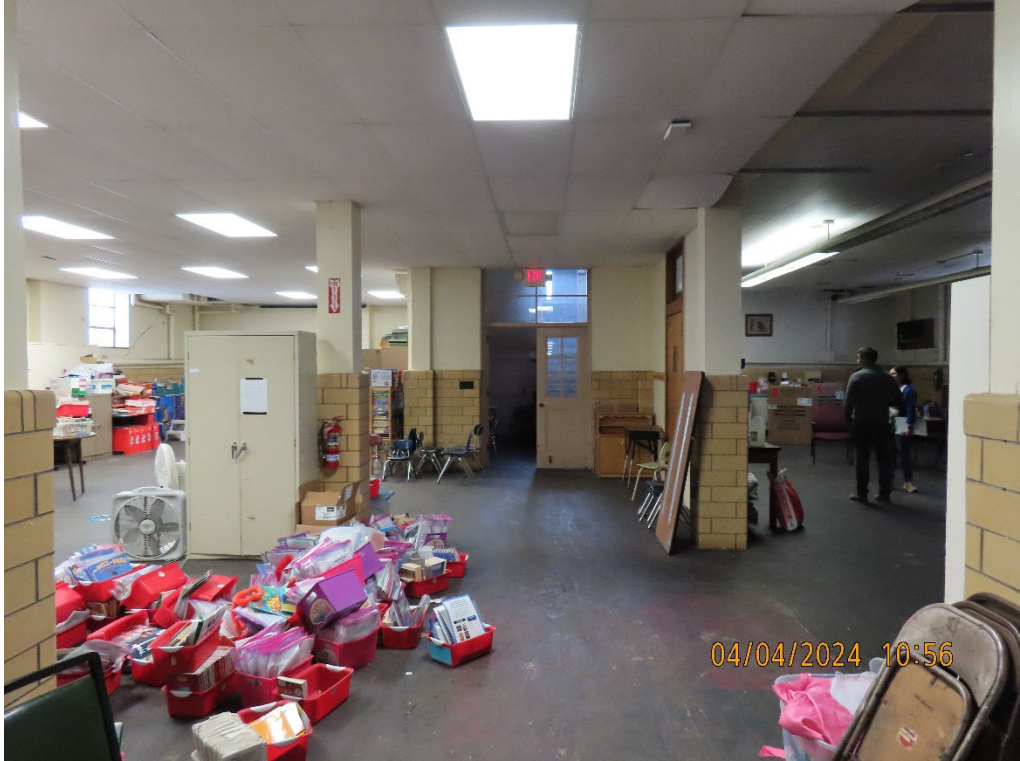
39.	Date Taken: 04/04/2024	Time Taken: 10:56 AM ET

Sample No.: IMG_0628		
	Description of Digital Image: Lower Level – Instruction area/Book supplies storage/ Crystal Clear Staff area: Full room photo with the instruction area on the left and staff area on the right. The whole area had removed floor tile with exposed black mastic.		
	Modifications: Reduced scale of photo for the purpose of inspection report.

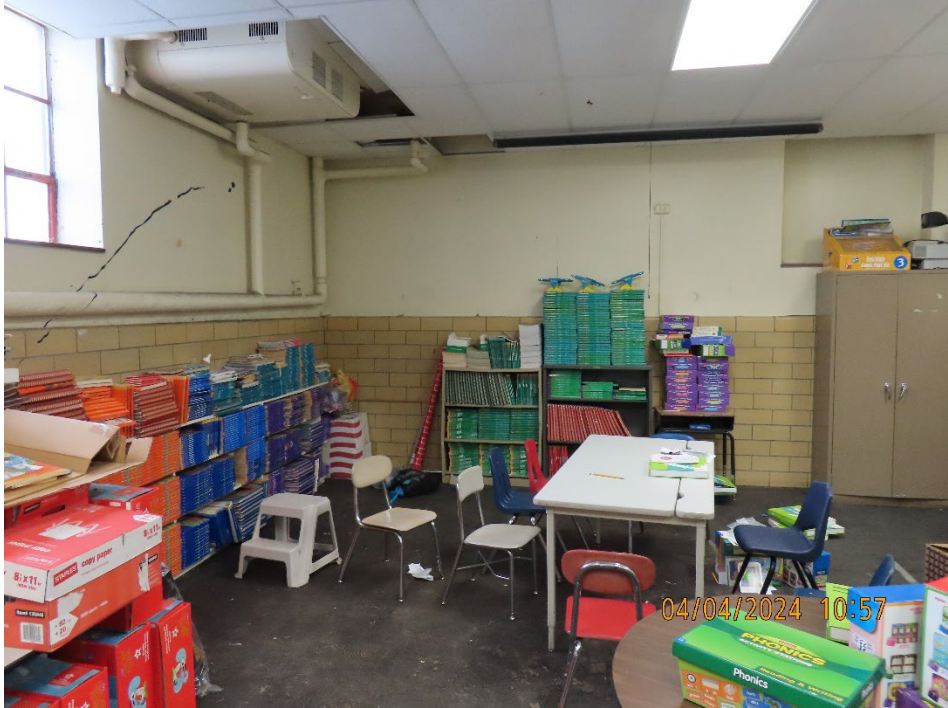
40.	Date Taken: 04/04/2024	Time Taken: 10:57 AM ET

Sample No.: IMG_0629		
	Description of Digital Image: Lower Level – Instruction area/Book supplies storage/ Crystal Clear Staff area: Book supply storage and instruction area set up with pipe TSI along the wall and black flooring mastic.		
	Modifications: Reduced scale of photo for the purpose of inspection report.

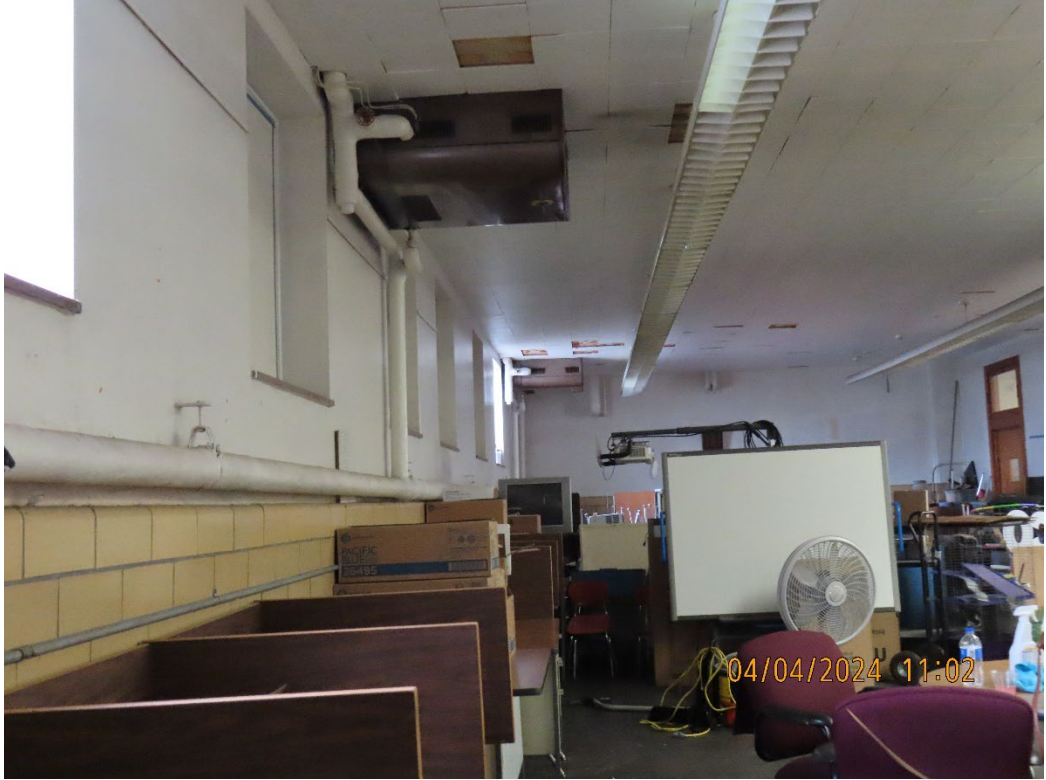
44.	Date Taken: 04/04/2024	Time Taken: 11:02 AM ET

Sample No.: IMG_0633		
	Description of Digital Image: Lower Level – Instruction area/Book supplies storage/ Crystal Clear Staff area: Rear portion of Crystal-Clear staff area. The pipe TSI extends the perimeter of the room past the school supplies stored at the back of the room.		
	Modifications: Reduced scale of photo for the purpose of inspection report.

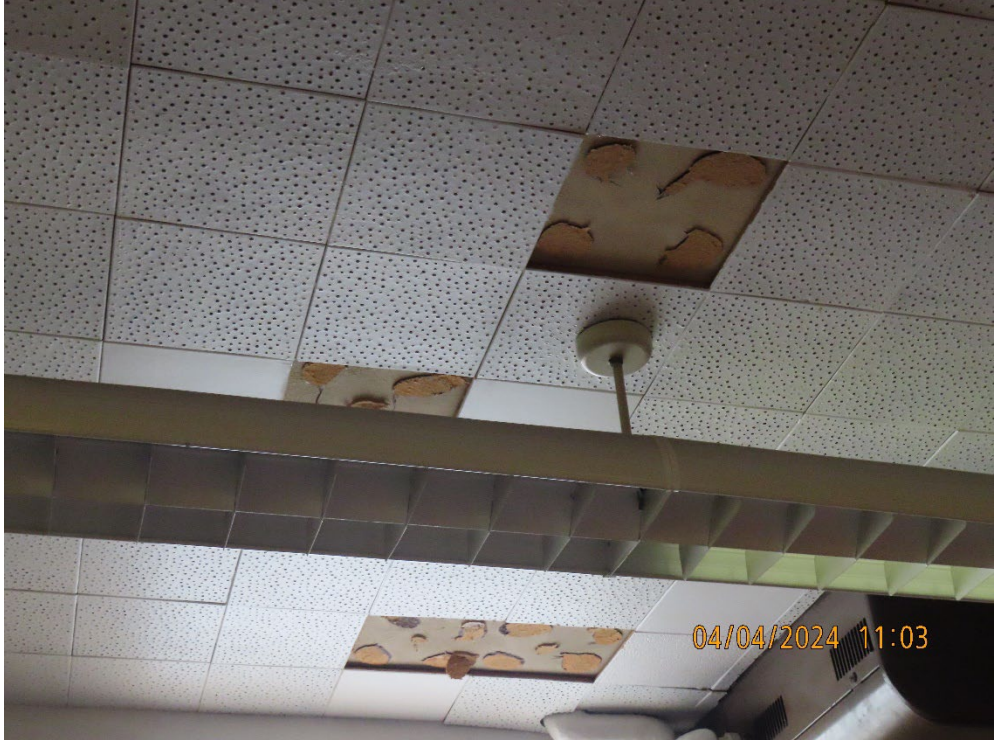
45.	Date Taken: 04/04/2024	Time Taken: 11:03 AM ET

Sample No.: IMG_0634		
	Description of Digital Image: Lower Level – Instruction area/Book supplies storage/ Crystal Clear Staff area: Close up of ceiling tiles and exposed glue pucks above Crystal Clear staff area.		
	Modifications: Reduced scale of photo for the purpose of inspection report.

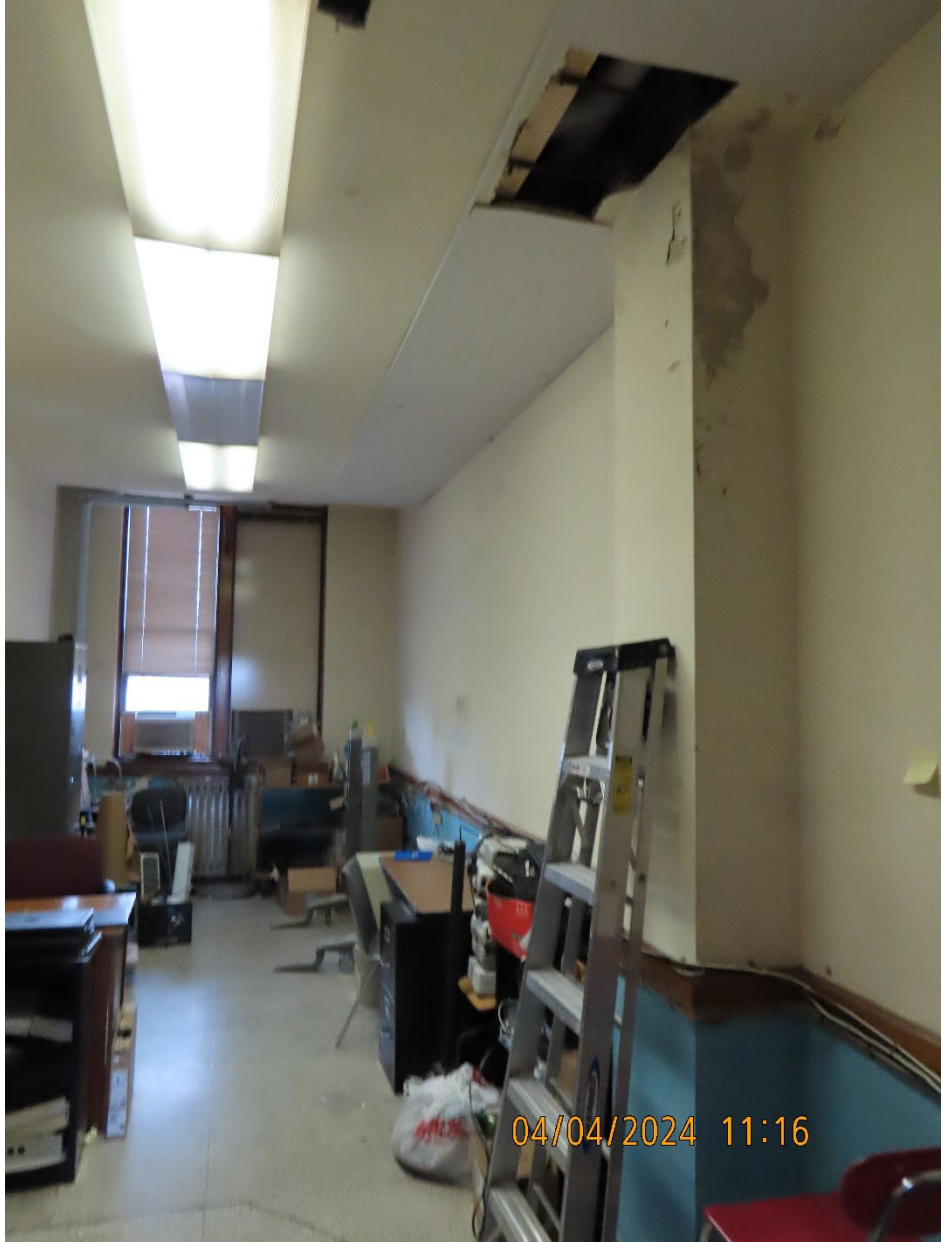
51.	Date Taken: 04/04/2024	Time Taken: 11:16 AM ET

Sample No.: IMG_0640		
	Description of Digital Image: Second Level – Technology and Server Room: Terrazzo flooring with chipping and flaking painted wall materials, debris covered the floor.		
	Modifications: Reduced scale of photo for the purpose of inspection report.

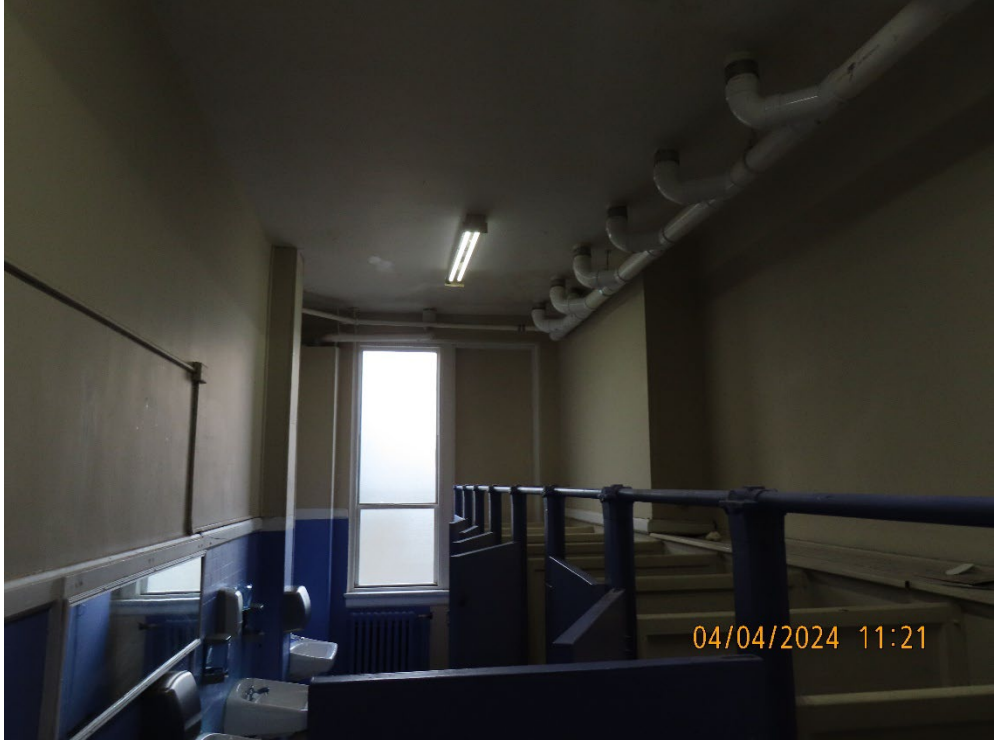
54.	Date Taken: 04/04/2024	Time Taken: 11:21 AM ET

Sample No.: IMG_0643		
	Description of Digital Image: Second Level – Women’s Restroom: A pipe run of aerosol TSI spanned the width of the restroom above the window with duct tape patches observed on the pipe elbow in fair/damaged condition.		
	Modifications: Reduced scale of photo for the purpose of inspection report.

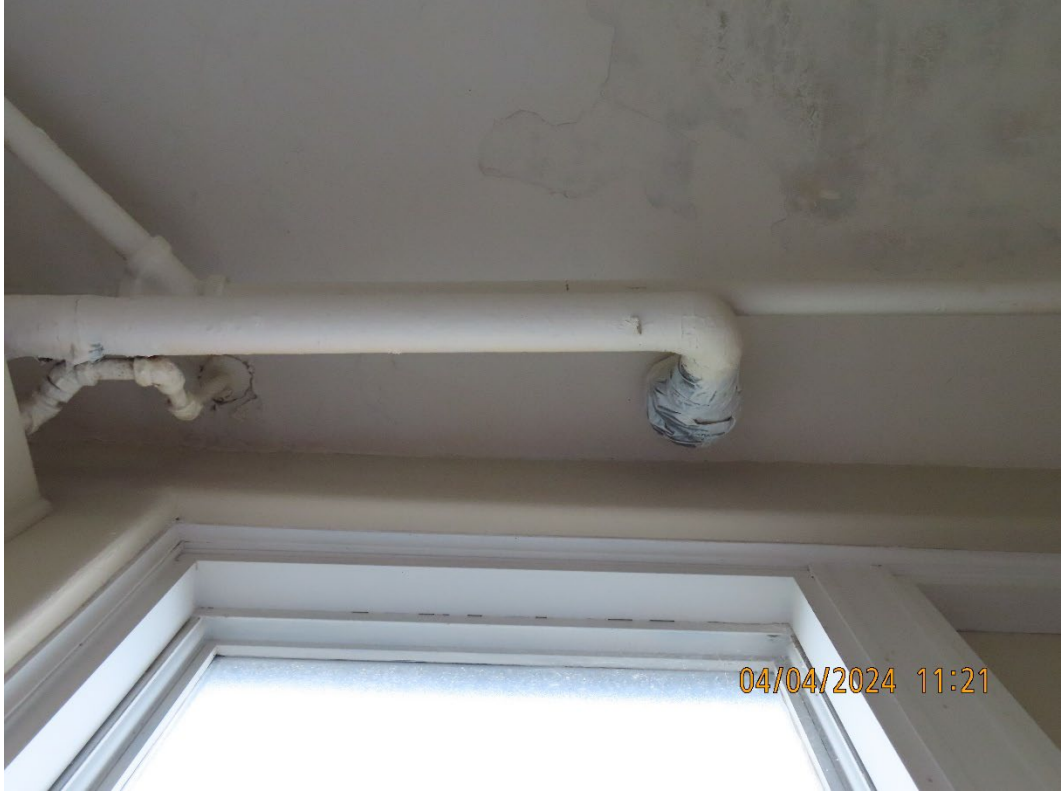
55.	Date Taken: 04/04/2024	Time Taken: 11:21 AM ET

Sample No.: IMG_0644		
	Description of Digital Image: Second Level – Women’s Restroom: Close up of the pipe run of aerosol TSI that spanned the width of the restroom above the window with duct tape patches observed on the pipe elbow in fair/damaged condition.		
	Modifications: Reduced scale of photo for the purpose of inspection report.

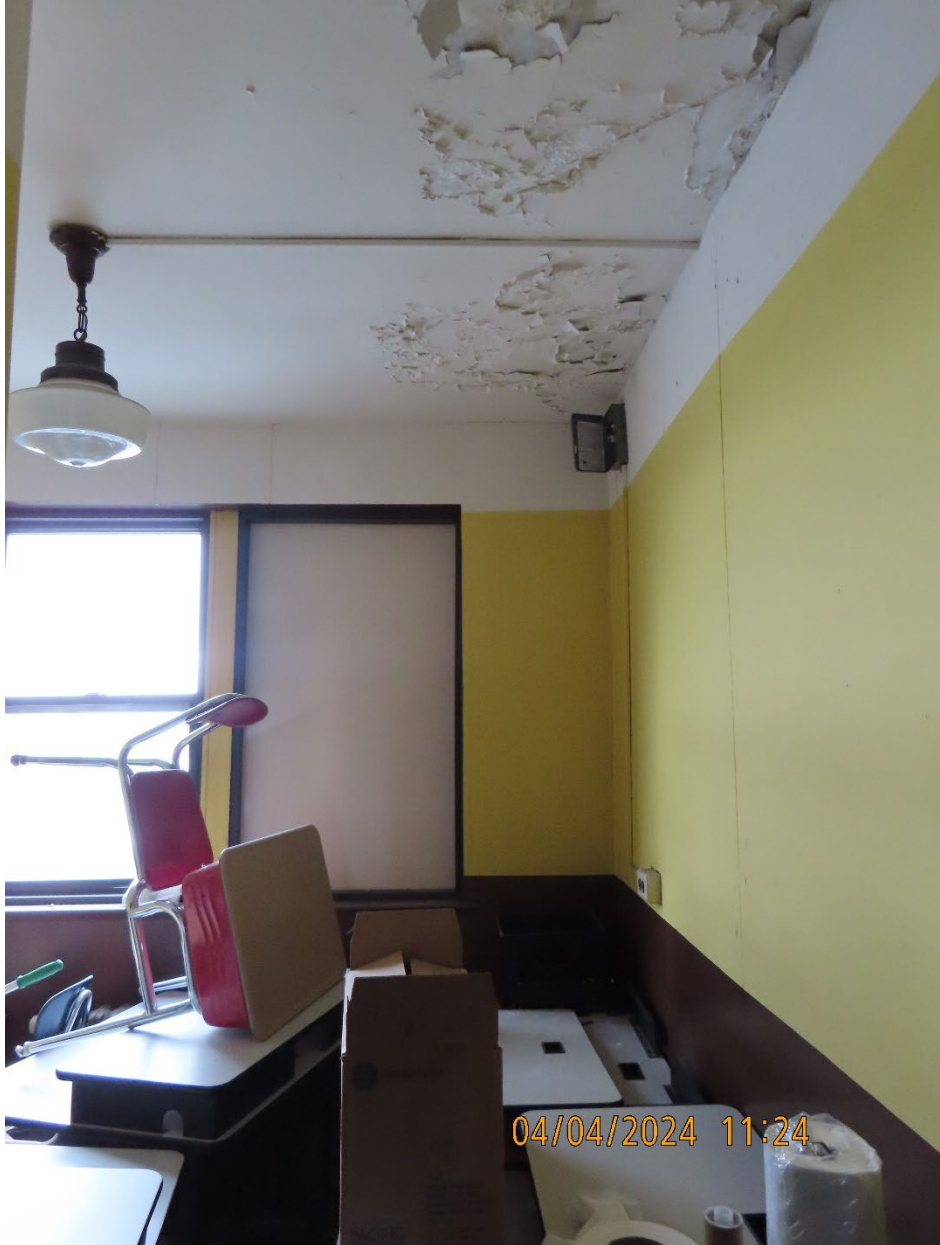
56.	Date Taken: 04/04/2024	Time Taken: 11:24 AM ET

Sample No.: IMG_0645		
	Description of Digital Image: Third Level – Southwestern Custodial Closet: The closet contained stacked/piled classroom desks and chairs. The ceiling was observed to be severely flaking and damaged.		
	Modifications: Reduced scale of photo for the purpose of inspection report.

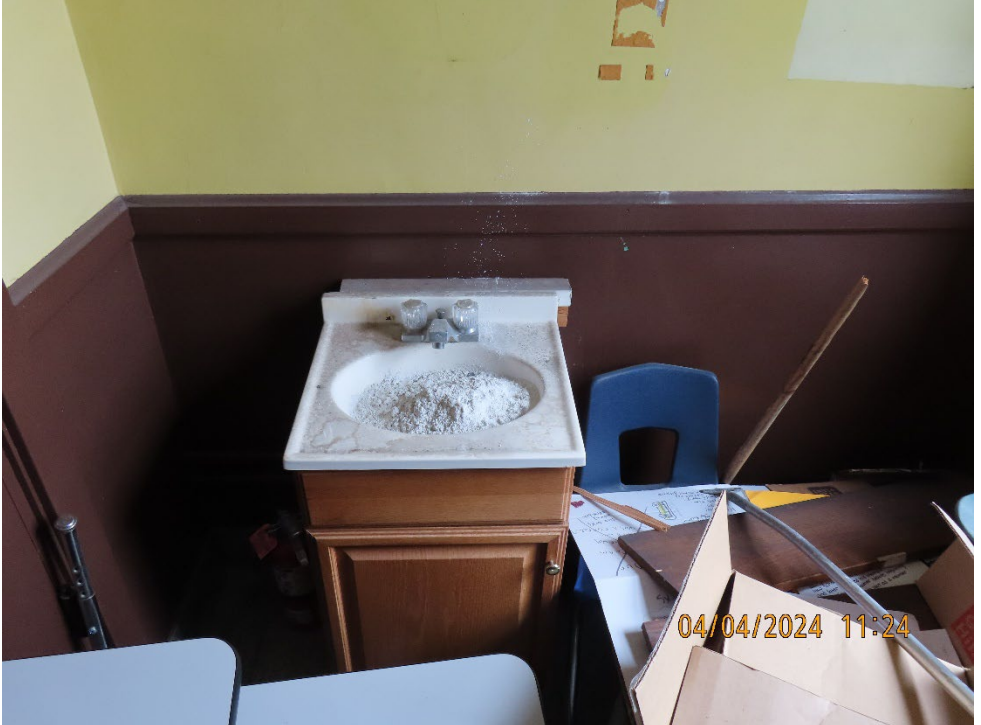
57.	Date Taken: 04/04/2024	Time Taken: 11:24 AM ET

Sample No.: IMG_0646		
	Description of Digital Image: Third Level – Southwestern Custodial Closet: The closet contained a sink bowl filled with a pulverized/dust- like powder material.		
Modifications: Reduced scale of photo for the purpose of inspection report.

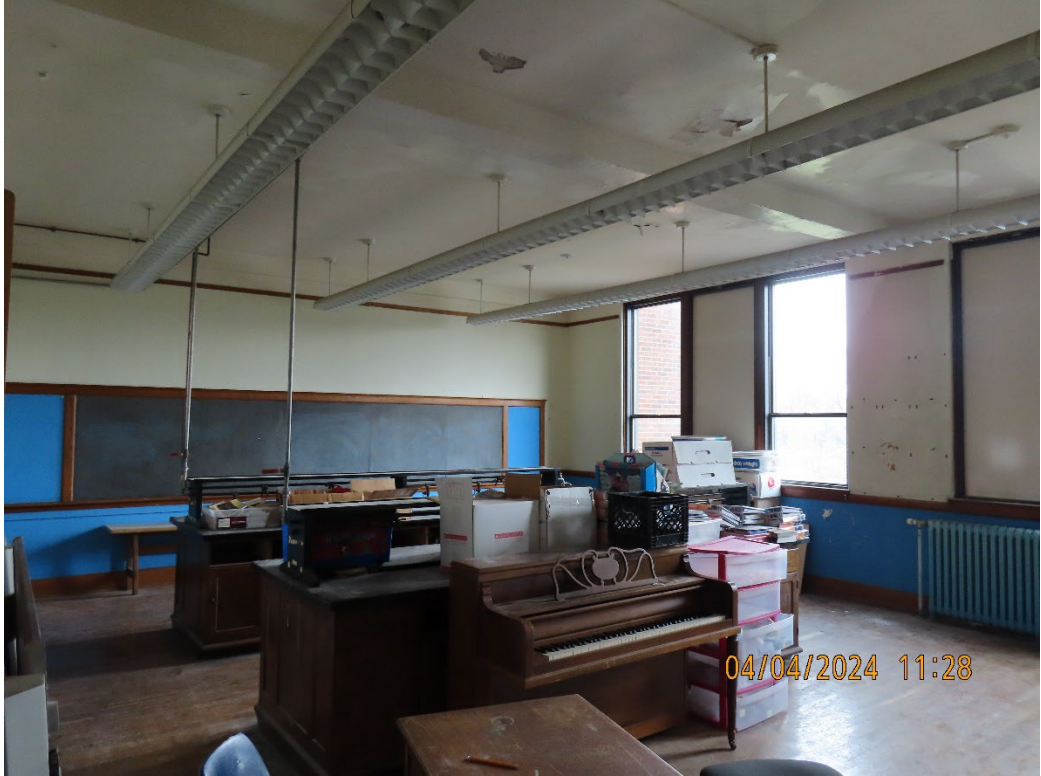
59.	Date Taken: 04/04/2024	Time Taken: 11:28 AM ET

Sample No.: IMG_0648		
	Description of Digital Image: Third Level – Classroom 302/old Lab room: The wall and ceiling materials were painted plaster in a damaged and flaking condition. Dust and Debris covered flat surfaces and the floor. The room had old lab tables commonly known to be asbestos containing as well as a fire blanket stored at the front of the room against the blackboard.		
Modifications: Reduced scale of photo for the purpose of inspection report.
