File Number: 24TA007	Entity Name: ACCEL Schools – Steam Academy of Warren	Inspection Address, City, State, Zip Code: 261 Elm Road Northeast, Warren, Ohio 44483
Date of Inspection: April 4, 2024	Inspector-Photographer: Brandon Brewster	Number of Photographs Taken: 75
Camera Used: SY2376	Digital Recording Media: SD CARD	Notes:

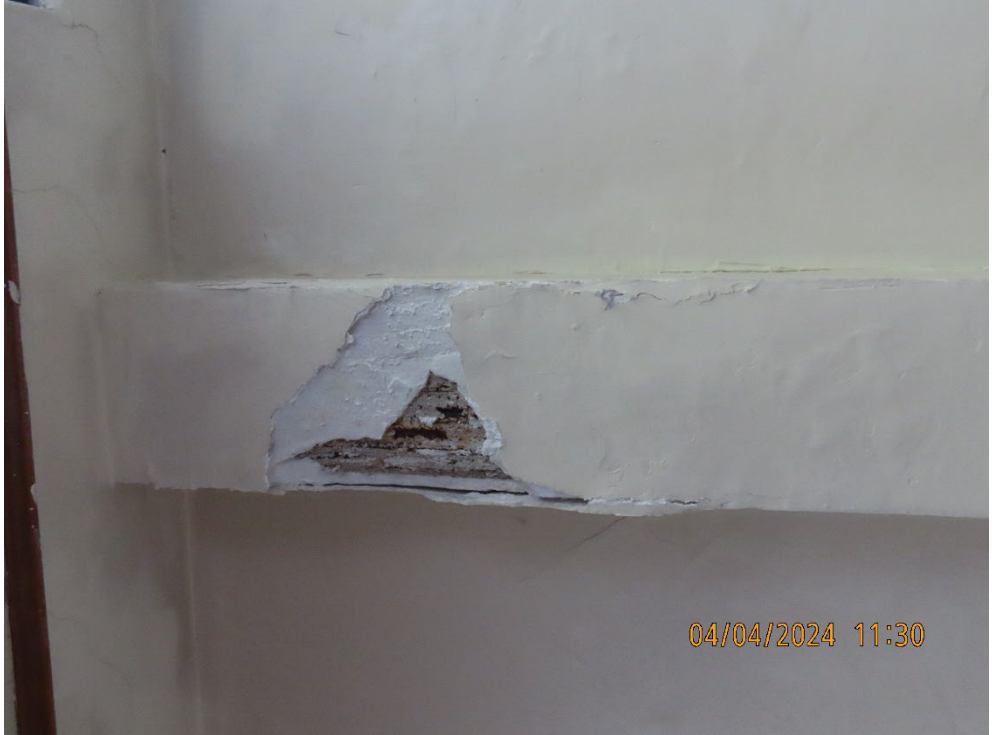
63.	Date Taken: 04/04/2024	Time Taken: 11:30 AM ET

Sample No.: IMG_0652		
	Description of Digital Image: Third Level – Classroom 302/old Lab room: Close-up of the damaged ceiling plaster in image 0650.		
	Modifications: Reduced scale of photo for the purpose of inspection report.

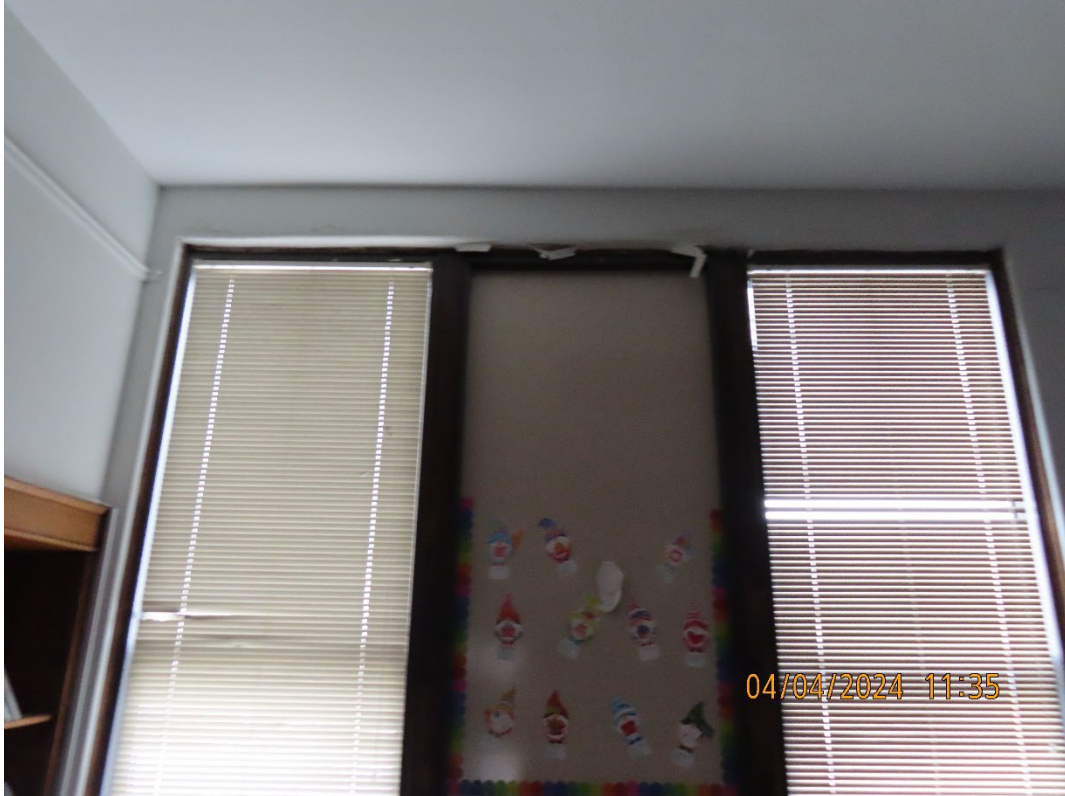
65.	Date Taken: 04/04/2024	Time Taken: 11:35 AM ET

Sample No.: IMG_0654		
	Description of Digital Image: Third Level – Classroom 301/Library: The painted materials of the wall in the classroom were observed to be flaking and peeling off in large sections in areas bordering the windows and on the ceiling.		
	Modifications: Reduced scale of photo for the purpose of inspection report.

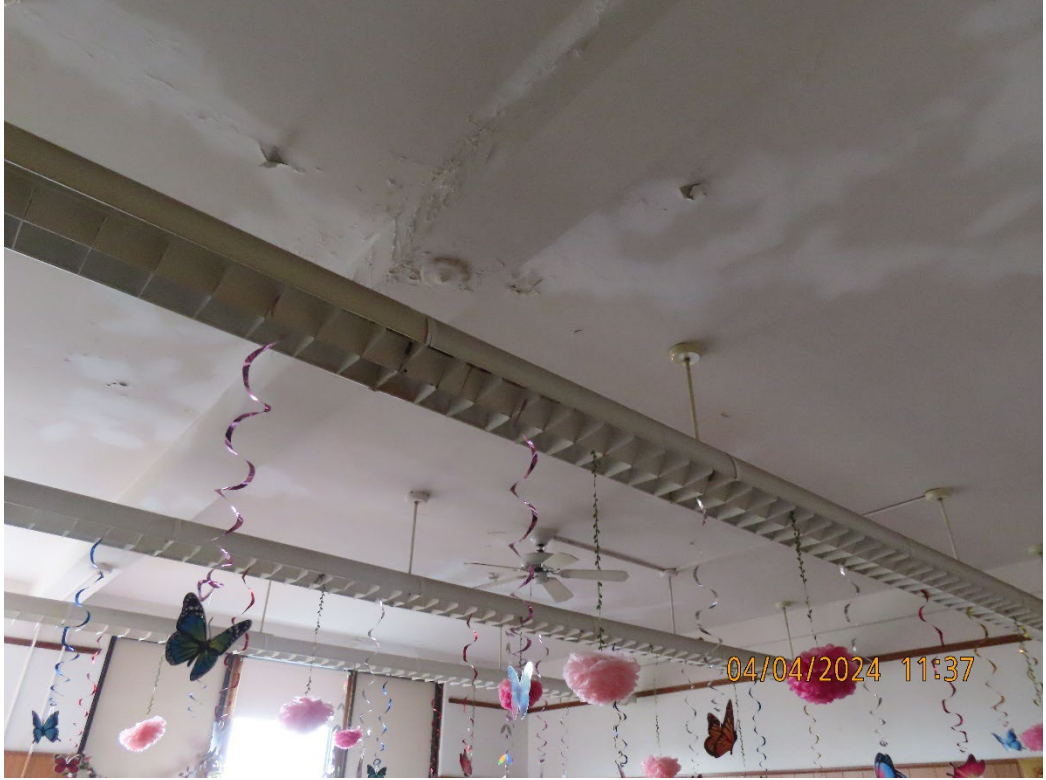
66.	Date Taken: 04/04/2024	Time Taken: 11:37 AM ET

<p>04/04/2024 11:37</p>
	Sample No.: IMG_0655		
	Description of Digital Image: Third Level – Classroom 306: The painted materials of the wall in the classroom were observed to be flaking and peeling off in large sections in areas bordering the windows and crumbling from the ceiling.		
	Modifications: Reduced scale of photo for the purpose of inspection report.

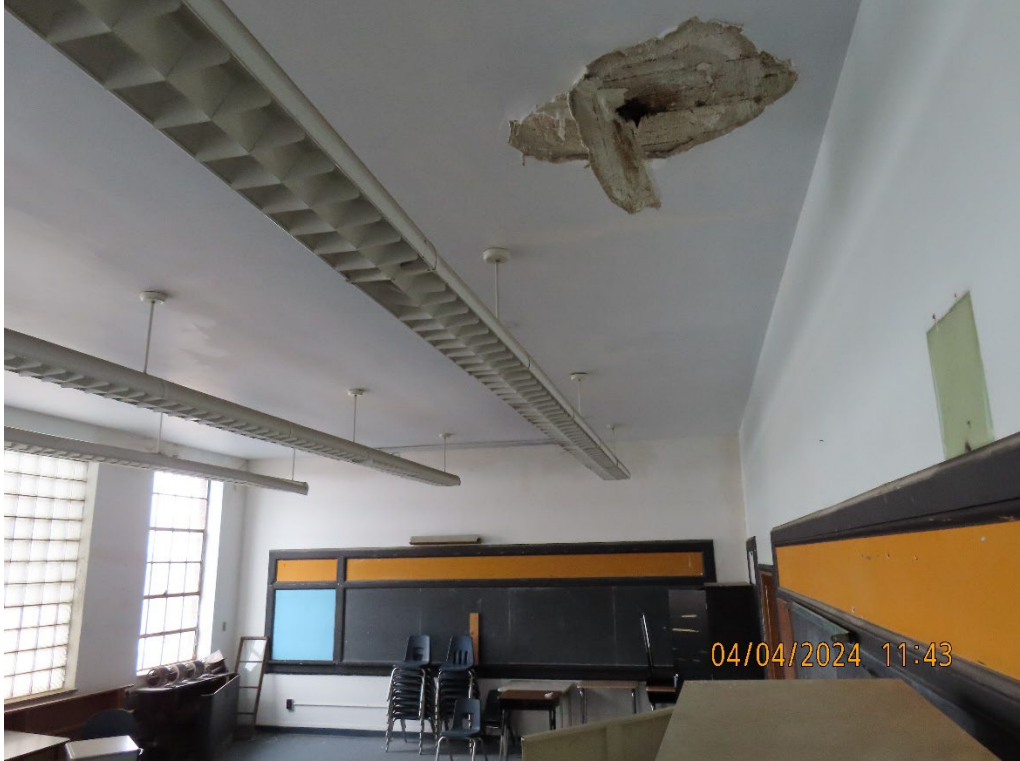
70.	Date Taken: 04/04/2024	Time Taken: 11:43 AM ET

Sample No.: IMG_0659		
	Description of Digital Image: Third Level – Classroom 309: Ceiling plaster observed to be significantly damaged with a large chunk dangling from the ceiling. Additionally, the wall materials showed significant cracking, peeling, and flaking. The Cove base/baseboard around the perimeter of the room were peeling away from the wall leaving the adhesive exposed. At the entrance to the classroom a gap existed between the carpet and hallway floor tile leaving exposed black mastic.		
	Modifications:

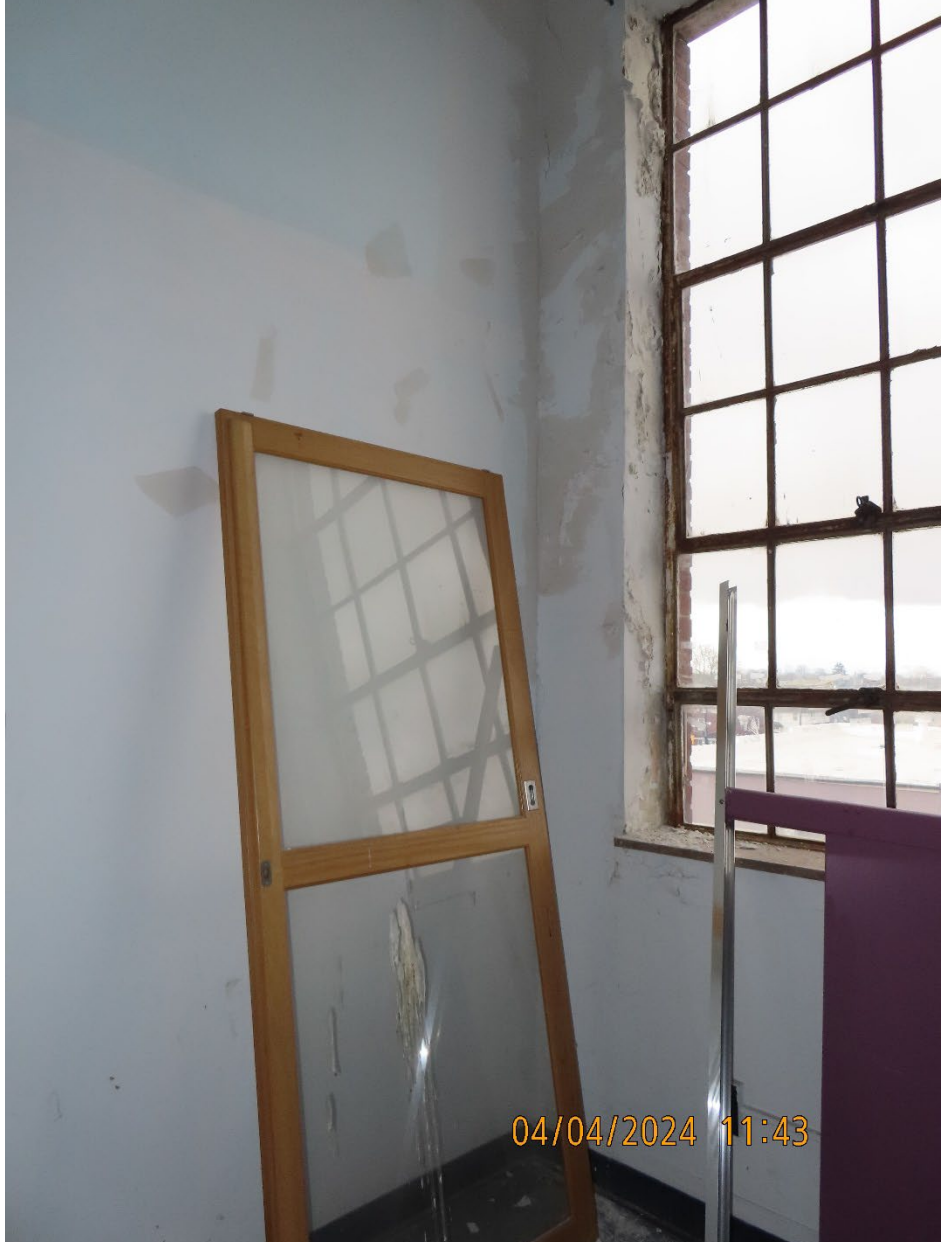
71.	Date Taken: 04/04/2024	Time Taken: 11:43 AM ET

Sample No.: IMG_0660		
	Description of Digital Image: Third Level – Classroom 309: Close up of the wall materials showed significant cracking, peeling, and flaking.		
	Modifications: Reduced scale of photo for the purpose of inspection report.

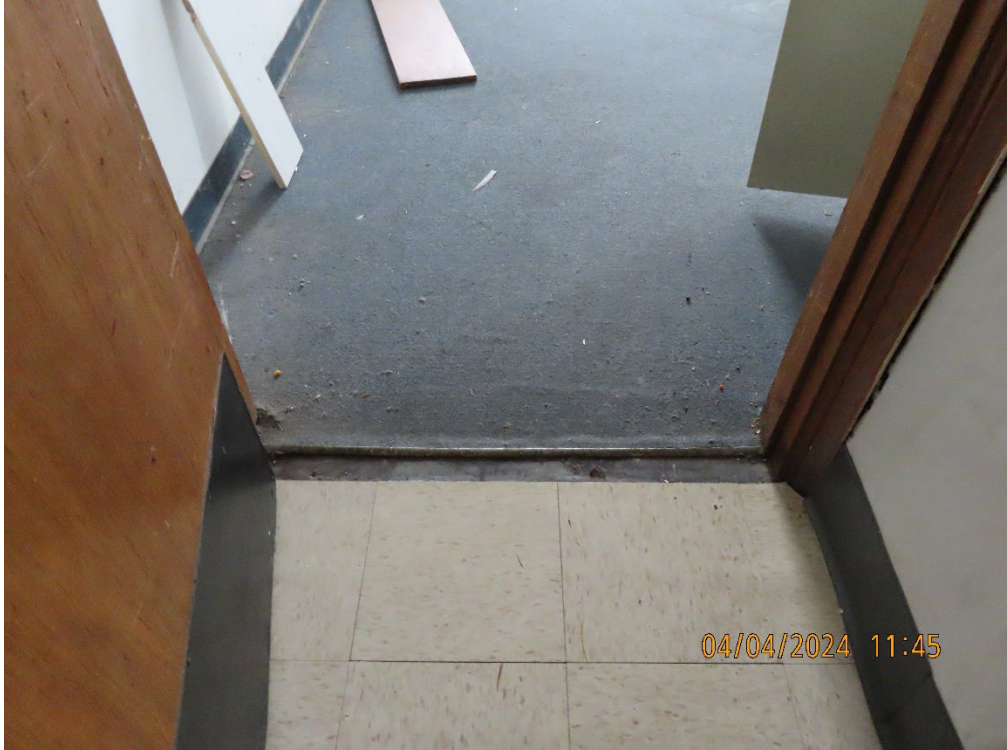
74.	Date Taken: 04/04/2024	Time Taken: 11:45 AM ET

Sample No.: IMG_0663		
	Description of Digital Image: Third Level – Classroom 309: Close-up of the entrance to the classroom a gap existed between the carpet and hallway floor tile leaving exposed black mastic.		
	Modifications: Reduced scale of photo for the purpose of inspection report.
