**Third Five-Year Review Report for the
Hudson River PCBs Superfund Site**

**APPENDIX 4
CAPPING EVALUATION**

Prepared by:
WSP USA Solutions Inc.

July 2024

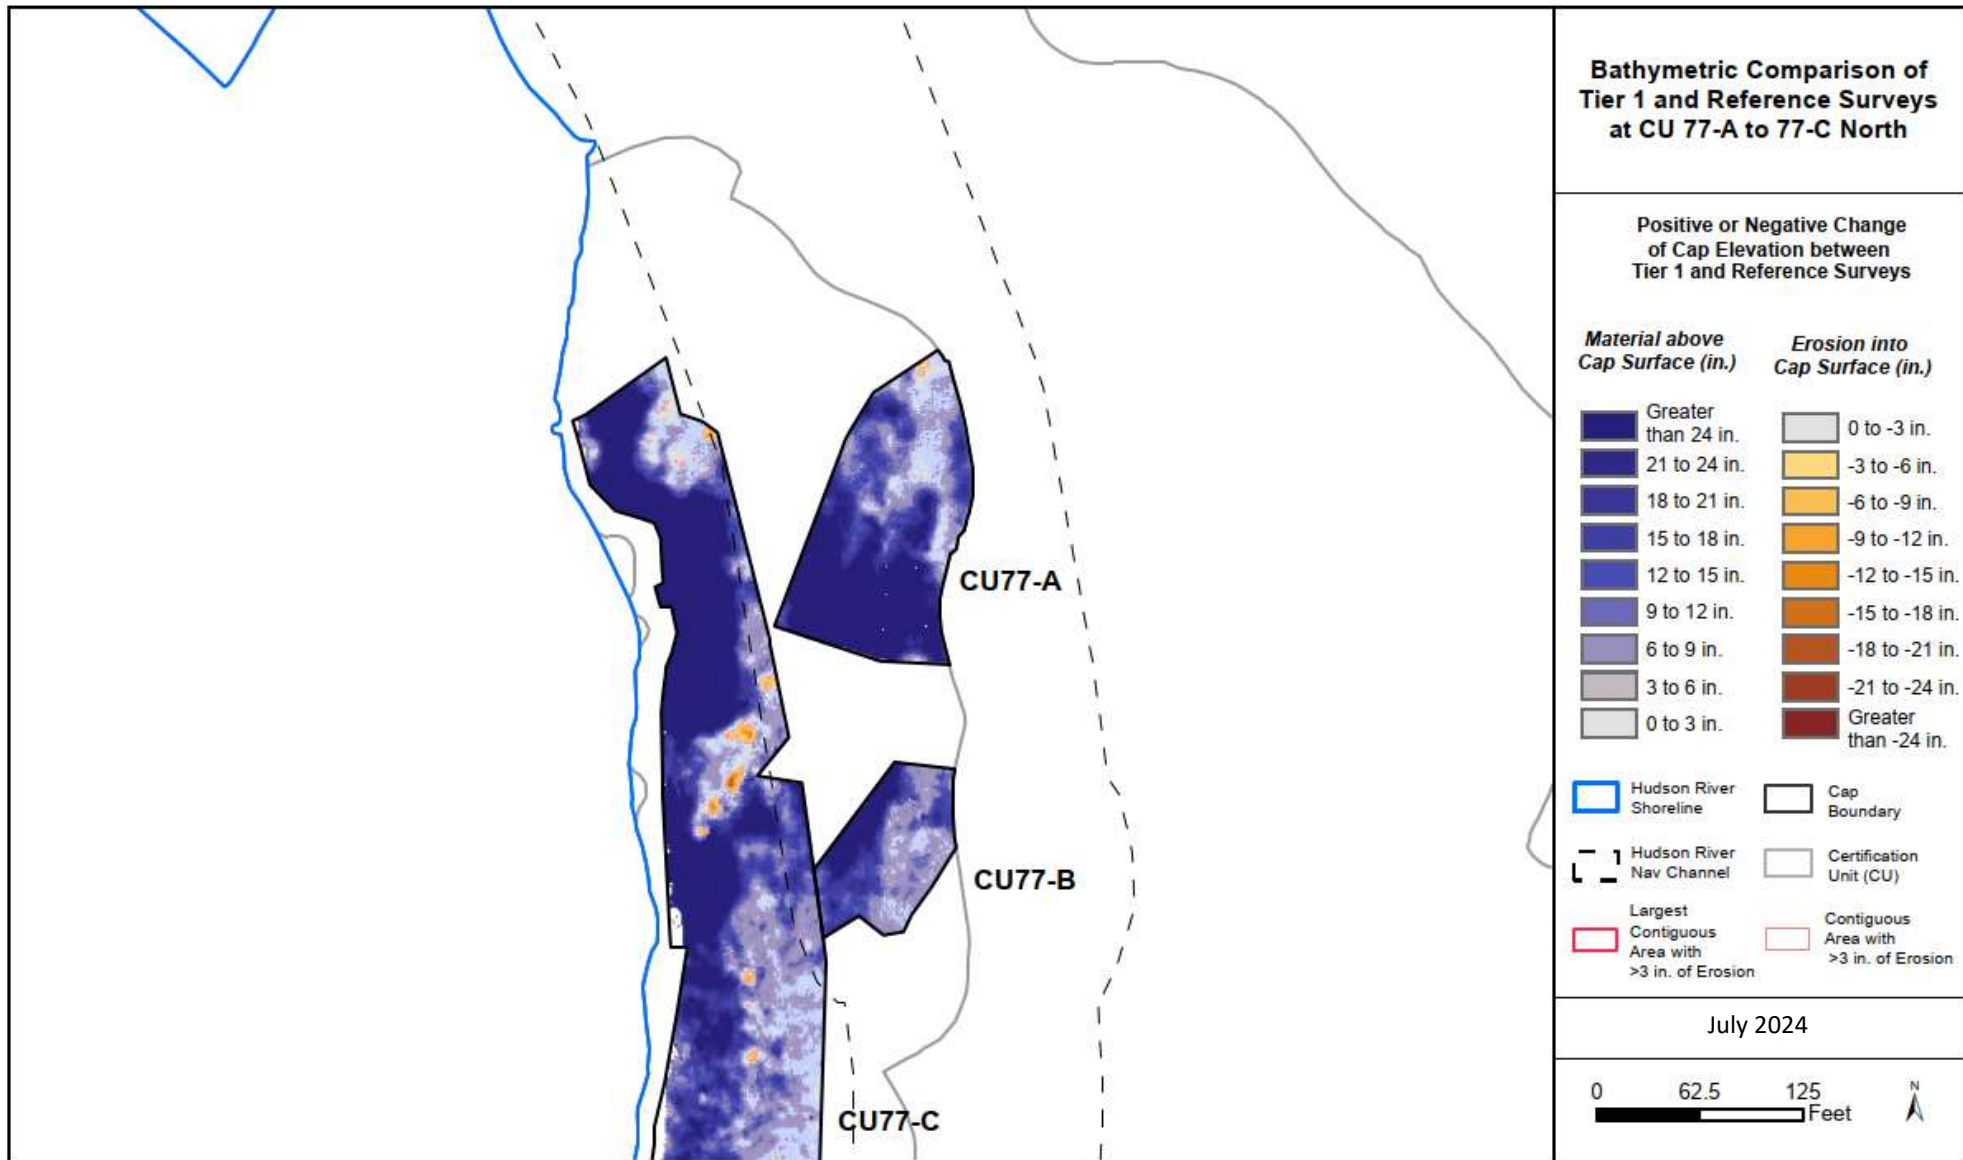
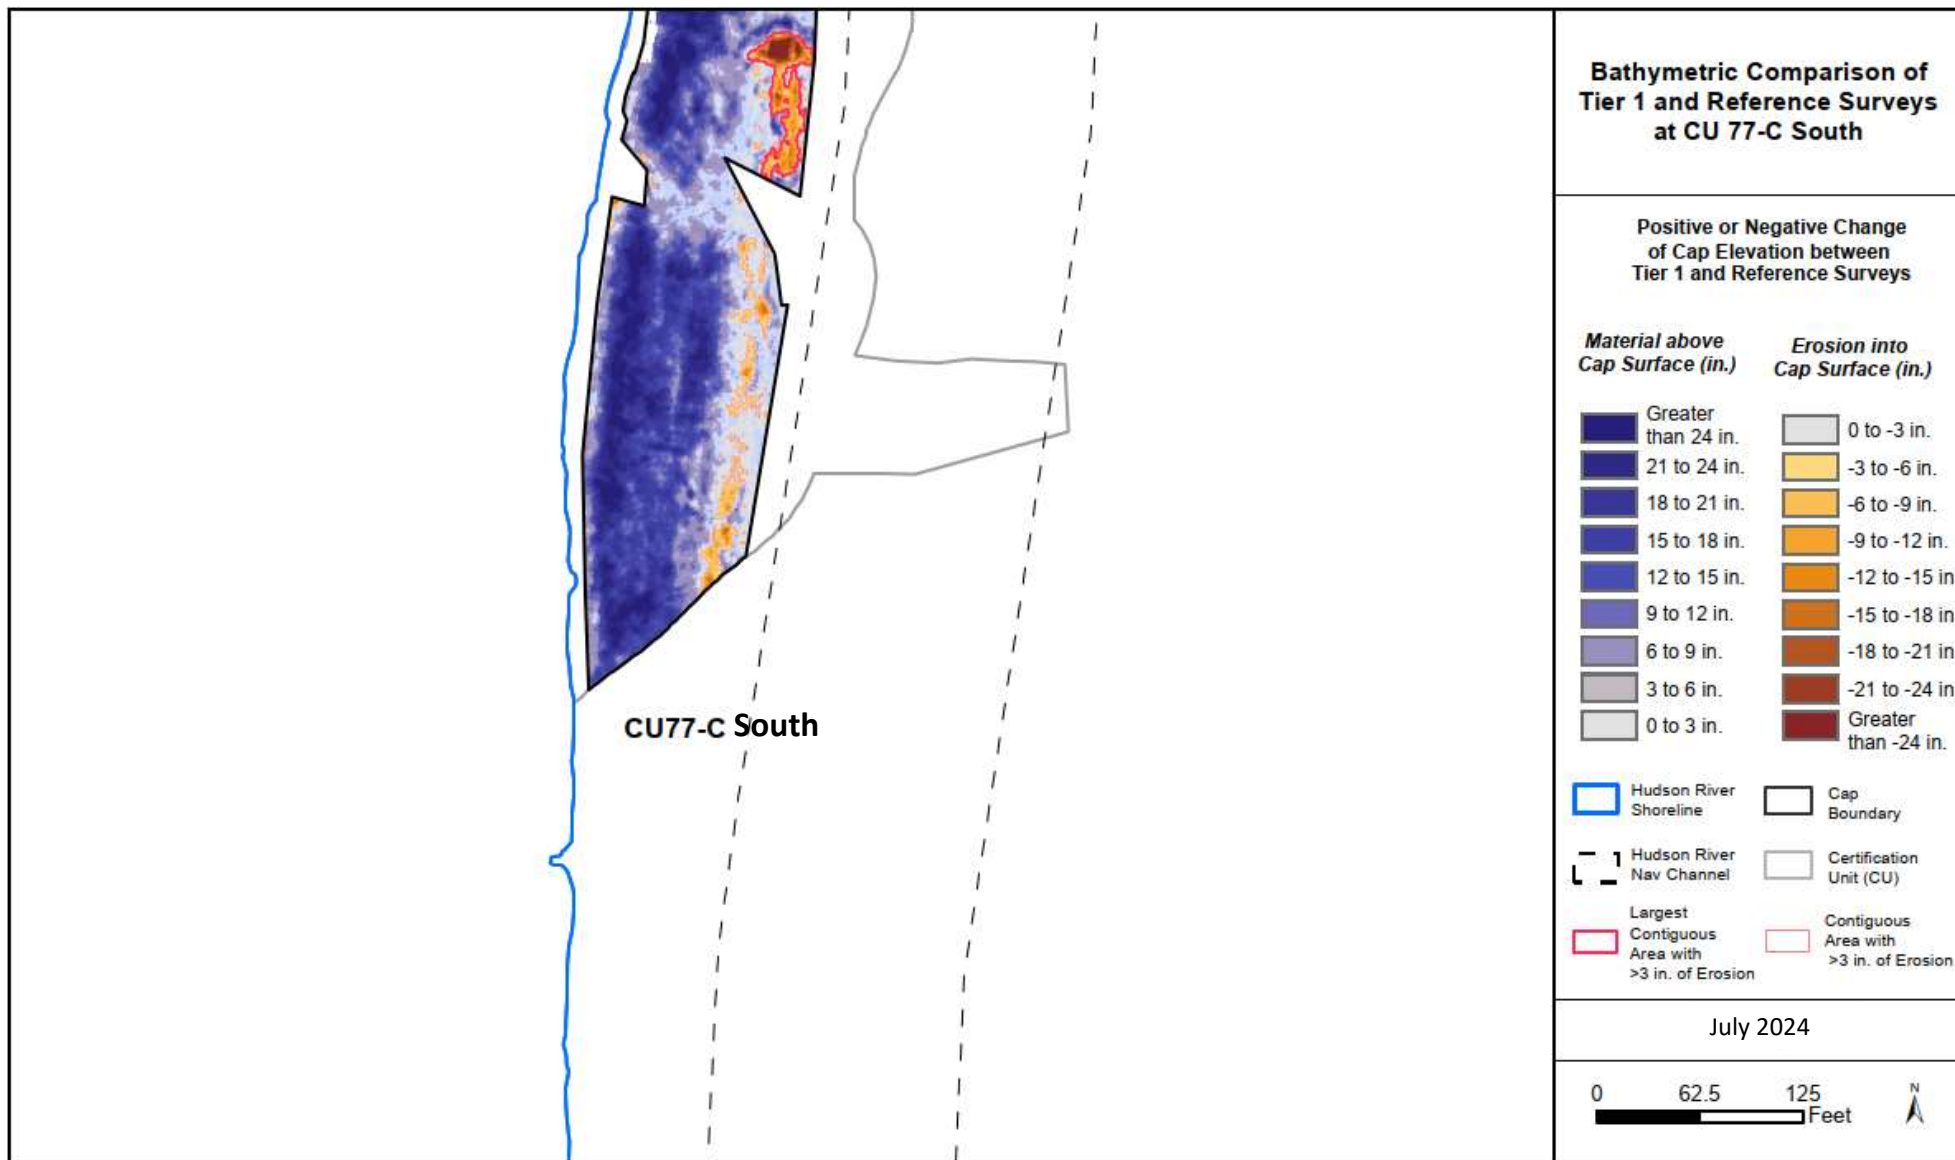
Figure A4-7a and A4-7b present the comparison of the five-year Tier 1 survey completed in 2018 to the established cap reference surface for CU 77. The largest contiguous capped area with >3 inches of erosion in CU 77 is located along the eastern boundary of cap CU 77-C, totaling 1,462 ft² (Table A4-2, Figure A4-7a). Comparison of the Tier 1 survey with Year 1 (2014) survey data showed that the largest contiguous capped area of >3 inches of erosion has increased in size between the Year 1 (2014) and five-year (2018) surveys (Figure A4-10). This is particularly evident at the upstream portion of the largest contiguous area of >3 inches of erosion observed during the five-year Tier 1 survey, which contains a localized area of >9 inches of erosion (approximately 30 feet by 18 feet) that was not present at the time of the Year 1 survey. Though no structures nor obstructions were observed in the adjacent area, this localized area of erosion is bounded upstream by a narrow crescent-shaped area of thicker cap material (approximately 21 inches of material above the cap surface at its thickest), indicating that bathymetry may be the product of a physical disturbance (e.g., buoy or similar structure, prop wash) resulting in a thin band of deposition and subsequent scour. Though CU 77 does not meet the Measurable Loss

criteria, the presence of the localized erosion at the time of the five-year Tier 1 survey indicates that close monitoring of this cap will continue, to determine if this is a localized issue/one-time event or continues to grow in the future.
