Appendix I

Letter from EPA Documenting Problems with Manufacturer D Device

REF: Equipment Comparison Phase I Sampling Results of THMSI Bulb Crushing Unit

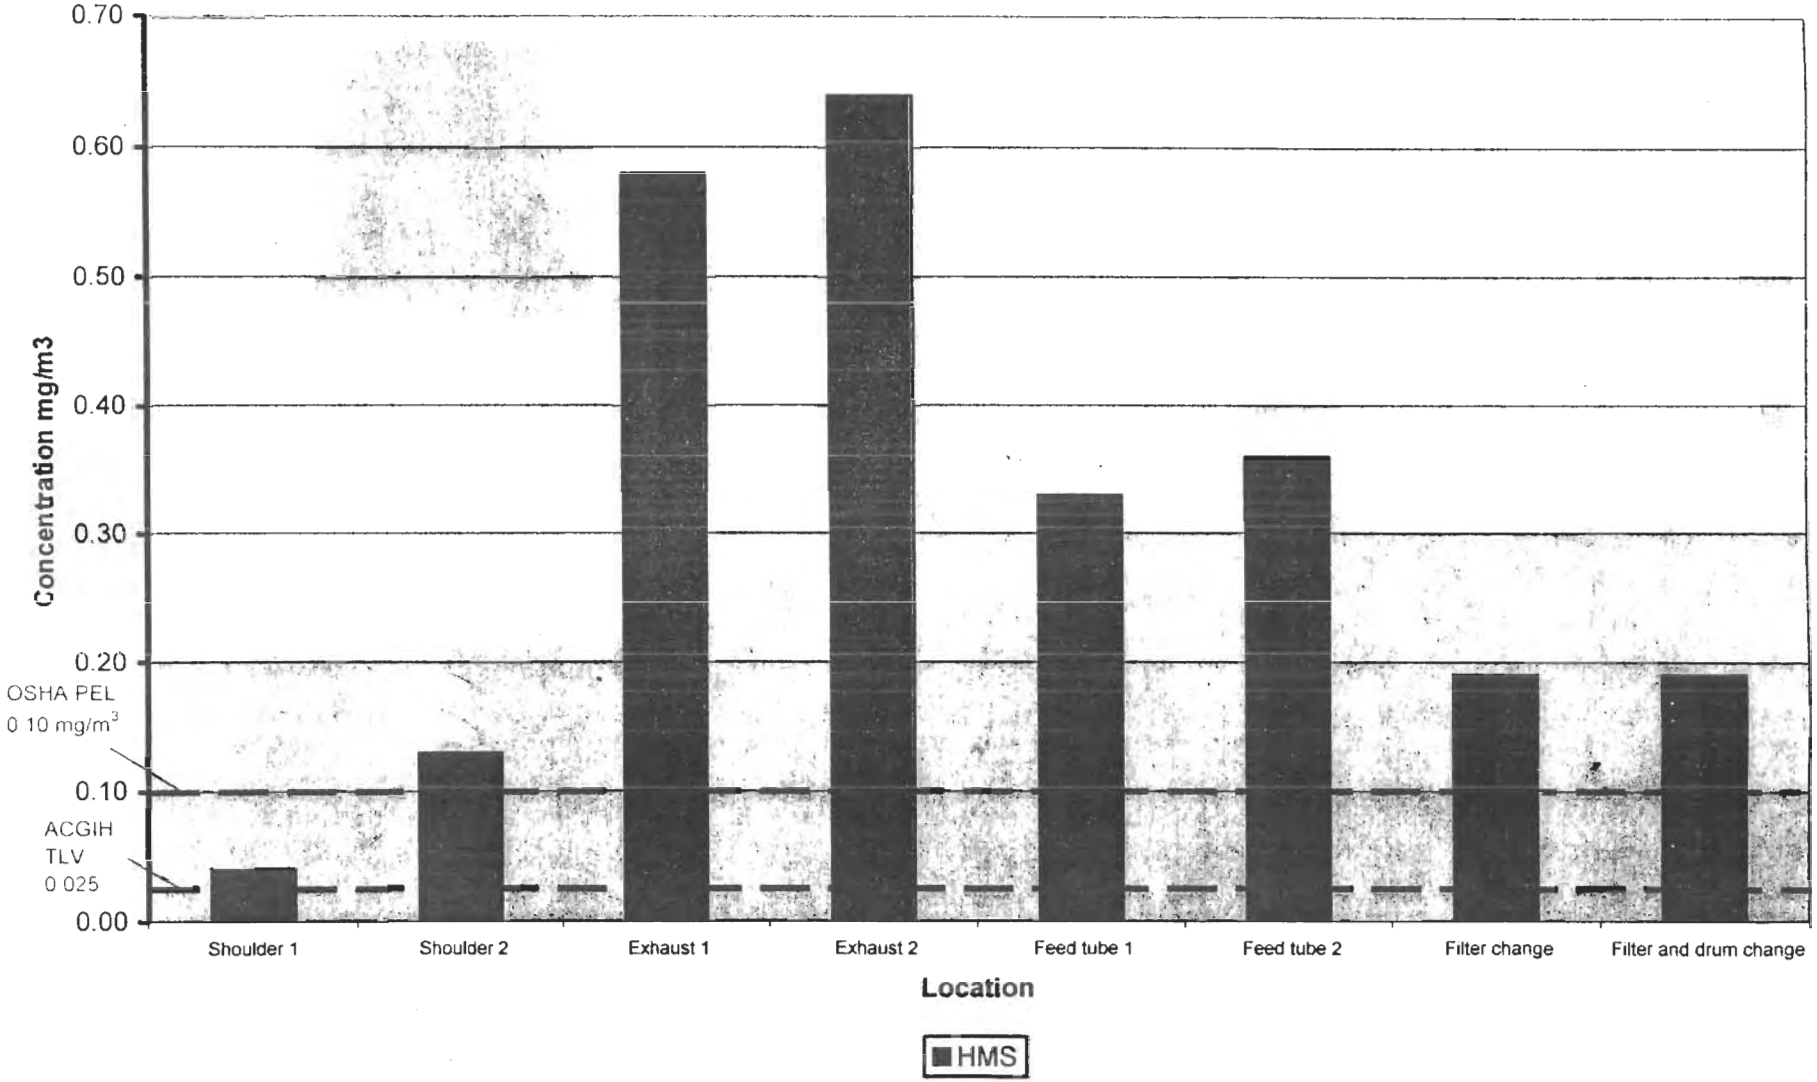
Ashland, VA AERC Facility Analytical Air Results February 2003

Analysis of the analytical air sample results indicate that the HMS device was not efficient in capturing and retaining mercury vapor, and exceeded OSHA PEL and ACGIH TLV exposure limits. Out of eight samples collected during the operation of this device, one sample did not exceed the OSHA PEL, while the remaining seven samples did exceed the OSHA PEL (reference the "Ashland, VA AERC Facility Analytical Air Results February 2003" graph.)

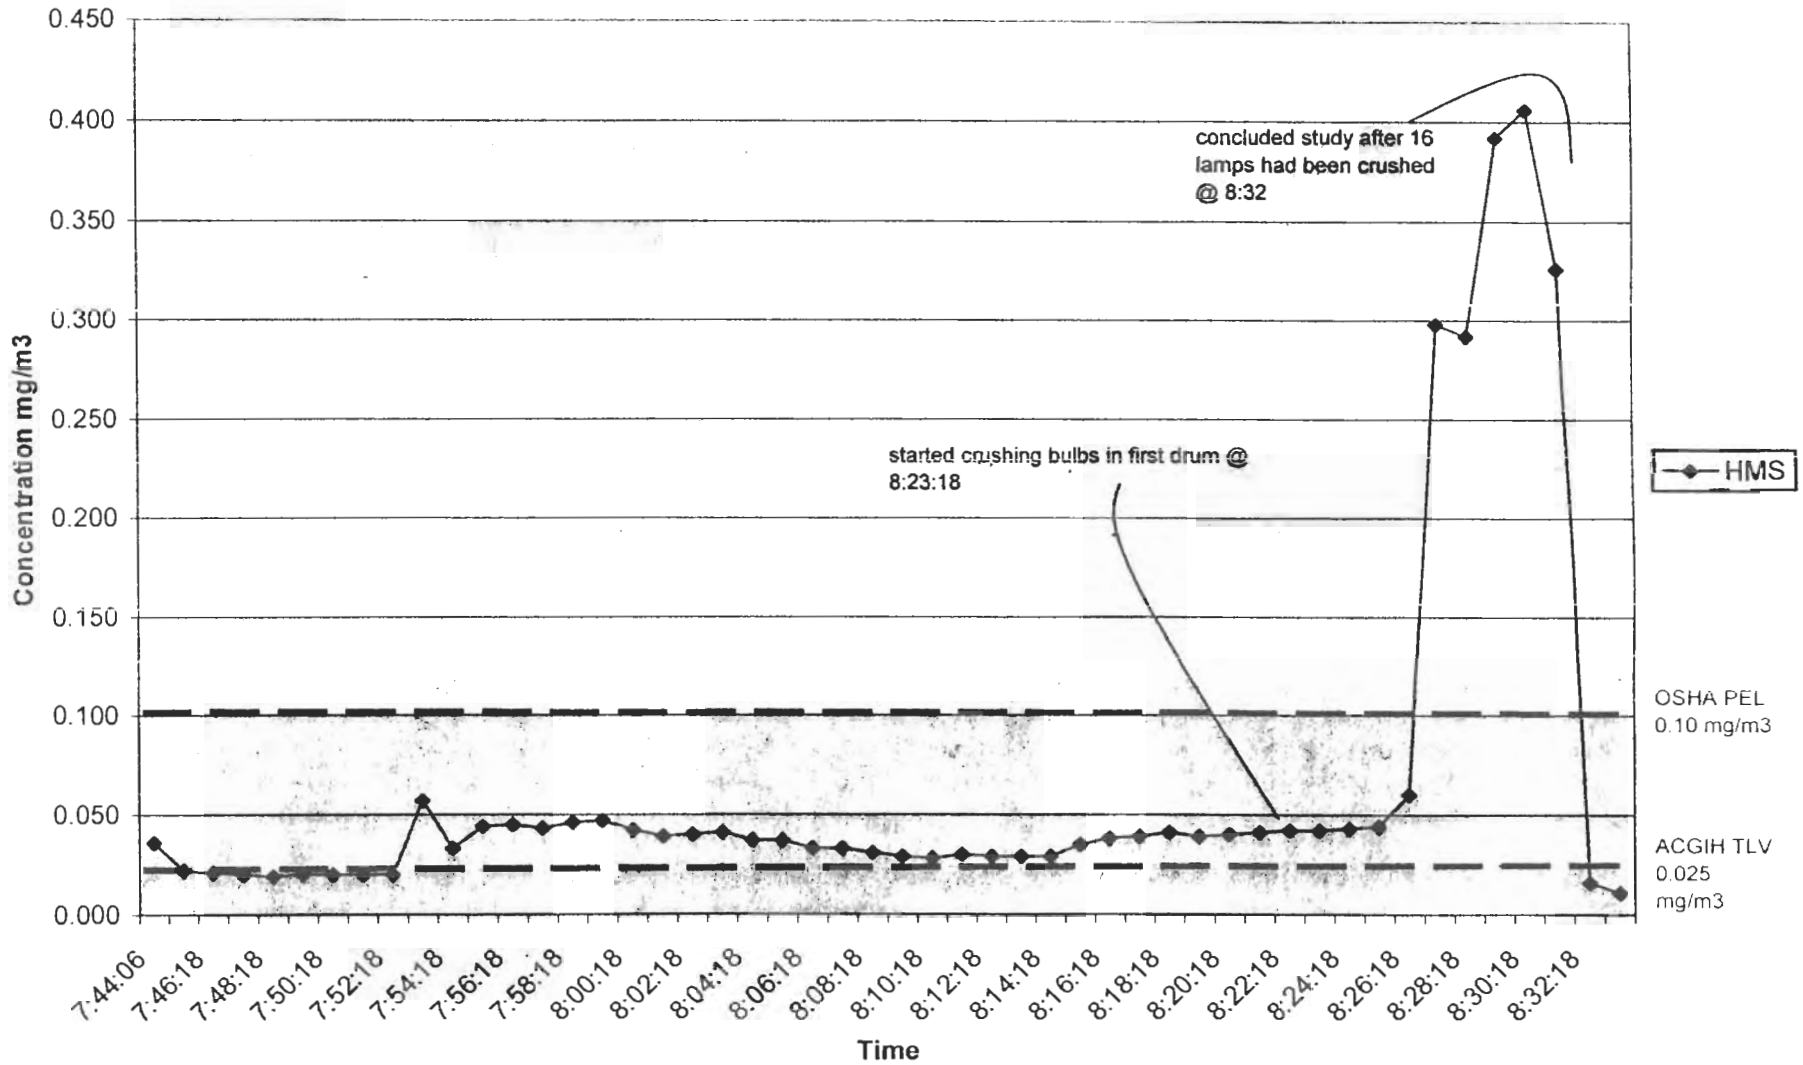
Phoenix, AZ EPSI Facility Jerome Hg Vapor Analyzer Direct Reading Air Results March 2003

To meet testing protocols established for this study each DTC device vendor was required to provide one machine that would be used throughout the entire test. Changing the design of the machine not only violated the testing protocol, which would make HMS ineligible to continue participation in the study, but also eliminated an opportunity to verify that repairs to the machine originally tested in Ashland, Virginia had corrected the mercury vapor release problem. Since the unit was damaged when received in Phoenix, EPA could not perform the complete "Real World" testing of the unit. However, EPA decided to take some Jerome readings and air samples of the HMS device with the cracked filter assembly. With this type of damage mercury levels

exceeded the OSHA PEL after processing only 16 lamps (see attached "Phoenix, AZ EPSI Facility Jerome Hg Vapor Analyzer Direct Reading Air Results March 2003" graph and "Phoenix, AZ EPSI Facility Analytical Air Results March 2003" graph.)
