Navajo Abandoned Uranium Mine

Site Screen Report

Mine Name: **C-3**
Mine ID: **516**

April 2012

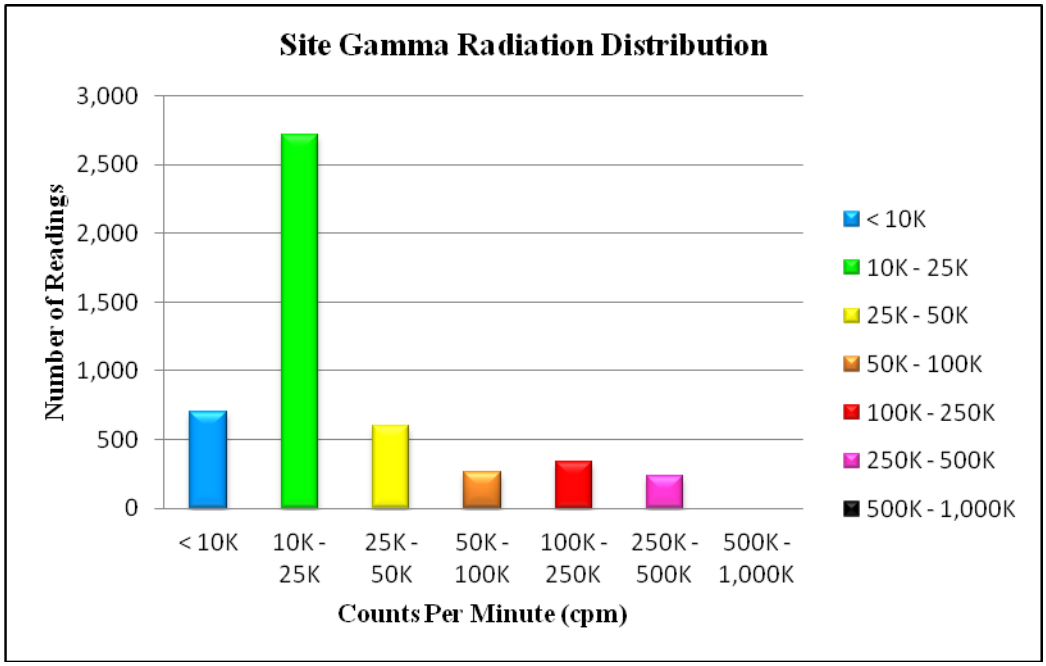
Distribution Chart and Statistics:

A total of 4,878 gamma radiation measurements were collected from the mine site, ranging from 4,575 cpm to 494,991 cpm. Maximum levels of approximately 500,000 cpm were found in the vicinity of the waste rock. The measurements are represented in Figures 1 and 2.

Site Gamma Radiation Statistics	
Number of Readings	4,878
Minimum (cpm)	4,575
Maximum (cpm)	494,991
Mean (cpm)	43,217
Median (cpm)	14,377
Standard Deviation	71,608

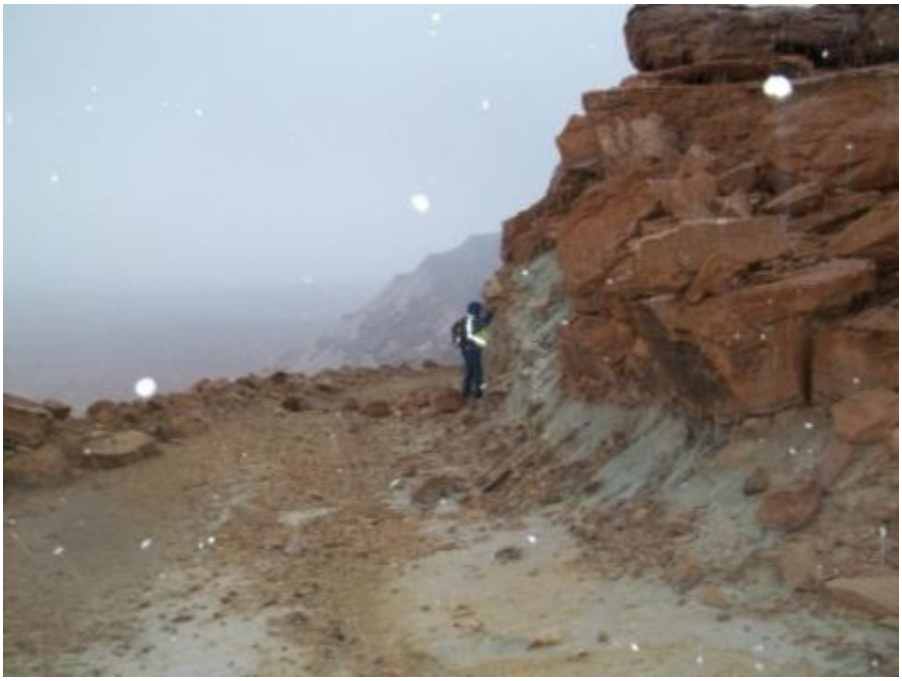
Photo 7	Mine Site #516 - Berm

Other Debris and Mine Features:
Erosional berm above the site
