WHEN LOW TECHNOLOGY IS THE ANSWER: RESPONSE TO A REMOTE OIL SEEP:

Robert M. Mandel

Federal On-Scene Coordinator
United States Environmental Protection Agency
75 Hawthorne St.
San Francisco, CA 94105 USA

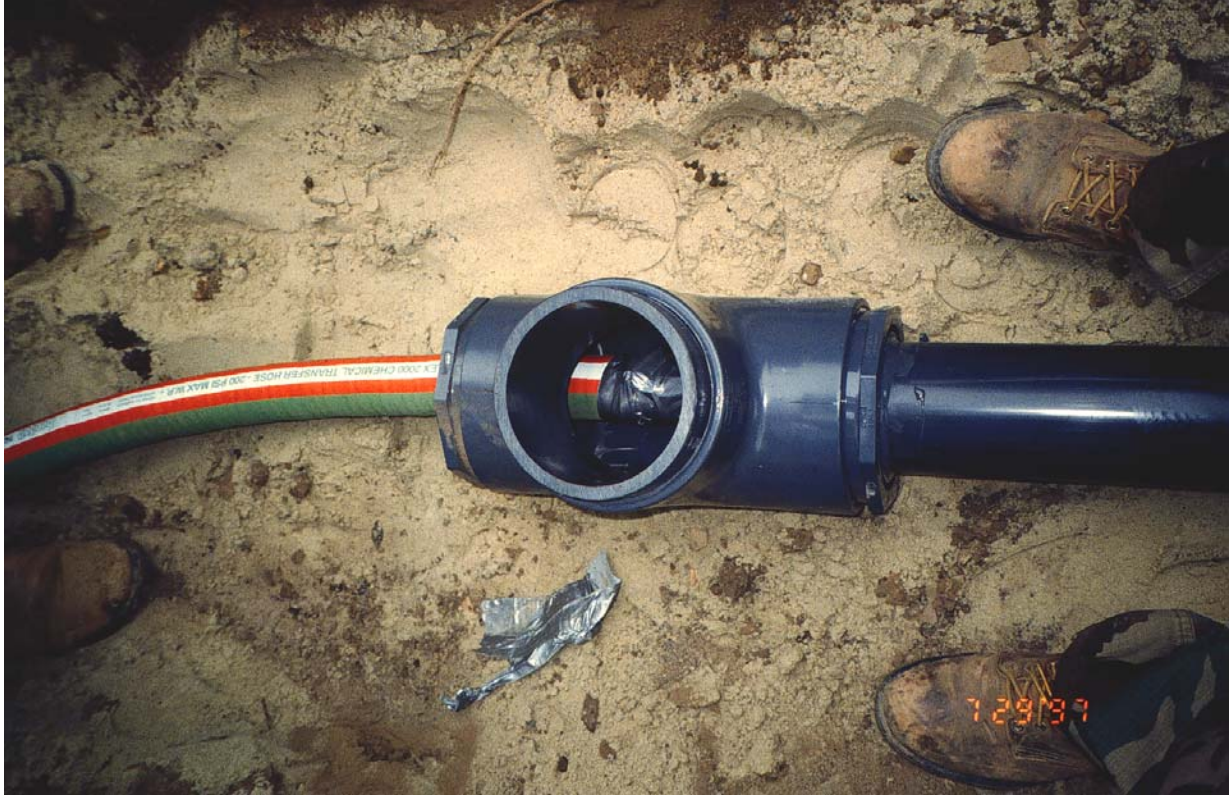
three separation chambers in a concrete industrial water clarifier. This clarifier was readily available because industrial wastewater dischargers in the area commonly used it. The clarifier was transported up the dirt road in a sling suspended from an excavator and installed mostly below-grade. Figure 2 shows the OWS clarifier being positioned. Oil was separated by gravity in the primary and secondary chambers prior to flowing into a chemically resistant two-inch (5.1 cm) hose. This hose was encased within a 4-inch (10.2 cm) schedule 80 polyvinyl chloride (PVC) pipe. Figure 3 shows the hose inside the PVC pipe. This arrangement provided secondary containment in case the chemical hose ruptured. This pipeline was buried 24 inches (61 cm) deep under the dirt access road. Figure 4 shows the pipeline trench. The pipeline ran 900 feet (275 meters) downhill to a buried underground storage tank (UST). The vertical drop for this run of pipe was just over 300 feet (91.5 meters), almost a 30% gradient. This tank, a 6,000-gallon (26,400 liters) capacity conventional double-walled fiberglass tank, provides secondary containment and is typical of those being installed currently at gasoline stations in the US. Buried to provide security both from vandals and the threat of wild fire, the UST uses conventional pipe fittings. Figure 5 shows the UST being installed. The void between the walls provides the ability to detect leaks and collect oil should the inner tank leak.

- Fig 1: A heavily oiled portion of upper Toro Creek during July 1997.
- Fig 2: Workers set the 3-chambered OWS clarifier in position.
- Fig 3: The chemical hose holding the oil is enclosed within the PVC pipe to provide secondary containment.

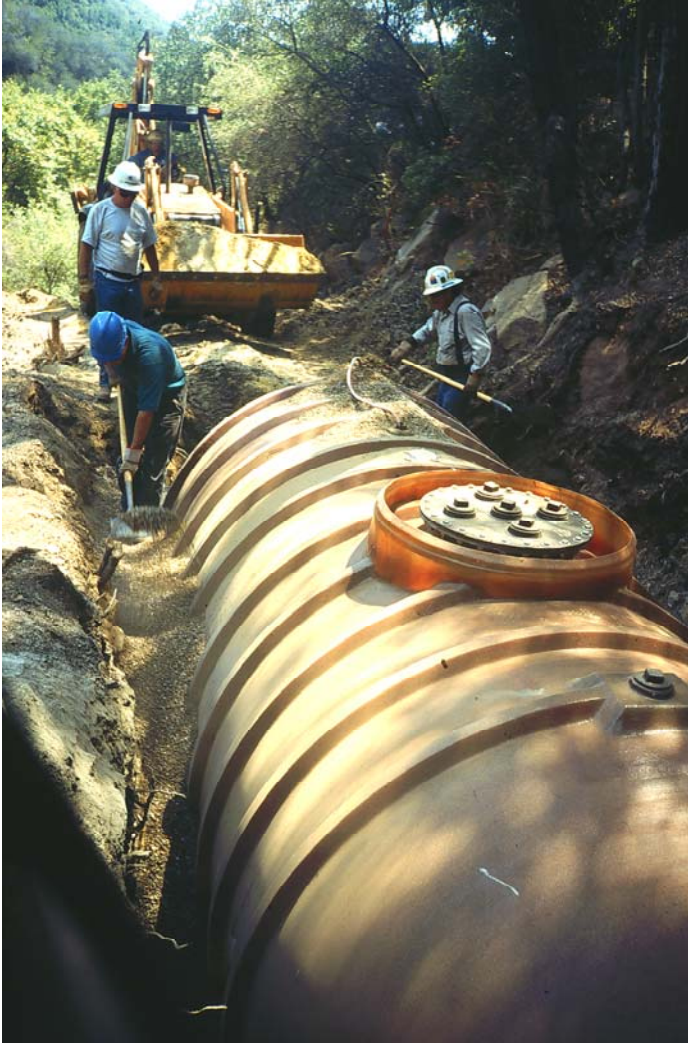
Figure 4

- Fig 4: Pipeline trench containing the secondary containment hose and electrical wiring for the high level alarm.
- Fig 5: The UST is installed.
- Fig 6: Here is the thick oil layer that accumulates in the primary separation chamber.

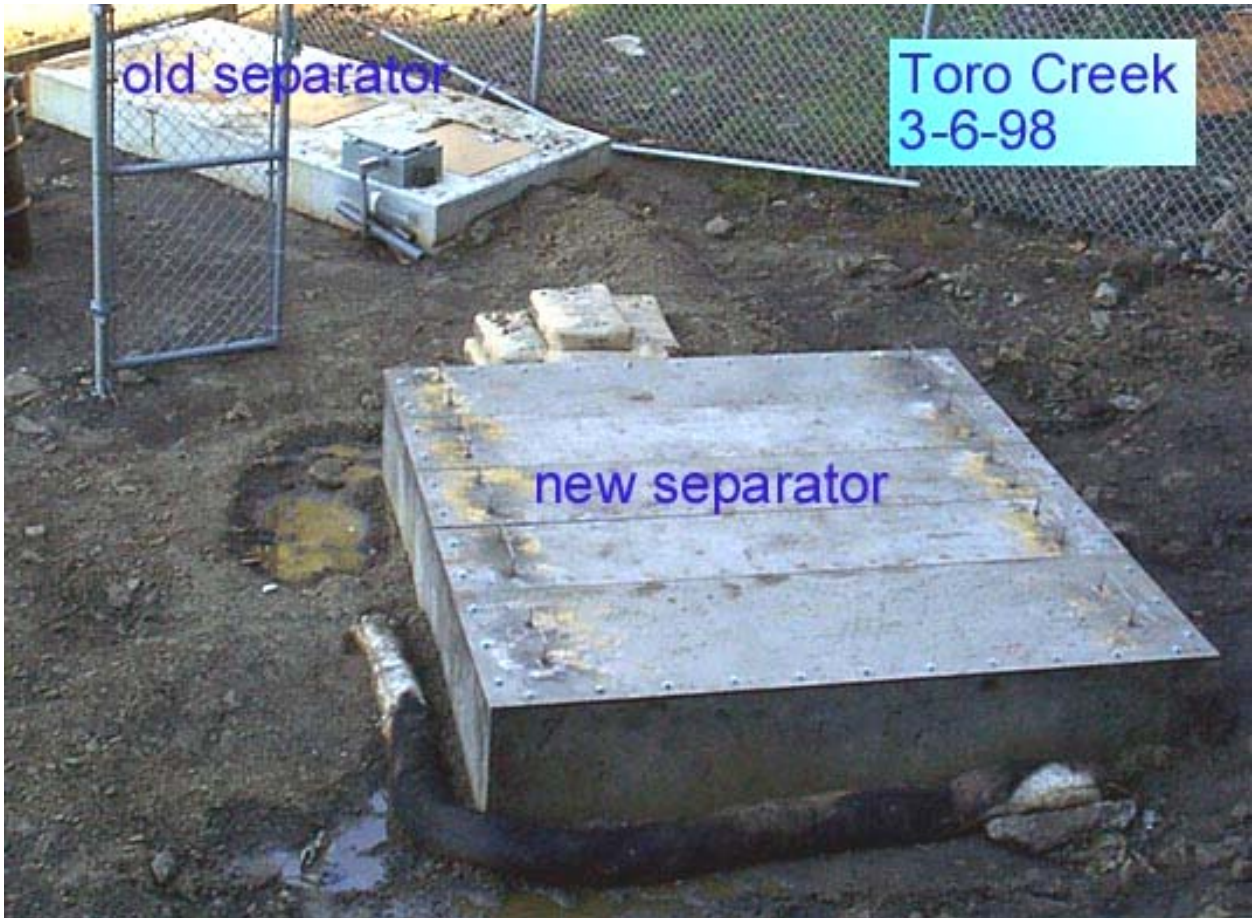
Figure 12

- Fig 12: New primary clarifier in place directly over the seep.
- Fig 13: Current OWS system configuration.
- Fig 14: Diagram of final as-built for the OWS system at Toro Creek.

The exposed portions of the pipeline were re-buried and a large dirt and rock berm constructed to direct high surface water flows and debris flows away from sensitive areas. Figure 11 shows the serious erosion around the buried secondary containment pipeline resulting from the El Nino storms. Figures 12 and 13 show the new OWS being placed and the final configuration of the OWS system. Figure 14 shows a schematic of the OWS system as built at Toro Creek.
