**2006 ANNUAL RESTORATION MONITORING REPORT  
1 ½ MILE REMOVAL REACH  
GENERAL ELECTRIC (GE)/HOUSATONIC RIVER SITE,**

**Environmental Remediation Contract  
GE/Housatonic River Project  
Pittsfield, Massachusetts**

**DCN: GE-021207-ADME**

**February 2007**

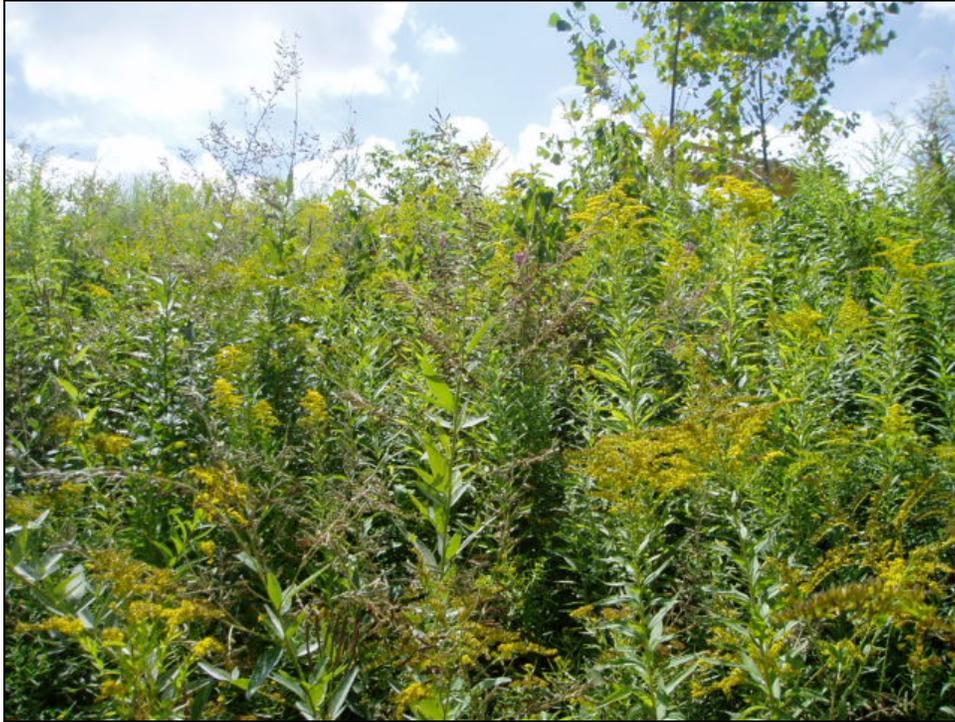
Herbaceous cover was at or above 95% and therefore achieved the performance standard, in all but one of the monitoring plots (Table 2). Herbaceous growth was particularly robust in the Lyman Street to Elm Street monitoring area, exceeding 6 feet in height (Photo 1) in some of this area. Monitoring plot 3-W-2 exhibited 90 percent herbaceous cover. Bare ground in this plot appeared to be the result of mowing and weed removal in close proximity to the ground surface by the property owner (Photo 2). Monitoring plot 2-W-1 exhibited 95 percent herbaceous plant cover, but some bare ground was observed. This appeared to be a result of hedge bindweed (*Calystegia sepium*) removal activities. Hedge bindweed had previously

**Photo 1. Dense Herbaceous Growth in Lyman Street to Elm Street Monitoring Area.**

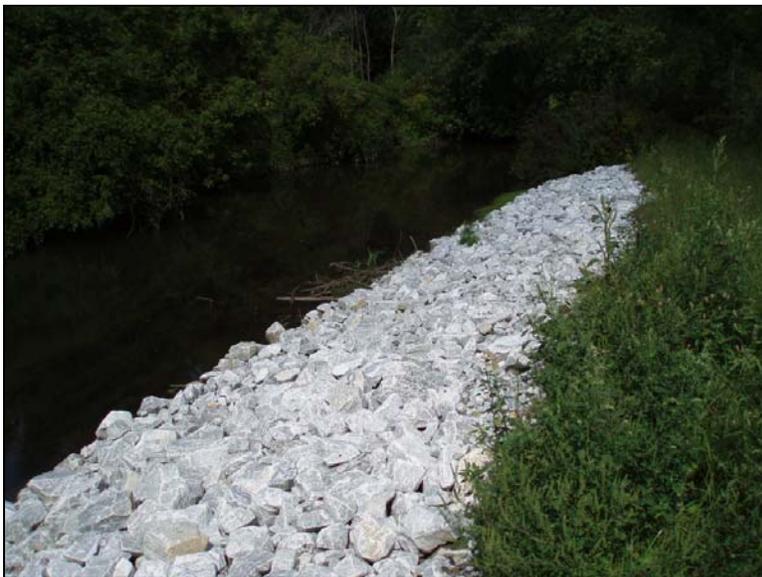
**Photo 12: Monitoring Area 4, View Upstream of Riprap Installed on East Bank of the West Branch of the Housatonic River Immediately Upstream of the Confluence**
