Second Five-Year Review Report Vandale Junkyard Superfund Site Washington County, Ohio

February 2009

United States Environmental Protection Agency
Region 5
Chicago, Illinois

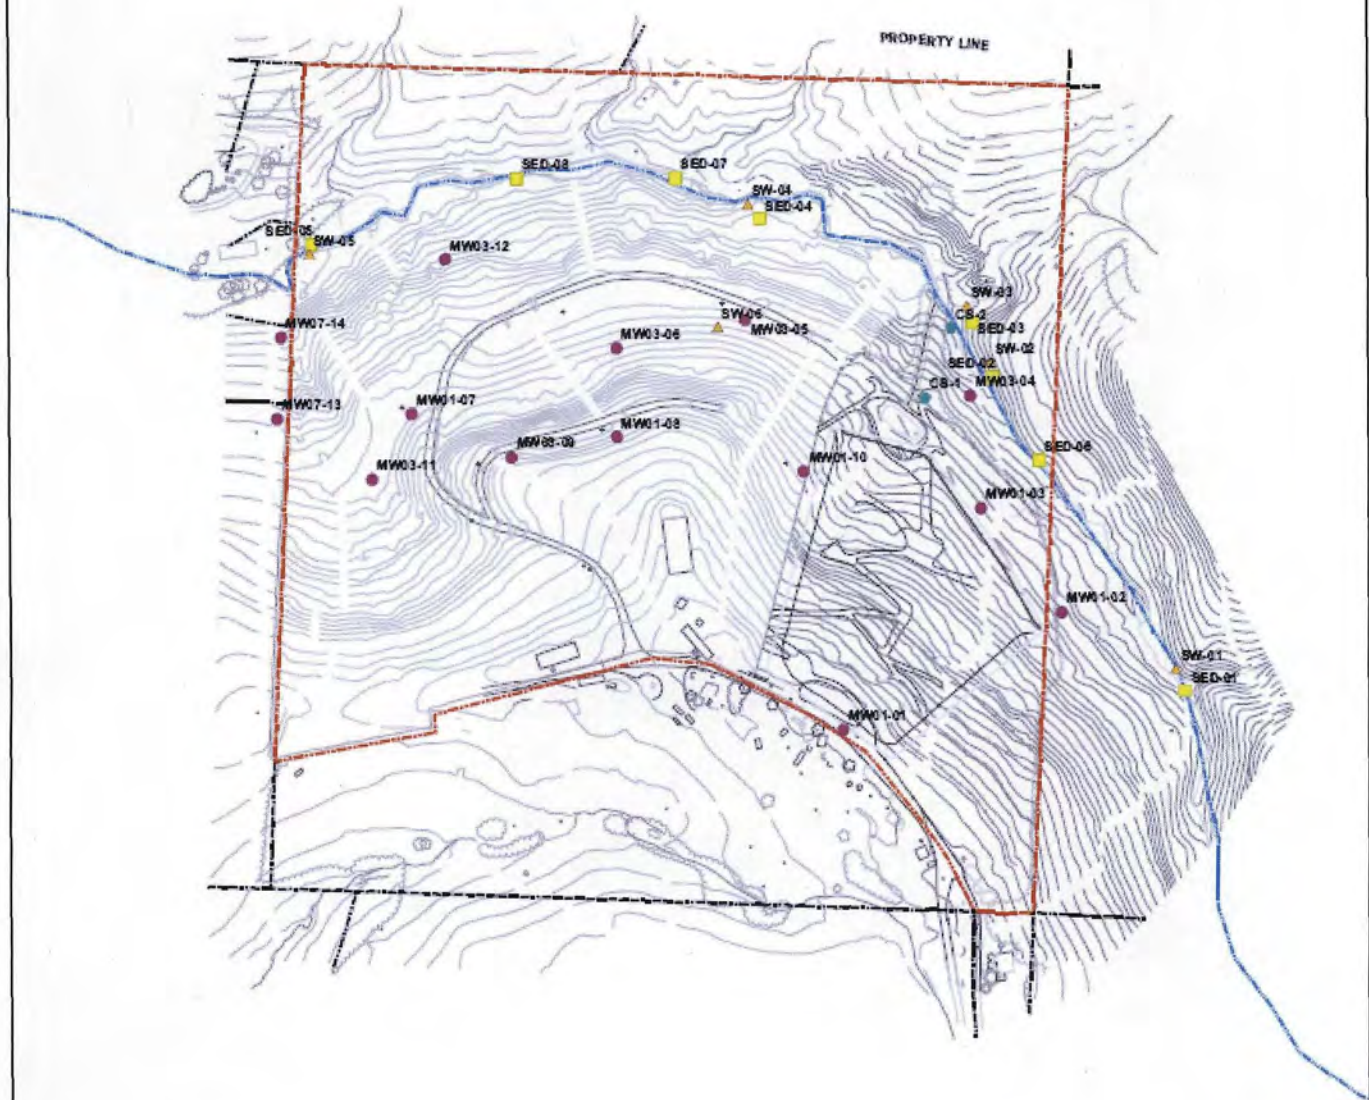
DATE: 06/05/2008	SCALE: 1"=300 FEET
PROJECT NO: GR111-200	FIGURE NO: 2
DOCUMENT NO: GA080396	FILE NO: Figure2_2ndQuarter2008.mxd

Elevated levels of the chlorinated VOCs have been detected consistently at wells MW01-07, MW01-08, MW03-09, MW01-10 and MW03-11. See Figure 2 for well locations. Since construction completion in 2000, 4 of the 13 contaminants for which groundwater cleanup levels have been established (arsenic, beryllium, cadmium, nickel) have remained below their respective cleanup levels in all sampling events. There was only a single exceedance for vanadium (although many of the recent detection limits for vanadium have exceeded the cleanup level). Since the previous Five-Year Review, 1,1,1-trichloroethane (1,1,1-TCA) has also remained below its cleanup level in all sampling events.
