**Subpart A Inspection Report
in Response to the February 14, 2014 WIPP Incident**

April 7 - 29, 2014

**U. S. ENVIRONMENTAL PROTECTION AGENCY
Office of Radiation and Indoor Air
Center for Waste Management and Federal Regulation
1200 Pennsylvania Avenue, NW
Washington, DC 20460**

September 2014

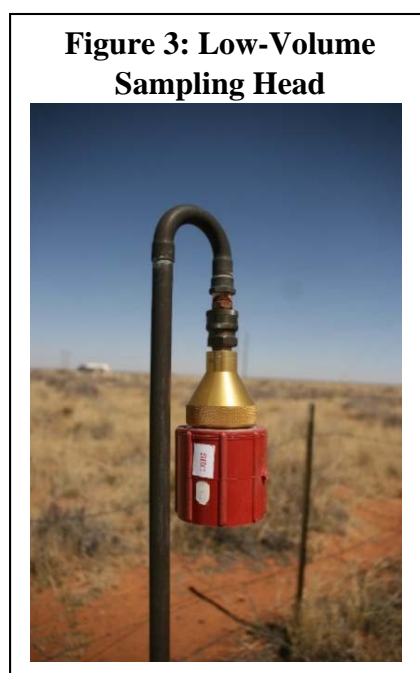
Figure 3: Low-Volume Sampling Head

All of the ambient environmental air samplers are Hi-Q Model CMP-0523CU, housed in metal “birdhouses.” Figure 2 shows these samplers as they are typically set up. The sampling heads protrude vertically from the housing and face downward, at heights that vary between 4 and 8 feet (see Figure 3). A pump inside the birdhouse draws air through the sample head, which contains a filter that captures particulate material. The ambient air samplers have an integrated analog flow meter and pressure gauges. This instrumentation is not used, and therefore does not have a formal maintenance or calibration program. Instead, when a new filter is installed, a calibrated digital flow meter is used to adjust the pump so that 2.0 cubic feet per minute (cfm) of air is drawn across the filter. When the filter is removed, the same calibrated flow meter is used to measure flow across the filter, which typically decreases slightly as material builds up on the filter. Total flow across the filter is calculated by averaging these two flow rates, and multiplying the result by the amount of time that the filter was in operation. This time is measured by a digital timer on the sampler. These digital timers are hand-verified on an annual basis, and paper tags on the unit are used to indicate the date of the last timer verification.

Many of the ambient air samplers were observed to be placed in appropriate, unobstructed areas, and the filter changes took place according to procedures. At the Carlsbad sampling location, however, inspectors observed that the samplers were placed in close proximity to an outbuilding, which could potentially restrict airflow to the sampler. Additionally, while Sampler 14889 showed 170.3 hours elapsed, its duplicate (9916) showed only 129 hours elapsed. According to DOE procedure, a sample can be accepted, with a notation, as long as at least 100 hours are shown for the weekly sample. Sampling staff expected that the discrepancy was caused either by a timer failure, or by overheating, which can cause the pump motor to shut off intermittently. A hand timer was used to verify the timer on sampler 9916. More than 8 minutes elapsed before the timer gave a reading of 0.1 hours, indicating timer failure. Sampling staff allowed the sampler to continue running, and stated that they would return to replace the timer later that day. It was not clear to EPA whether the resulting sample would be considered a duplicate. EPA staff inquired about how instrument failures and maintenance are recorded, and sampling staff stated that the both of these occurrences are noted on the sample sheets.
