### DRAFT TECHNICAL MEMORANDUM

**TO:** [REDACTED] EPA Region 8, On-Scene Coordinator  
**FROM:** [REDACTED], Superfund Technical Assessment and Response Team (START)  
**DATE:** August 12, 2015  
**SUBJECT:** Gold King Mine Investigation and Blowout Event

# PHOTOGRAPH LOG

<b>Project Name:</b> Gold King Mine	<b>Site Location:</b> Silverton, San Juan County, Colorado	<b>Project No.:</b> 0001/1408-01
--	---	-------------------------------------

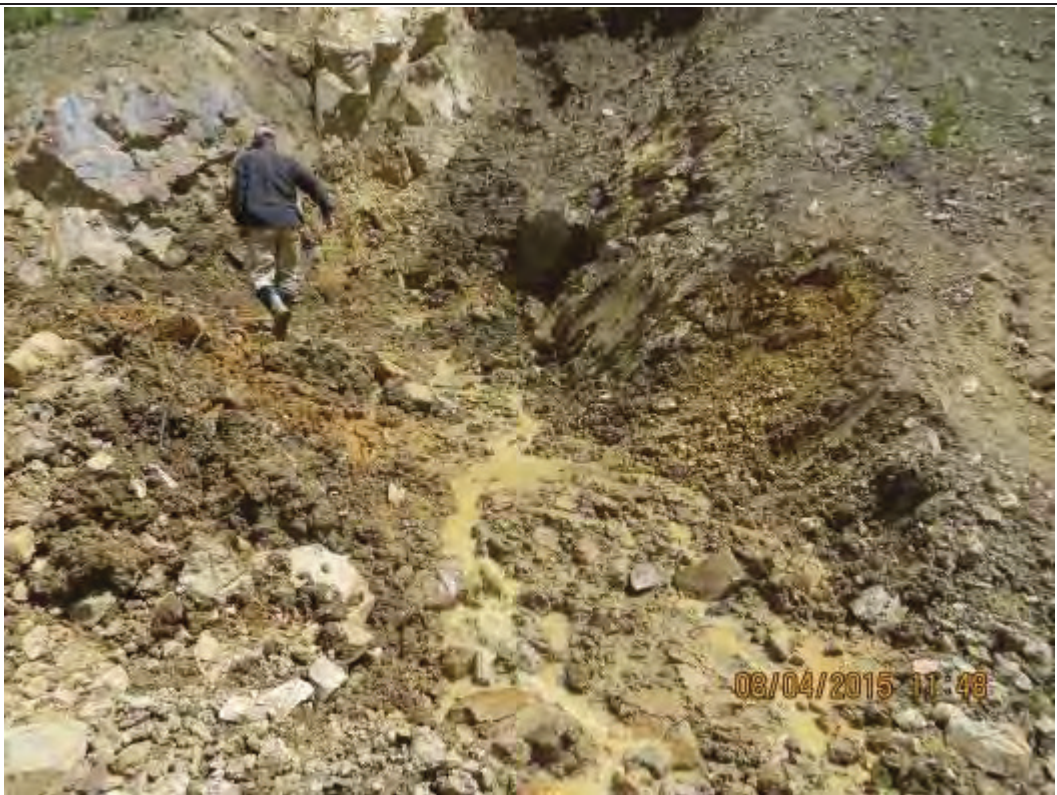
<b>Photo No.</b> <b>5</b>	<b>Date:</b> 08/04/2015
<b>Direction Photo Taken:</b>  North	
<b>Description:</b>  DRMS looking at adit excavation progress.

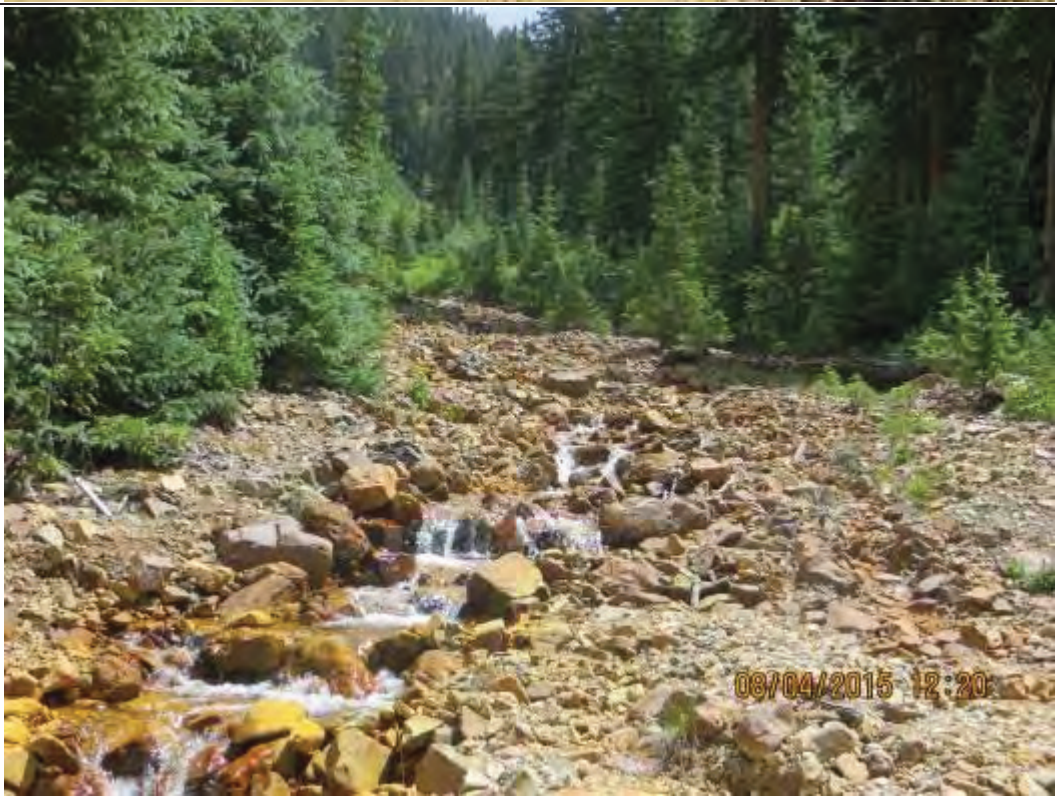
<b>Photo No.:</b> <b>10</b>	<b>Date:</b> 08/04/2015
<b>Direction Photo Taken:</b>  East	
<b>Description:</b> Water of the North Fork just upstream of Cement Creek.

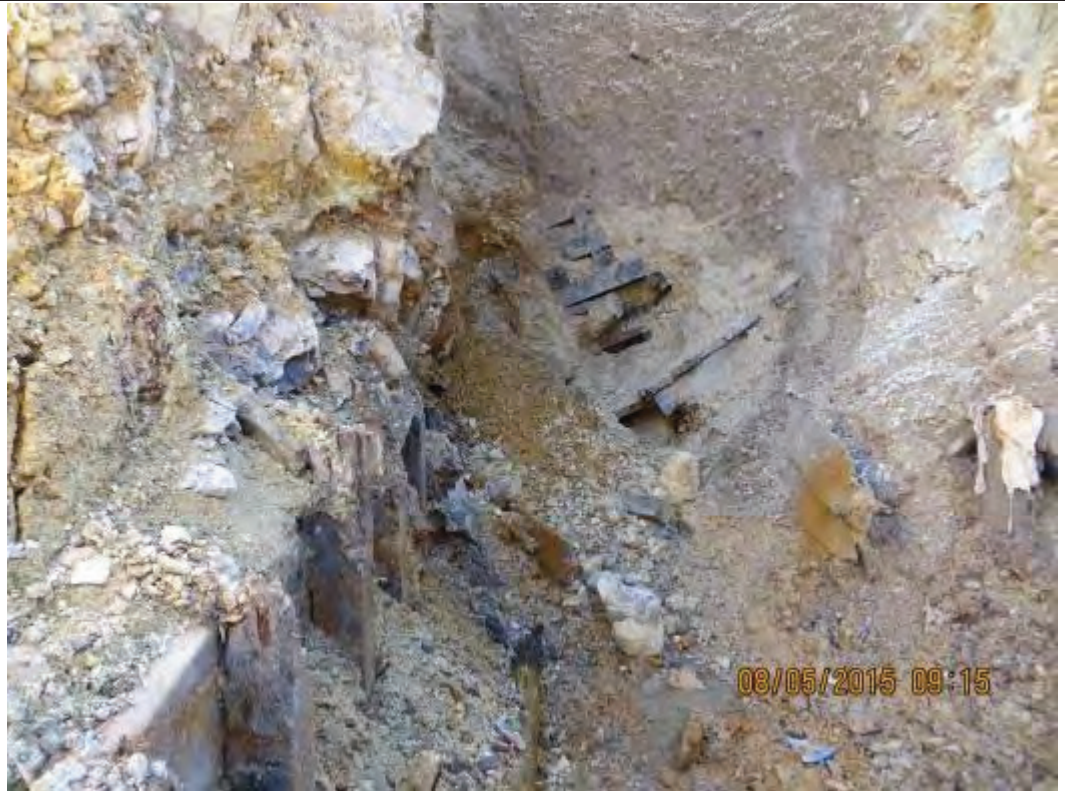
<b>Photo No.</b> <b>13</b>	<b>Date:</b> 08/05/2015
<b>Direction Photo Taken:</b>  North	
<b>Description:</b> Adit conditions the morning of 8/5.

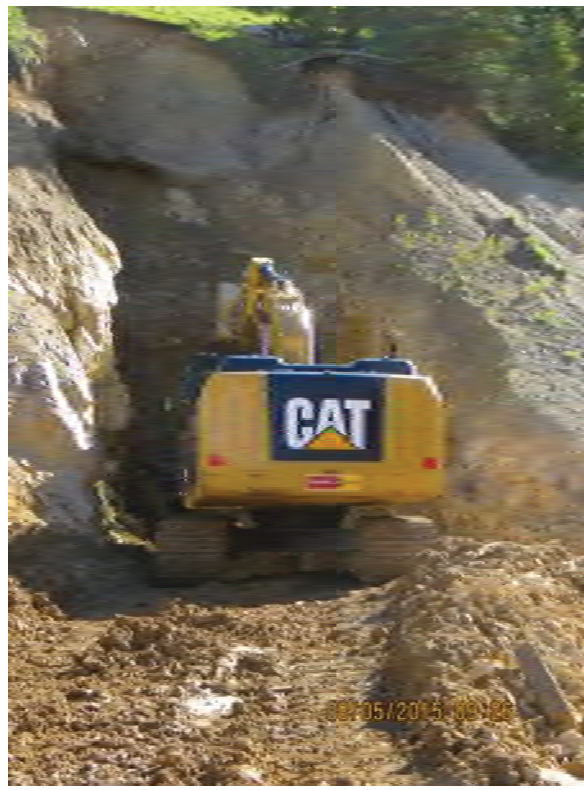
<b>Photo No.</b> <b>14</b>	<b>Date:</b> 08/05/2015
<b>Direction Photo Taken:</b>  Northeast	
<b>Description:</b> Excavating material above the collapsed adit.

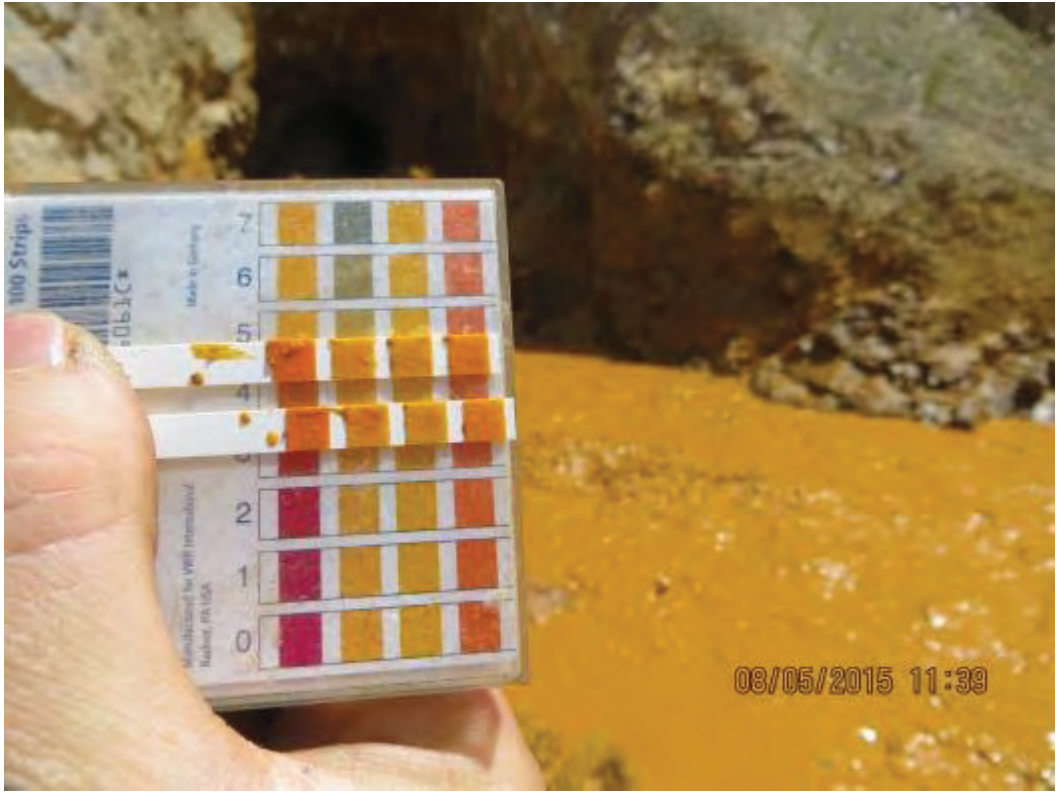
<b>Photo No.</b> <b>28</b>	<b>Date:</b> 08/05/2015
<b>Direction Photo Taken:</b>  North	
<b>Description:</b> pH of discharge water is approximately 4 to 4.5.

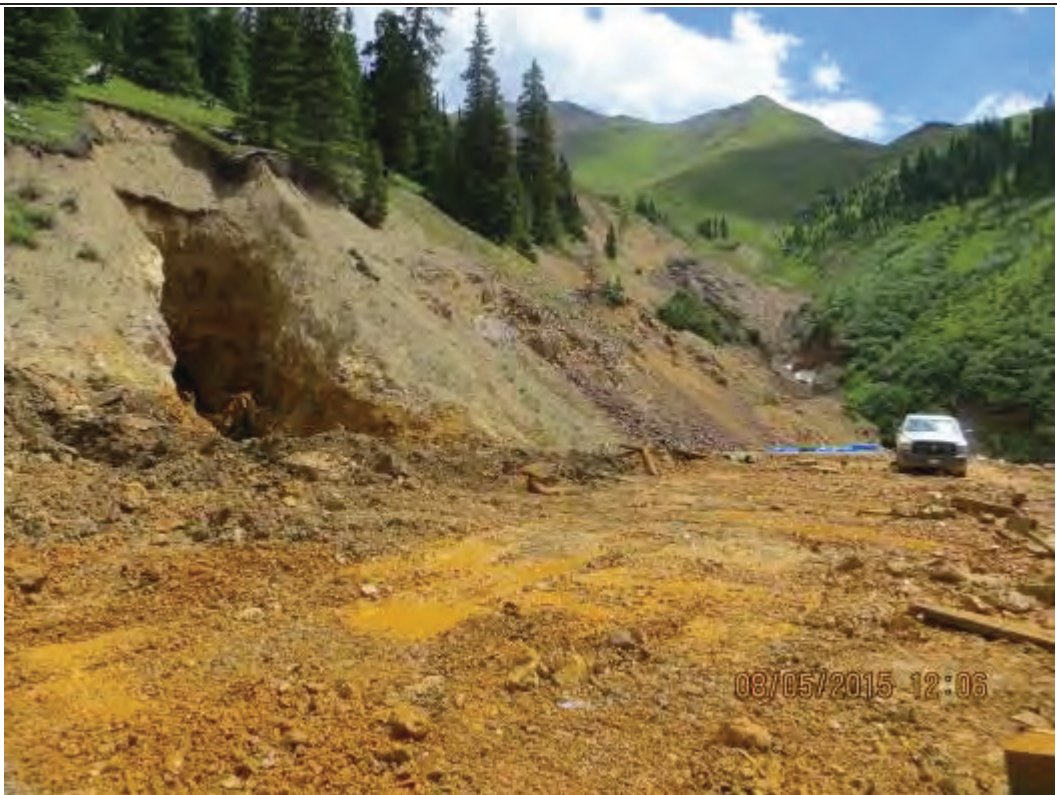
<b>Photo No.:</b> <b>31</b>	<b>Date:</b> 08/05/2015
<b>Direction Photo Taken:</b>  Northeast	
<b>Description:</b> Adit area after regrading.

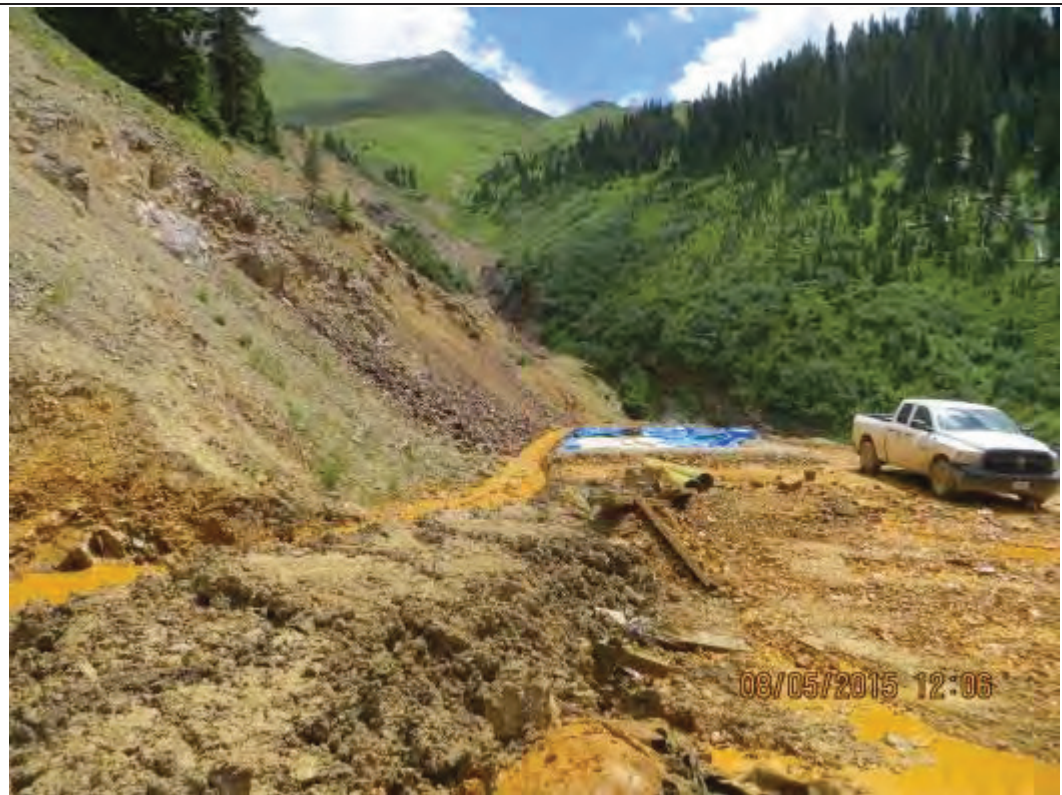
<b>Photo No.:</b> <b>33</b>	<b>Date:</b> 08/05/2015
<b>Direction Photo Taken:</b>  East	
<b>Description:</b> Redirected flow into existing half culvert channel.

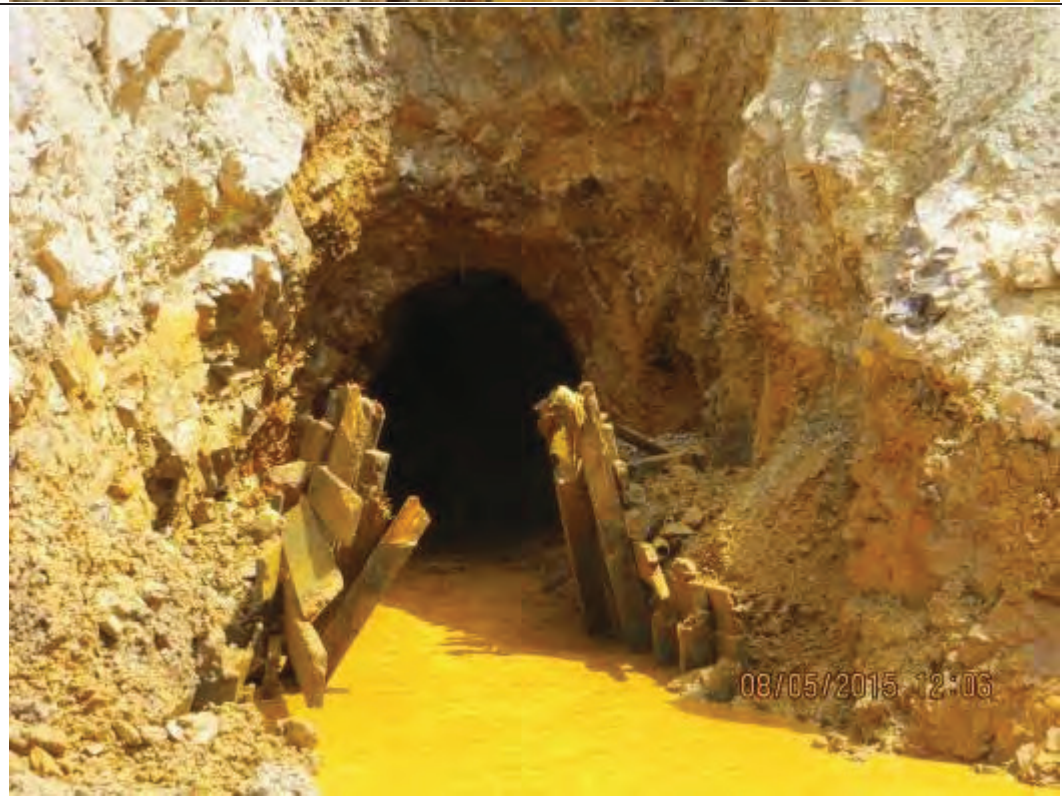
<b>Photo No.:</b> <b>34</b>	<b>Date:</b> 08/05/2015
<b>Direction Photo Taken:</b>  North	
<b>Description:</b> Closeup of adit.

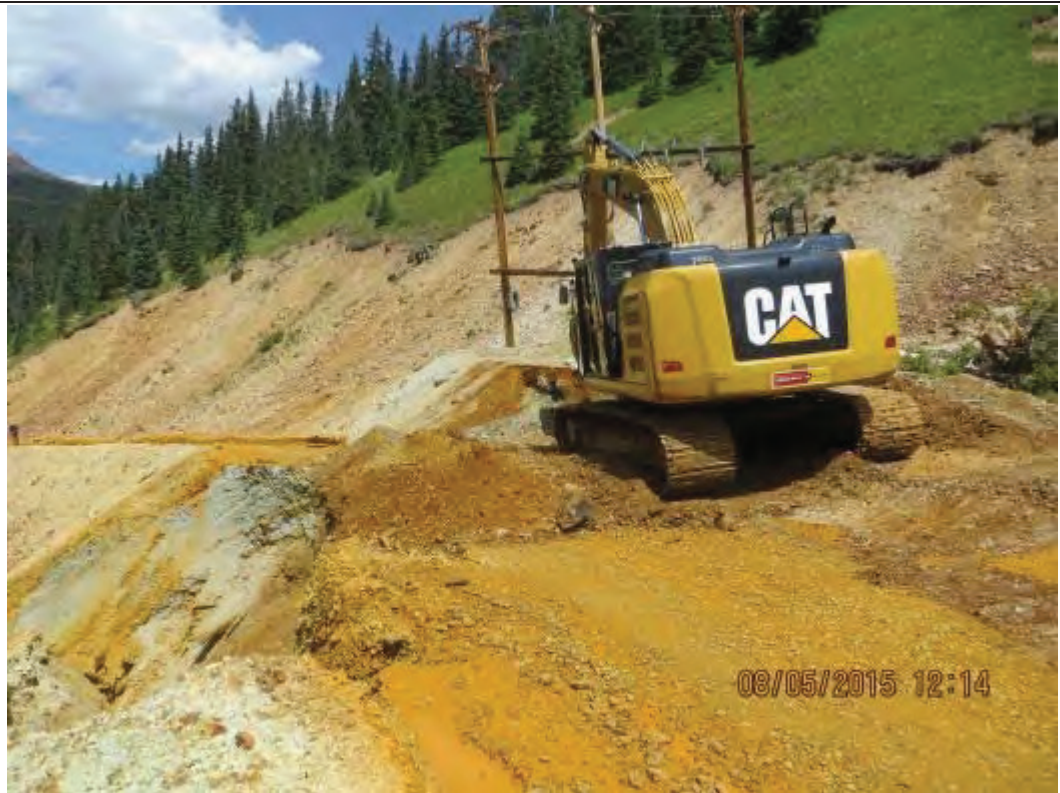
<b>Photo No.:</b> <b>35</b>	<b>Date:</b> 08/05/2015
<b>Direction Photo Taken:</b>  West	
<b>Description:</b> Excavator beginning work to secure safe exit route for equipment, vehicles, and personnel.

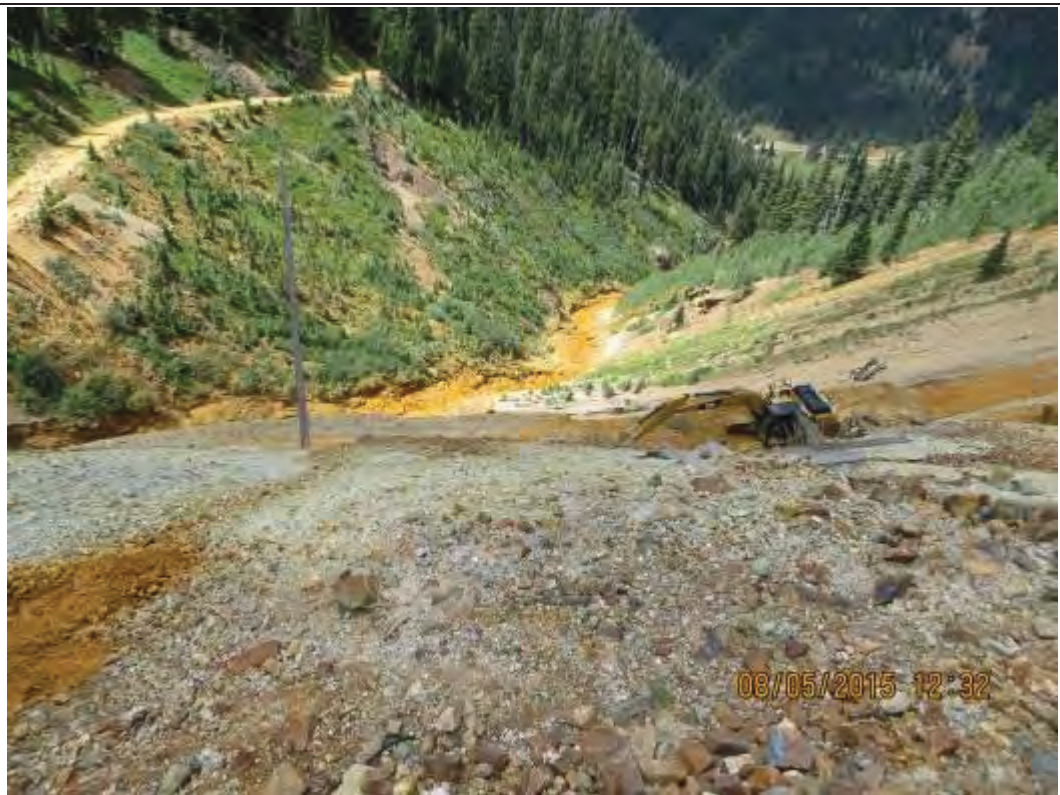
<b>Photo No.:</b> <b>37</b>	<b>Date:</b> 08/05/2015
<b>Direction Photo Taken:</b>  Southwest/Down	
<b>Description:</b> Excavator progress on fixing access road to create a safe exit route.

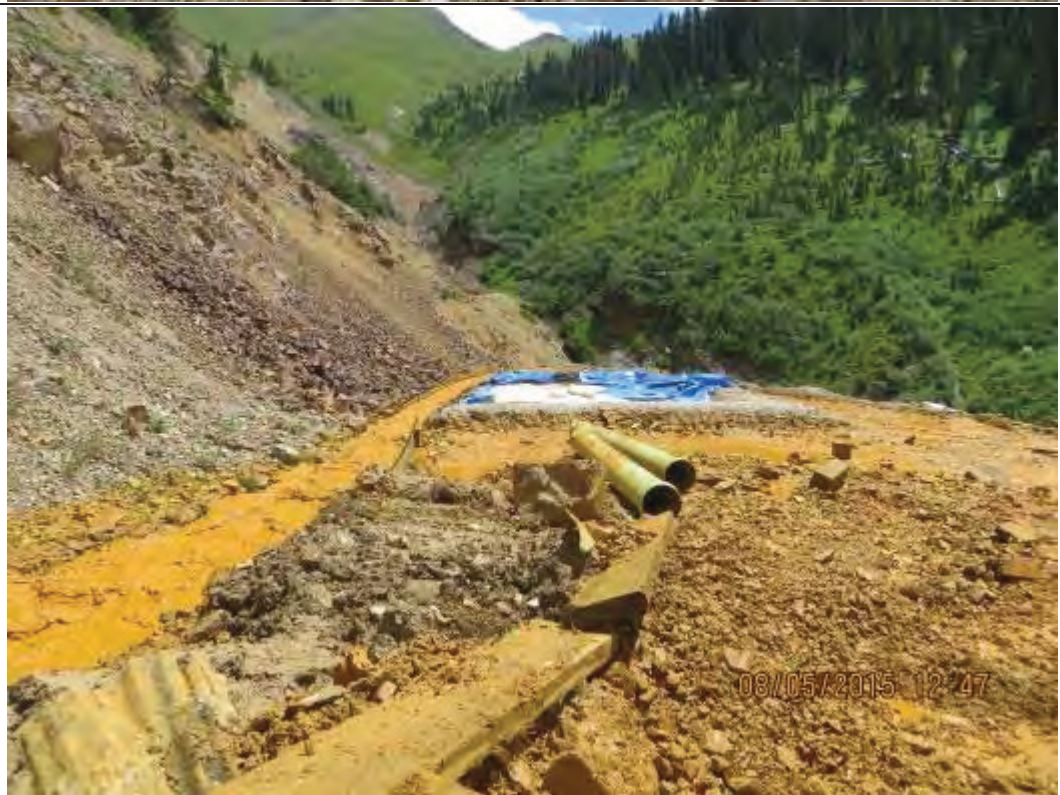
<b>Photo No.:</b> <b>38</b>	<b>Date:</b> 08/05/2015
<b>Direction Photo Taken:</b>  East	
<b>Description:</b> Existing culvert flows subsiding minimally.

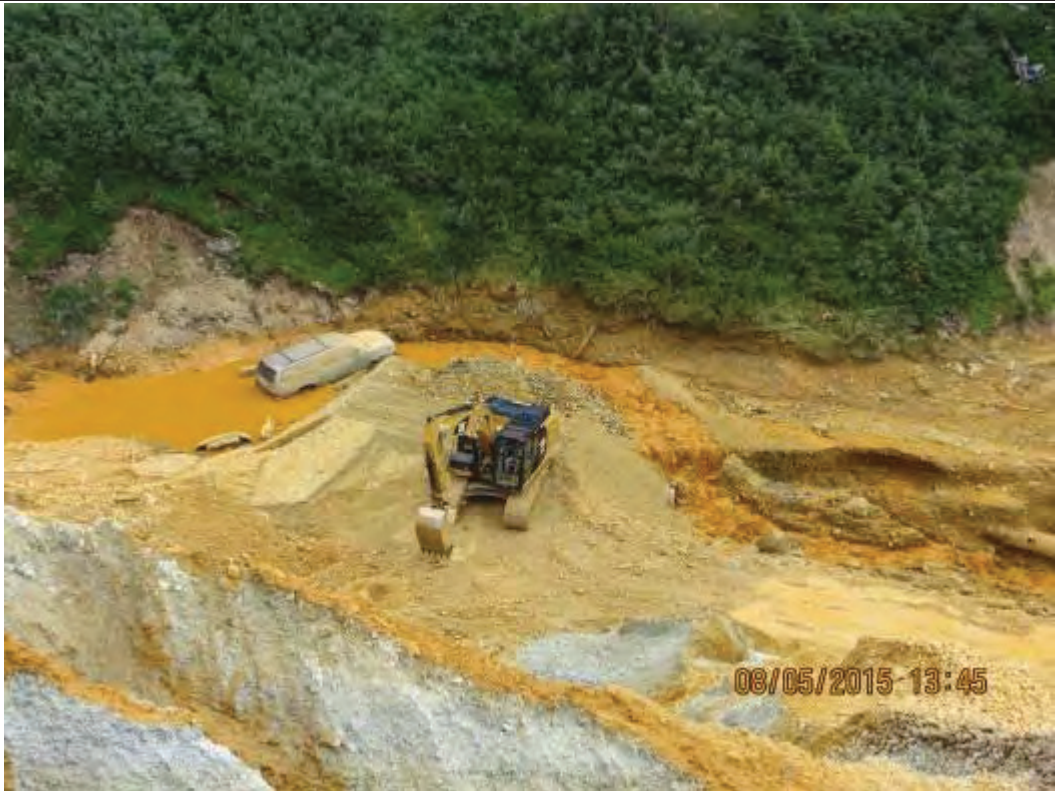
<b>Photo No.:</b> <b>43</b>	<b>Date:</b> 08/05/2015
<b>Direction Photo Taken:</b>  South/Down	
<b>Description:</b> Excavator continues to fix access road. Continued high flow is slowing progress.

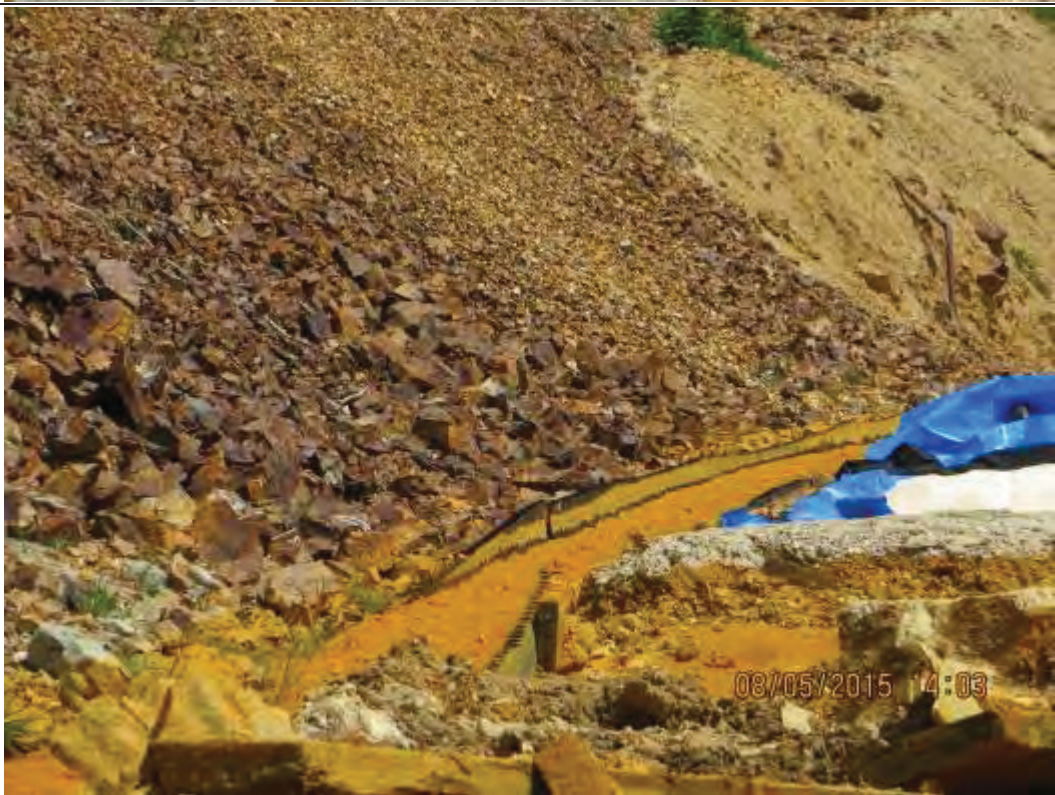
<b>Photo No.:</b> <b>44</b>	<b>Date:</b> 08/05/2015
<b>Direction Photo Taken:</b>  East	
<b>Description:</b> Half culvert flow continues to subside.

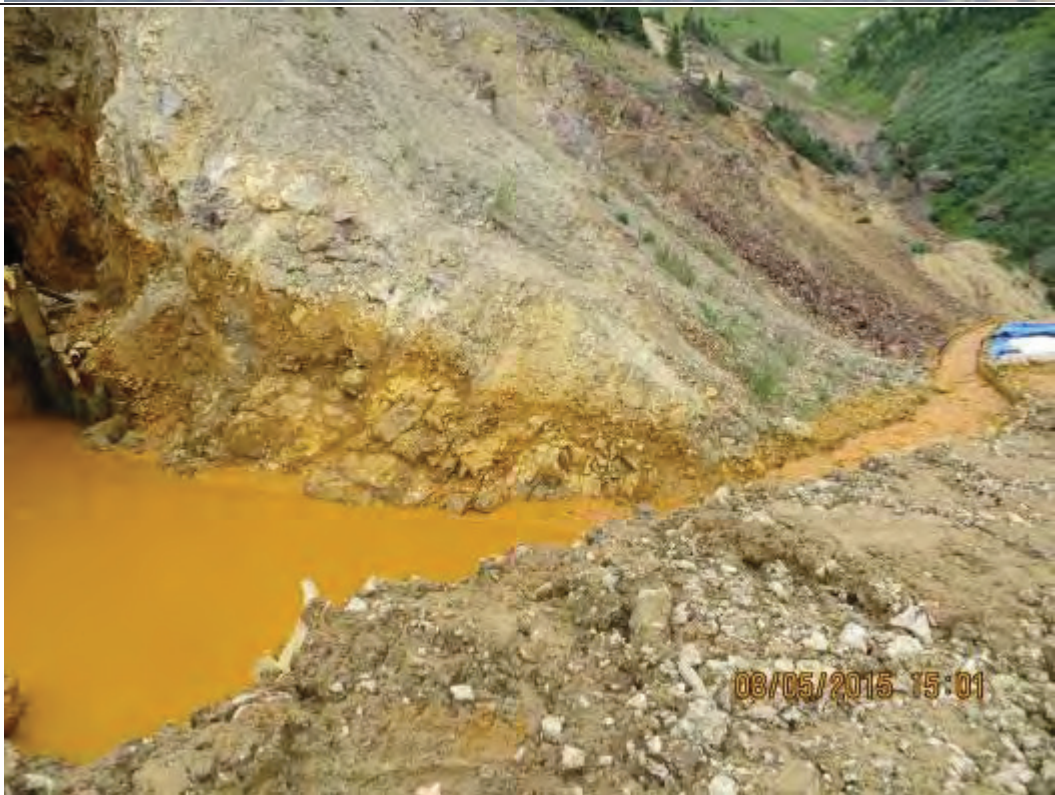
<b>Photo No.</b> <b>48</b>	<b>Date:</b> 08/05/2015
<b>Direction Photo Taken:</b>  Northeast	
<b>Description:</b> Flow path from adit, water flow appears to have stabilized around 1400.

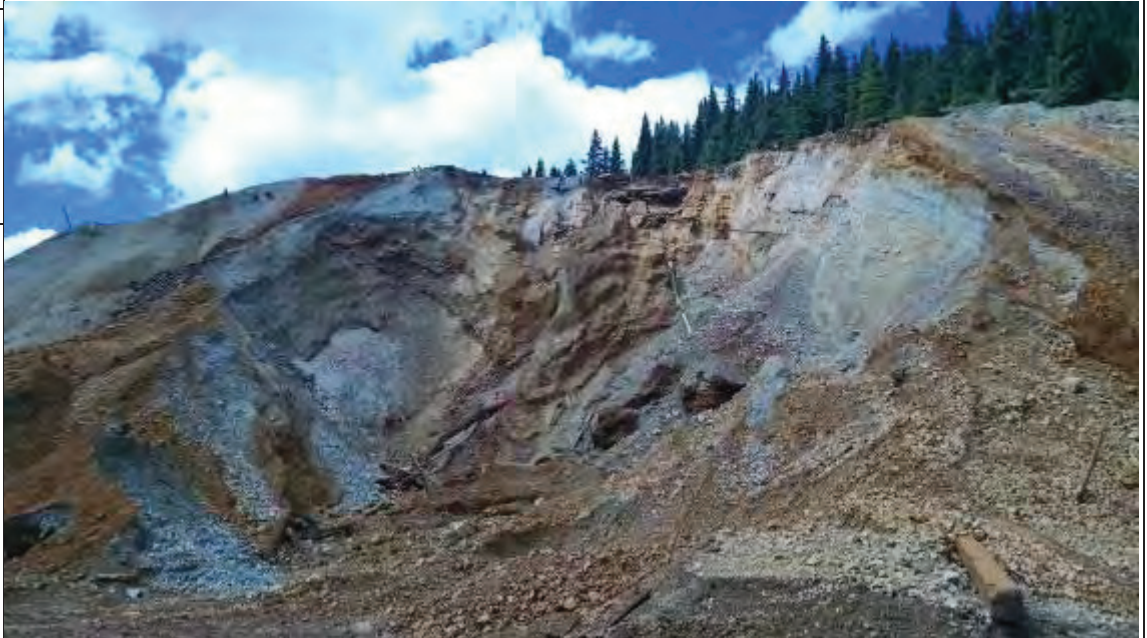
**Photo No.**  
**51**

Looking up from the toe of the Gold King waste dump directly south of the adit.

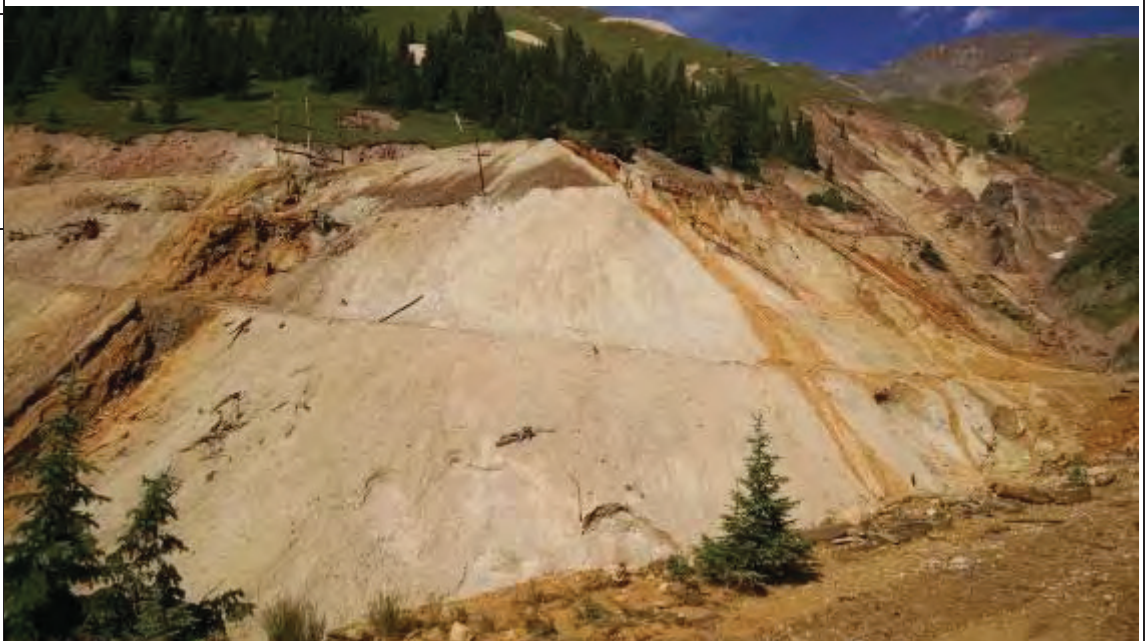
**Photo No.**  
**52**

Gold King Mine tailings dump after water discharge.

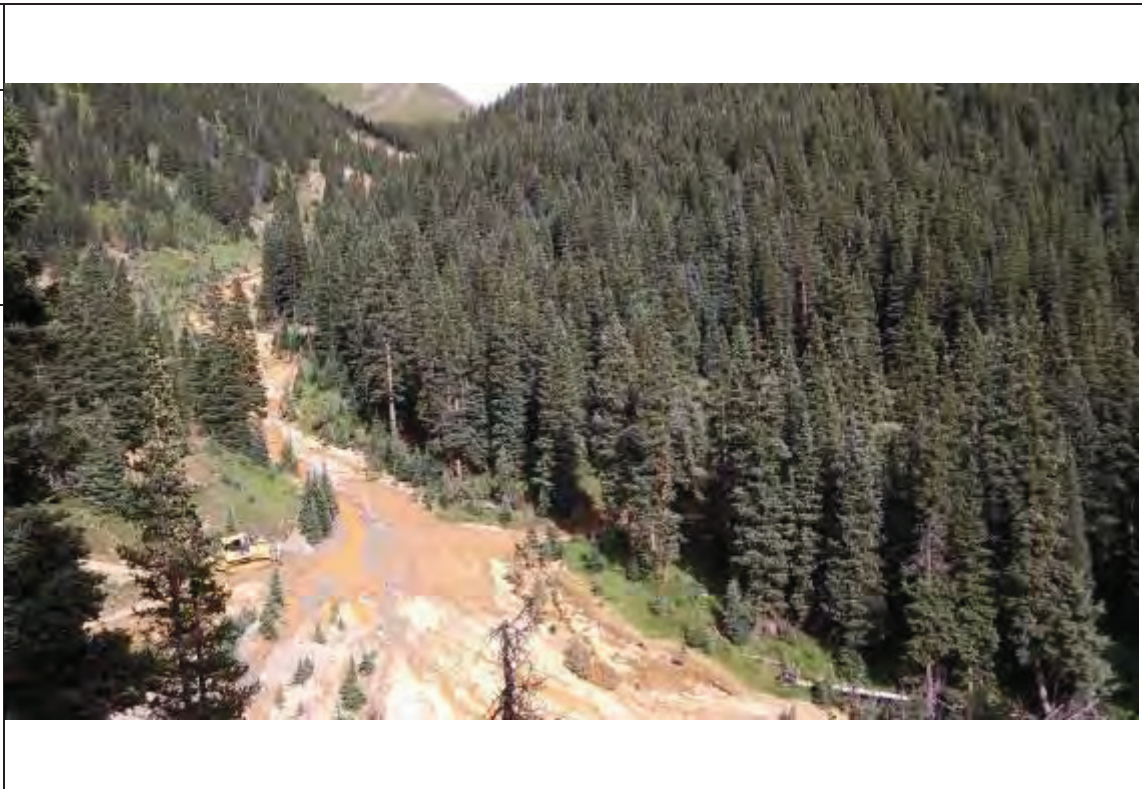
**Photo No.**  
**53**

Looking east across Cement Creek from County Road 10 to excavator fixing County Road 52 at North Fork crossing just south of Red and Bonita Mine.

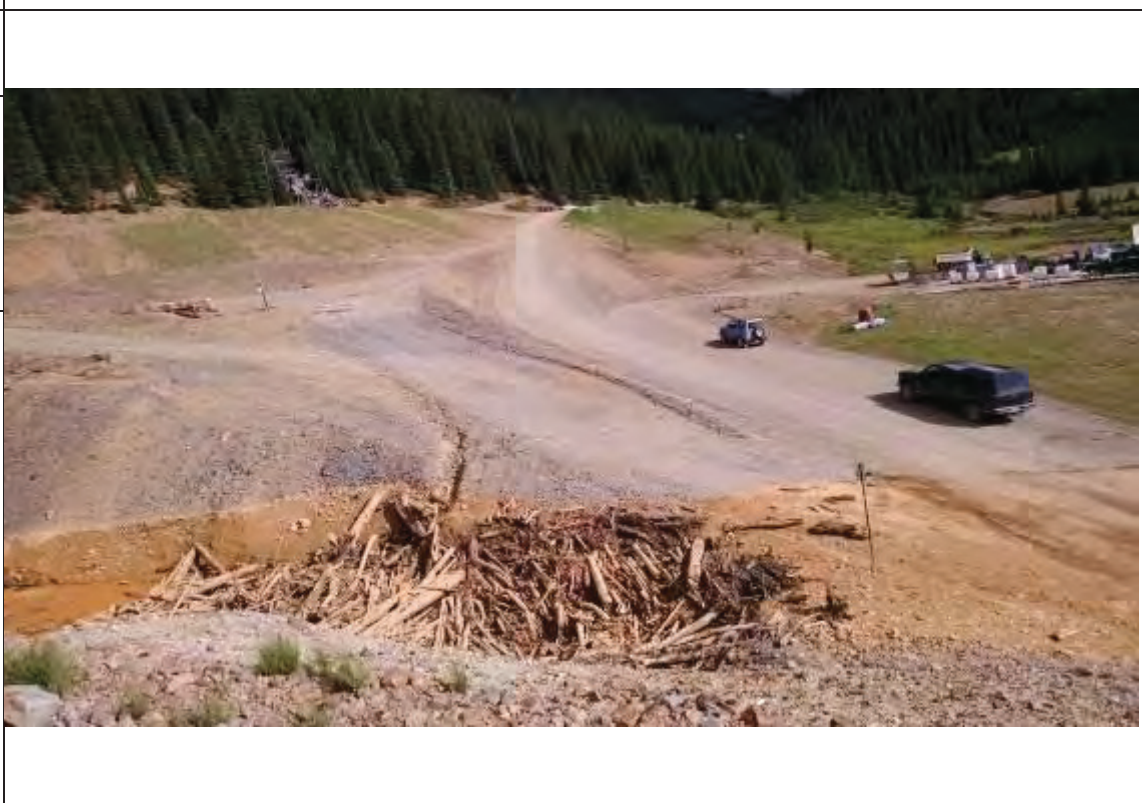
**Photo No.**  
**54**

Cement Creek crossing at Gladstone.

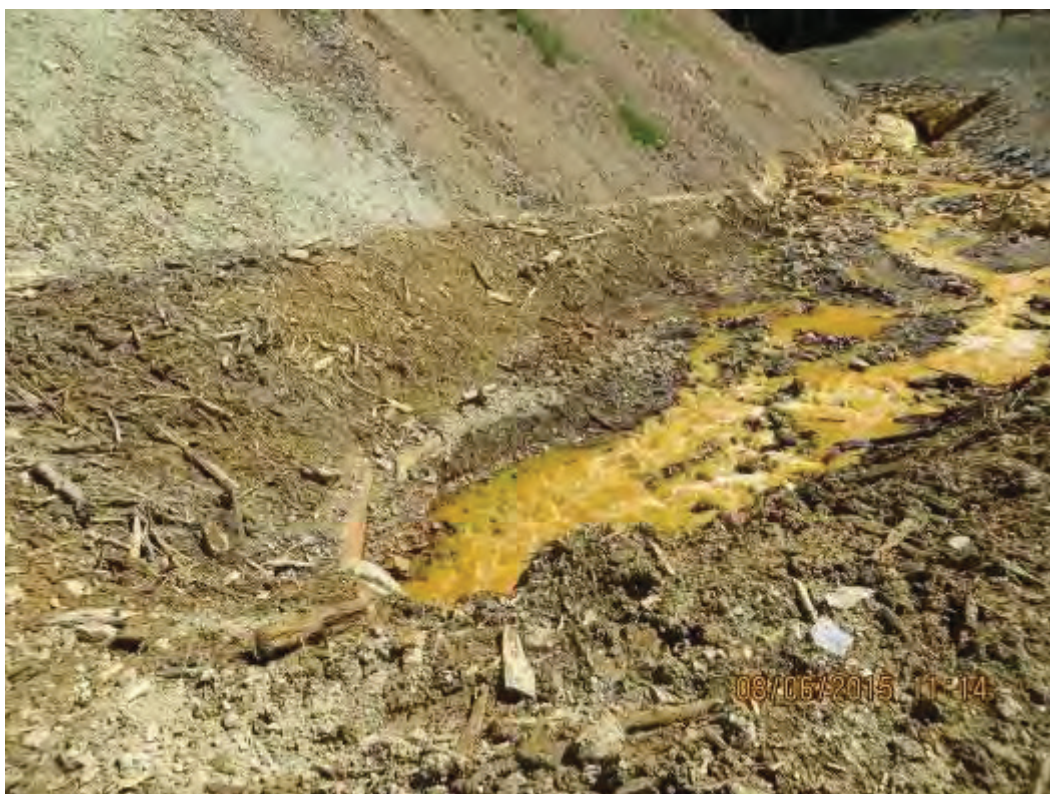
**Photo No.**  
**7**

**Description:**  
Upstream of Cement Creek culvert at Gladstone.

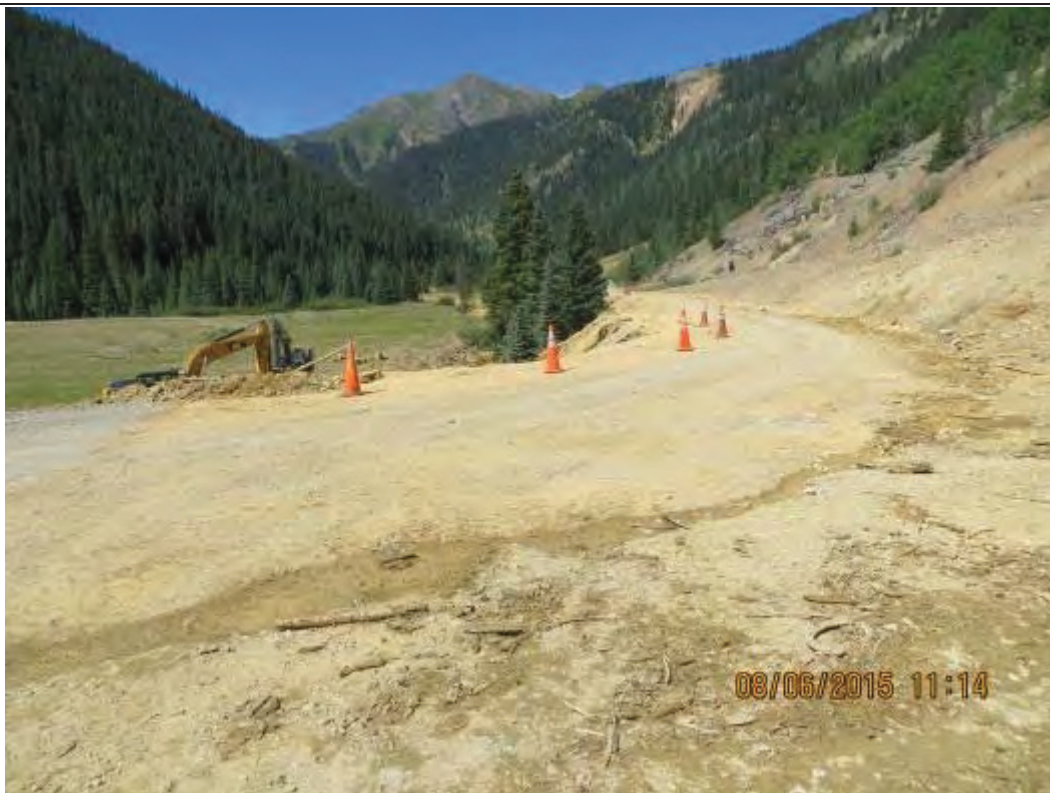
**Photo No.**  
**8**

**Description:**  
Road at Gladstone coned off.

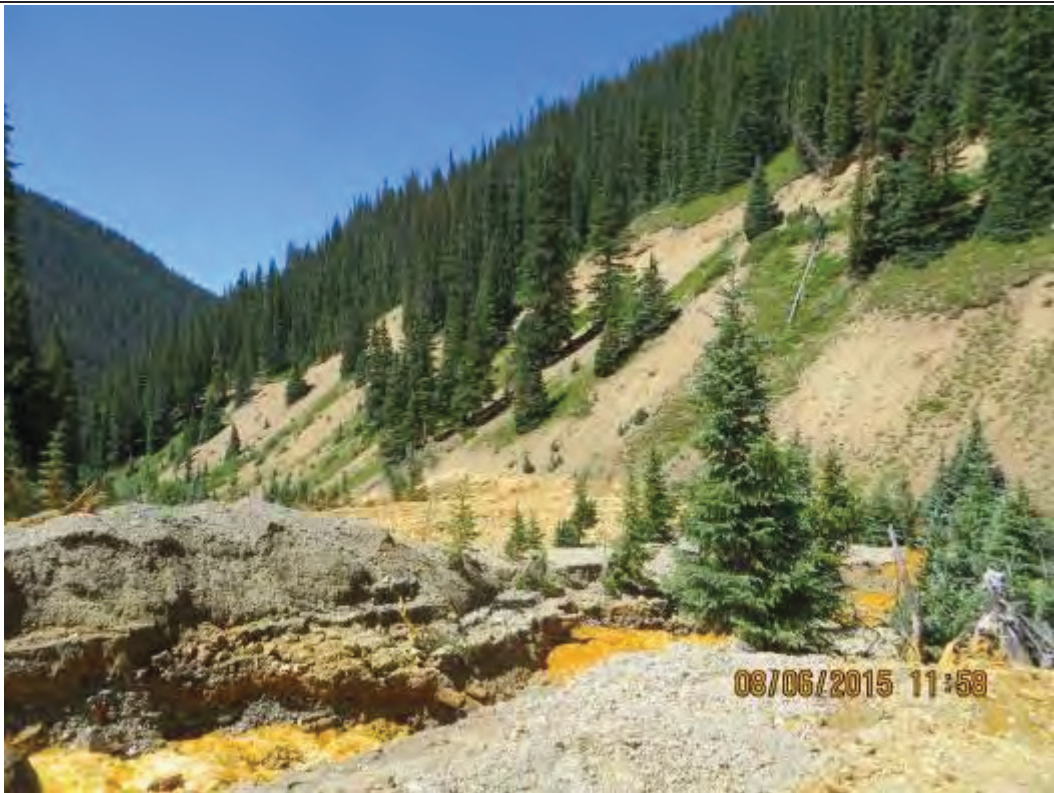
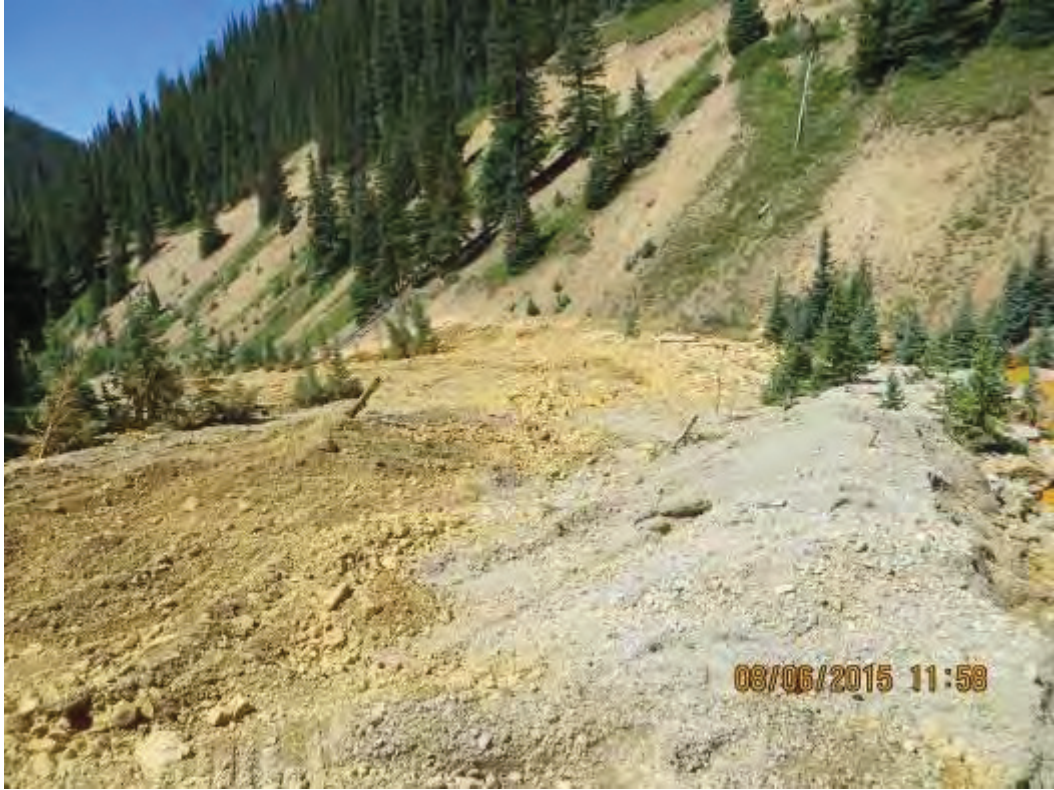
<b>Direction Photo Taken:</b>  South		
<b>Description:</b>  Cement Creek and North Fork convergence after Gold King discharge.

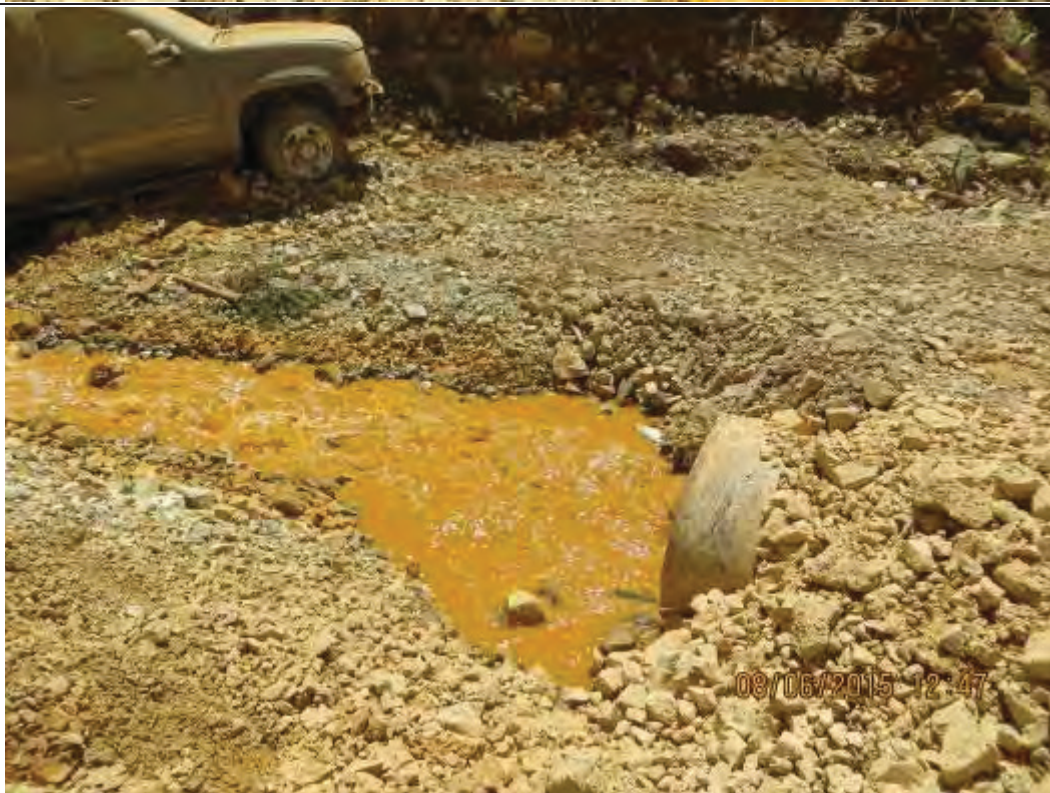
<b>Photo No.</b> <b>12</b>	<b>Date:</b> 08/06/2015
<b>Direction Photo Taken:</b>  South	
<b>Description:</b>  Temporary culvert for North Fork Cement Creek at road at base of Gold King mine dump.

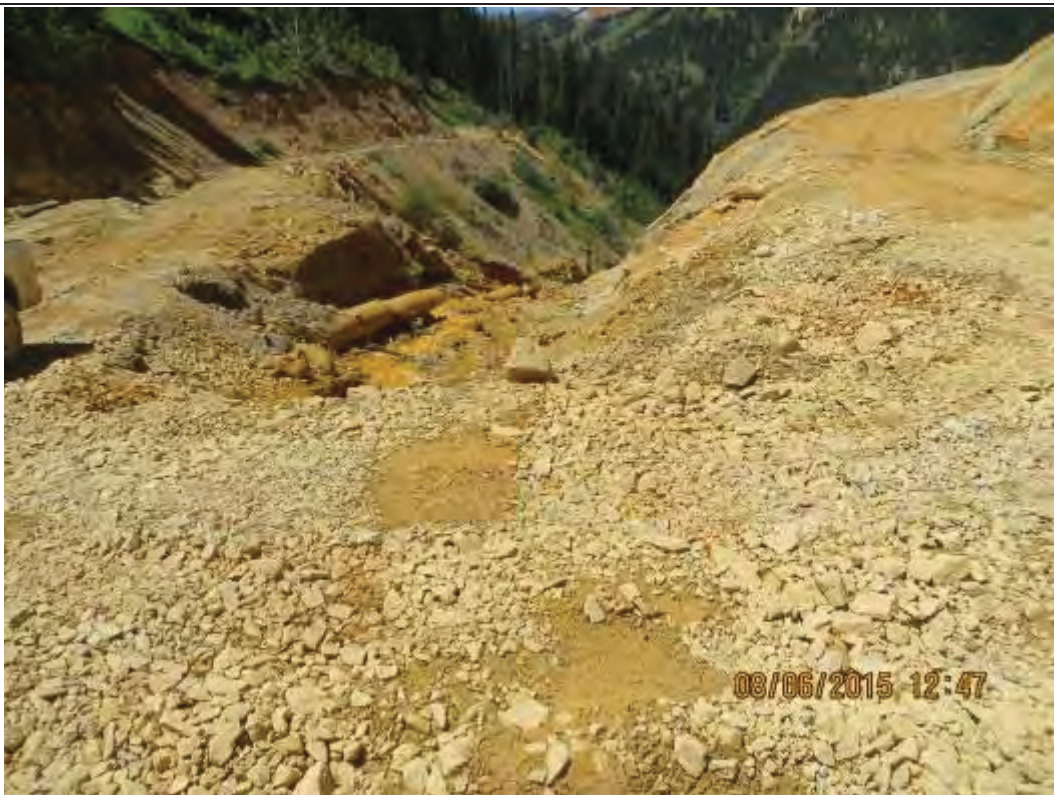
**Photo No.**  
**13**

Temporary road crossing at base of Gold King mine dump.

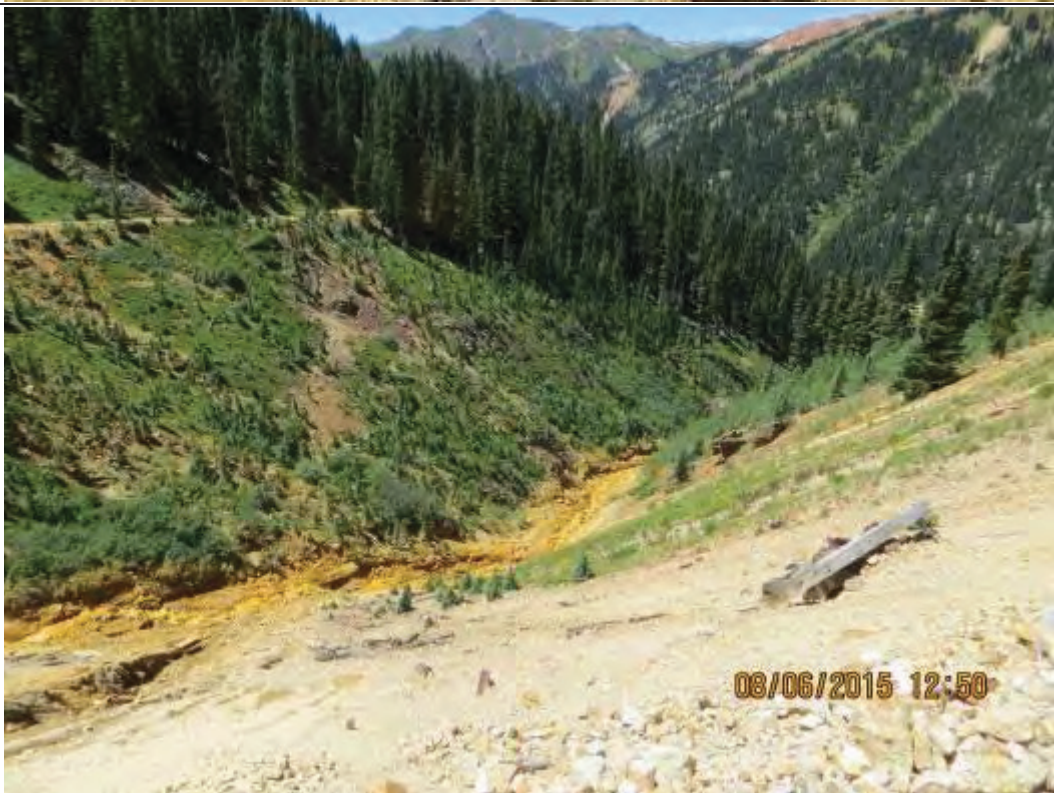
<b>Photo No.</b> <b>20</b>	<b>Date:</b> 08/06/2015
<b>Direction Photo Taken:</b>  Southwest	
<b>Description:</b>  North Fork Cement Creek downstream of Gold King road crossing. North Fork Cement Creek is orange.

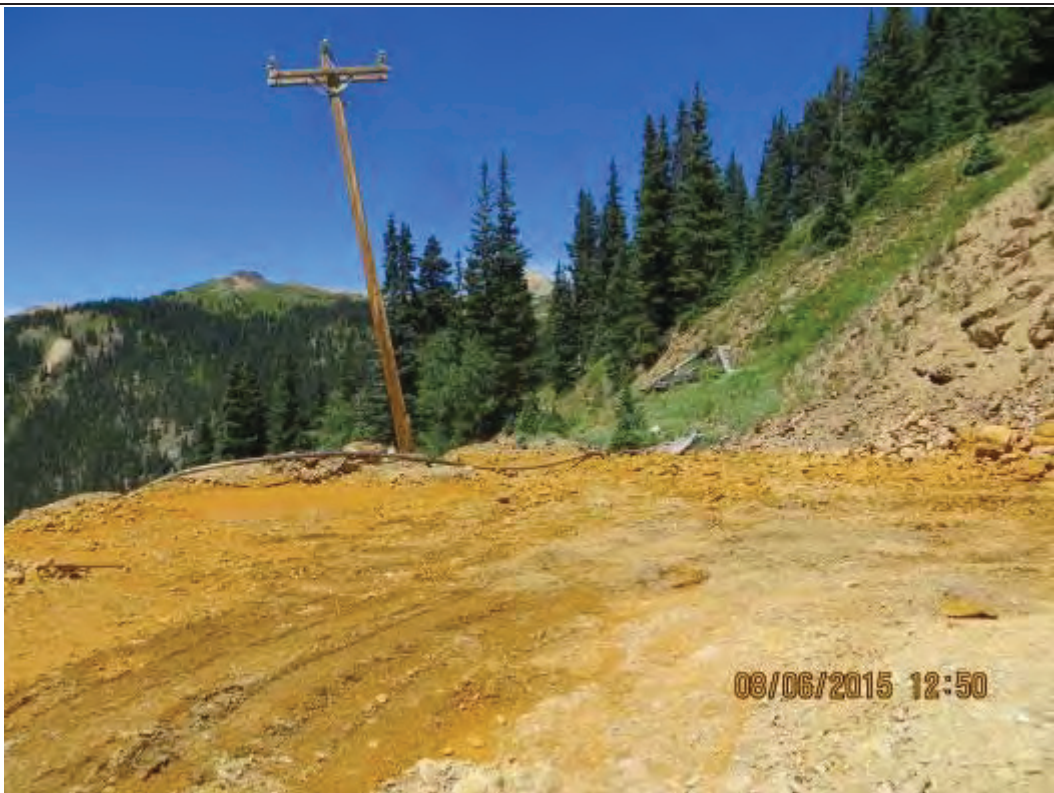
<b>Photo No.</b> <b>21</b>	<b>Date:</b> 08/06/2015
<b>Direction Photo Taken:</b>  West	
<b>Description:</b>  Switchback at the Gold King access road.

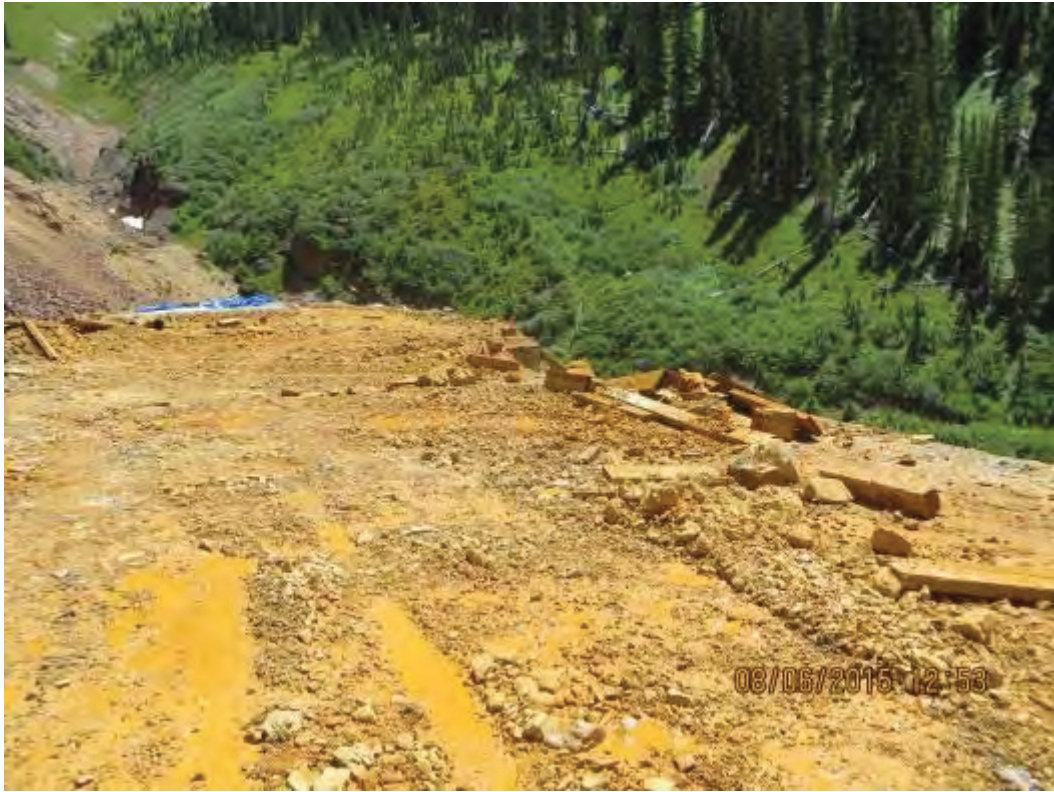
**Photo No.**  
**24**

Top of Gold King Mine Dump.
