### DRAFT TECHNICAL MEMORANDUM

**TO:** [REDACTED] EPA Region 8, On-Scene Coordinator  
**FROM:** [REDACTED], Superfund Technical Assessment and Response Team (START)  
**DATE:** August 12, 2015  
**SUBJECT:** Gold King Mine Investigation and Blowout Event

# PHOTOGRAPH LOG

<b>Project Name:</b> Gold King Mine	<b>Site Location:</b> Silverton, San Juan County, Colorado	<b>Project No.:</b> 0001/1408-01
--	---	-------------------------------------

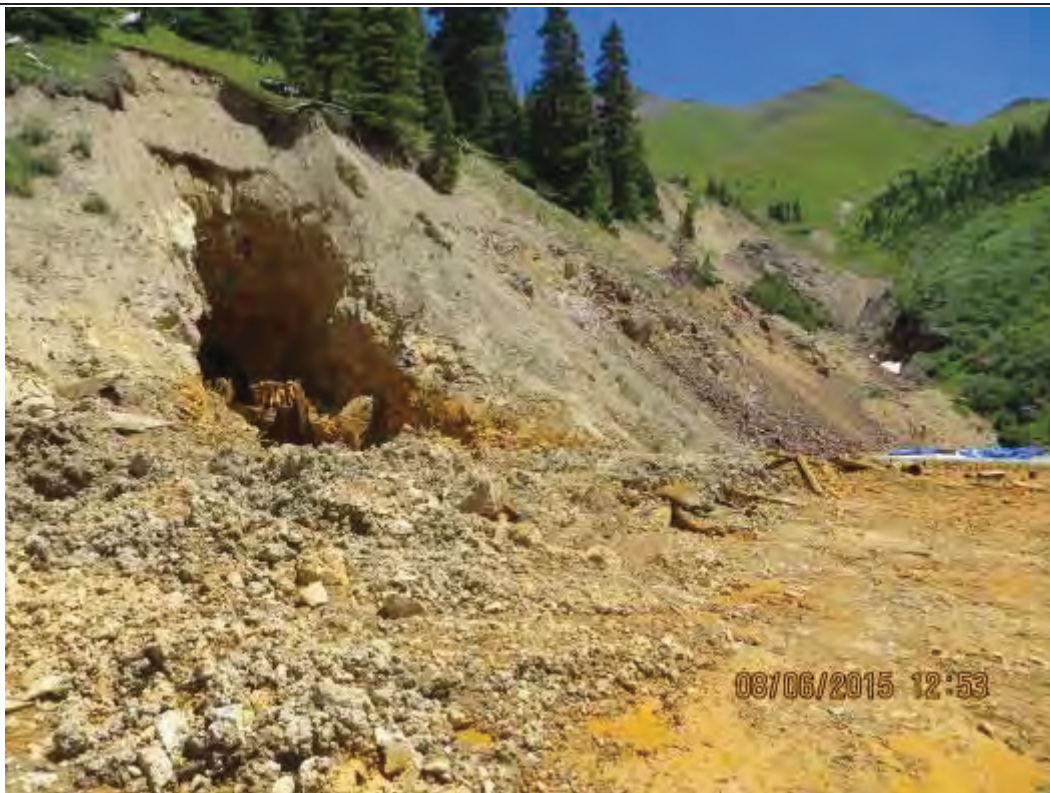
**Photo No.**  
**25**

Gold King adit post discharge.

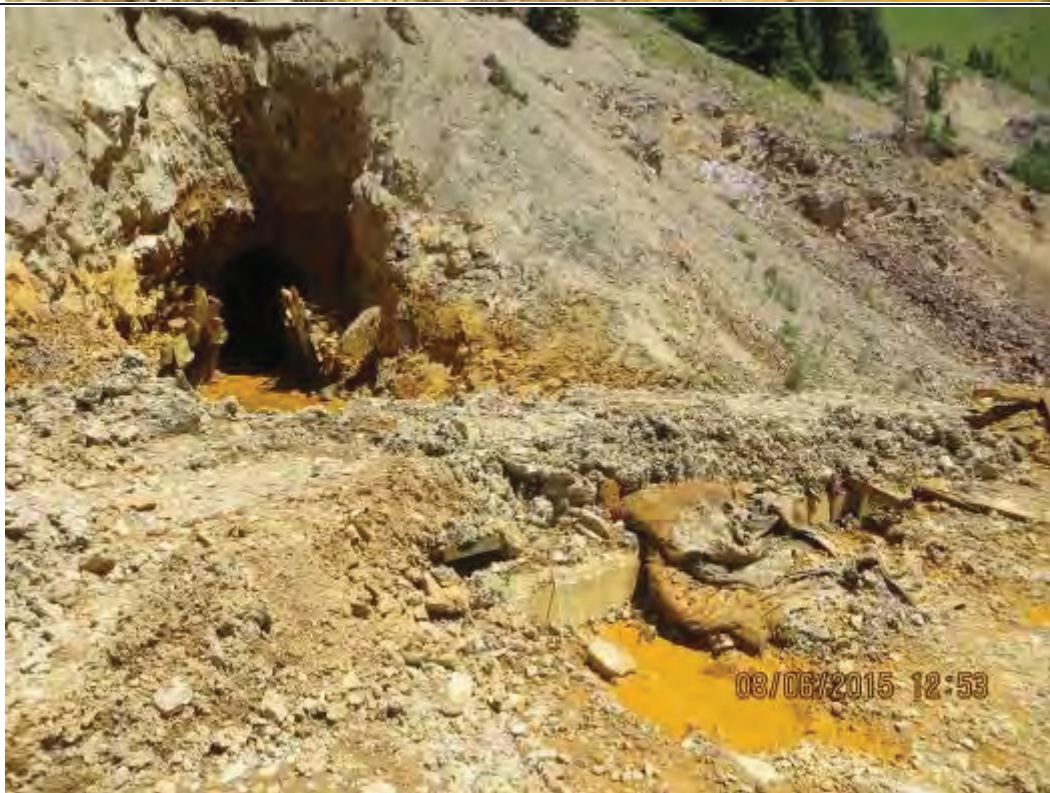
**Photo No.**  
**26**

Gold King adit post discharge.

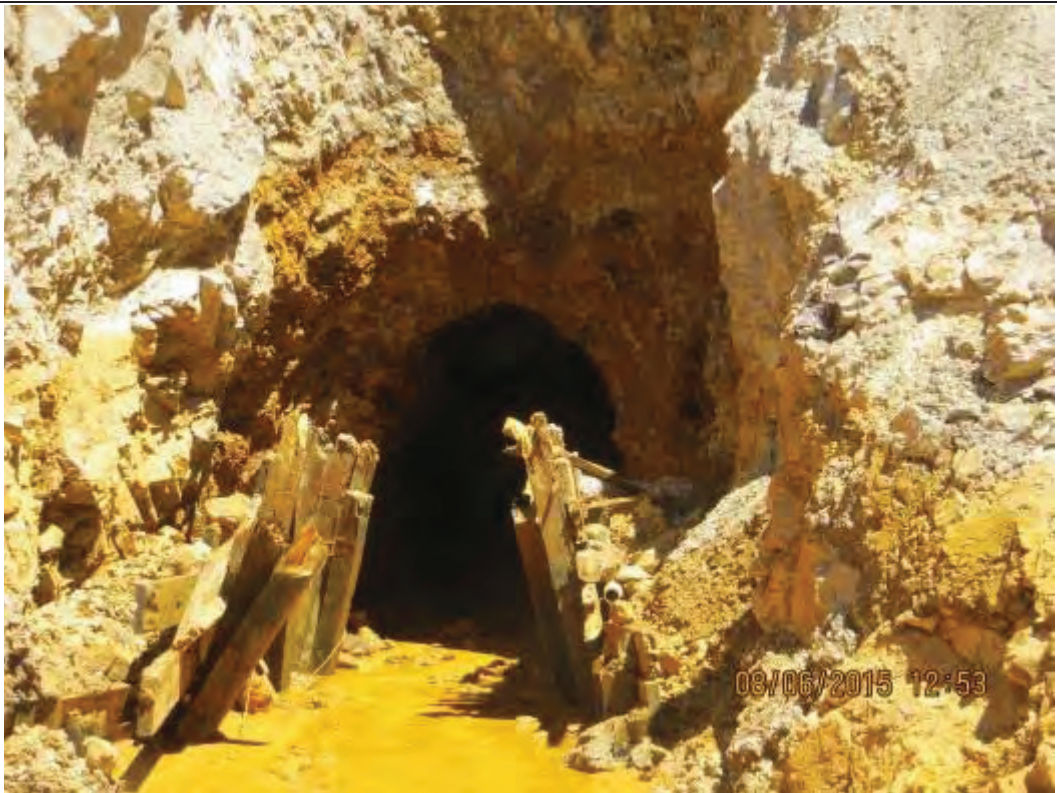
<b>Photo No.</b> <b>27</b>	<b>Date:</b> 08/06/2015
<b>Direction Photo Taken:</b>  North	
<b>Description:</b>  Gold King adit

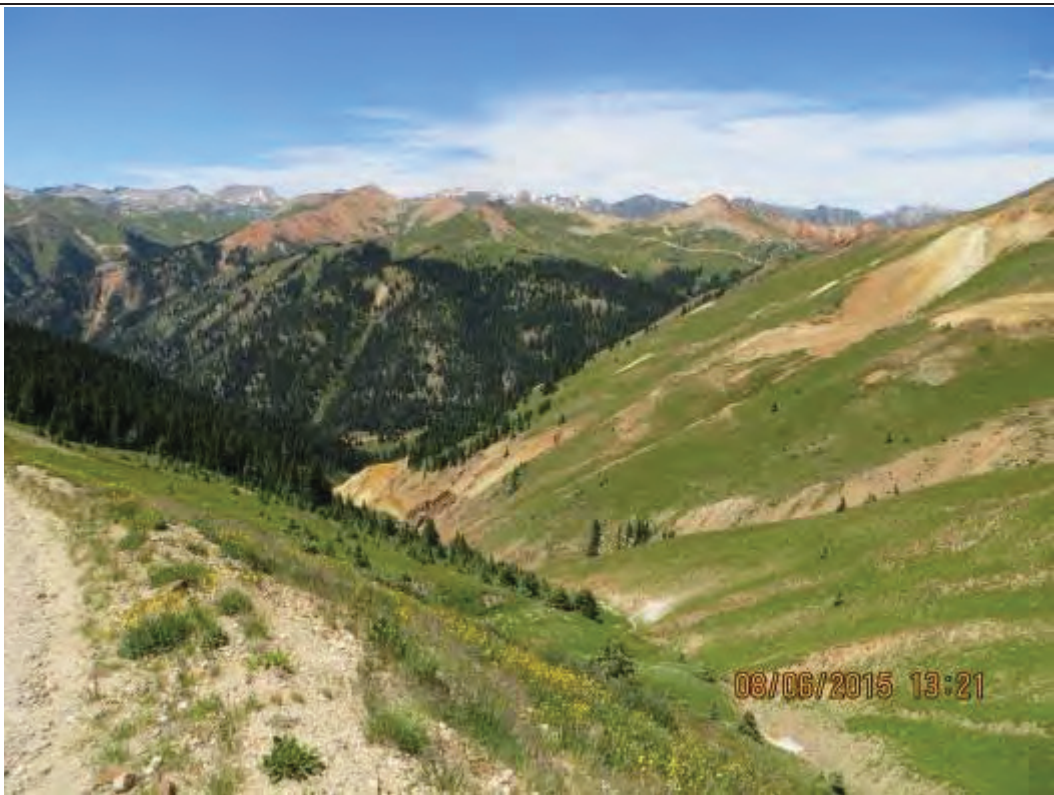
**Photo No.**  
**34**

Overview of the Gold King mine dump after mine discharge.

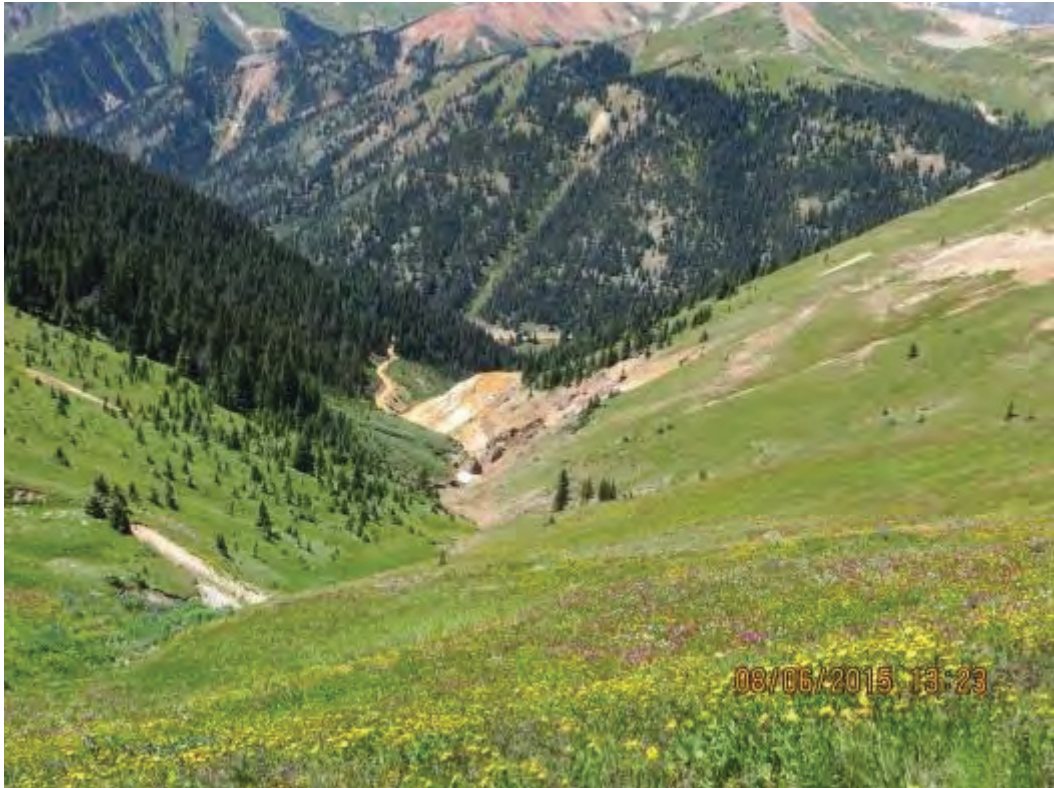
**Photo No.**  
**35**

Overview of the Gold King mine dump after mine discharge.

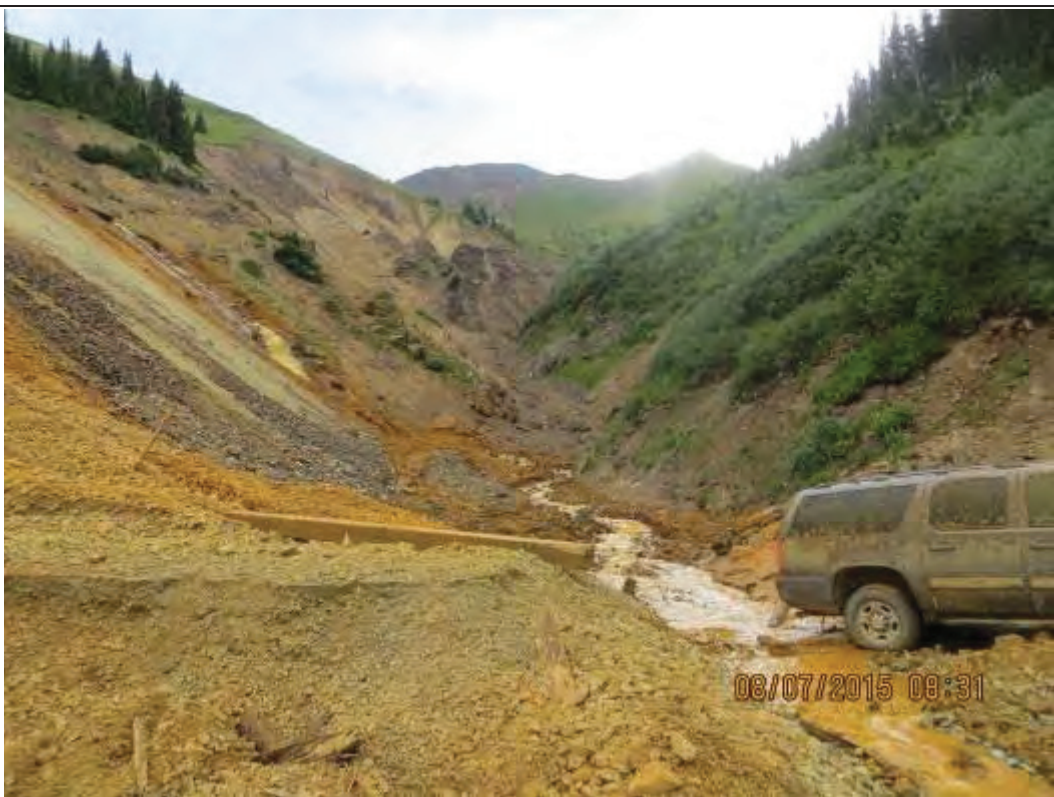
**Photo No.:**  
**6**

**Description:**  
GSA Suburban and water drain down to Cement Creek
