SUBJECT: DESTRUCTIVE ANALYSIS OF 10 STEEL COUPONS REMOVED FROM RED HILL FUEL STORAGE TANK NO. 14, PURSUANT TO SECTION 5.3 OF THE ADMINISTRATIVE ORDER ON CONSENT STATEMENT OF WORK, RED HILL BULK FUEL STORAGE FACILITY, JOINT BASE PEARL HARBOR-HICKAM, OAHU, HAWAII

Destructive Analysis of 10 Steel Coupons Removed from Red Hill Fuel Storage Tank #14

REPORT No. 201801967

December 17, 2018

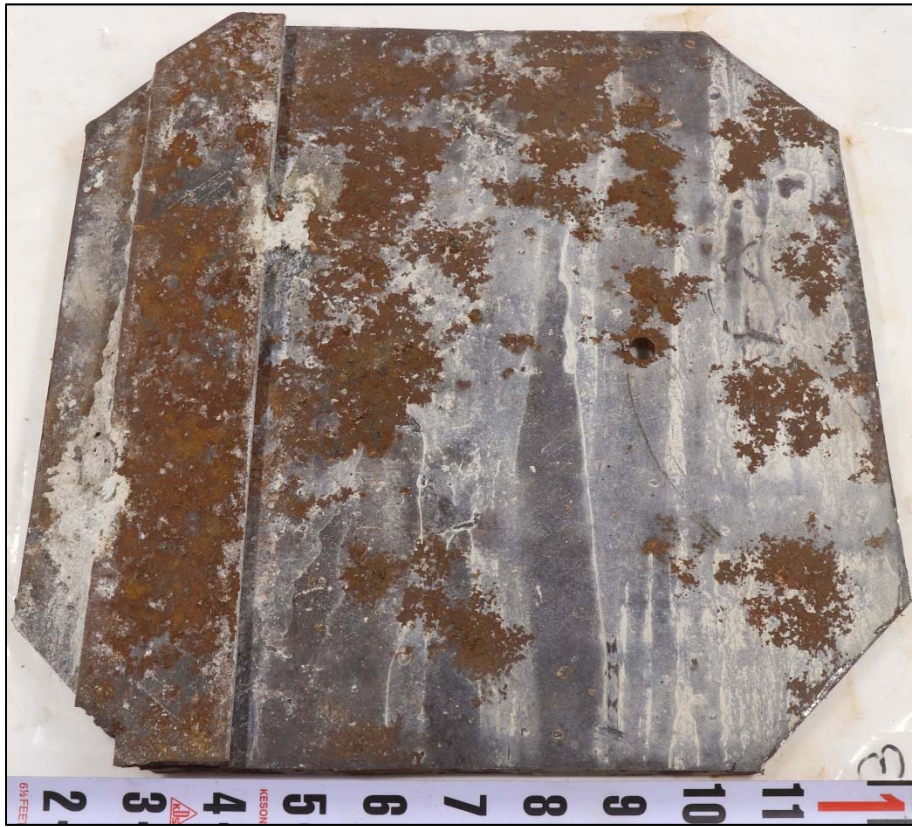
Coupon 8 exhibited what is presumed to be a prior weld repair and/or addition of a backing plate, where a patch was made on the tank wall. Representative images of the welds are presented as Figures 208 through 213. A full weld evaluation is outside the scope of this effort. The results are thus provided for information only.

Figure 19. An image of the interior surface of Coupon 8 in the as-received condition.

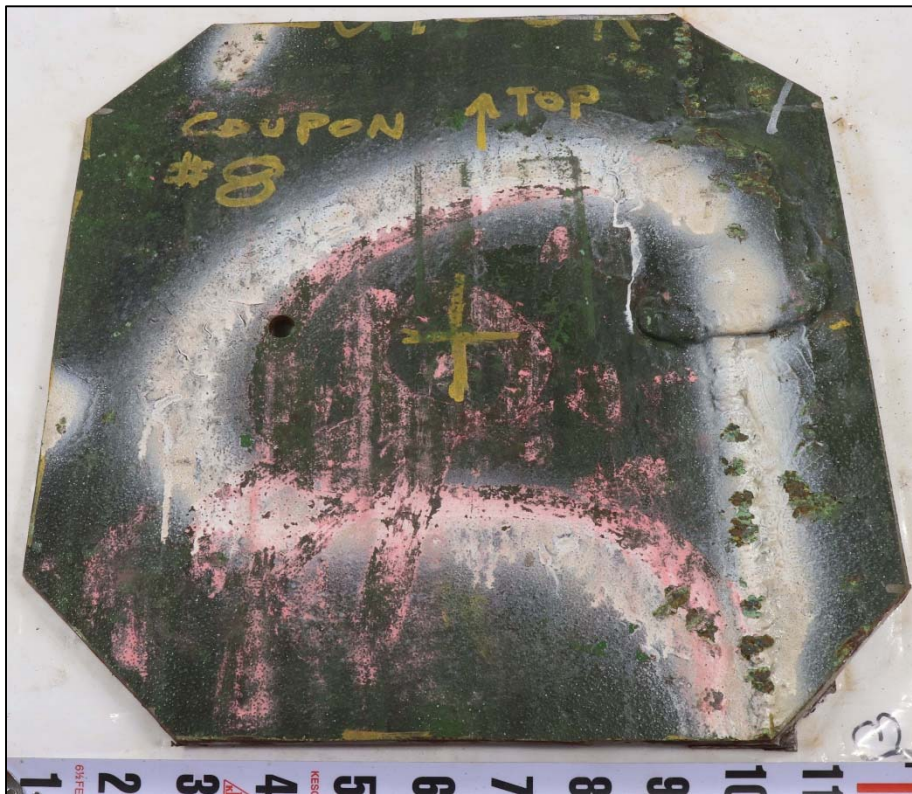
Figure 20. An image of the exterior surface of Coupon 8 in the as-received condition.

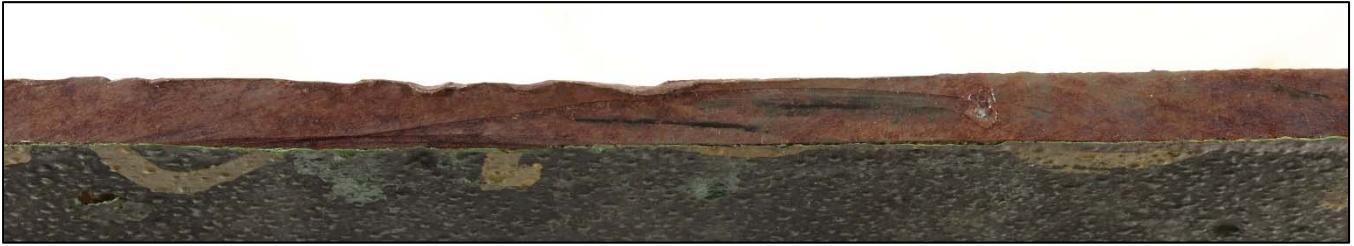
Figure 21. An image of a representative edge of Coupon 8 in the as-received condition.

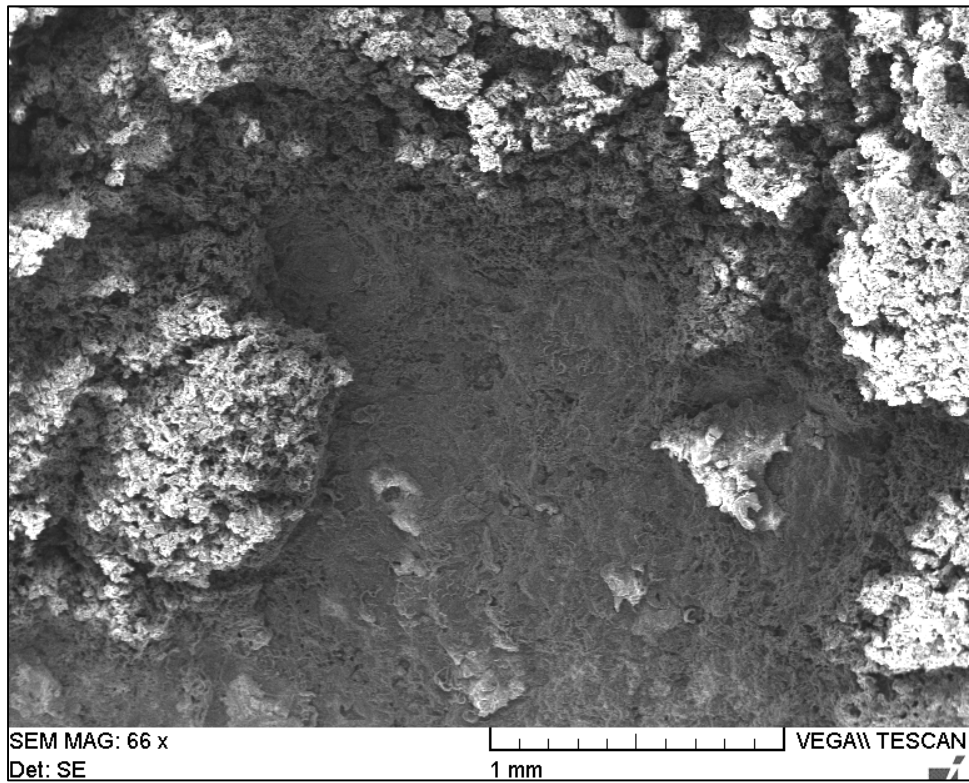
Figure 49. A representative SEM image of a pit on a specimen excised from Coupon 3 labeled as 3-3, prior to cleaning. (SEM, 39X)

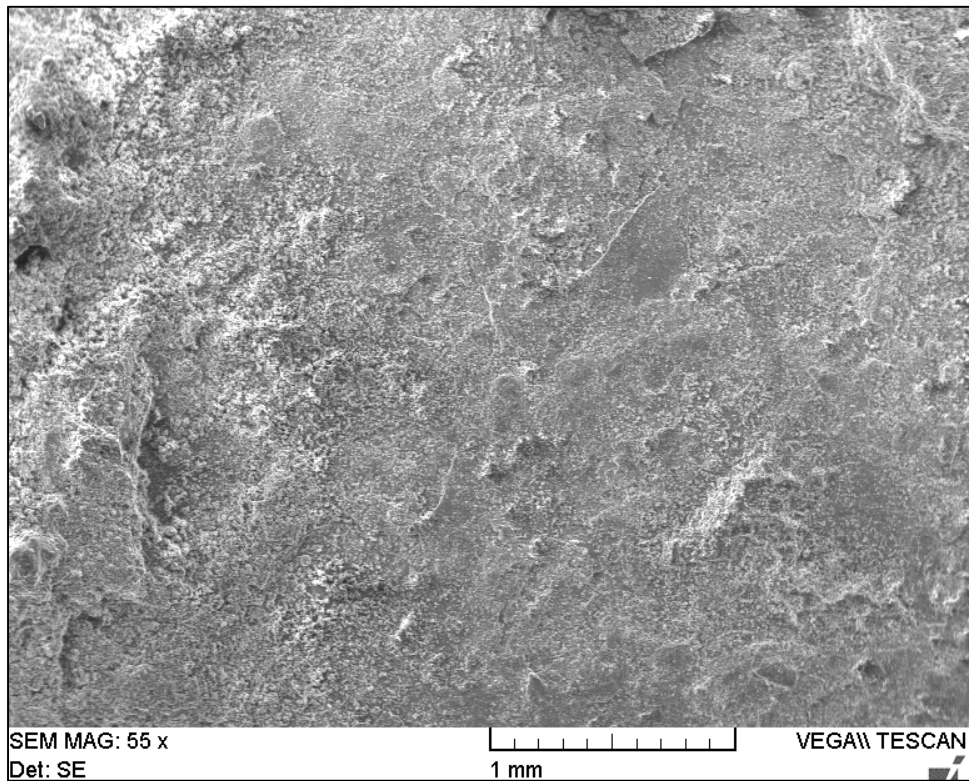
Figure 52. A representative SEM image of a pit on a specimen excised from Coupon 5 labeled as 5-3, prior to cleaning. (SEM, 32X)

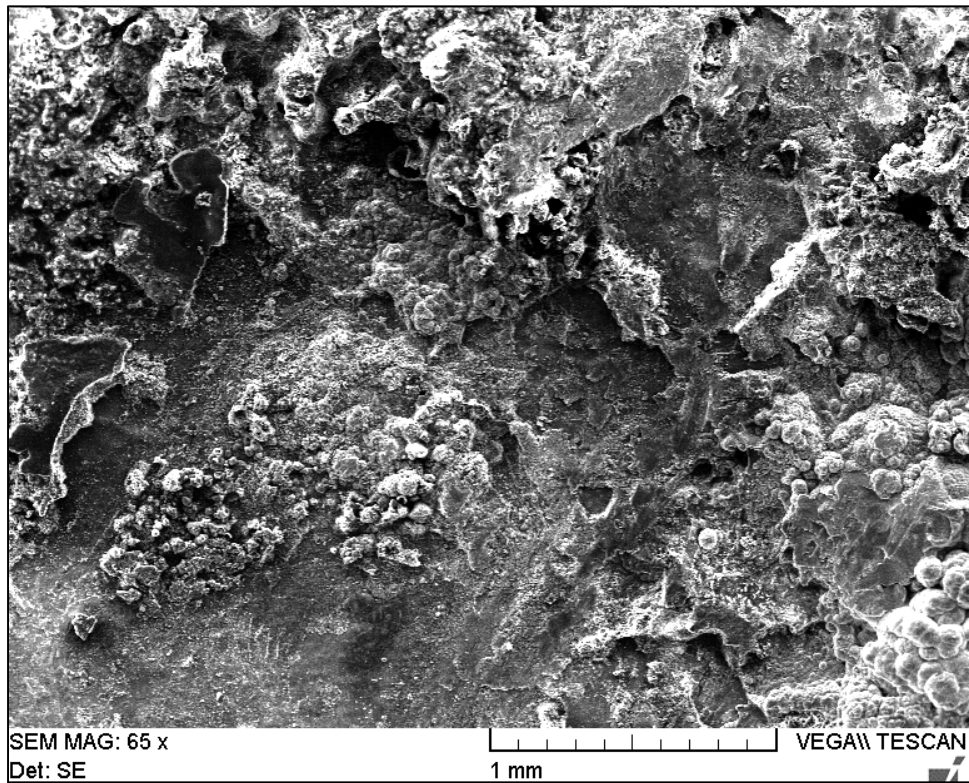
Figure 53. A representative SEM image of a pit on a specimen excised from Coupon 6 labeled as 6-1, prior to cleaning. (SEM, 38X)

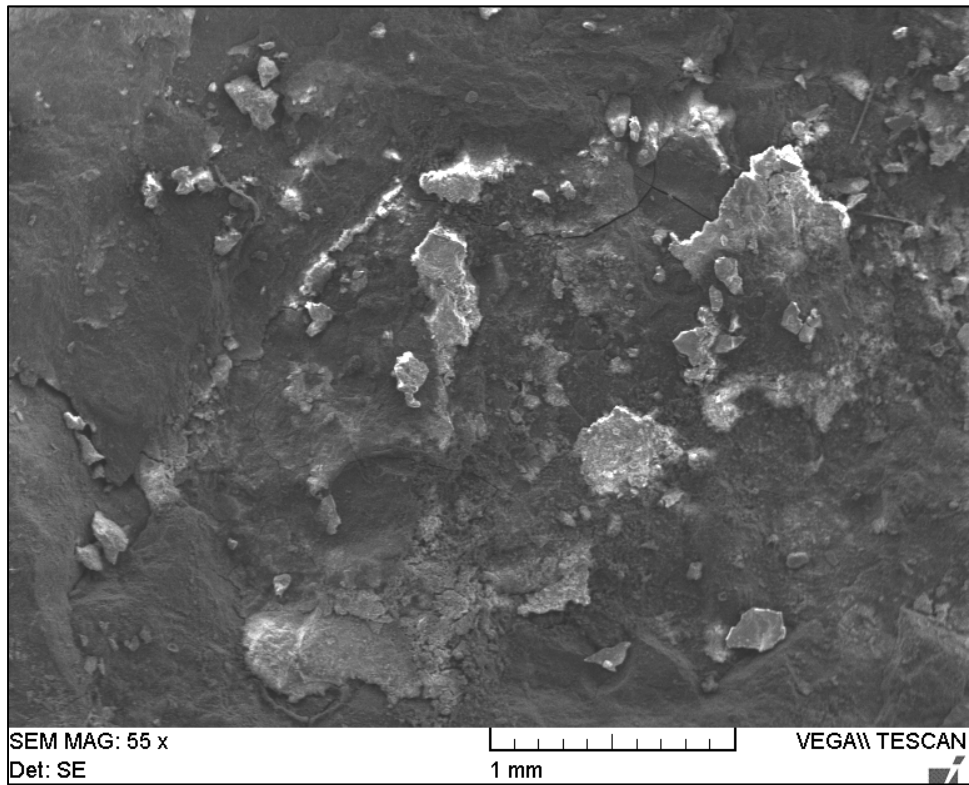
Figure 57. A representative SEM image of a pit on a specimen excised from Coupon 7 labeled as 7-2, prior to cleaning. (SEM, 32X)

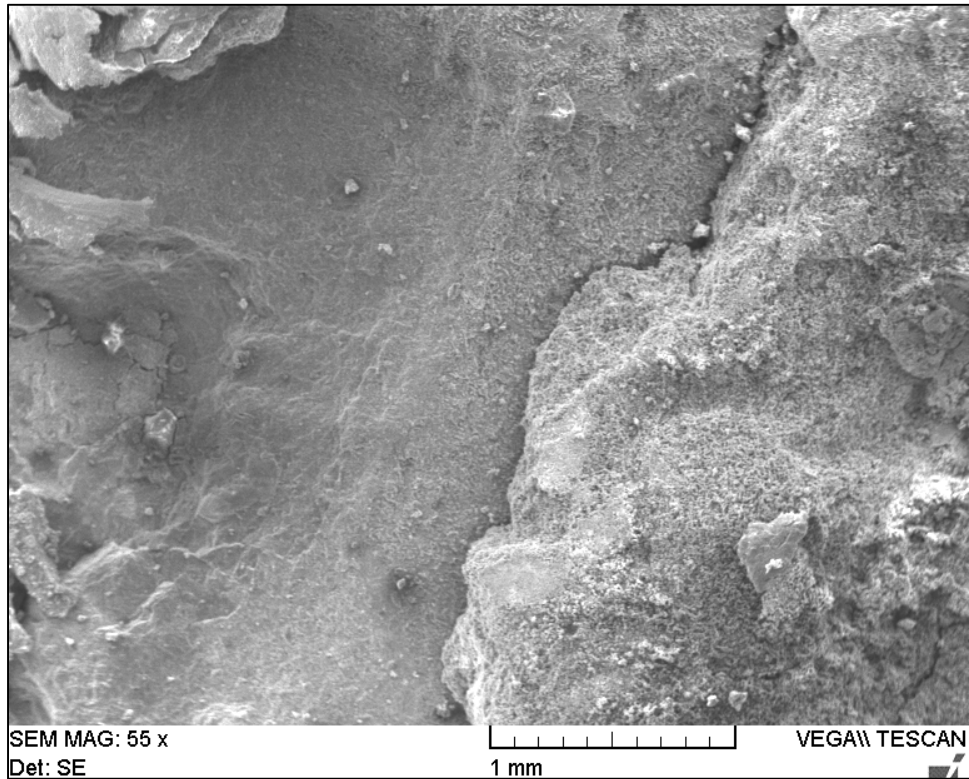
Figure 58. A representative SEM image of a pit on a specimen excised from Coupon 7 labeled as 7-3, prior to cleaning. (SEM, 32X)

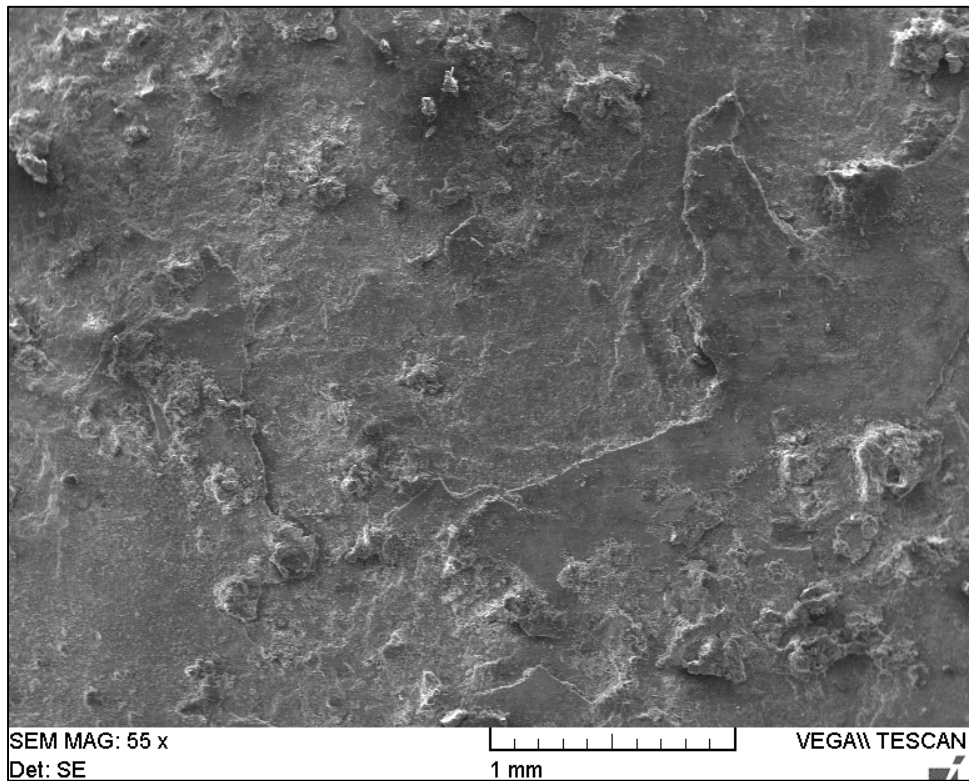
Figure 60. A representative SEM image of a pit on a specimen excised from Coupon 8 labeled as 8-2, prior to cleaning. (SEM, 33X)

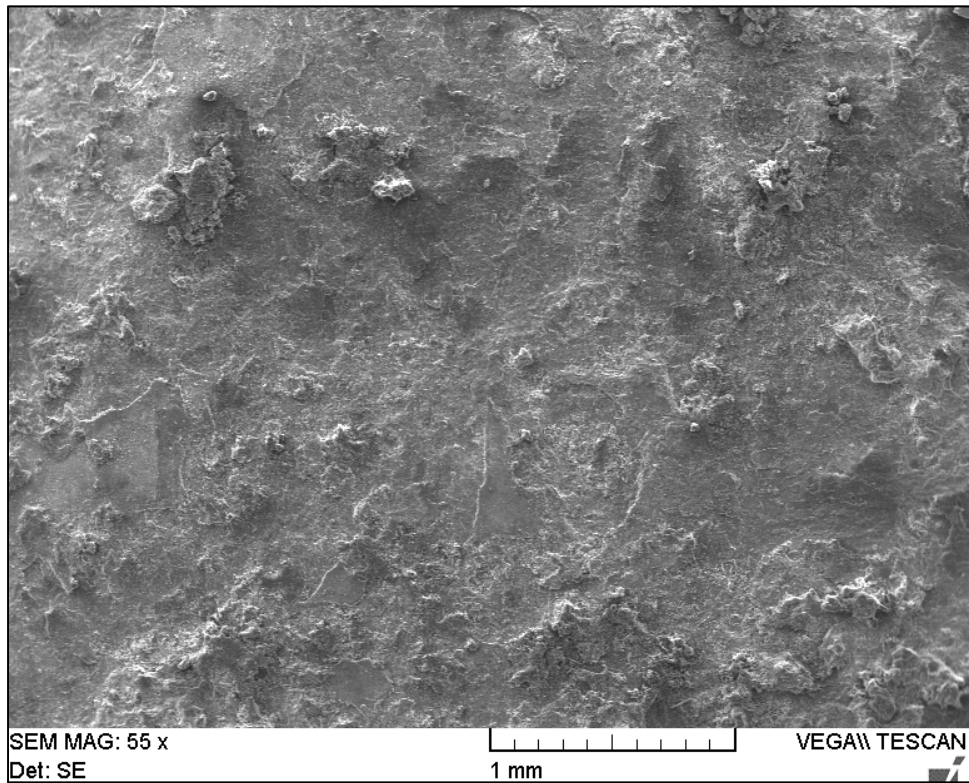
④ This is the weld-repaired plate section. Sample 8-3 exhibited a depression or pit on the painted surface.

Figure 61. A representative SEM image of a pit on a specimen excised from Coupon 8 labeled as 8-3, prior to cleaning. (SEM, 33X)

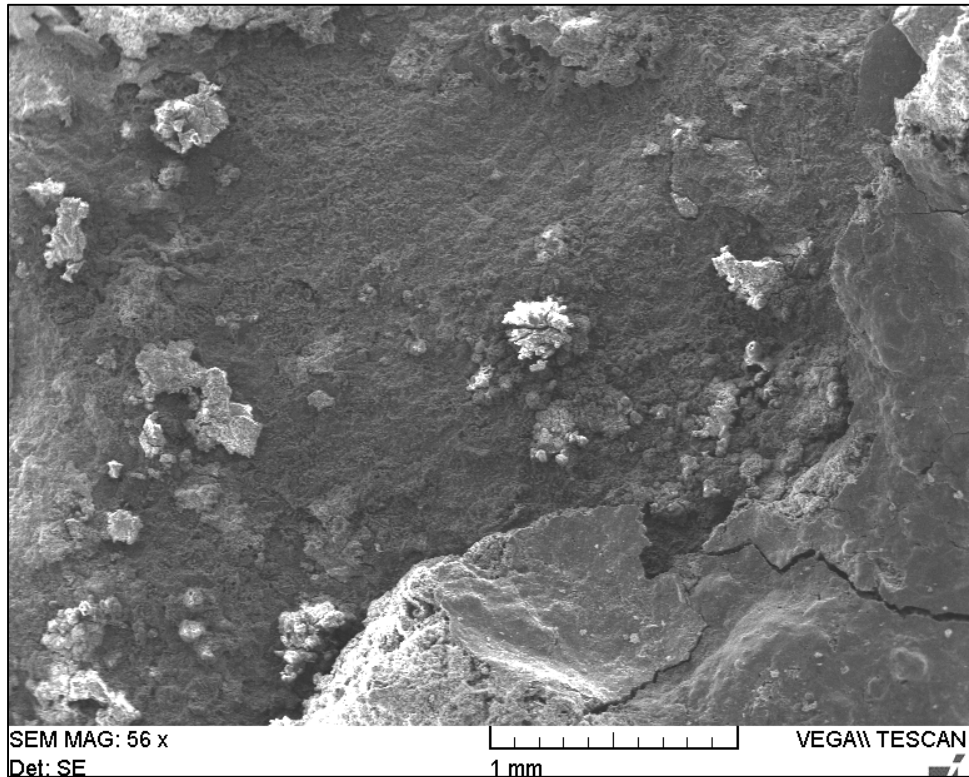
Figure 66. A representative SEM image of a pit on a specimen excised from Coupon A-1 labeled as A1-2, prior to cleaning. (SEM, 33X)

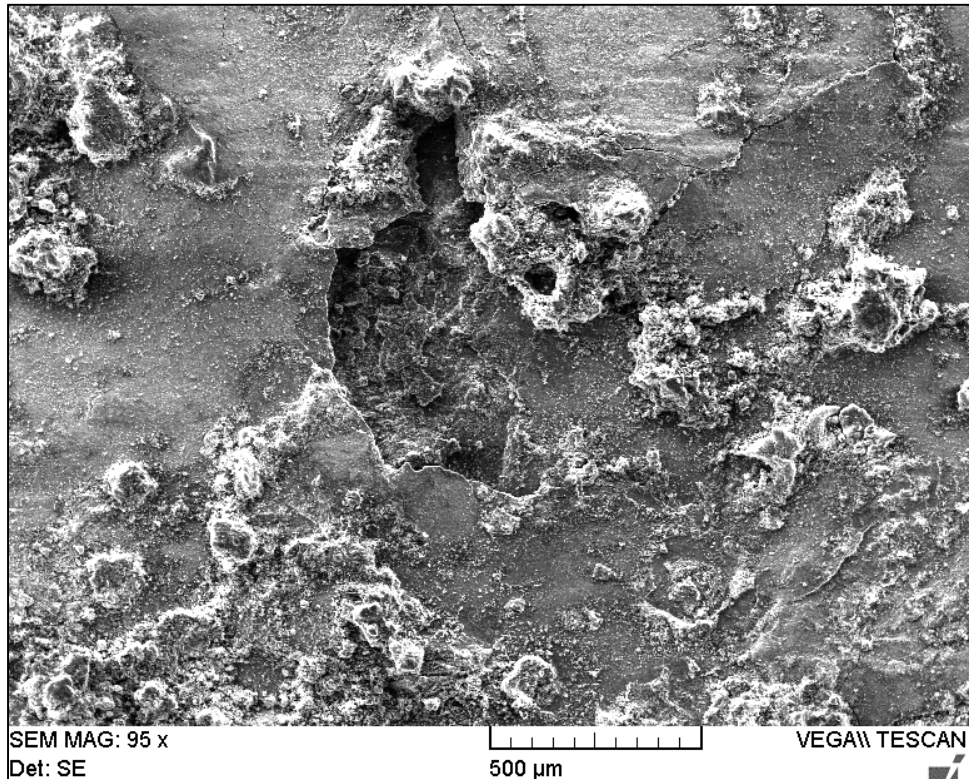
Figure 68. A representative SEM image of a pit on a specimen excised from Coupon A-2 labeled as A2-1, prior to cleaning. (SEM, 56X)

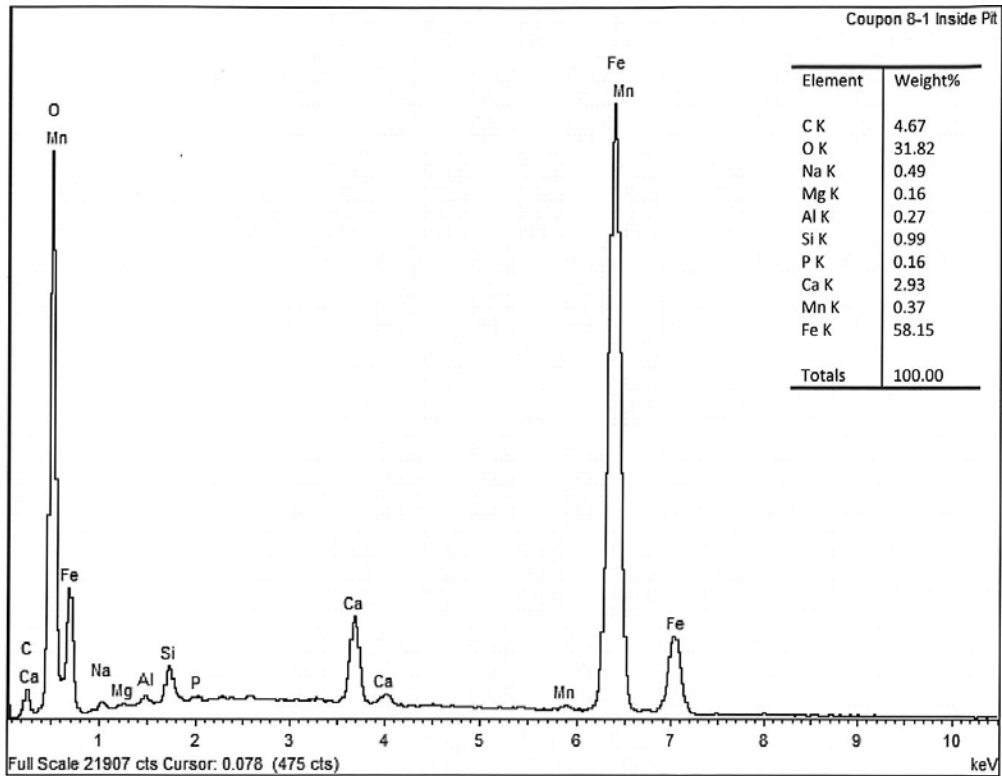
Figure 89. A representative EDS spectrum generated from of a pit on a specimen excised from Coupon 8 labeled as 8-1, prior to cleaning.

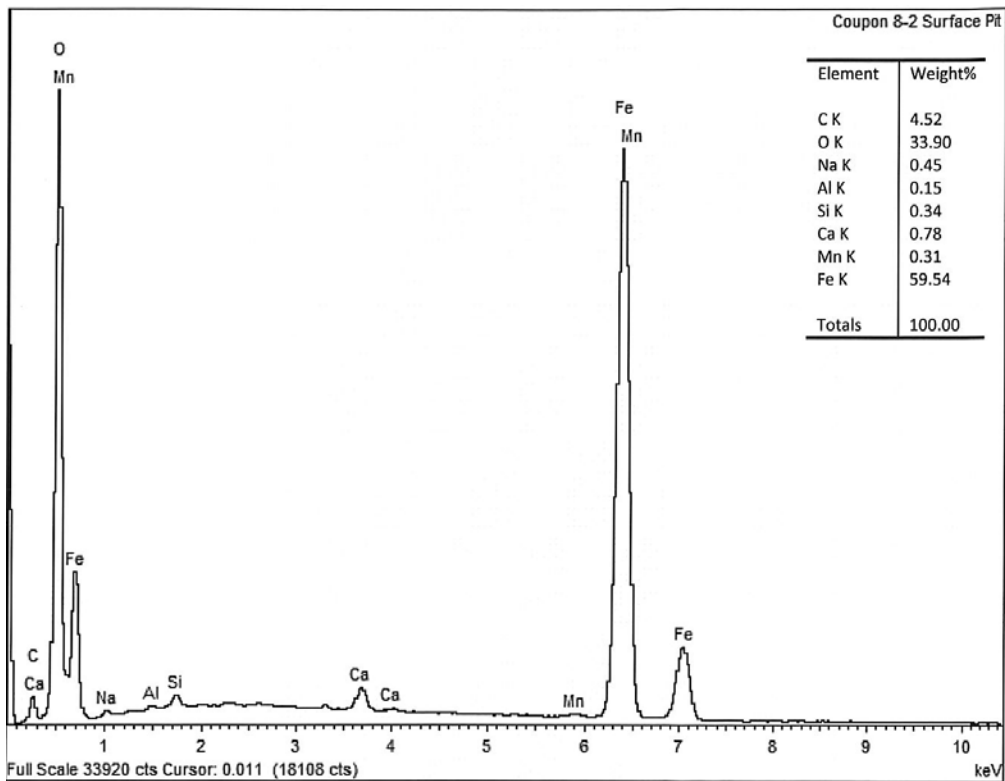
Figure 90. A representative EDS spectrum generated from the surface of a specimen excised from Coupon 8 labeled as 8-2, prior to cleaning.

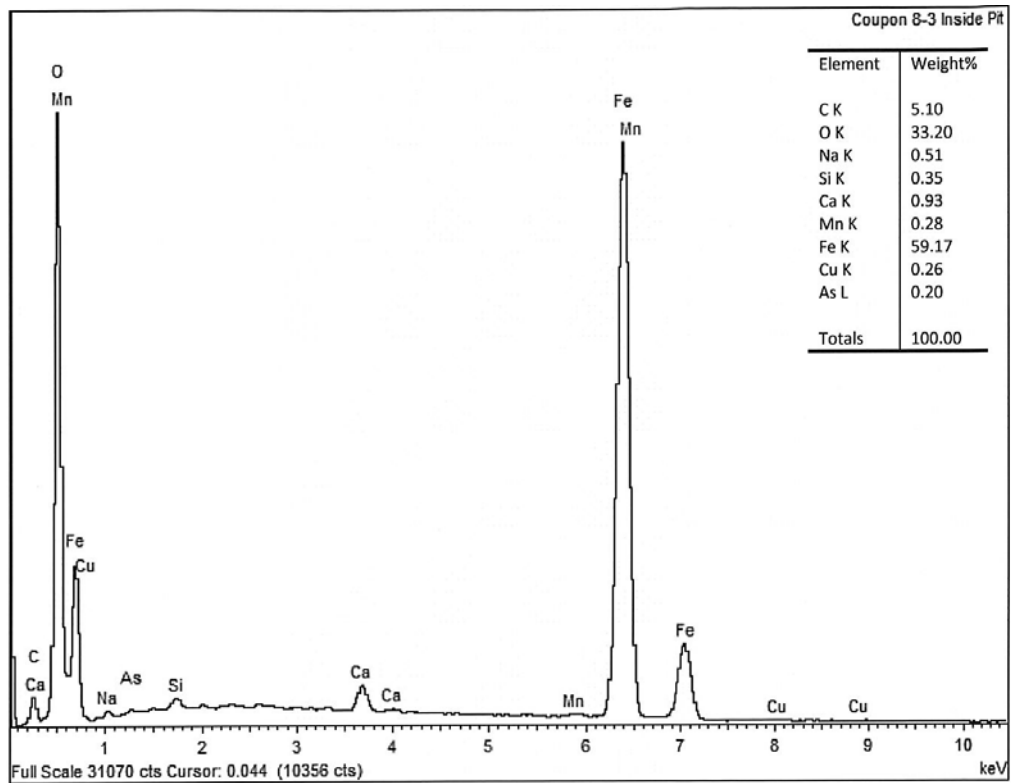
Figure 91. A representative EDS spectrum generated from of a pit on a specimen excised from Coupon 8 labeled as 8-3, prior to cleaning.

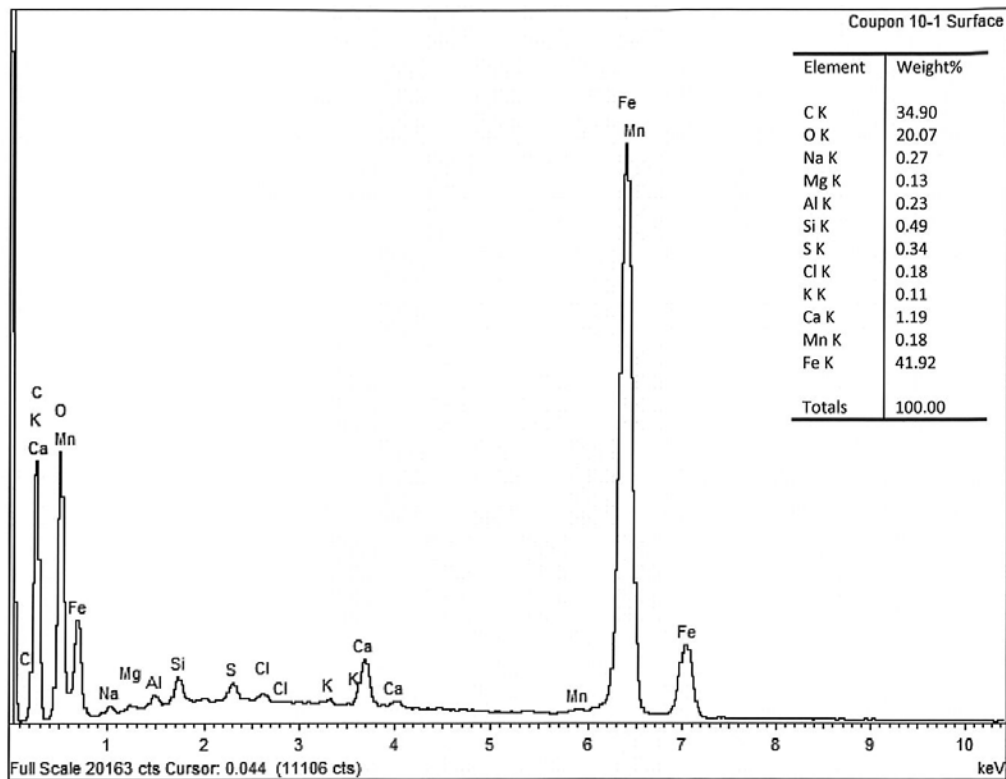
Figure 92. A representative EDS spectrum generated from the surface of a specimen excised from Coupon 10 labeled as 10-1, prior to cleaning.

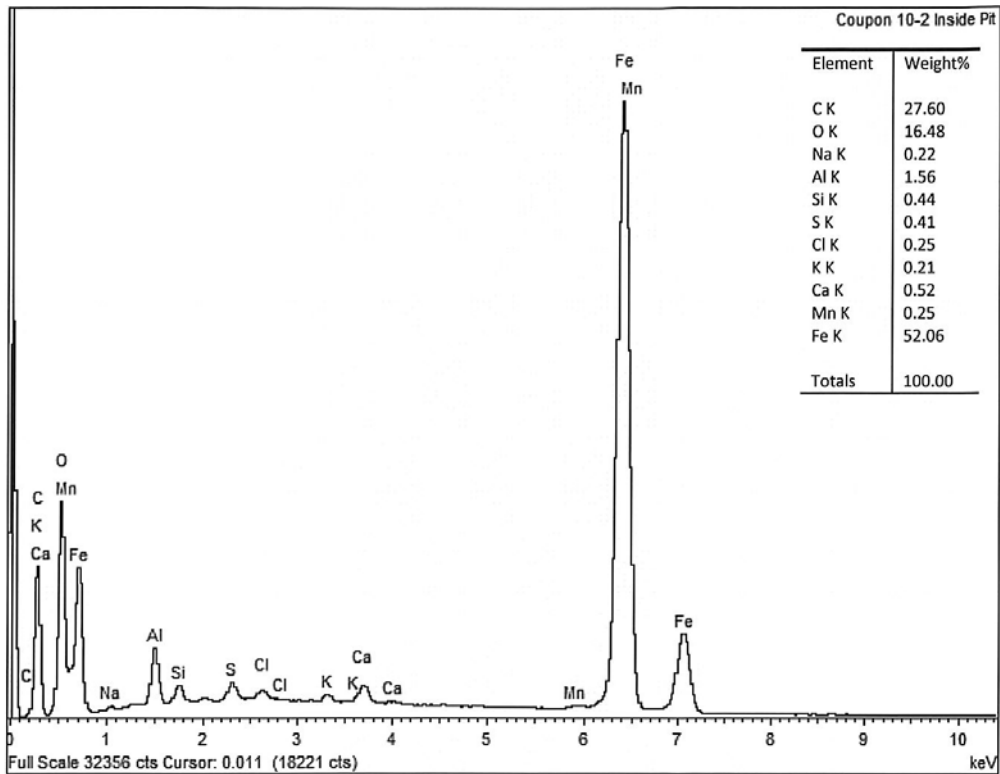
Figure 93. A representative EDS spectrum generated from of a pit on a specimen excised from Coupon 10 labeled as 10-2, prior to cleaning.

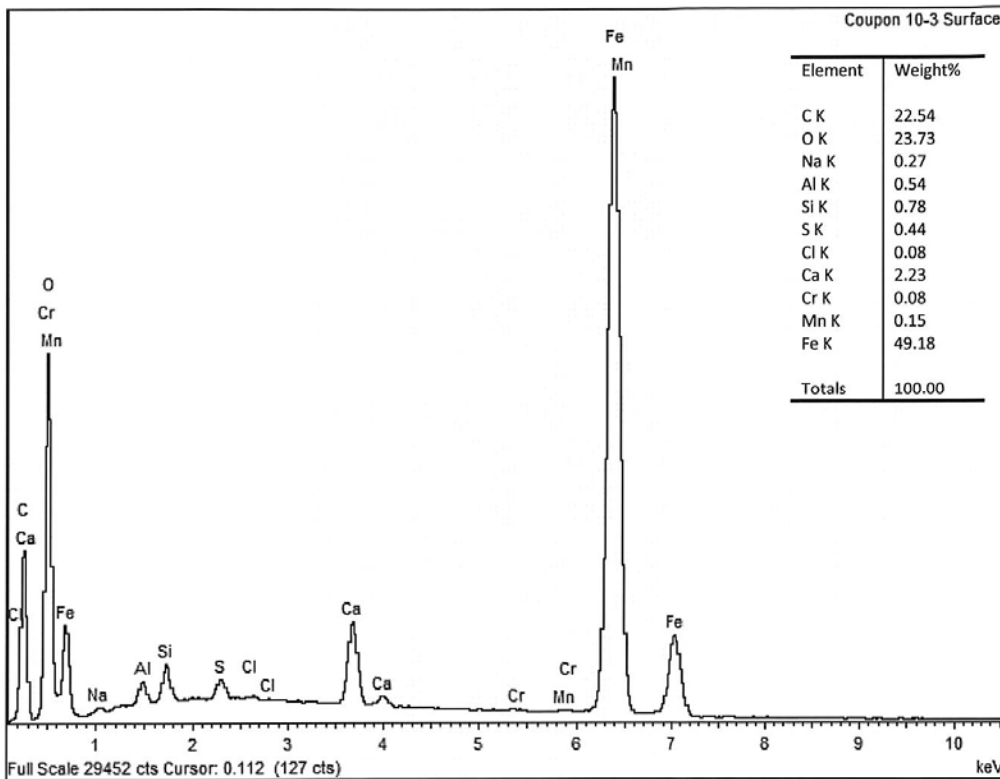
Figure 94. A representative EDS spectrum generated from the surface of a specimen excised from Coupon 10 labeled as 10-3, prior to cleaning.

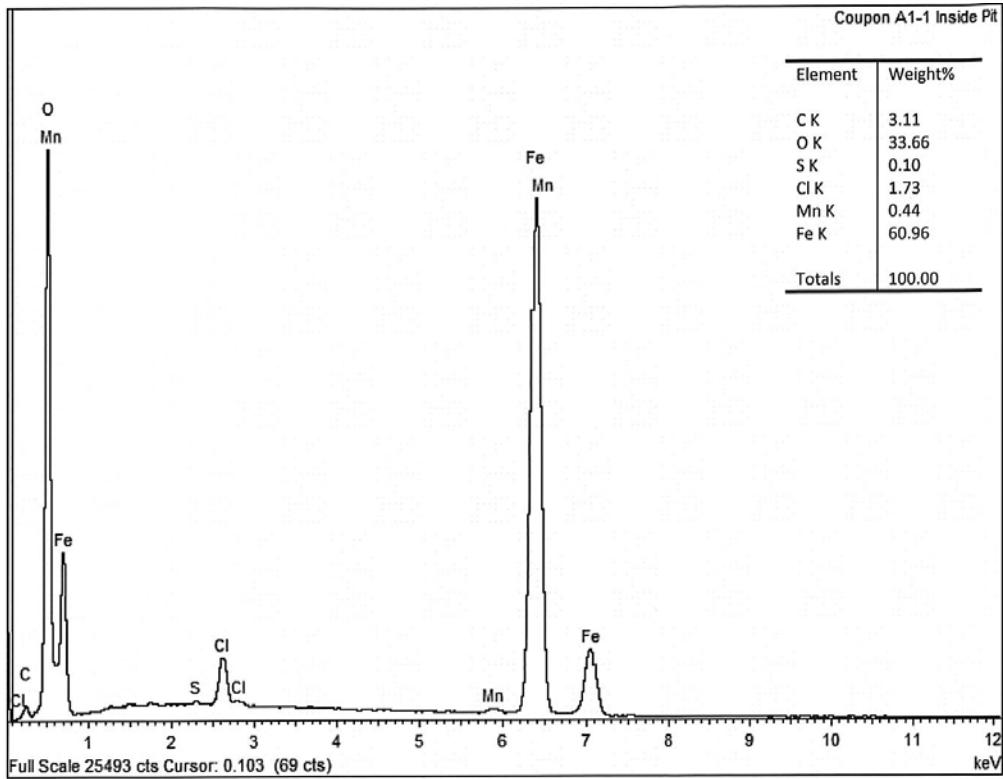
Figure 95. A representative EDS spectrum generated from of a pit on a specimen excised from Coupon A1 labeled as A1-1, prior to cleaning.

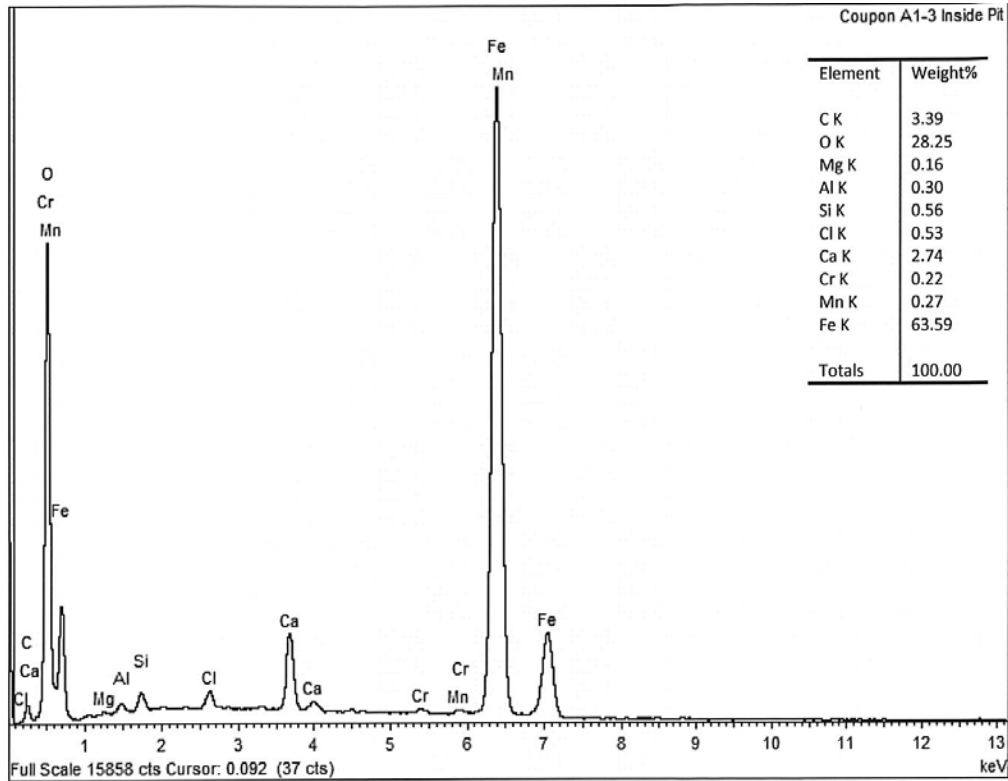
Figure 97. A representative EDS spectrum generated from of a pit on a specimen excised from Coupon A1 labeled as A1-3, prior to cleaning.

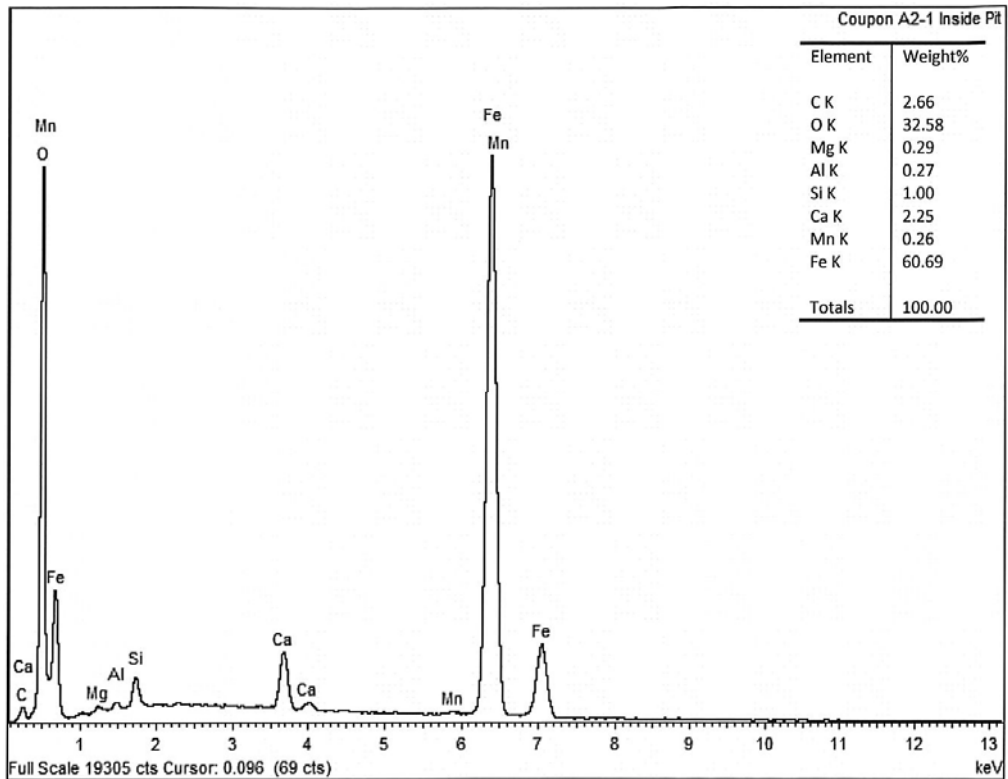
Figure 98. A representative EDS spectrum generated from of a pit on a specimen excised from Coupon A2 labeled as A2-1, prior to cleaning.

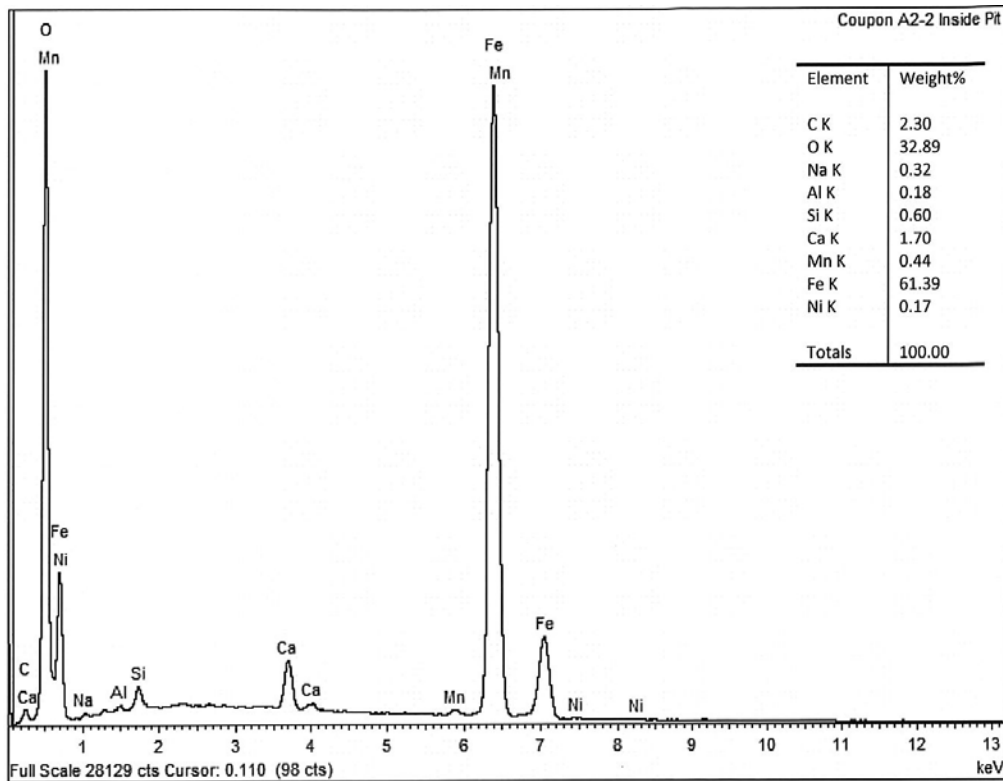
Figure 99. A representative EDS spectrum generated from of a pit on a specimen excised from Coupon A2 labeled as A2-2, prior to cleaning.

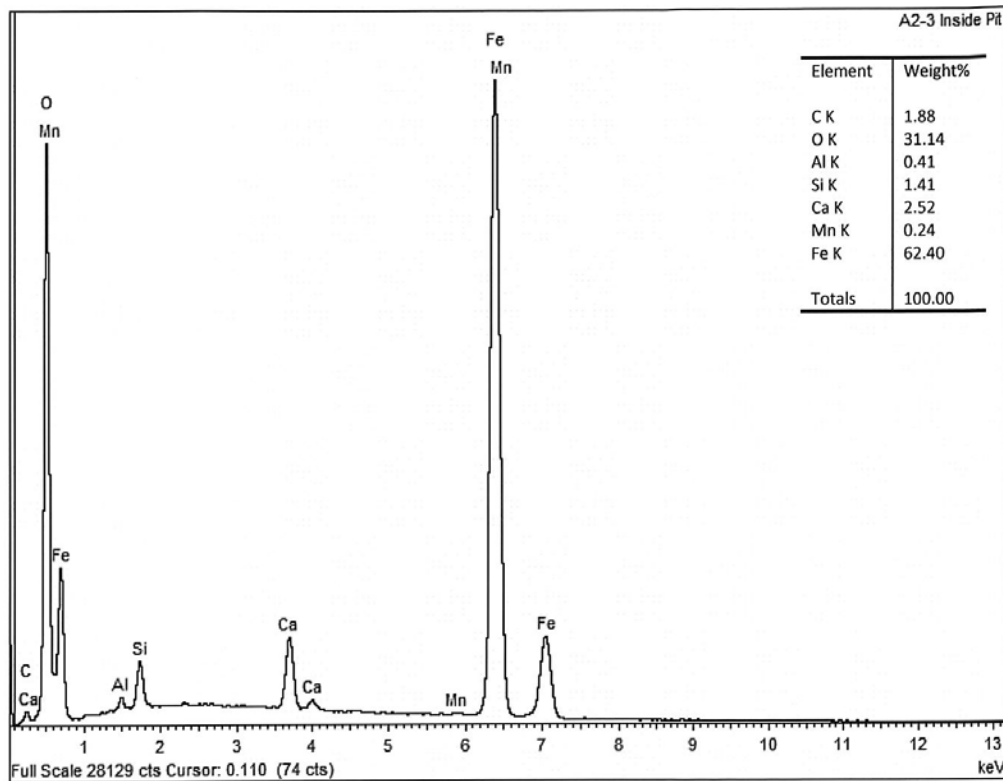
Figure 100. A representative EDS spectrum generated from of a pit on a specimen excised from Coupon A2 labeled as A2-3, prior to cleaning.

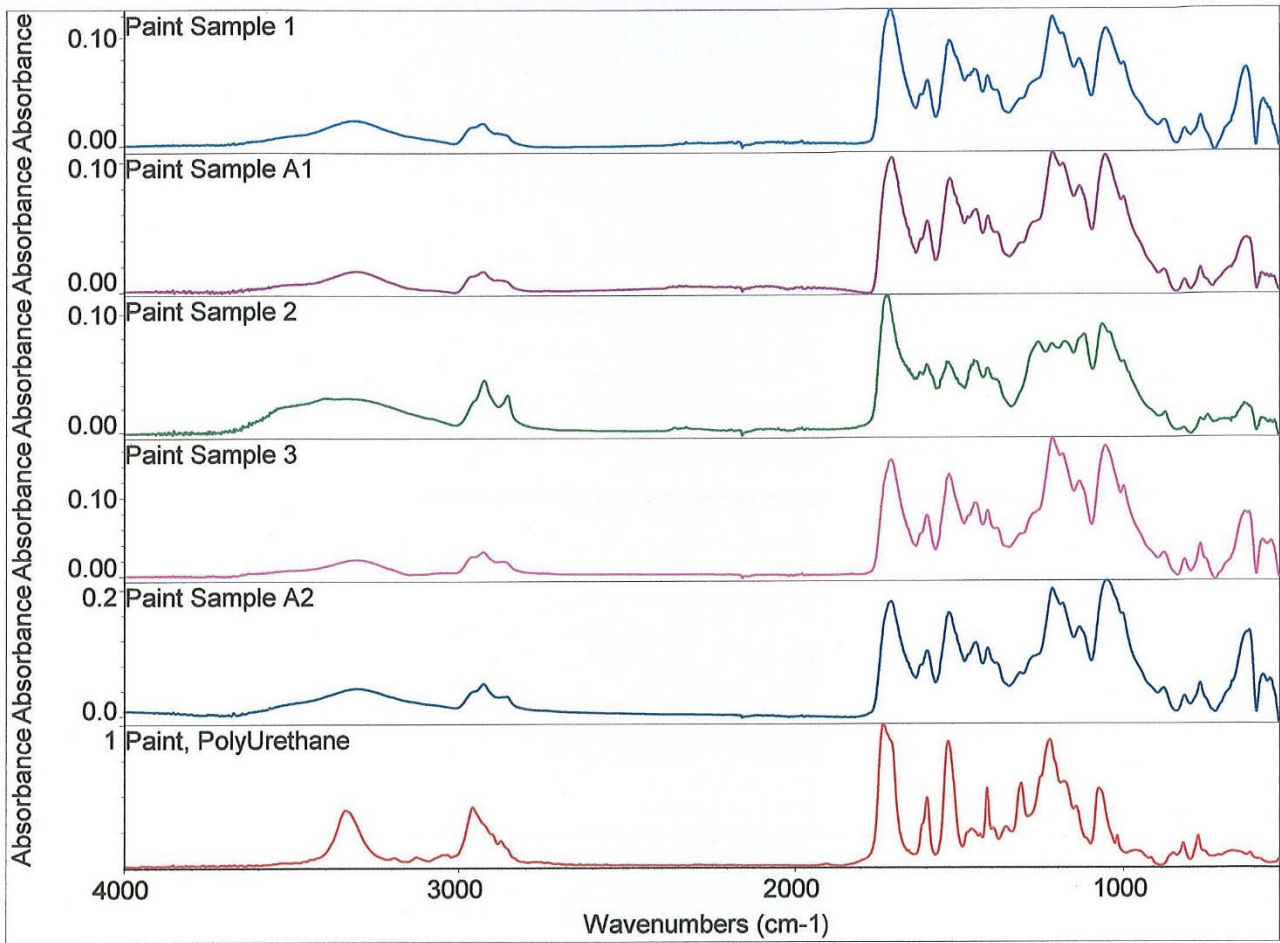
Fourier transform infrared (FTIR) spectroscopy was performed on paint samples removed from each coupon using Attenuated Total Reflectance (ATR) with a diamond crystal. All paint samples were identified as polyurethane enamel. The resulting FTIR spectra of the samples and the best matches from the spectral FTIR library of standards for polyurethane enamel are provided as Figures 111 and 112.

Figure 111. The FTIR spectra generated from a paint samples removed from the exterior surfaces of Coupons 1, A1, 2, A2 and 3 the best matches from the spectral FTIR library of standards for polyurethane enamel.

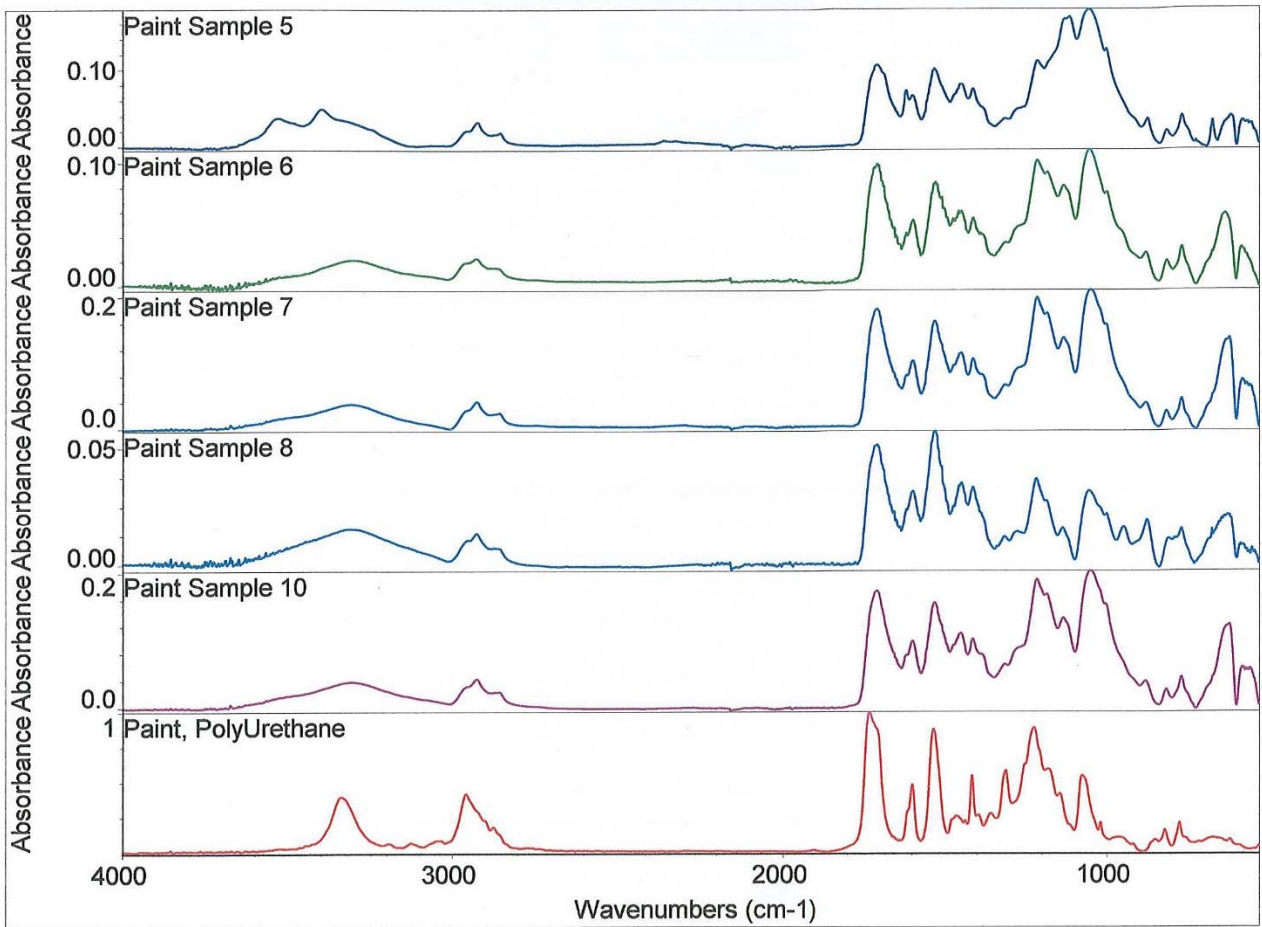
Figure 112. The FTIR spectra generated from a paint samples removed from the exterior surfaces of Coupons 5, 6, 7, 8 and 10 the best matches from the spectral FTIR library of standards for polyurethane enamel.

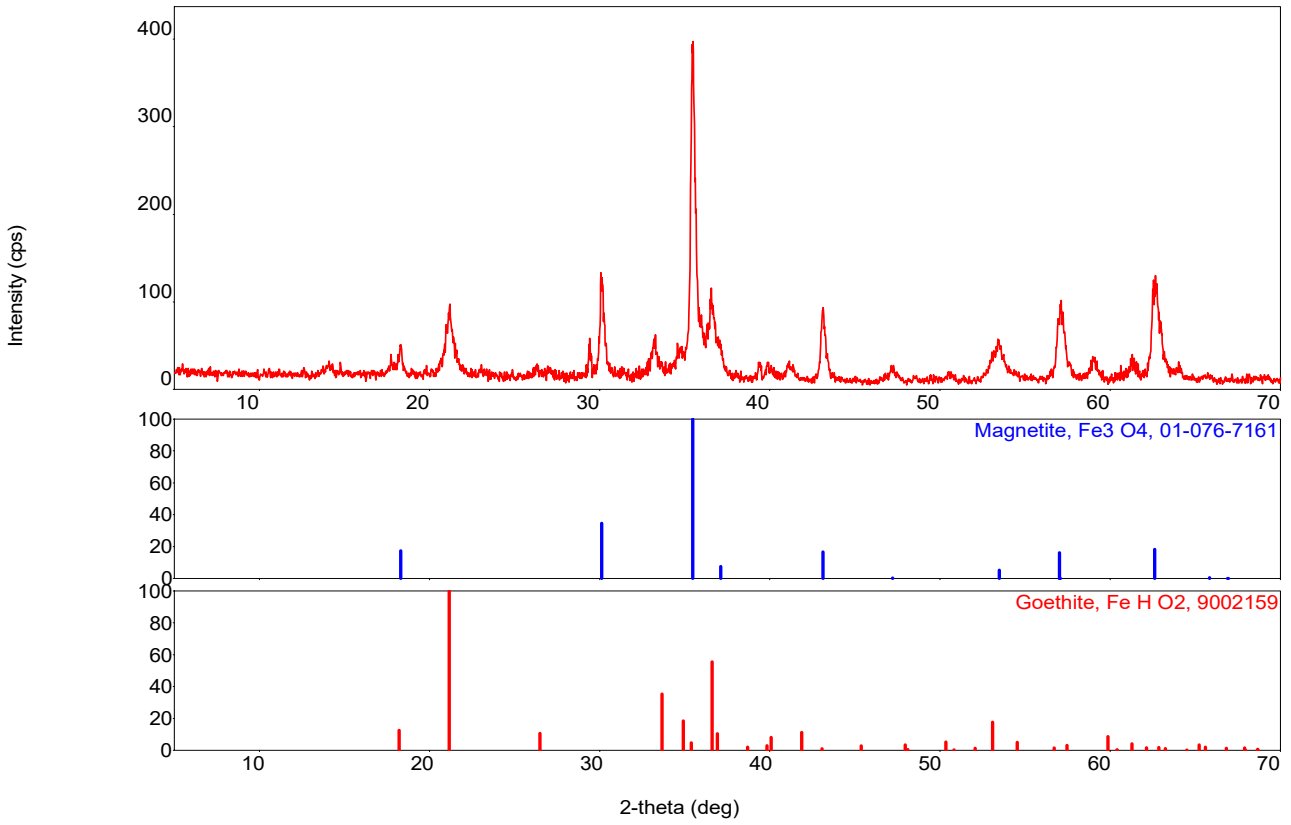
X-Ray Diffraction Spectroscopy (XRD) analysis of the corrosion product from the metal panels revealed the presence of the following crystalline phases: iron oxide (magnetite); iron hydroxide (goethite); calcium carbonate (calcite); silicon dioxide and hydrous calcium aluminum sulfate (ettringite). The results are summarized in Tables 19 and 20. The XRD diffractograms for the corrosion samples are provided as Figures 123 through 128.

Figure 123. The XRD diffractogram generated from corrosion product removed Coupon 1.

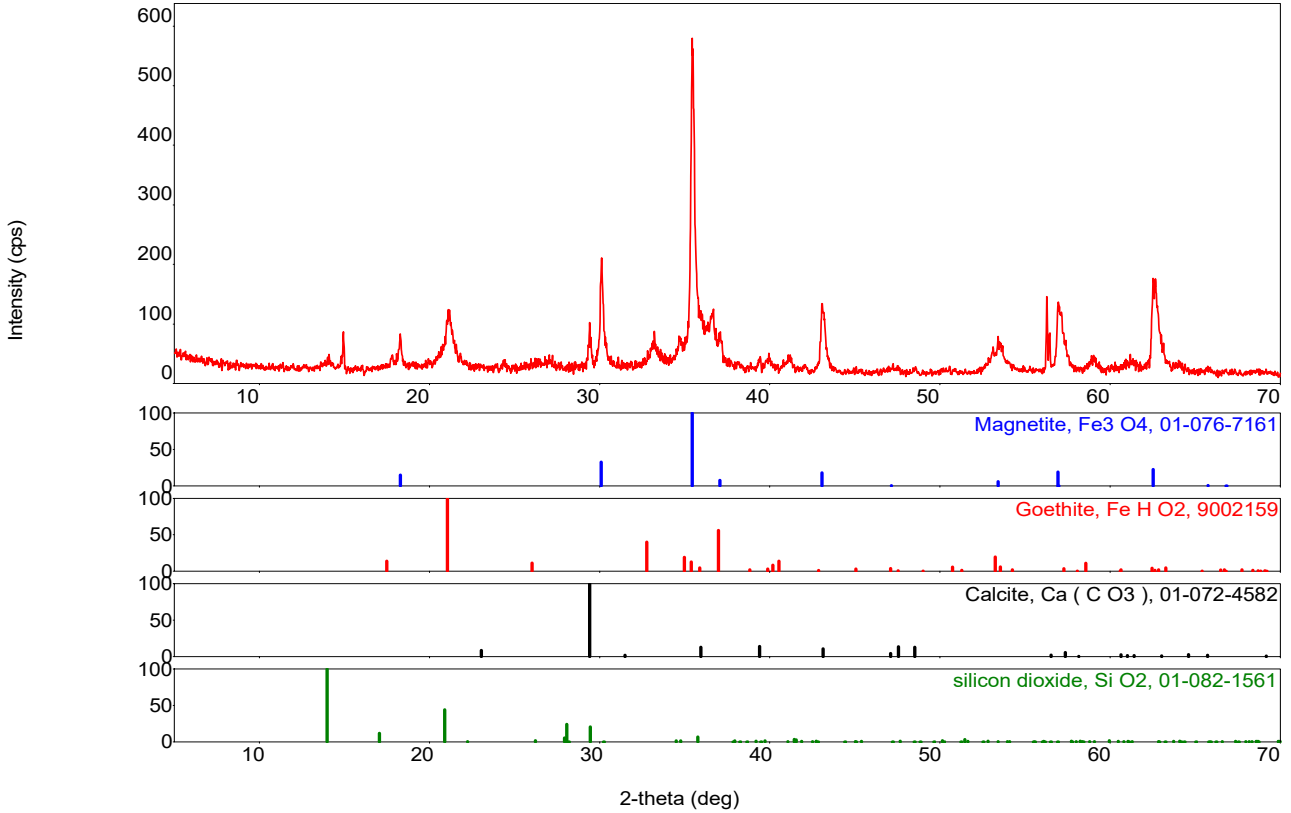
Figure 124. The XRD diffractogram generated from corrosion product removed Coupon 2.
