SUBJECT: DESTRUCTIVE ANALYSIS OF 10 STEEL COUPONS REMOVED FROM RED HILL FUEL STORAGE TANK NO. 14, PURSUANT TO SECTION 5.3 OF THE ADMINISTRATIVE ORDER ON CONSENT STATEMENT OF WORK, RED HILL BULK FUEL STORAGE FACILITY, JOINT BASE PEARL HARBOR-HICKAM, OAHU, HAWAII

Destructive Analysis of 10 Steel Coupons Removed from Red Hill Fuel Storage Tank #14

REPORT No. 201801967

December 17, 2018

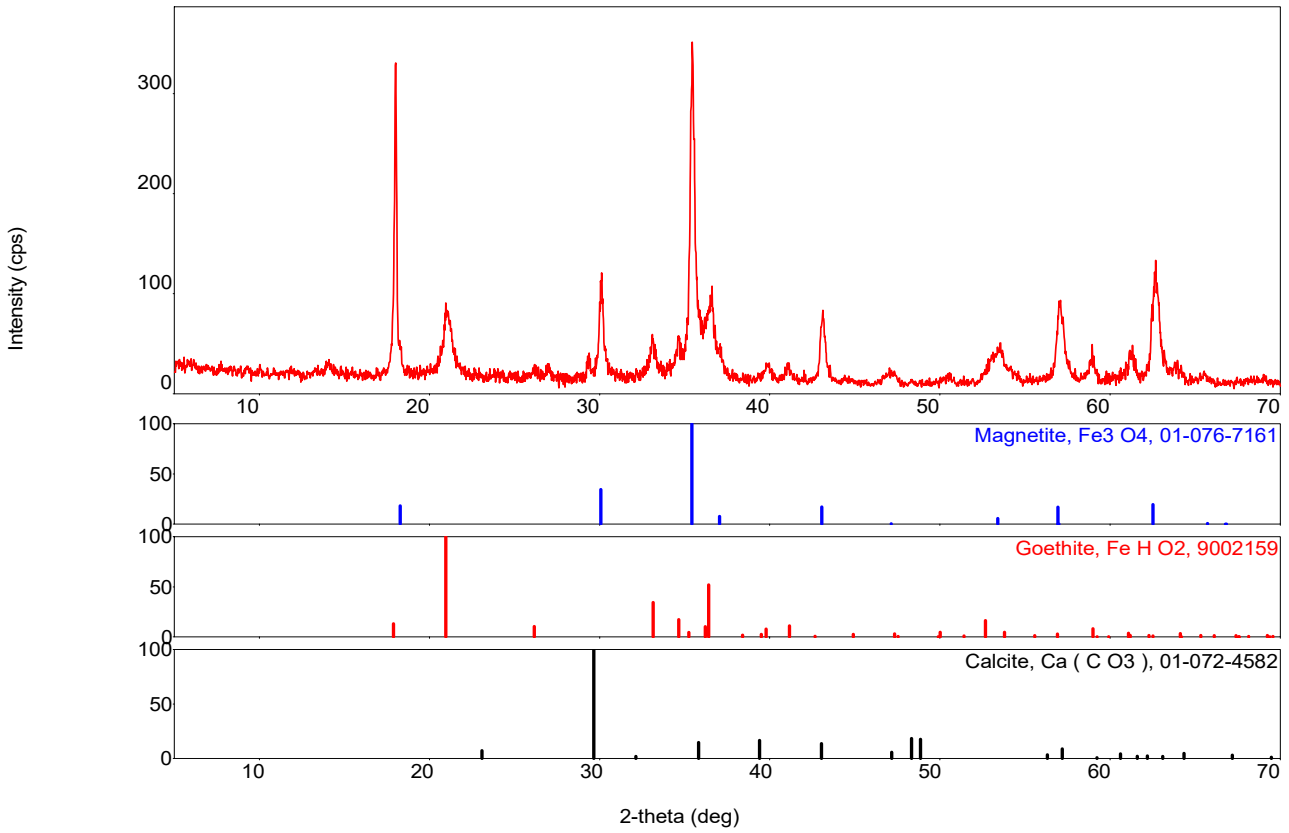
X-Ray Diffraction Spectroscopy (XRD) analysis of the corrosion product from the metal panels revealed the presence of the following crystalline phases: iron oxide (magnetite); iron hydroxide (goethite); calcium carbonate (calcite); silicon dioxide and hydrous calcium aluminum sulfate (ettringite). The results are summarized in Tables 19 and 20. The XRD diffractograms for the corrosion samples are provided as Figures 123 through 128.

Figure 125. The XRD diffractogram generated from corrosion product removed Coupon 3.

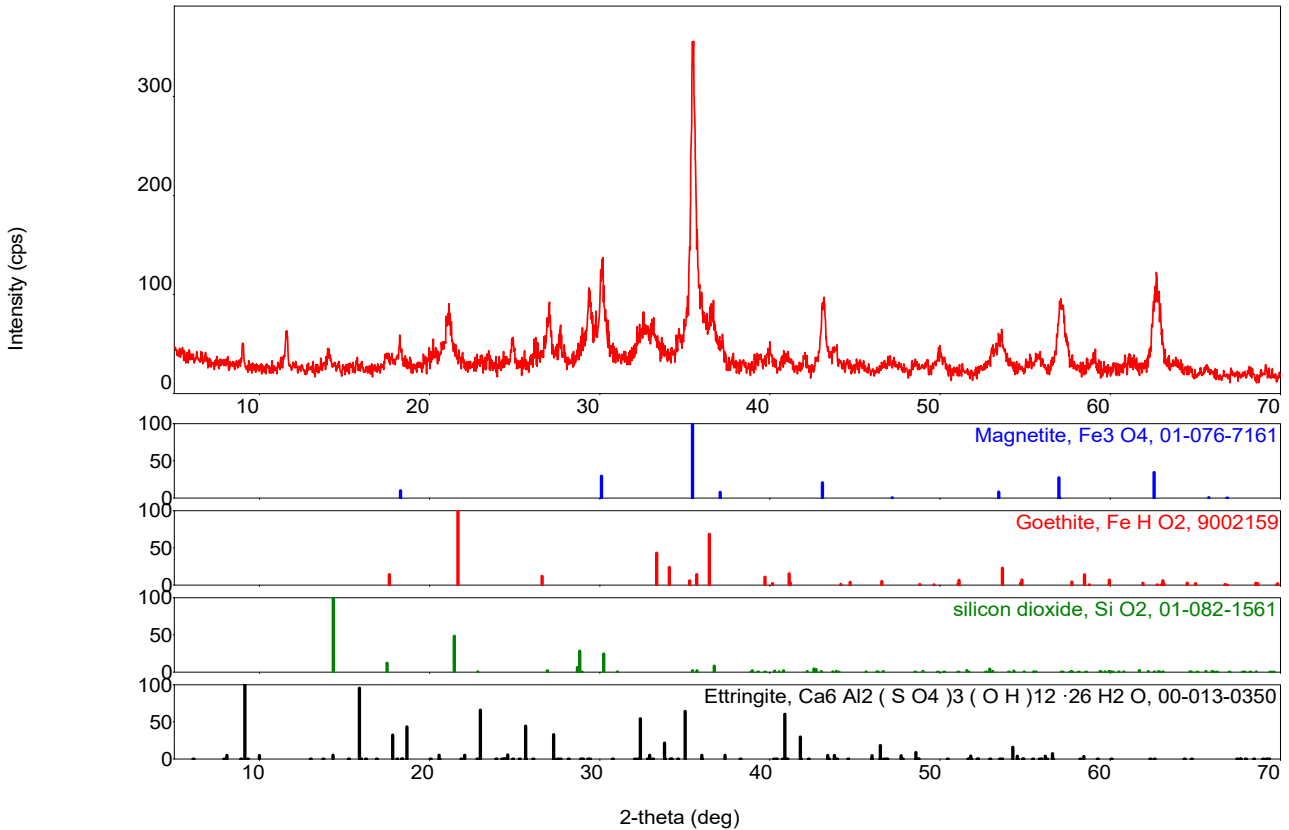
Figure 126. The XRD diffractogram generated from corrosion product removed Coupon 6.

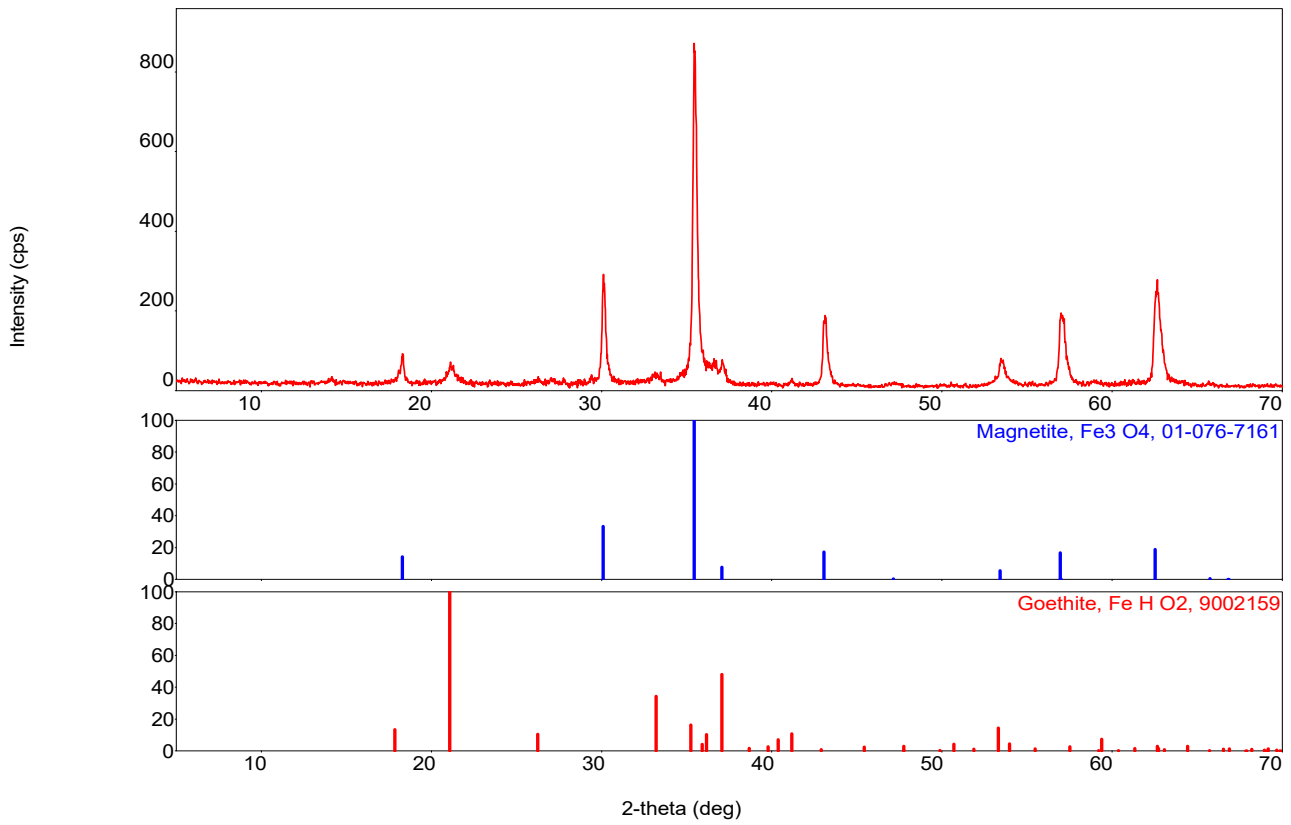
Figure 127. The XRD diffractogram generated from corrosion product removed Coupon 7.

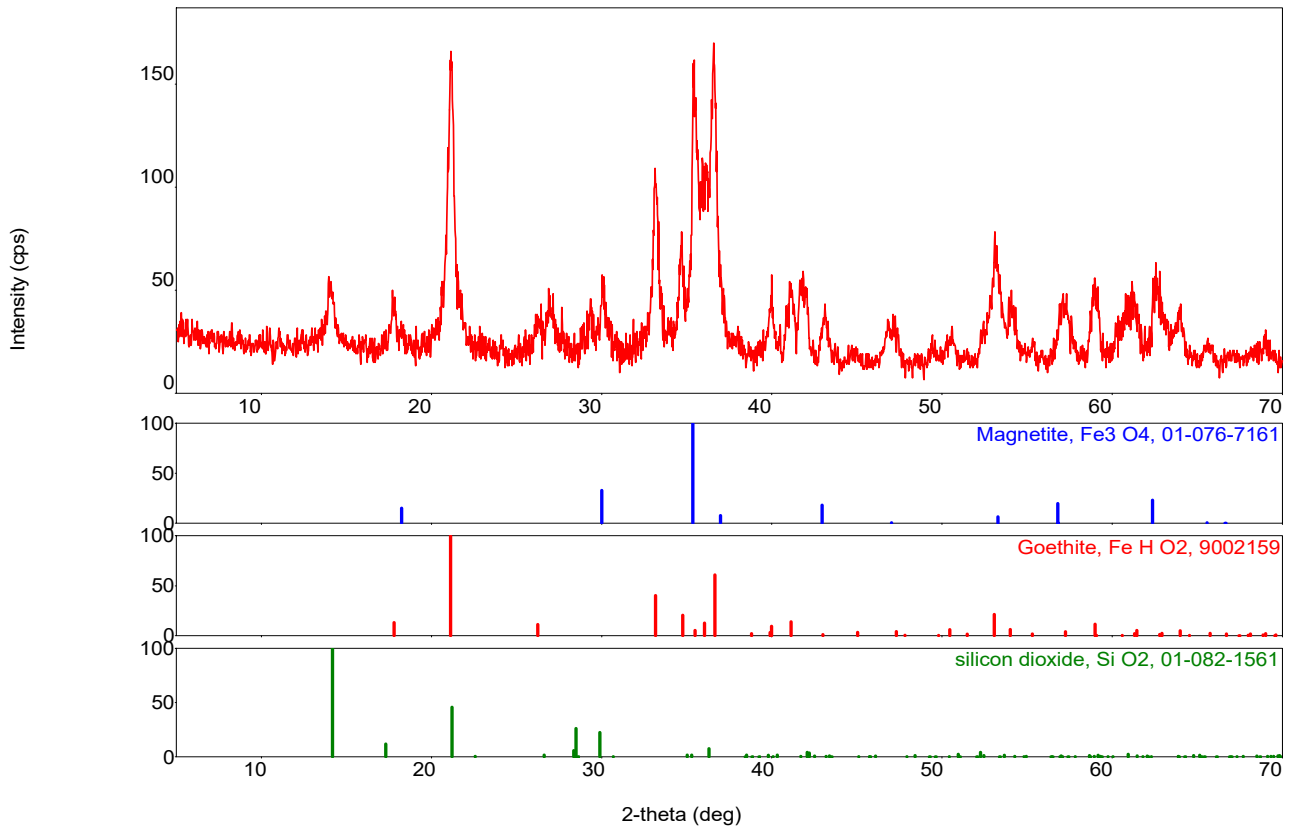
Figure 128. The XRD diffractogram generated from corrosion product removed Coupon 8.

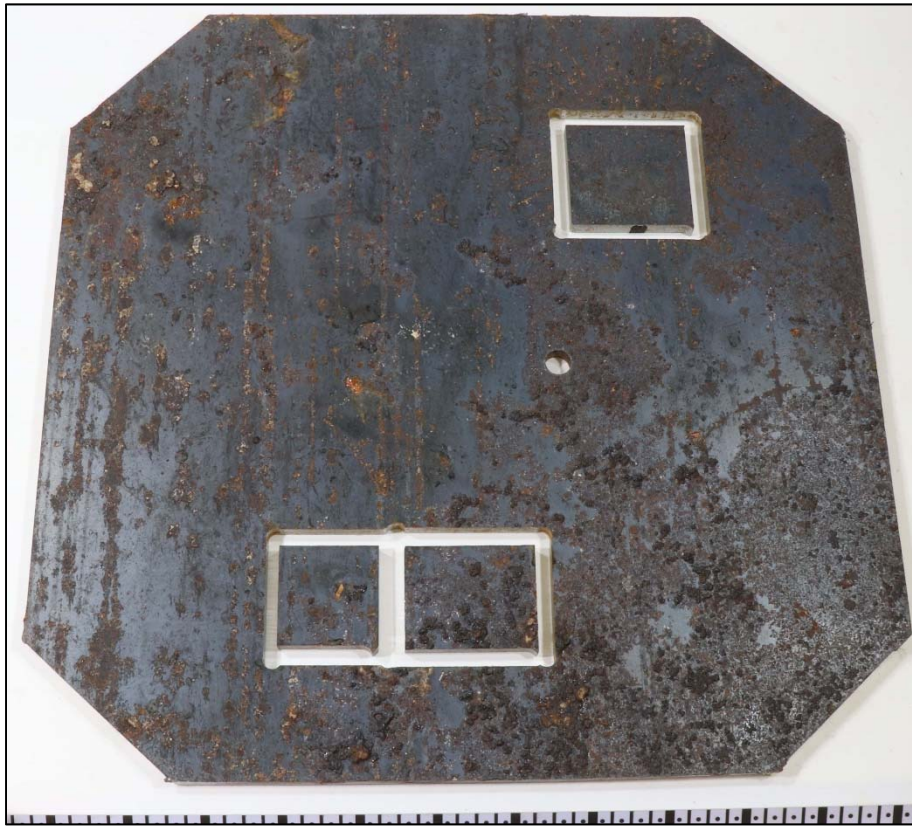
Figure 129. An image of the interior surface of Coupon 1 after CO₂ blast cleaning.

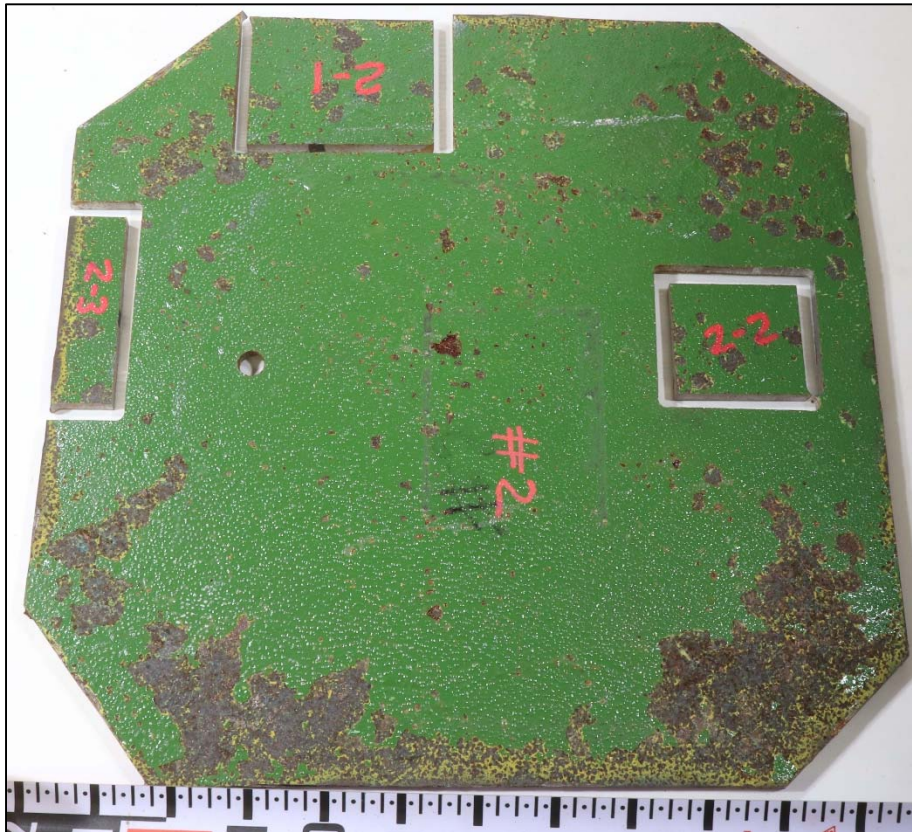
Figure 132. An image of the exterior surface of Coupon 2 after CO₂ blast cleaning.

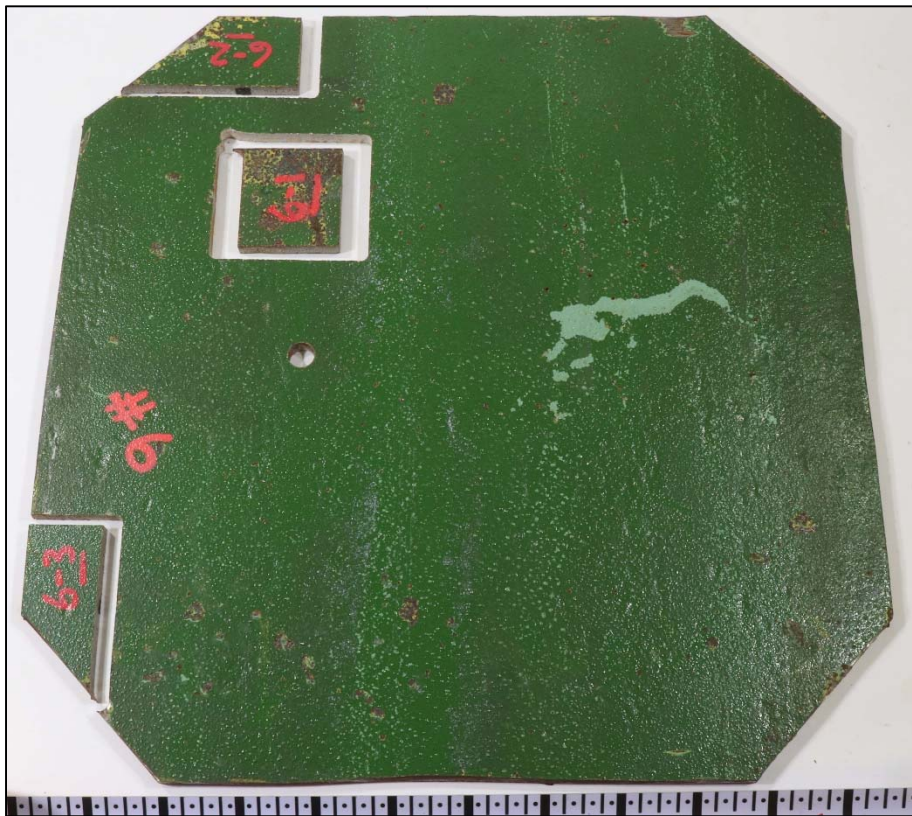
Figure 138. An image of the exterior surface of Coupon 6 after CO₂ blast cleaning.

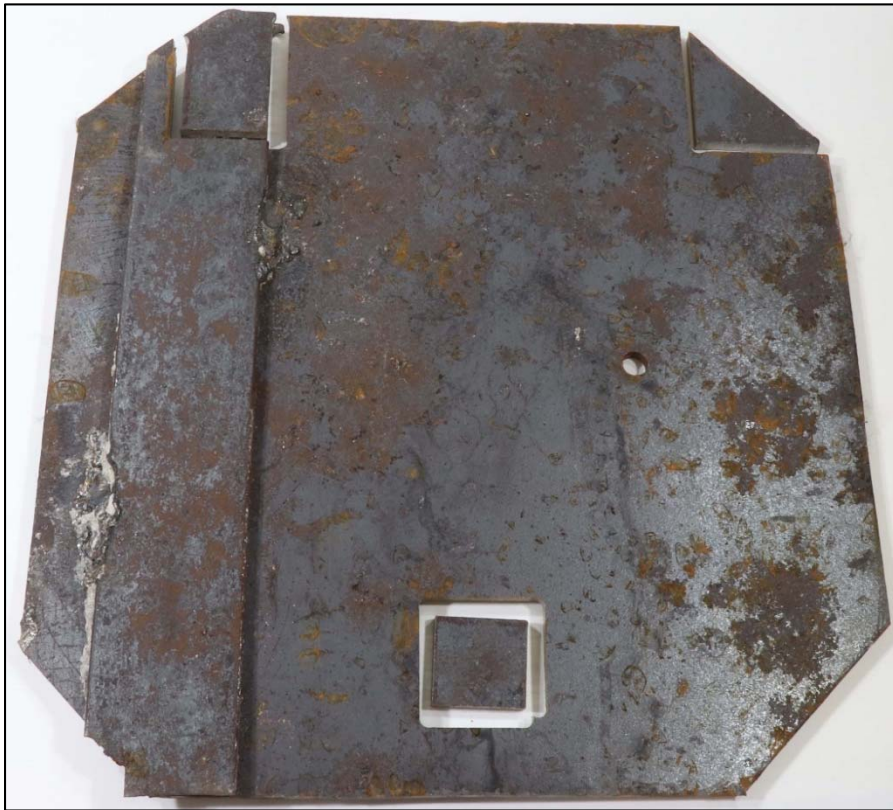
Figure 141. An image of the interior surface of Coupon 8 after CO₂ blast cleaning.

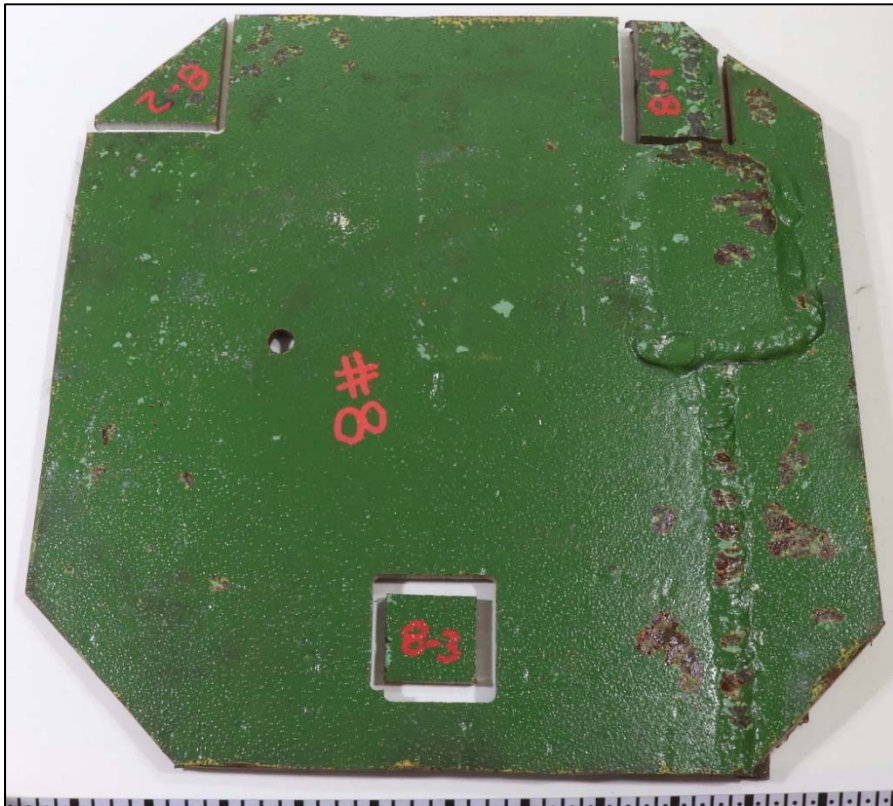
Figure 142. An image of the exterior surface of Coupon 8 after CO₂ blast cleaning.

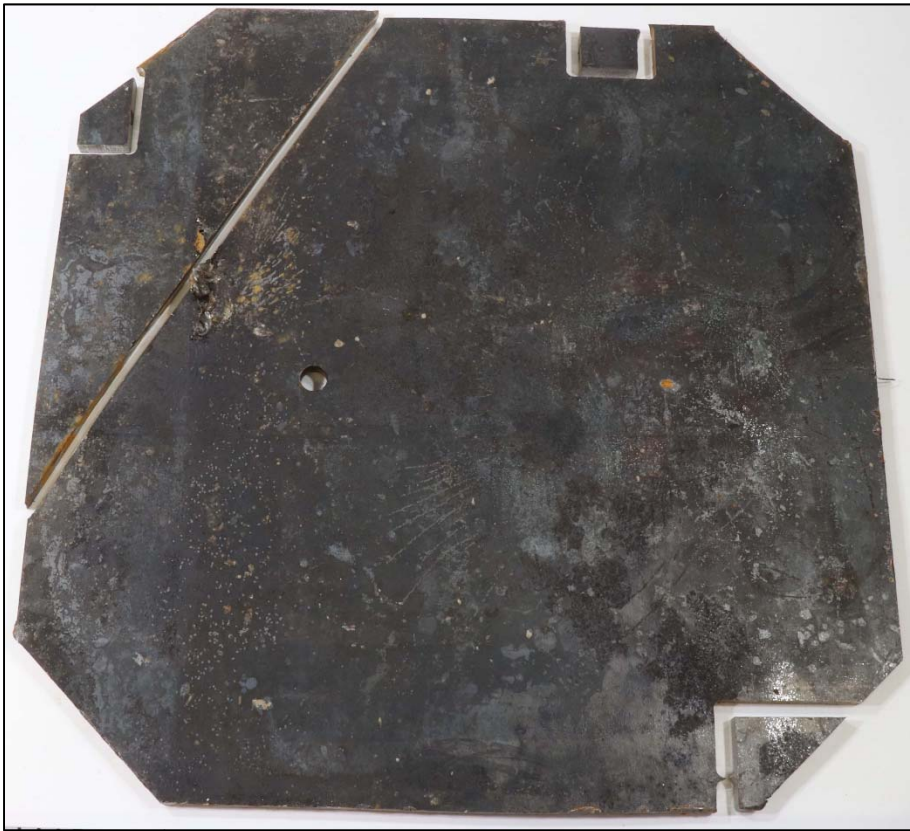
Figure 143. An image of the interior surface of Coupon 10 after CO₂ blast cleaning.

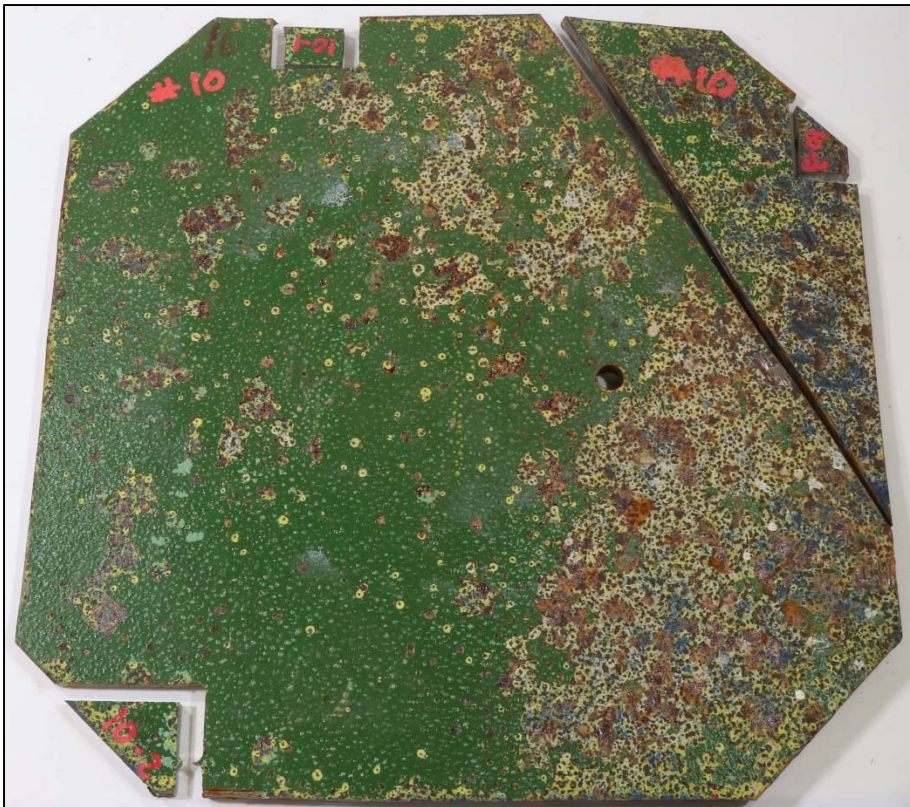
Figure 144. An image of the exterior surface of Coupon 10 after CO₂ blast cleaning.

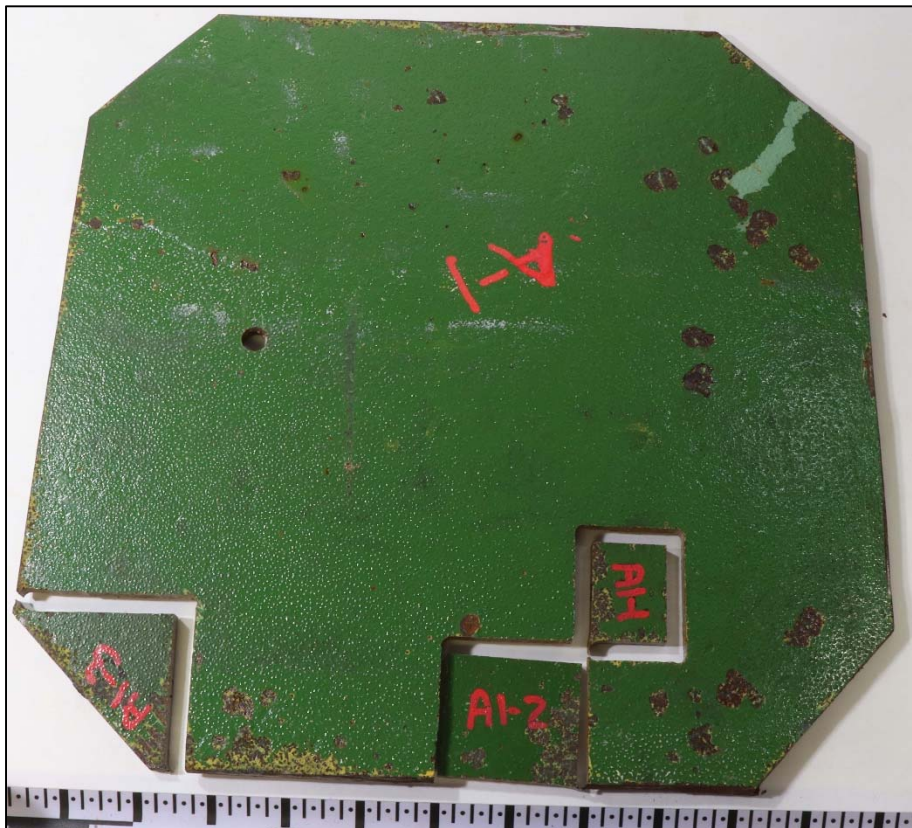
Figure 146. An image of the exterior surface of Coupon A1 after CO₂ blast cleaning.

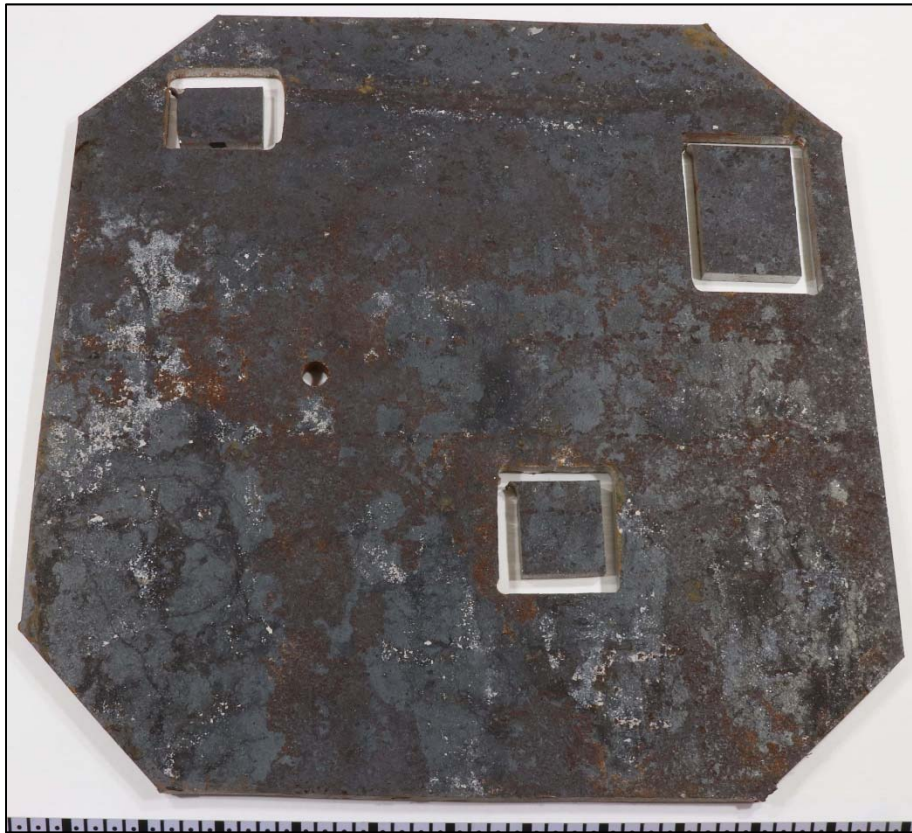
Figure 147. An image of the interior surface of Coupon A2 after CO₂ blast cleaning.

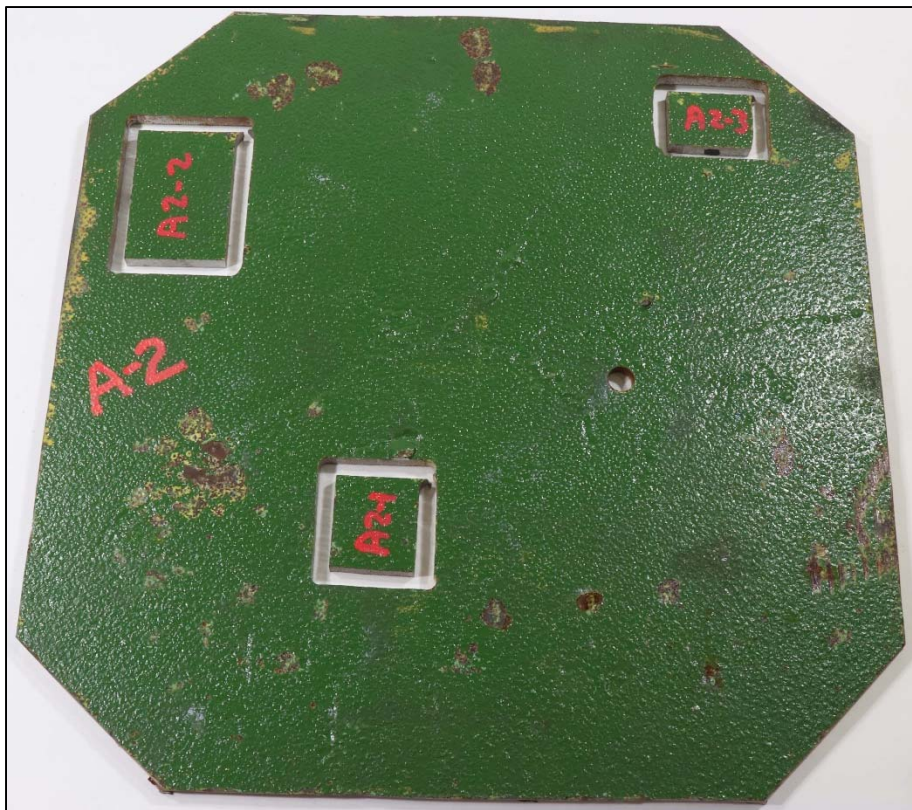
Figure 148. An image of the exterior surface of Coupon A2 after CO₂ blast cleaning.

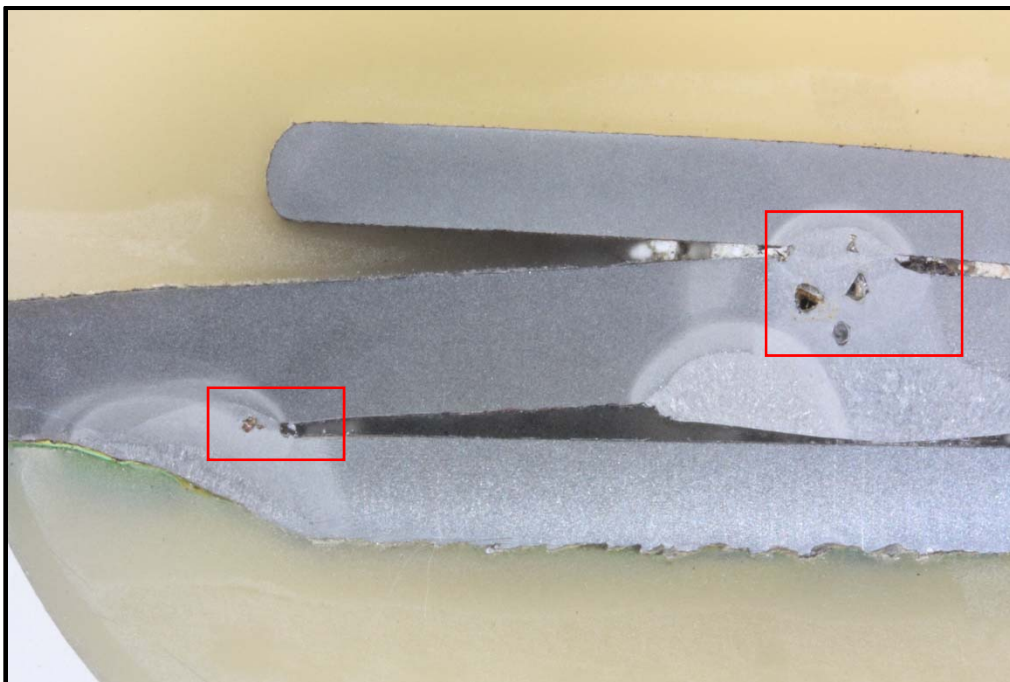
Figure 210. The prepared metallographic cross-section through welded sample 8-4 is shown in an overall view. The painted exterior surface is along the bottom section. The areas identified by the red boxes are shown in the next two figures at higher magnification.

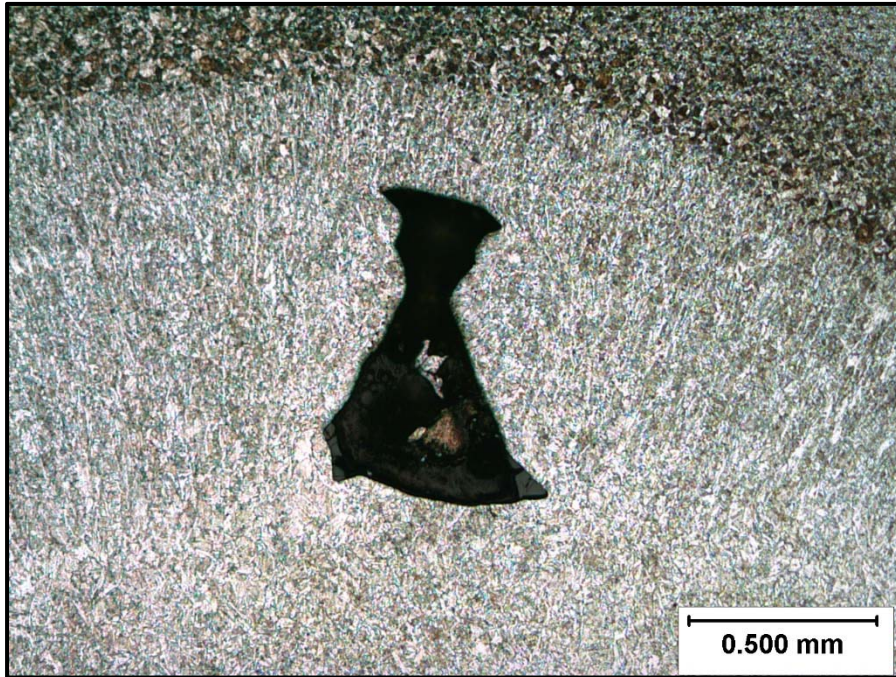
Figure 213. The one of the voids is shown at higher magnification. (2% Nital Etch, 50X)

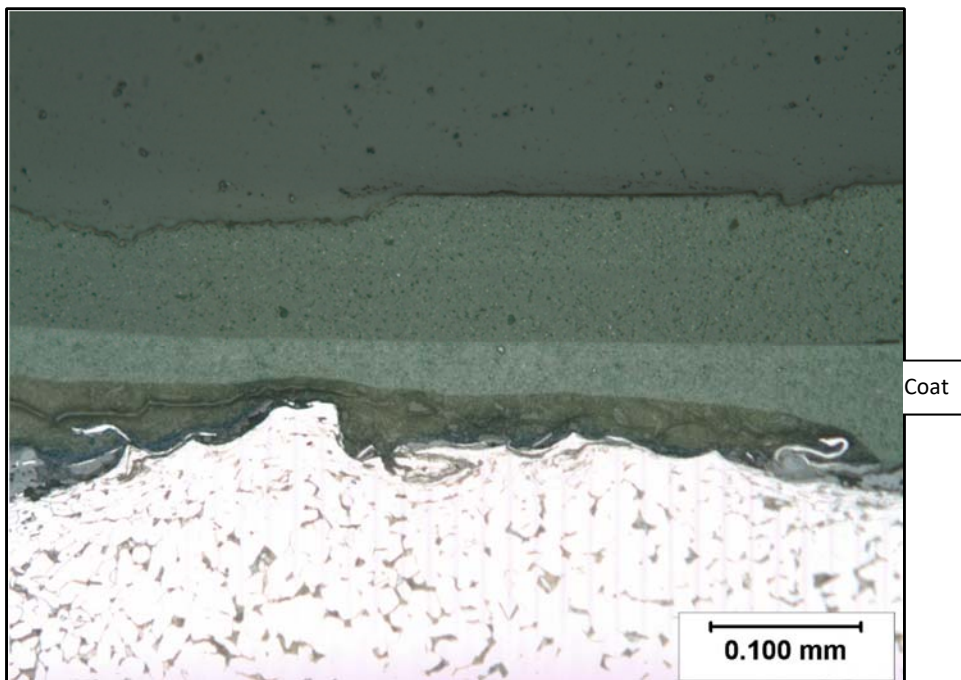
A typical paint layer was examined microscopically and was determined to consist of two layers, as shown in Figure 214. This indicates that the exterior tank wall exhibits a primer layer with a top coat. The scraped paint samples that were excised from each coupon previously for FTIR analysis would likely have captured some of both layers. The FTIR results presented previously were a good match for polyurethane, with no observable secondary component. Although this indicates that both the primer and top coat were polyurethane-based, it cannot be ruled out that the primer exhibited a different composition.

Figure 214. A typical paint layer is shown in cross-section, with key characteristics identified. (2% Nital Etch, 200X)
