SUBJECT: ADMINISTRATIVE ORDER ON CONSENT (AOC) STATEMENT OF WORK (SOW) SECTION 5 CORROSION AND METAL FATIGUE PRACTICES, DESTRUCTIVE TESTING RESULTS REPORT, RED HILL BULK FUEL STORAGE FACILITY (RED HILL), JOINT BASE PEARL HARBOR-HICKAM, OAHU, HAWAII

As identified in Red Hill Bulk Fuel Storage Facility Scope of Work for Destructive Testing Administrative Order on Consent (AOC) and Statement of Work (SOW) Section 5.3.2, the purpose of this effort is to verify the findings of the Corrosion and Metal Fatigue Practices Report, using destructive testing on at least one tank at the Facility.

In 2018, ten coupons were removed from Tank 14, so that a metallurgical and corrosion analysis of the coupons could be undertaken, with the primary aim of validating non-destructive examination (NDE) results. The steel coupons, concrete powder samples, and corrosion product were submitted to a certified third-party laboratory to perform this analysis.

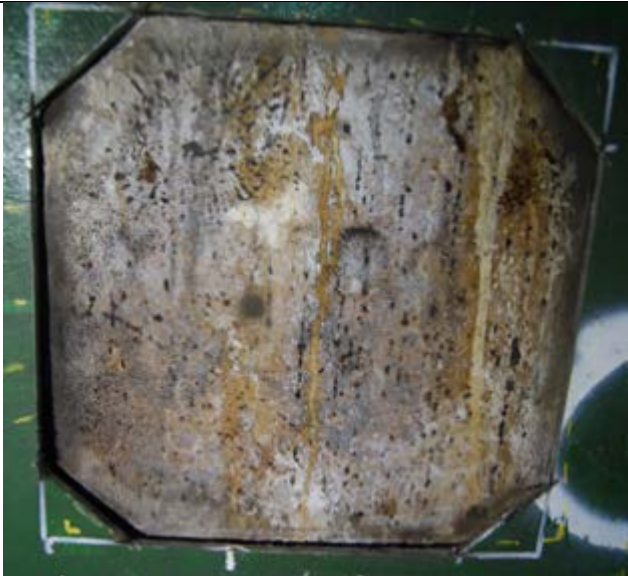
6/20/2018: 1400
CONCRETE SAMPLE SPECIFICS		
Sample ID	1	1
Sample Location	14-UD-A-42-45-107	
Sample Dimensions	12" × 12"	
ON SITE VISUAL EXAMINATION		
Checks	Observations	
	Exterior	Units
Void space between concrete and liner (if any)	1/8" Void on left side, no voids in all other areas	
Biological Materials	None	
Wet or Dry	Dry	
Smell	None	
Temperature	76.9	Degrees F
Surface pH	9 to 9.5	
Structure to Electrolyte	-0.252	Volts/CSE
Concrete Resistivity	26.4 Horizontal 31.1 Vertical	k-ohm-cm k-ohm-cm
General Condition	Excellent, sound concrete with some discoloration and no cracks and no delamination	
Concrete behind Coupon 1

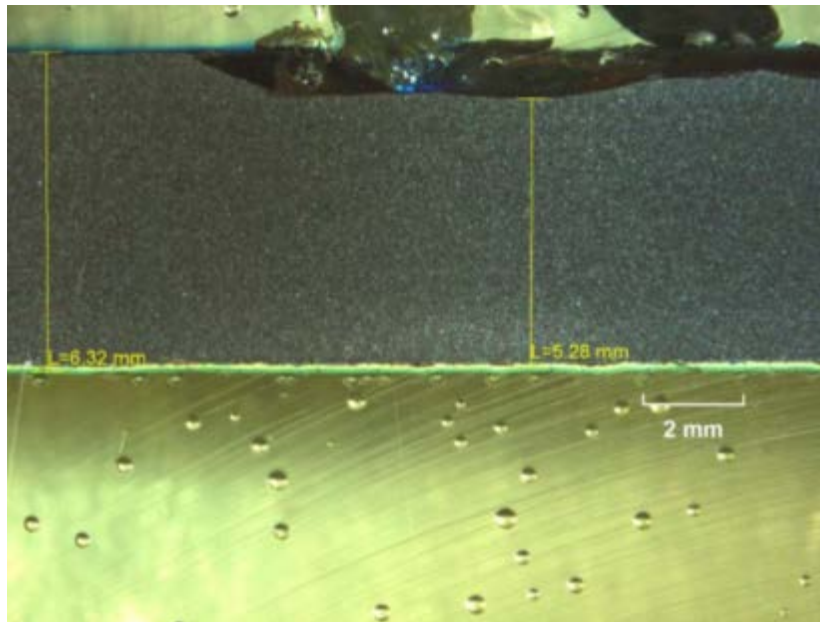
Figure 3-2 Cross Section of Coupon 1 at Area of Maximum Wall Loss

- Detailed results of the Destructive Testing Laboratory analysis of Coupon 1 are contained in Appendix A.
- The thinnest measured location was 207.9 mils (5.28 mm).
- Assuming a nominal wall thickness of 250 mils, the remaining wall thickness at the thinnest location was 83.1%.
- Coupon 1 exhibited backside corrosion as was predicted.
- A cross-section view of Coupon 1 is shown in Figure 3-2.

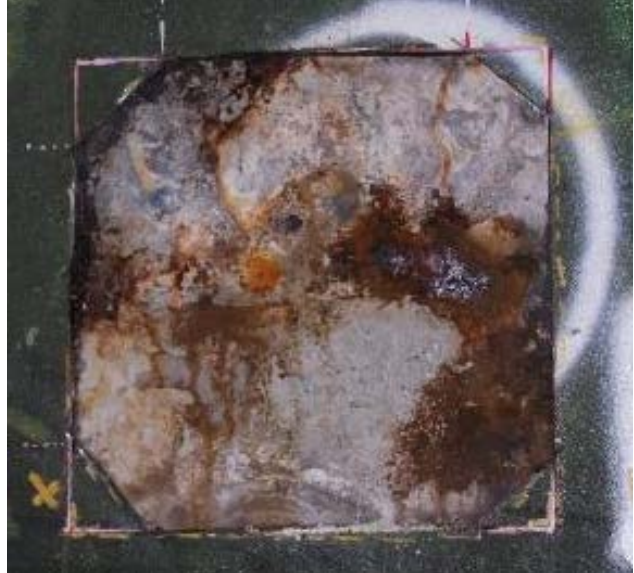
6/19/2018: 0930		
CONCRETE SAMPLE SPECIFICS		
Sample ID	2	2
Sample Location	14-ER-E3-12-33-40	
Sample Dimensions	12" × 12"	
ON SITE VISUAL EXAMINATION		
Checks	Observations	
	Exterior	Units
Void space between concrete and liner (if any)	1/8" void at upper left side. Otherwise no voids.	
Biological Materials	None	
Wet or Dry	Slightly damp	
Smell	Musty, no fuel	
Temperature	80.0	Degrees F
Surface pH	10-11 corroded area 11-12 non-corroded area	
Structure to Electrolyte	-0.380	Volts/CSE
Concrete Resistivity	19.0 Horizontal 17.5 Vertical	k-ohm-cm k-ohm-cm
General Condition	Good sound condition with some minor spalling and corrosion product. Coupon took some hammering to remove.	
Concrete behind Coupon 2

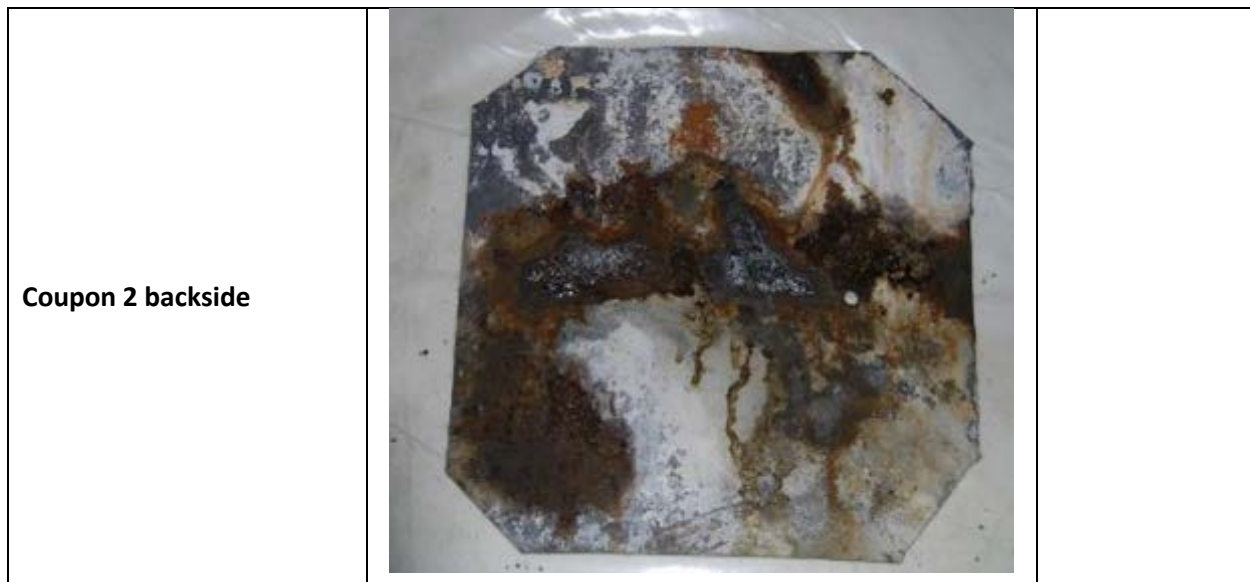
Tue, 19 Jun 2018, 10:46 AM		
COUPON SPECIFICS		
Coupon ID	2	2
Coupon Location	14-ER-E3-12-33-40	
Coupon Dimensions	12" × 12"	
Coupon Thickness	¼" (NDE: minimum 0.157")	Prove-up: minimum 0.150"
Locations of Welds	None	
ON SITE VISUAL EXAMINATION		
Checks	Observations	
	Exterior	Interior
Deposits, Coatings, Debris	Lots of deposits and concrete	Regular coating
Scale	None	None
Observed Biological Material	None	None
Wet or Dry	damp	Dry
Smell	burnt, musty, muddy	Burnt but less intense than exterior
Presence of petroleum product between steel and concrete surface.	No	No
Presence of corrosion	Yes	Yes
Isolated pitting	Yes	Yes
Isolated pitting within areas of general corrosion	Yes	No
Linked pitting within areas of general corrosion	No	No
Identify color of corrosion products	Brown, black, gray	Brown
Identify if selected attack at welds	N/A	N/A

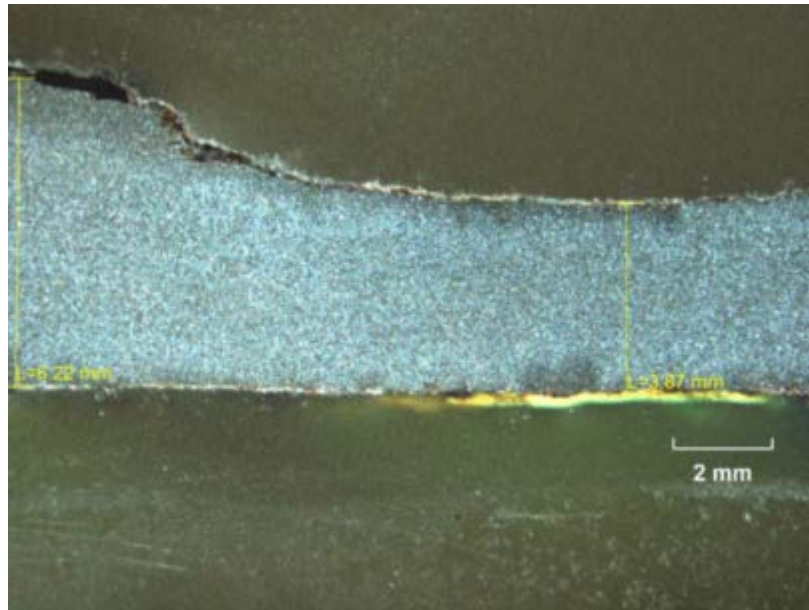
Figure 3-3 Cross Section of Coupon 2 at area of Maximum Wall Loss

- Detailed results of the Destructive Testing Laboratory analysis of Coupon 2 are contained in Appendix A.
- The thinnest measured location was 152.4 mils (3.87 mm).
- Assuming a nominal wall thickness of 250 mils, the remaining wall thickness at the thinnest location was 60.9%.

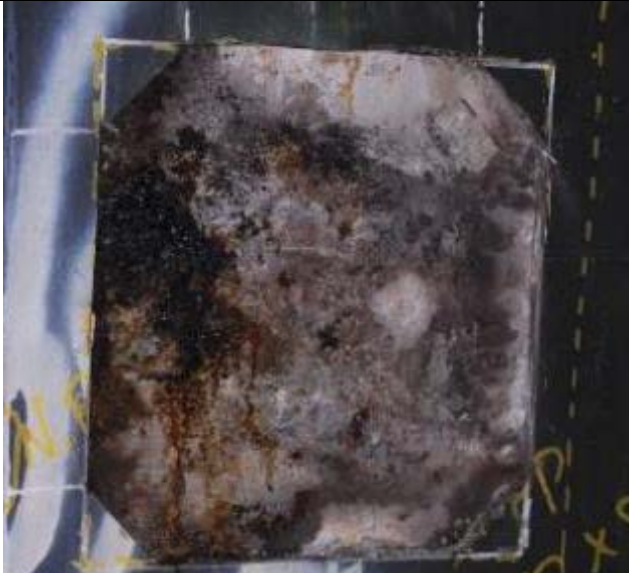
6/19/2018: 14:00		
CONCRETE SAMPLE SPECIFICS		
Sample ID	3	3
Sample Location	14-ER-E3-13-7-18	
Sample Dimensions	12" × 12"	
ON SITE VISUAL EXAMINATION		
Checks	Observations	
	Exterior	Units
Void space between concrete and liner (if any)	On left side, uneven corrosion product and a 1/16-inch void. Otherwise, no voids.	
Biological Materials	None	
Wet or Dry	Mostly dry, with some damp spots	
Smell	None	
Temperature	79.3	F
Surface pH	11-12 dry areas, 7-8 in areas with corrosion product	
Structure to Electrolyte	-0.488	Volts/CSE
Concrete Resistivity	27.8 Horizontal 31.2 Vertical	K-Ohm-cm
General Condition	Good, with some corrosion products. Corrosion product was black on the left side, and brown in some other areas. Concrete was hard and difficult to drill for powder samples. Coupons required some hammering and prying to remove after cutting.	
Concrete behind Coupon 3

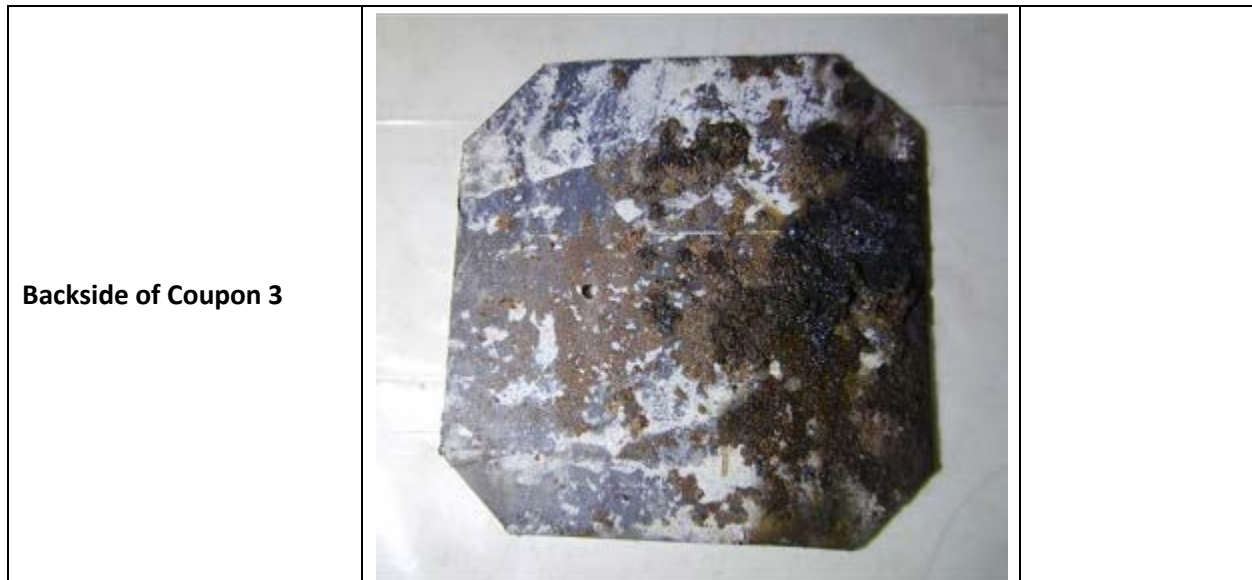
Tue, 19 Jun 2018, 3:00 PM		
COUPON SPECIFICS		
Coupon ID	3	3
Coupon Location	14-ER-E3-13-9-18	
Coupon Dimensions	12" × 12"	
Coupon Thickness	¼" (NDE: minimum 0.033")	
Locations of Welds	None	
ON SITE VISUAL EXAMINATION		
Checks	Observations	
	Exterior	Interior
Deposits, Coatings, Debris	Thick, brown, grey deposits	Standard coating with paint
Scale	None	None
Observed Biological Material	None	None
Wet or Dry	Wet	Dry
Smell	Burnt, like wax	None
Presence of petroleum product between steel and concrete surface	Yes	No
Presence of corrosion	Yes	Yes
Isolated pitting	Yes	Yes
Isolated pitting within areas of general corrosion	Yes	No
Linked pitting within areas of general corrosion	No	No
Identify color of corrosion products	White, brown	Brown
Identify if selected attack at welds	N/A	N/A

Coupon 3 exhibited backside corrosion that was not predicted. However, it must be noted that layout work to finalize sizing and location of a repair adjacent to Coupon 3 had not taken place prior to removal of the coupon. This corrosion was noted on the Spreadsheet that was reviewed by the Regulators, and one of the reasons why this coupon location was selected.

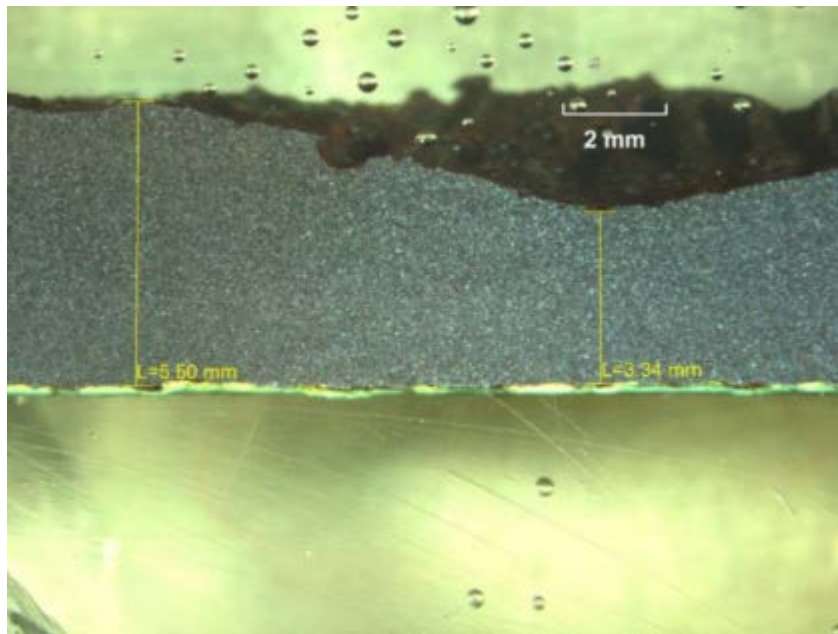
Figure 3-4 Cross Section of Coupon 3 at Area of Maximum Wall Loss

- Detailed results of the Destructive Testing Laboratory analysis of Coupon 3 are contained in Appendix A.
- The thinnest measured location was 131.5 mils (3.34 mm).
- Assuming a nominal wall thickness of 250 mils, the remaining wall thickness at the thinnest location was 52.6%.
- A cross-section view of Coupon 3 is shown in Figure 3-4.

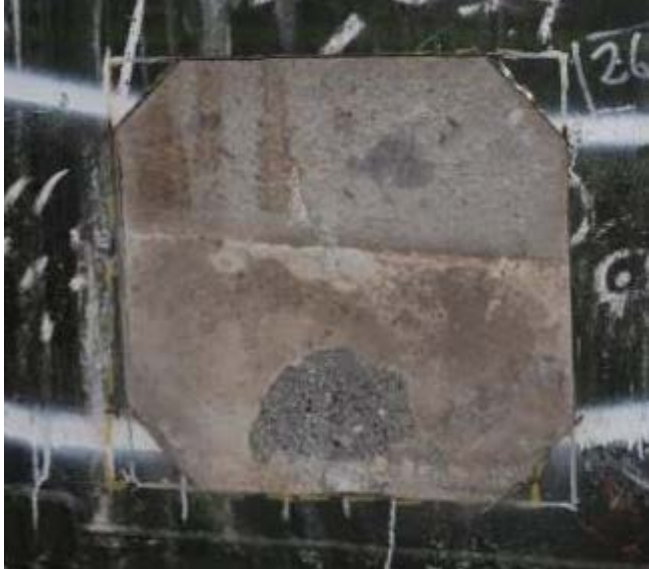
6/20/2018: 0800		
CONCRETE SAMPLE SPECIFICS		
Sample ID	5	5
Sample Location	14-BA-26-15-15-8	
Sample Dimensions	12" × 12"	
ON SITE VISUAL EXAMINATION		
Checks	Observations	
	Exterior	Units
Void space between concrete and liner (if any)	1/16" Void on top right side, no voids in all other areas	
Biological Materials	None	
Wet or Dry	Dry	
Smell	None	
Temperature	78.5	F
Surface pH	11-12	
Structure to Electrolyte	-0.220	Volts/CSE
Concrete Resistivity	19.1 Horizontal 22.0 Vertical	k-ohm-cm k-ohm-cm
General Condition	Excellent, sound concrete	
Concrete behind Coupon 5

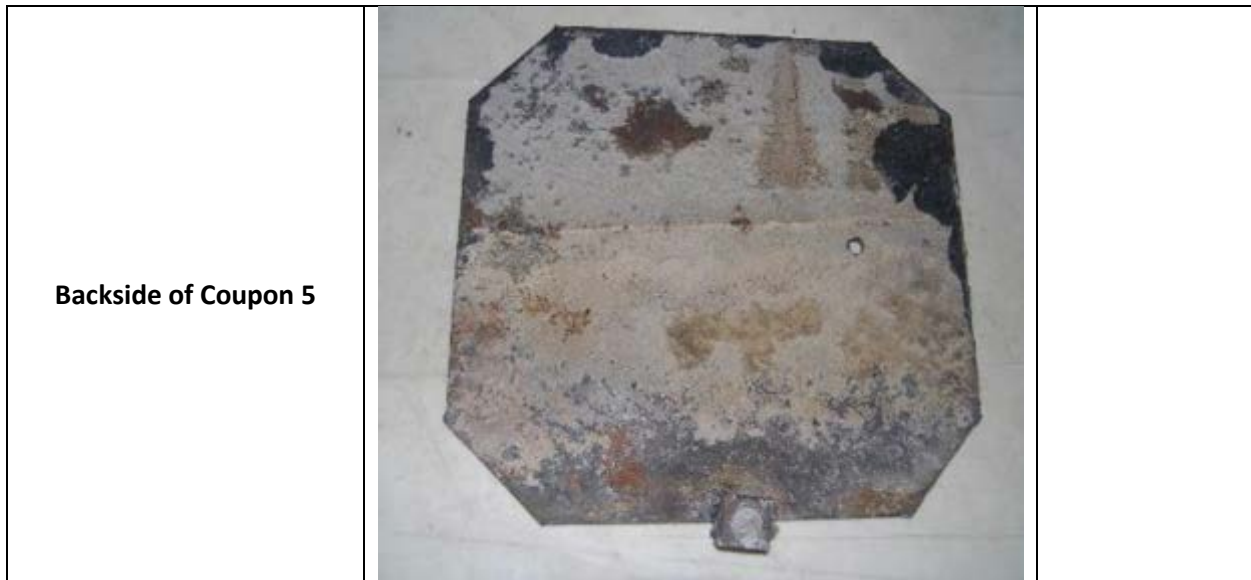
Wed, 20 Jun 2018, 08:20 AM		
COUPON SPECIFICS		
Coupon ID	5	5
Coupon Location	14-BA-26-15-15-8	
Coupon Dimensions	12" × 12"	
Coupon Thickness	¼" (NDE: minimum 0.047")	(No prove-up-phase thickness)
Locations of Welds	None	
ON SITE VISUAL EXAMINATION		
Checks	Observations	
	Exterior	Interior
Deposits, Coatings, Debris	Concrete layer, thin	Standard coating
Scale	None	None
Observed Biological Material	None	None
Wet or Dry	Dry	Dry
Smell	Burnt	Burnt
Presence of petroleum product between steel and concrete surface	No	No
Presence of corrosion	Yes	No
Isolated pitting	No	No
Isolated pitting within areas of general corrosion	No	No
Linked pitting within areas of general corrosion	No	No
Identify color of corrosion products	Brown	N/A
Identify if selected attack at welds	N/A	N/A

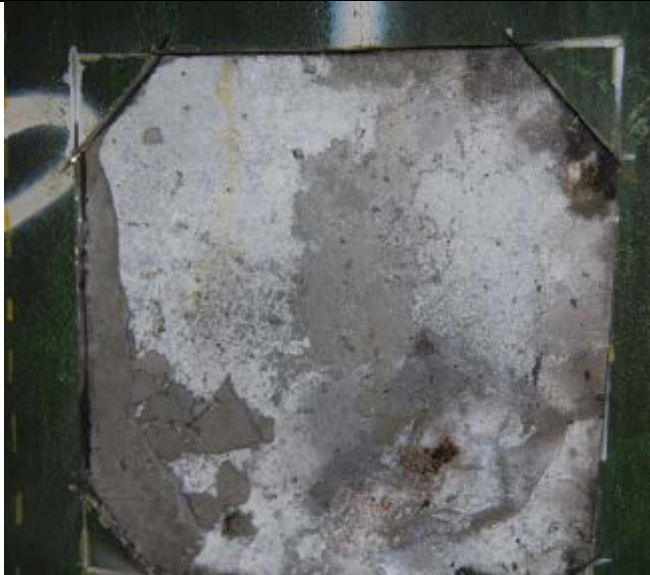
6/21/2018: 1100		
CONCRETE SAMPLE SPECIFICS		
Sample ID	6	6
Sample Location	14-BA-24-8-36-30	
Sample Dimensions	12" × 12"	
ON SITE VISUAL EXAMINATION		
Checks	Observations	
	Exterior	Units
Void space between concrete and liner (if any)	None, however some loose adhering grout present	
Biological Materials	None	
Wet or Dry	Dry	
Smell	None	
Temperature	77.4	F
Surface pH	12.5	
Structure to Electrolyte	-0.387	Volts/CSE
Concrete Resistivity	Horizontal = 10.1 Vertical = 18.2	k-ohm-cm k-ohm-cm
General Condition	Concrete is sound, no delamination. There is loose adhering grout on left side and middle	
Concrete behind Coupon 6

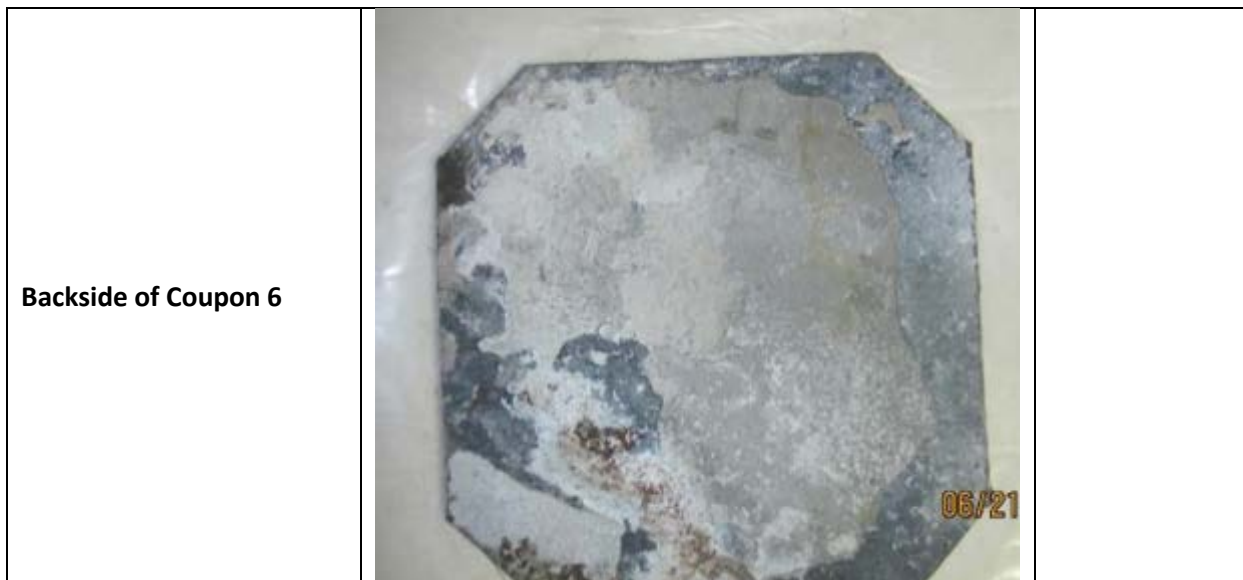
Thu, 21 Jun 2018, 11:05 AM		
COUPON SPECIFICS		
Coupon ID	6	6
Coupon Location	14-BA-24-8-36-30	
Coupon Dimensions	12" × 12"	
Coupon Thickness	¼" (NDE: No reported thickness; greater than 0.200")	(No prove-up-phase thickness)
Locations of Welds	None	
ON SITE VISUAL EXAMINATION		
Checks	Observations	
	Exterior	Interior
Deposits, Coatings, Debris	Scrapes	Standard coating
Scale	Concrete	None
Observed Biological Material	None	None
Wet or Dry	Dry	Dry
Smell	Burnt	Burnt
Presence of petroleum product between steel and concrete surface	No	No
Presence of corrosion	Yes, small	Yes, tiny
Isolated pitting	No	No
Isolated pitting within areas of general corrosion	No	No
Linked pitting within areas of general corrosion	No	No
Identify color of corrosion products	Brown	Brown
Identify if selected attack at welds	N/A	N/A

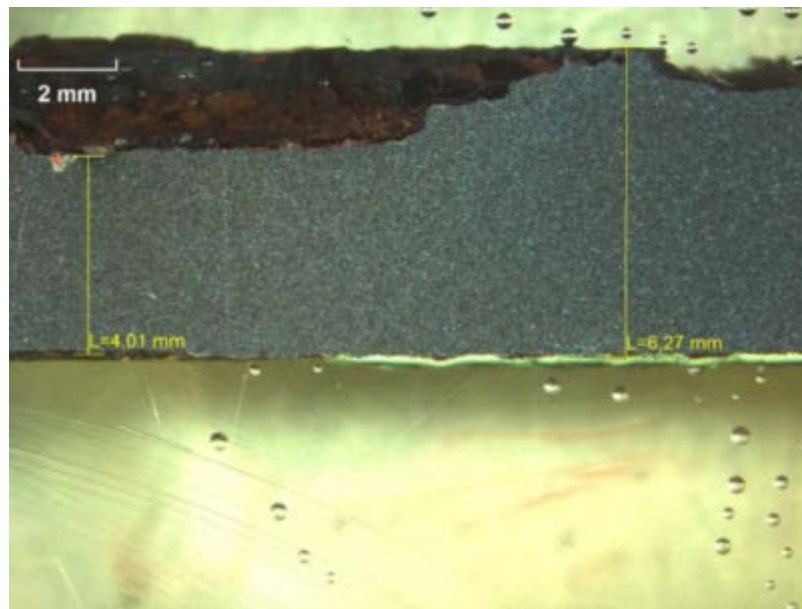
Figure 3-6 Cross Section of Coupon 6 at Area of Maximum Wall Loss

- Detailed results of the Destructive Testing Laboratory analysis of Coupon 6 are contained in Appendix A.
- The thinnest measured location was 157.9 mils (4.01 mm).
- Assuming a nominal wall thickness of 250 mils, the remaining wall thickness at the thinnest location was 63.1%.
- A cross-section view of Coupon 6 is shown in Figure 3-6.

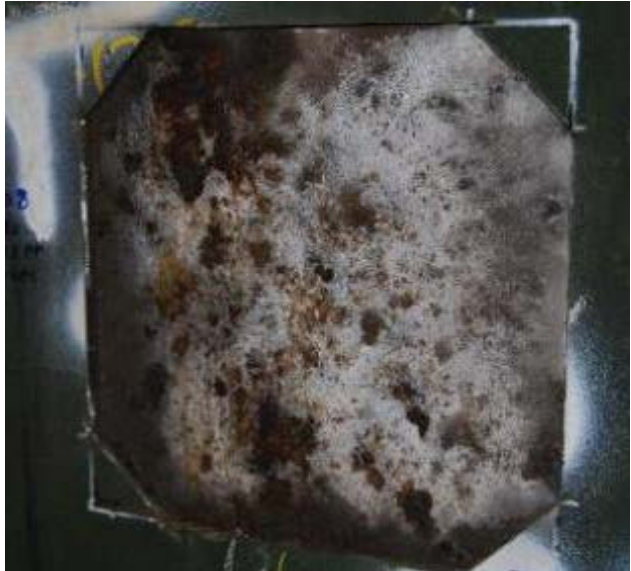
6/21/2018: 1030		
CONCRETE SAMPLE SPECIFICS		
Sample ID	7	7
Sample Location	14-BA-23-7-38-49	
Sample Dimensions	12" × 12"	
ON SITE VISUAL EXAMINATION		
Checks	Observations	
	Exterior	Units
Void space between concrete and liner (if any)	3/8" void on left side. 1/16" void on top right otherwise no voids	
Biological Materials	None	
Wet or Dry		
Smell	none	
Temperature	77.5	F
Surface pH	9-10	
Structure to Electrolyte	-0.276	Volts/CSE
Concrete Resistivity	Horizontal = 39.3 Vertical = 42.4	k-ohm-cm k-ohm-cm
General Condition	Concrete is sound with no delamination or cracks. Some brown and black corrosion products on concrete	
Concrete behind Coupon 7

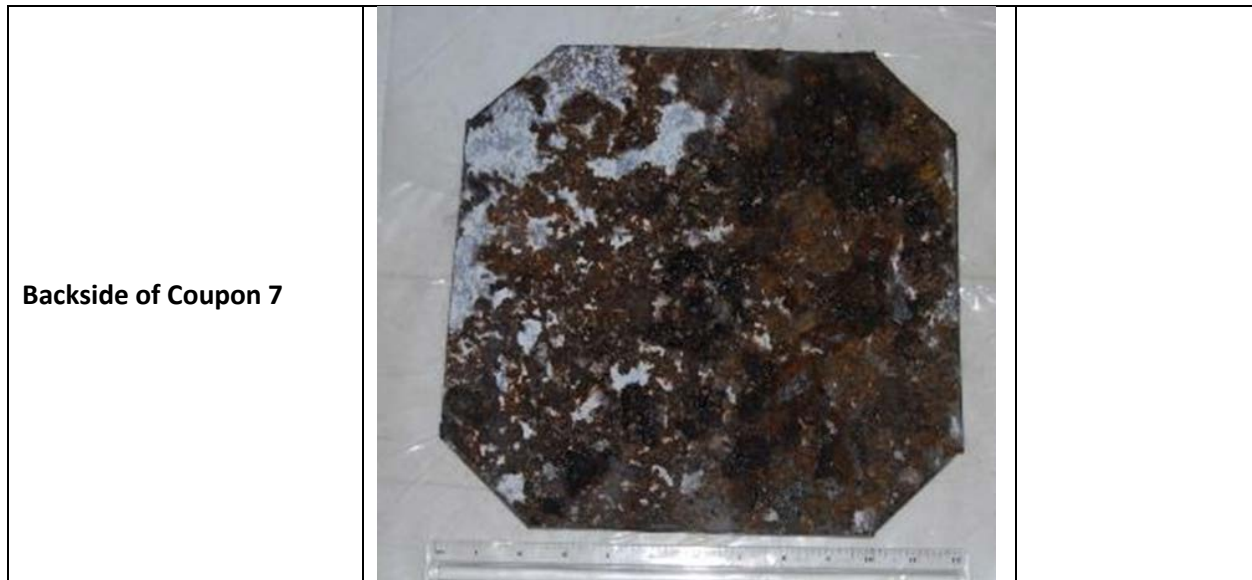
Thu, 21 Jun 2018, 10:35 AM		
COUPON SPECIFICS		
Coupon ID	7	7
Coupon Location	14-BA-23-7-38-49	
Coupon Dimensions	12" x 12"	
Coupon Thickness	¼" (NDE: minimum 0.157")	Prove-up: minimum 0.135"
Locations of Welds	None	
ON SITE VISUAL EXAMINATION		
Checks	Observations	
	Exterior	Interior
Deposits, Coatings, Debris	Lots of general corrosion	Standard coating
Scale	Yes, thick, varied	None
Observed Biological Material	None	None
Wet or Dry	Wet	Dry
Smell	Burnt, damp	Burnt
Presence of petroleum product between steel and concrete surface,	No	No
Presence of corrosion	Yes	Yes
Isolated pitting	Yes	No
Isolated pitting within areas of general corrosion	Yes	No
Linked pitting within areas of general corrosion	No	No
Identify color of corrosion products	Brown, black	Brown
Identify if selected attack at welds	N/A	N/A

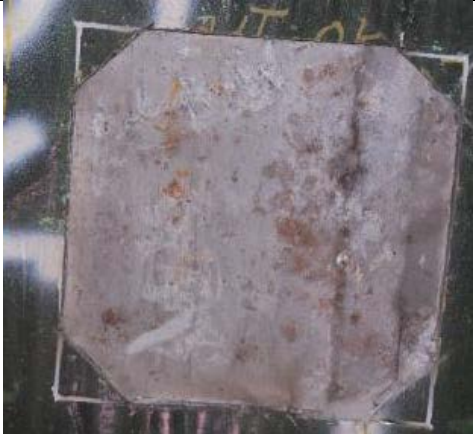
6/20/2018: 1400		
CONCRETE SAMPLE SPECIFICS		
Sample ID	8	8
Sample Location	14-BA-20-13-236-43	
Sample Dimensions	12" × 12"	
ON SITE VISUAL EXAMINATION		
Checks	Observations	
	Exterior	Units
Void space between concrete and liner (if any)	1/16" Void on left side, no voids in all other areas	
Biological Materials	None	
Wet or Dry	Dry	
Smell	None	
Temperature	80.0	F
Surface pH	11-12	
Structure to Electrolyte	-0.248	Volts/CSE
Concrete Resistivity	30.9 Horizontal 27.5 Vertical	k-ohm-cm k-ohm-cm
General Condition	Excellent, sound concrete with no cracks or delamination. Coupon had steel backing plate	
Concrete behind Coupon 8

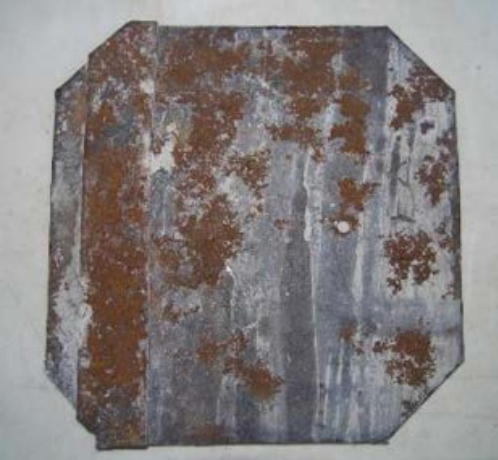
Backside of Coupon 8

Wed, 20 Jun 2018, 09:40 AM		
COUPON SPECIFICS		
Coupon ID	8	8
Coupon Location	14-BA-20-13-236-43	
Coupon Dimensions	12" × 12"	
Coupon Thickness	¼" (NDE: minimum 0.069")	Prove-up: minimum 0.200"
Locations of Welds	About 2" from right edge of front face (exterior face)	
ON SITE VISUAL EXAMINATION		
Checks	Observations	
	Exterior	Interior
Deposits, Coatings, Debris	White coating	Standard coating with pink, white paint
Scale	None	None
Observed Biological Material	None	None
Wet or Dry	Dry	Dry
Smell	Burnt metal	Fuel-like
Presence of petroleum product between steel and concrete surface	No	No
Presence of corrosion	Yes	No
Isolated pitting	Yes (Pit 1: 5" from left, 2" from top) (Pit 2: 7" from left, 5" from top)	No
Isolated pitting within areas of general corrosion	Yes	No
Linked pitting within areas of general corrosion	No	No
Identify color of corrosion products	Brown	No
Identify if selected attack at welds	Yes	N/A

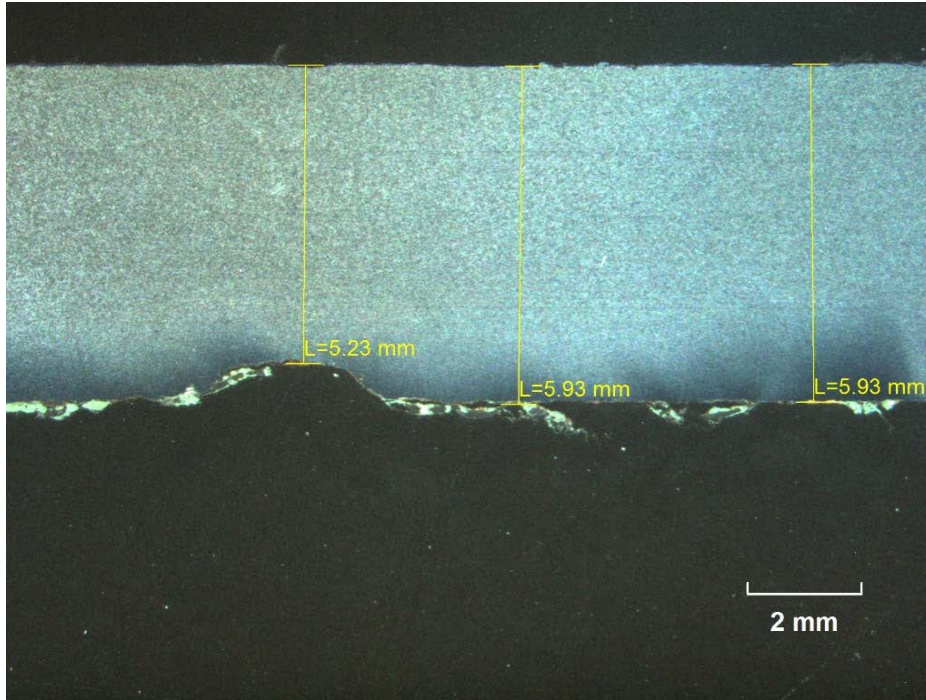
Figure 3-8 Cross Section of Coupon 8 at Area of Maximum Wall Loss

- Detailed results of the Destructive Testing Laboratory analysis of Coupon 8 are contained in Appendix A.
- The thinnest measured location was 205.9 mils (5.23 mm).
- Assuming a nominal wall thickness of 250 mils, the remaining wall thickness at the thinnest location was 82.4%.
- A cross-section view of Coupon 8 is shown in Figure 3-8.

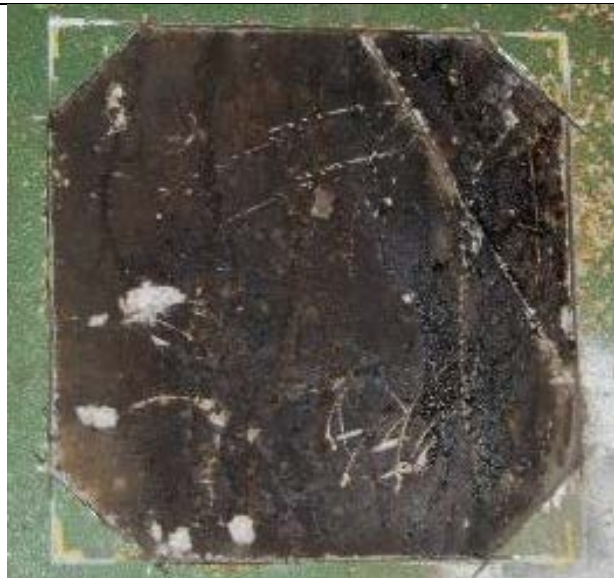
6/21/2018: 0930		
CONCRETE SAMPLE SPECIFICS		
Sample ID	10	10
Sample Location	14-LD-3-9-24-215	
Sample Dimensions	12" × 12"	
ON SITE VISUAL EXAMINATION		
Checks	Observations	
	Exterior	Units
Void space between concrete and liner (if any)	None	
Biological Materials	None	
Wet or Dry	Dry	
Smell	like coal tar	
Temperature	77.6	F
Surface pH	12-12.5	
Structure to Electrolyte	-0.181	Volts/CSE
Concrete Resistivity	27.3 Horizontal 38.1 Vertical	k-ohm-cm k-ohm-cm
General Condition	Excellent, sound concrete with no cracks or delamination. Coupon had to be cut into two pieces to remove. What appears to be coal tar coating present on backside of coupon and concrete.	
Concrete behind Coupon 10

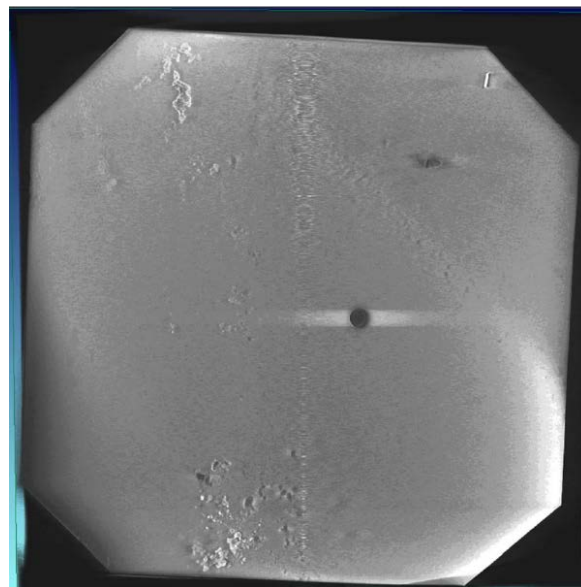
Figure 4-2 CT Scan Image from Destructive Testing Lab Report, Coupon 1

Destructive testing found pitting and minimum wall thickness of 0.208 inch. Remaining wall thickness greater than expected (208 mils vs. 112 mils). This deviation exceeded the 20 mils accuracy range for pitting.

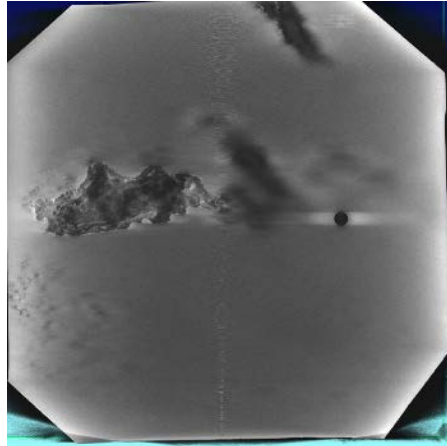
Figure 4-4 CT Scan Image from Destructive Testing Lab Report, Coupon 2

Destructive testing found pitting and minimum wall thickness of 0.152 inch.

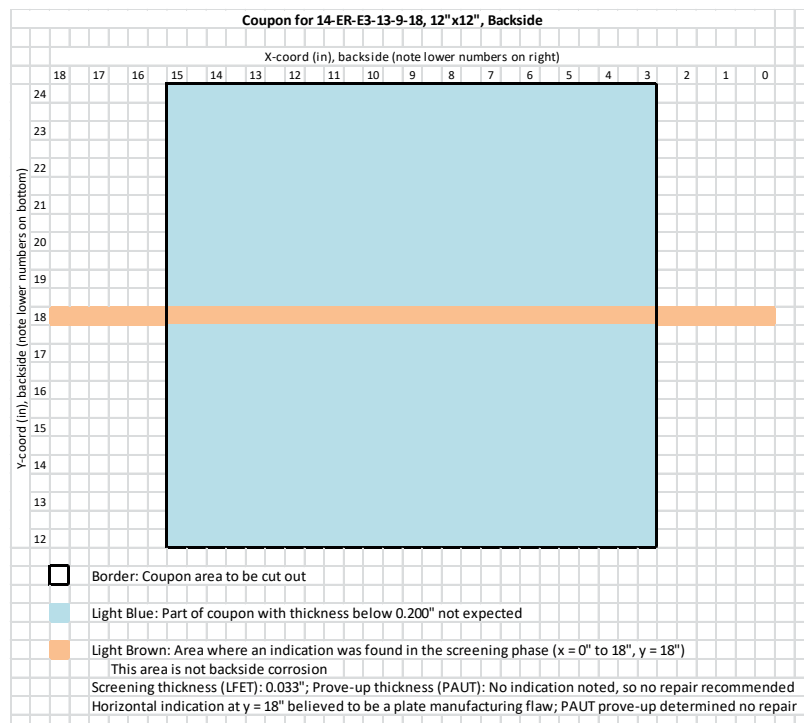
Figure 4-5 Expected Results from NDE Spreadsheet Data, Coupon 3

The LFET minimum screening thickness was 0.033 inch. During the PAUT prove-up, the 33-mil thickness was identified not to be metal loss but instead was a non-actionable lamination. Therefore, a repair was not initially specified in this area. Backside corrosion was not expected.

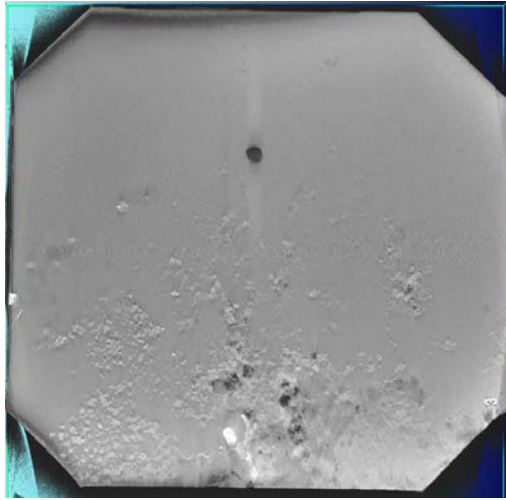
Figure 4-6 CT Scan Image from Destructive Testing Lab Report, Coupon 3

Destructive testing found pitting and minimum wall thickness of 0.132 inch. The remaining wall thickness, 132 mils, was less than expected (greater than 200 mils). The LFET value did not fall within the 20-mil accuracy range for pitting.

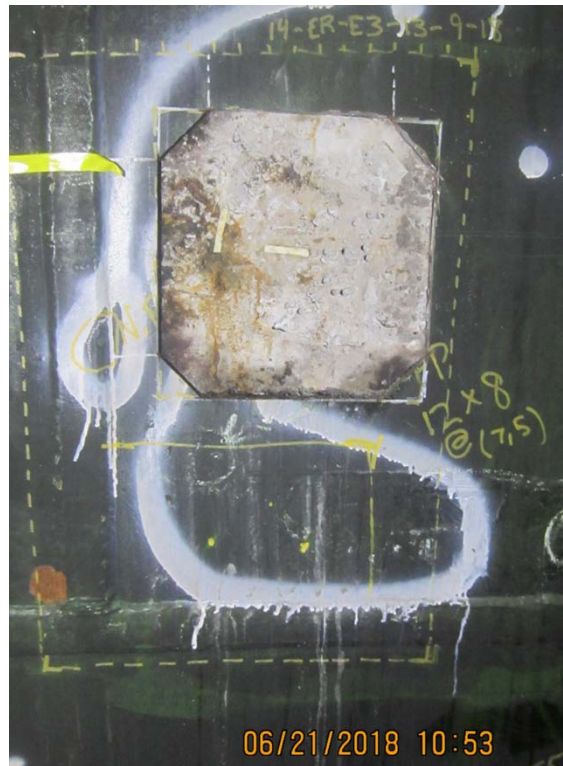
Figure 4-8 Location of Coupon 3 after Removal

was prevented from finishing the NDE process by being unable to layout the repair at Indication B. Instead of performing a layout at Indication B, the contractor was asked to layout repairs for Coupon 3 (Indication A). Figure 4-8 depicts the location after the coupon was removed.

Inner square indicates boundary of Coupon 3. Outer rectangle indicates boundary of patch plate for repair.

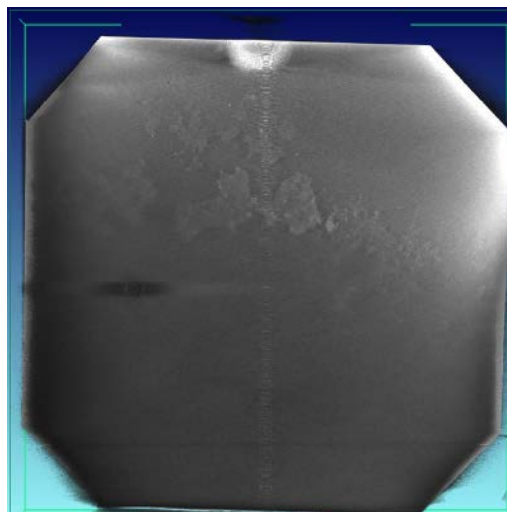
Figure 4-10 CT Scan Image from Destructive Testing Lab Report, Coupon 5

Destructive testing found pitting and minimum wall thickness of 0.224 inch. The remaining wall thickness was as expected.

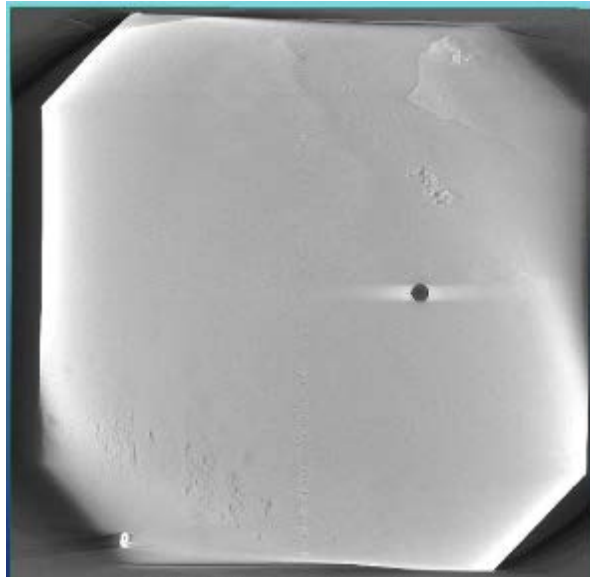
Figure 4-12 CT Scan Image from Destructive Testing Lab Report, Coupon 6

Destructive testing found pitting and minimum wall thickness of 0.158 inch. The remaining wall thickness was thinner than expected in the isolated pit.

LFET does not always detect metal loss of very small volume with narrow and non-uniform characteristics. The likelihood this single small pit, smaller than what the equipment could detect with more than 64% metal thickness remaining after 75 years in service, would form into a thru-hole before the next inspection, is extremely low. Given the steel plate's original thickness of 250 mils and the metal thickness of 158 mils upon removal (a loss of 92 mils), and assuming a constant rate of corrosion between the tank's construction in 1943 and coupon removal in 2018 (75 years),

the maximum corrosion rate at Coupon 6 is 1.23 mils per year (mpy). No conditions were evident that would support accelerated corrosion at Coupon 6.

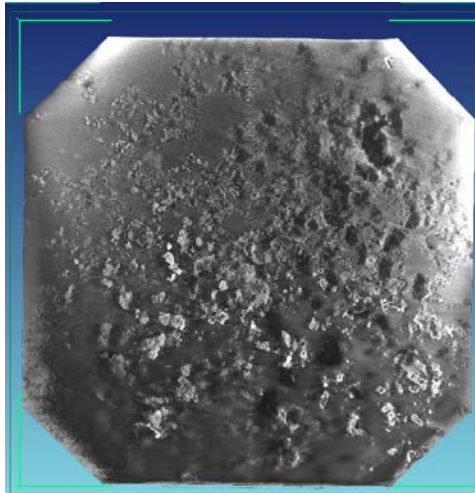
Figure 4-14 CT Scan Image from Destructive Testing Lab Report, Coupon 7

Destructive testing found pitting and a minimum wall thickness of 0.164 inch. The remaining wall thickness was within the 20-mil range for pitting but thicker than expected for the prove-up testing (164 mils vs. 135 mils).

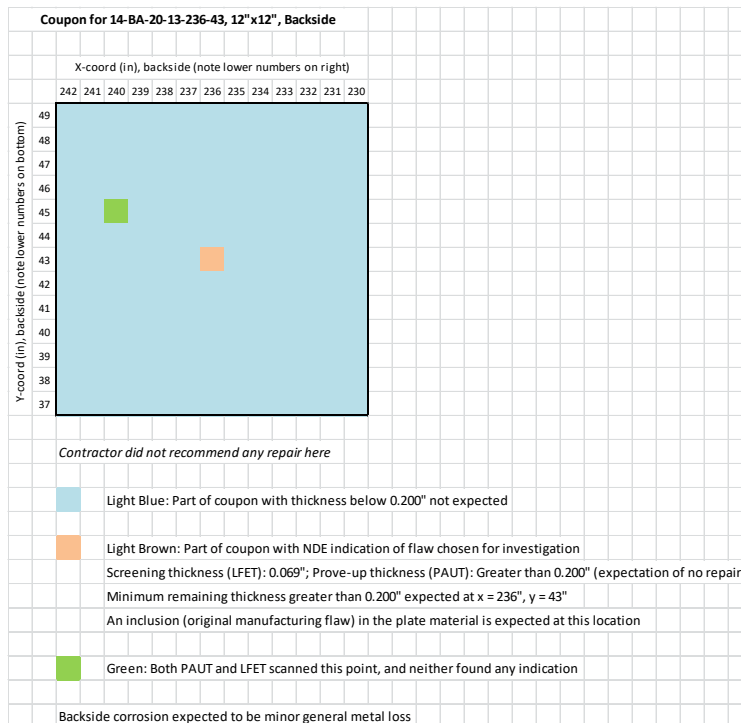
Figure 4-15 Expected Results from NDE Spreadsheet Data, Coupon 8

The LFET minimum screening thickness was 0.069 inch. The prove-up thickness was greater than 0.200 inch. Therefore, no repair was specified in this area.

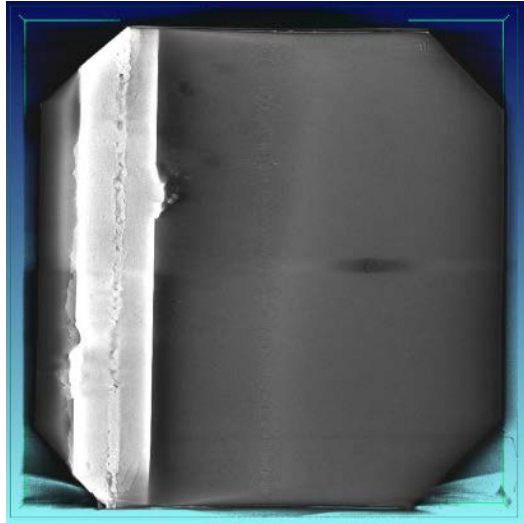
Figure 4-16 CT Scan Image from Destructive Testing Lab Report, Coupon 8

Destructive testing found pitting and minimum wall thickness of 0.206 inch. Remaining wall thickness was as expected.

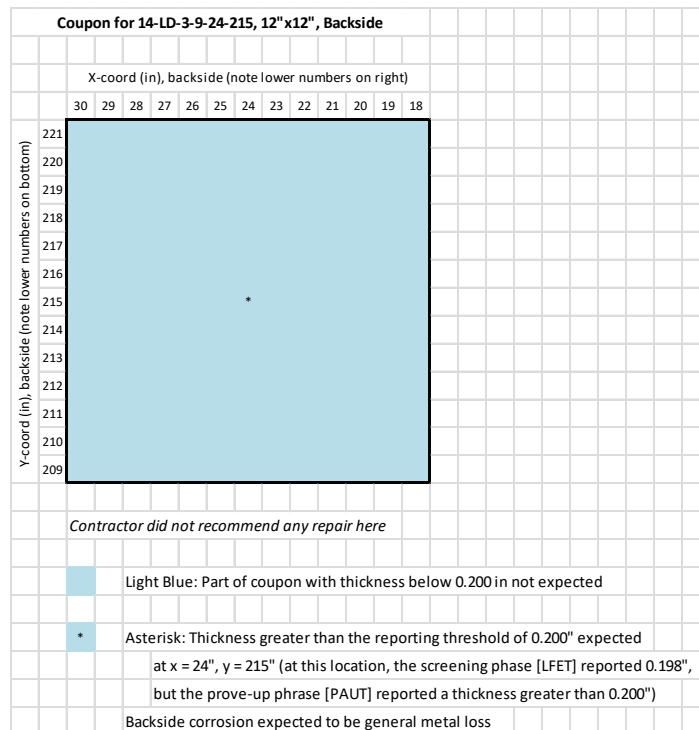
Figure 4-17 Expected Results From NDE Spreadsheet Data, Coupon 10

The LFET screening found no indications. Therefore, no repair was specified in this area.

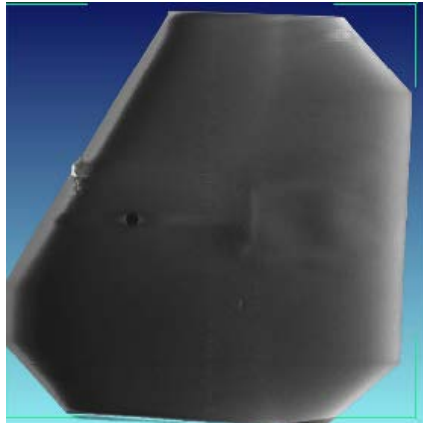
Figure 4-18 CT Scan Image from Destructive Testing Lab Report, Coupon 10

Destructive testing found a minimum wall thickness of 0.242 inch. Remaining wall thickness was as expected.

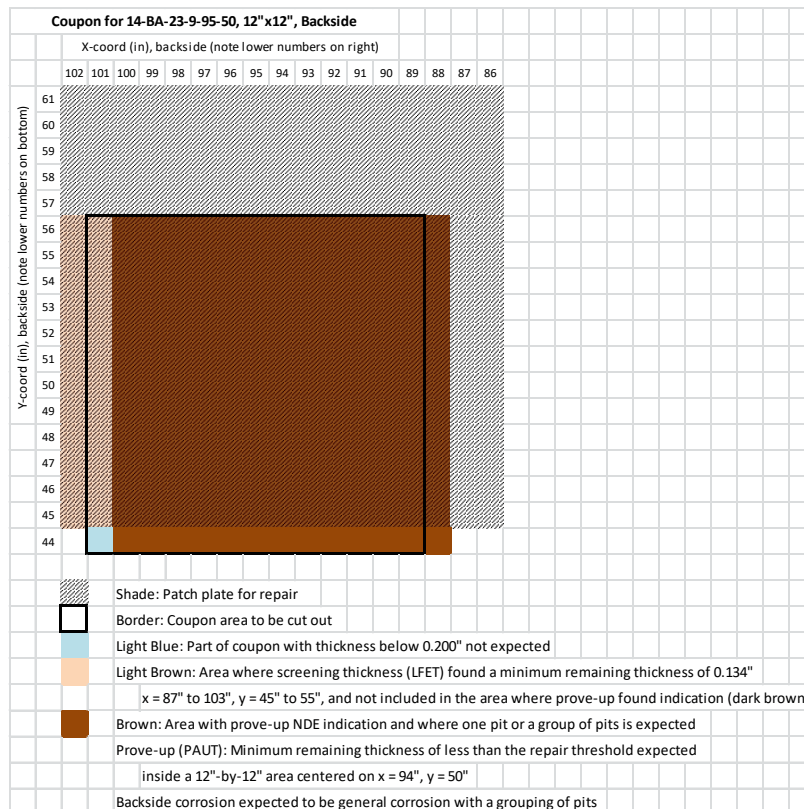
Figure 4-19 Expected Results from NDE Spreadsheet Data, Coupon A1

The LFET minimum screening thickness was 0.134 inch. No prove-up measurements were done in this location because a weld repair was indicated. A repair was specified in this area.

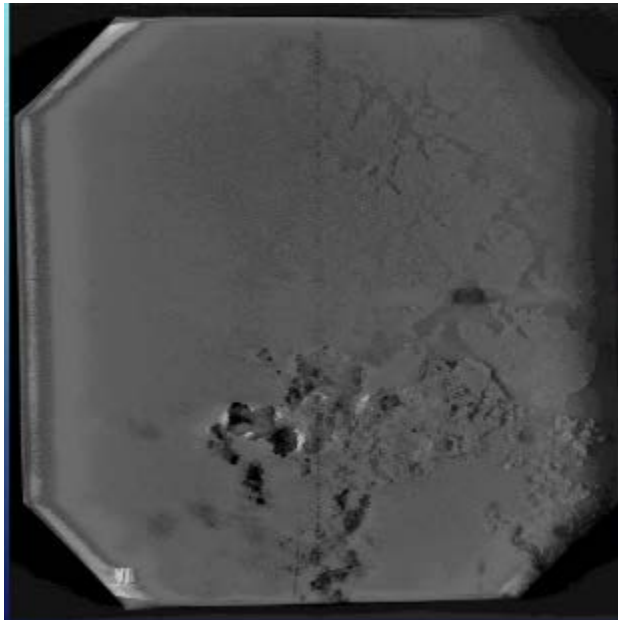
Figure 4-20 CT Scan Image from Destructive Testing Lab Report, Coupon A1

Destructive testing found pitting and minimum wall thickness of 0.122 inch. The remaining wall thickness was as expected. The LFET thickness fell within the 20-mil accuracy range.

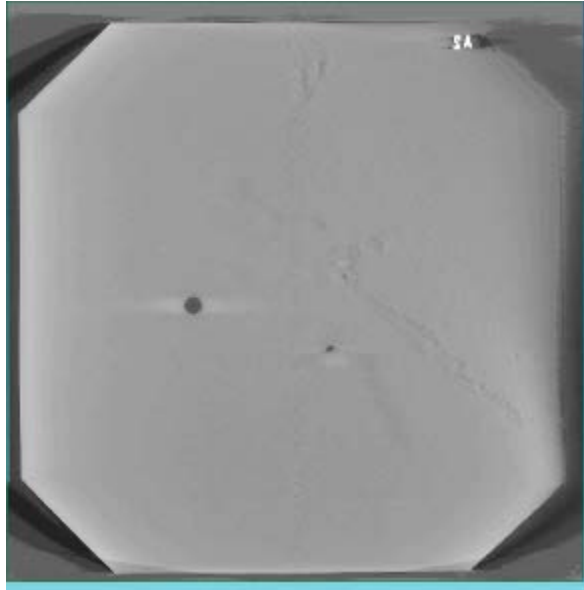
Figure 4-22 CT Scan Image from Destructive Testing Lab Report, Coupon A2

Destructive testing found a minimum wall thickness of 0.248 inch. The remaining wall thickness was as expected.

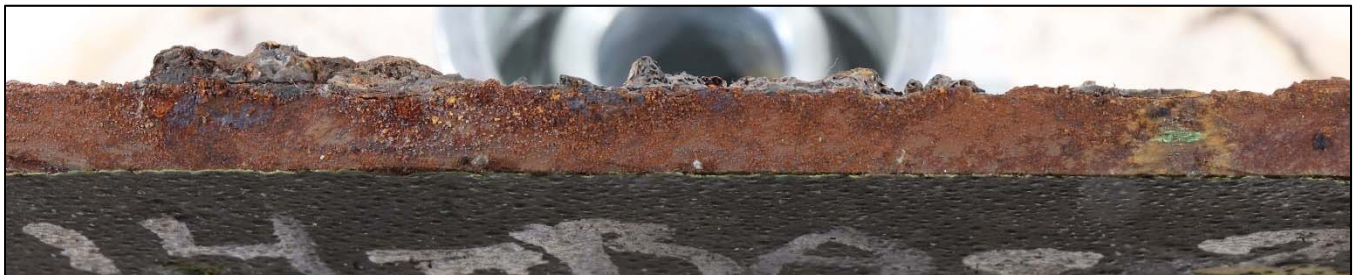
Figure 17. An image of the exterior surface of Coupon 7 in the as-received condition.

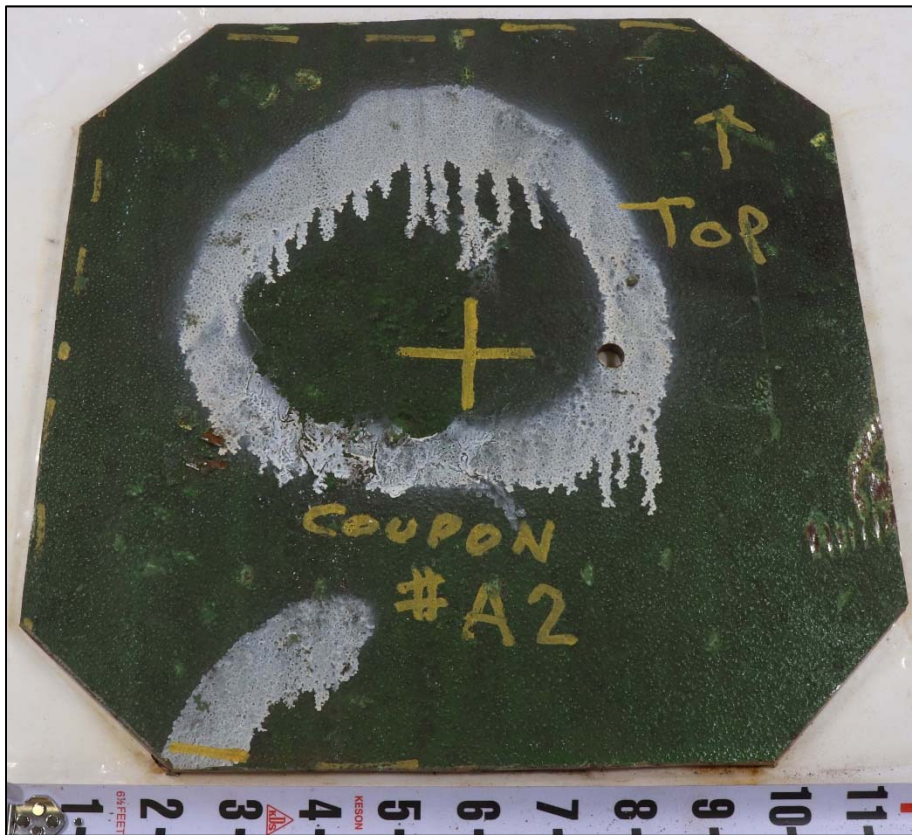
Figure 28. An image of the interior surface of Coupon A2 in the as-received condition.

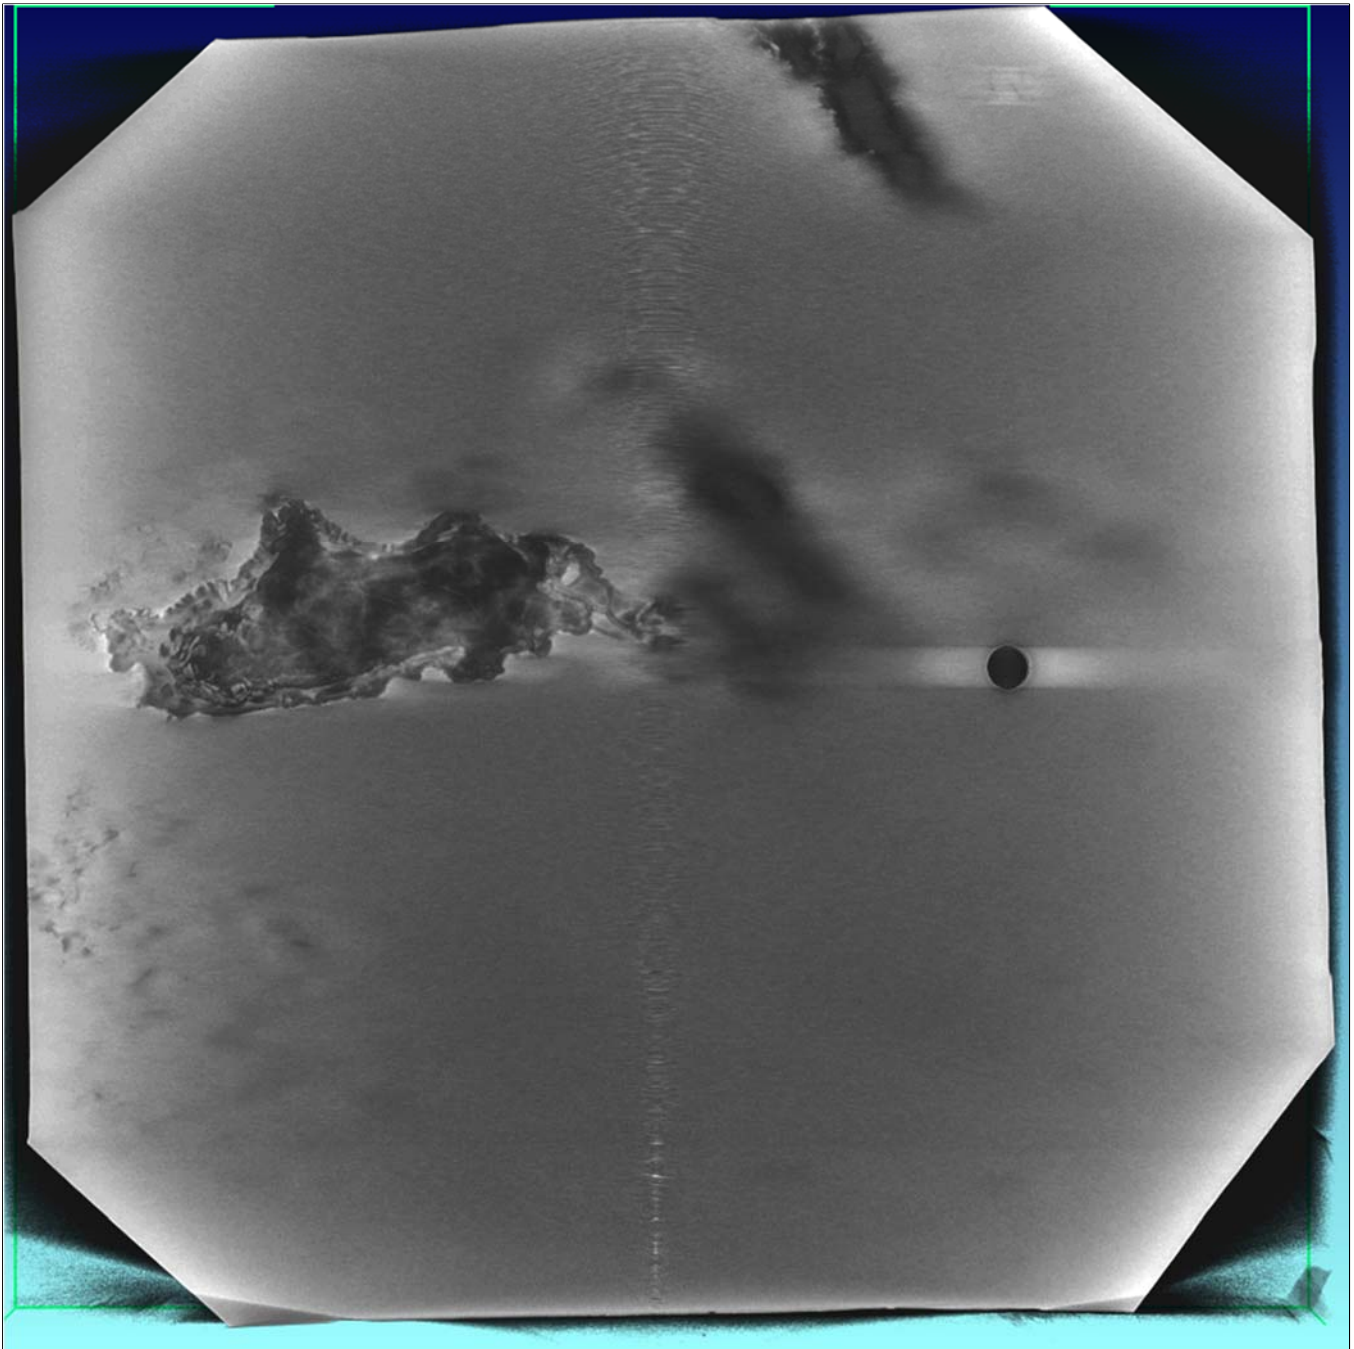
Figure 31. A representative screenshot of the CT scan performed on Coupon 1.
