SUBJECT: ADMINISTRATIVE ORDER ON CONSENT (AOC) STATEMENT OF WORK (SOW) SECTION 5 CORROSION AND METAL FATIGUE PRACTICES, DESTRUCTIVE TESTING RESULTS REPORT, RED HILL BULK FUEL STORAGE FACILITY (RED HILL), JOINT BASE PEARL HARBOR-HICKAM, OAHU, HAWAII

As identified in Red Hill Bulk Fuel Storage Facility Scope of Work for Destructive Testing Administrative Order on Consent (AOC) and Statement of Work (SOW) Section 5.3.2, the purpose of this effort is to verify the findings of the Corrosion and Metal Fatigue Practices Report, using destructive testing on at least one tank at the Facility.

In 2018, ten coupons were removed from Tank 14, so that a metallurgical and corrosion analysis of the coupons could be undertaken, with the primary aim of validating non-destructive examination (NDE) results. The steel coupons, concrete powder samples, and corrosion product were submitted to a certified third-party laboratory to perform this analysis.

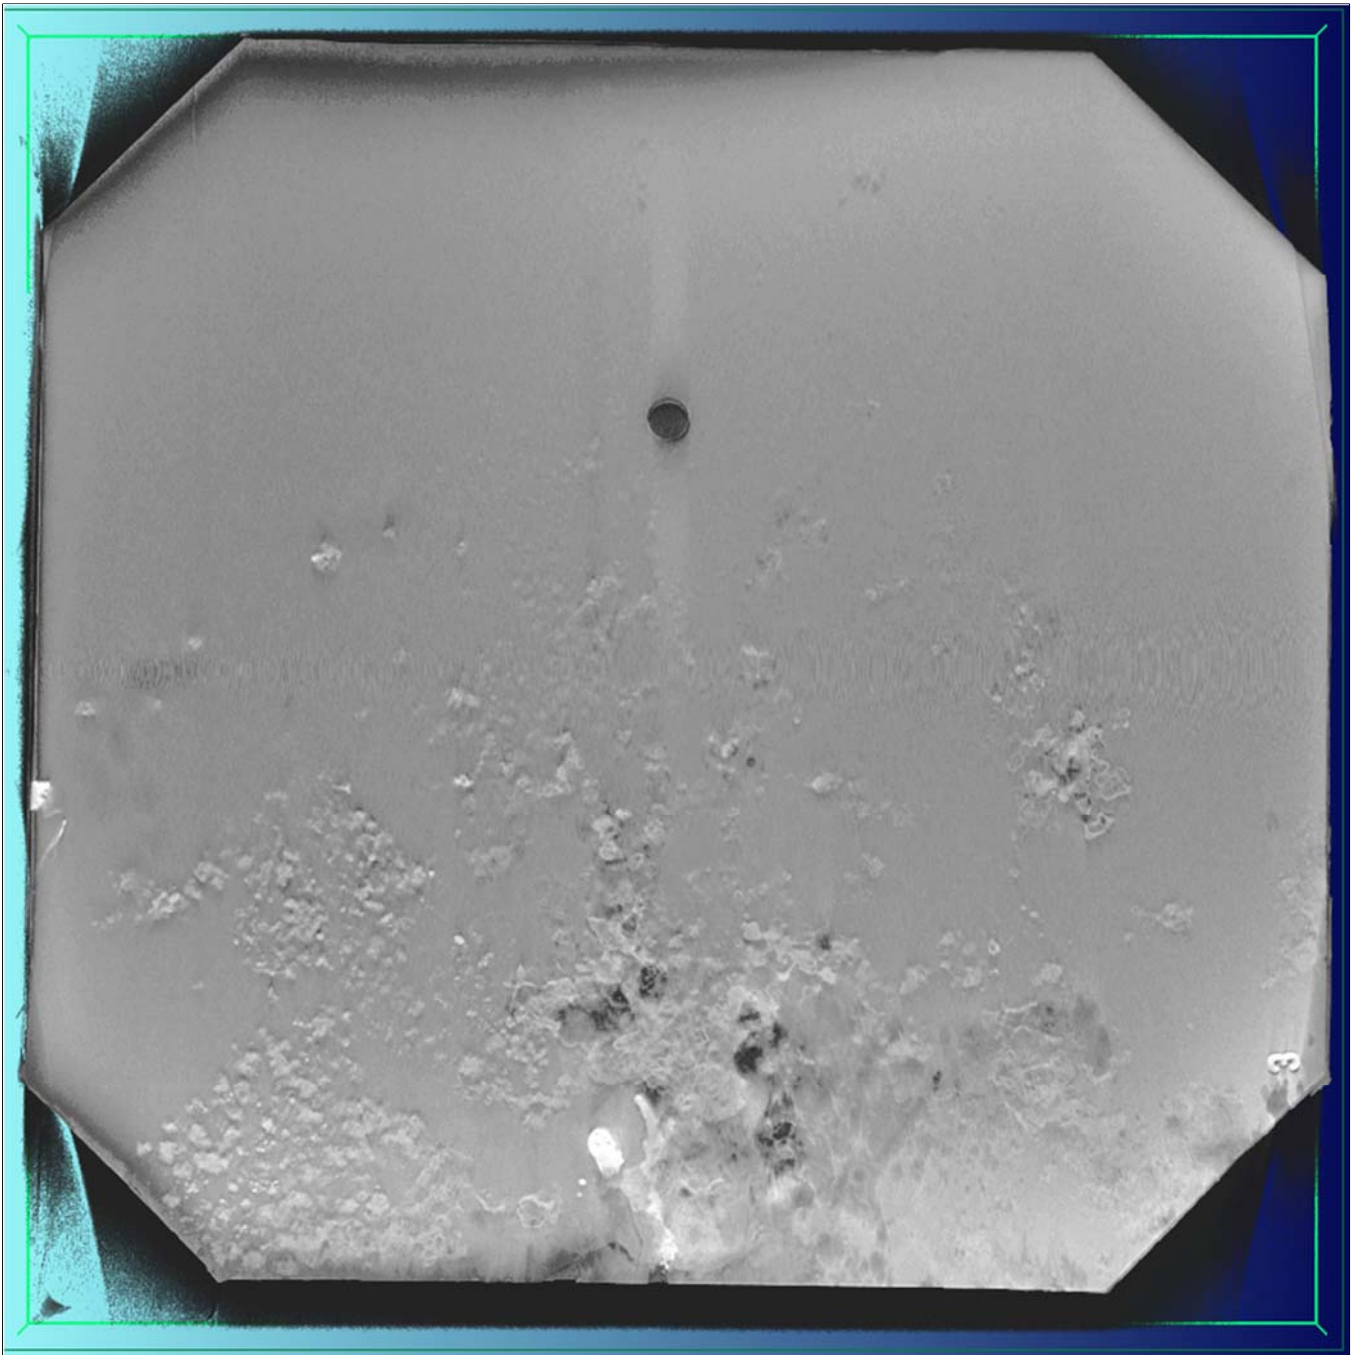
Figure 32. A representative screenshot of the CT scan performed on Coupon 2.

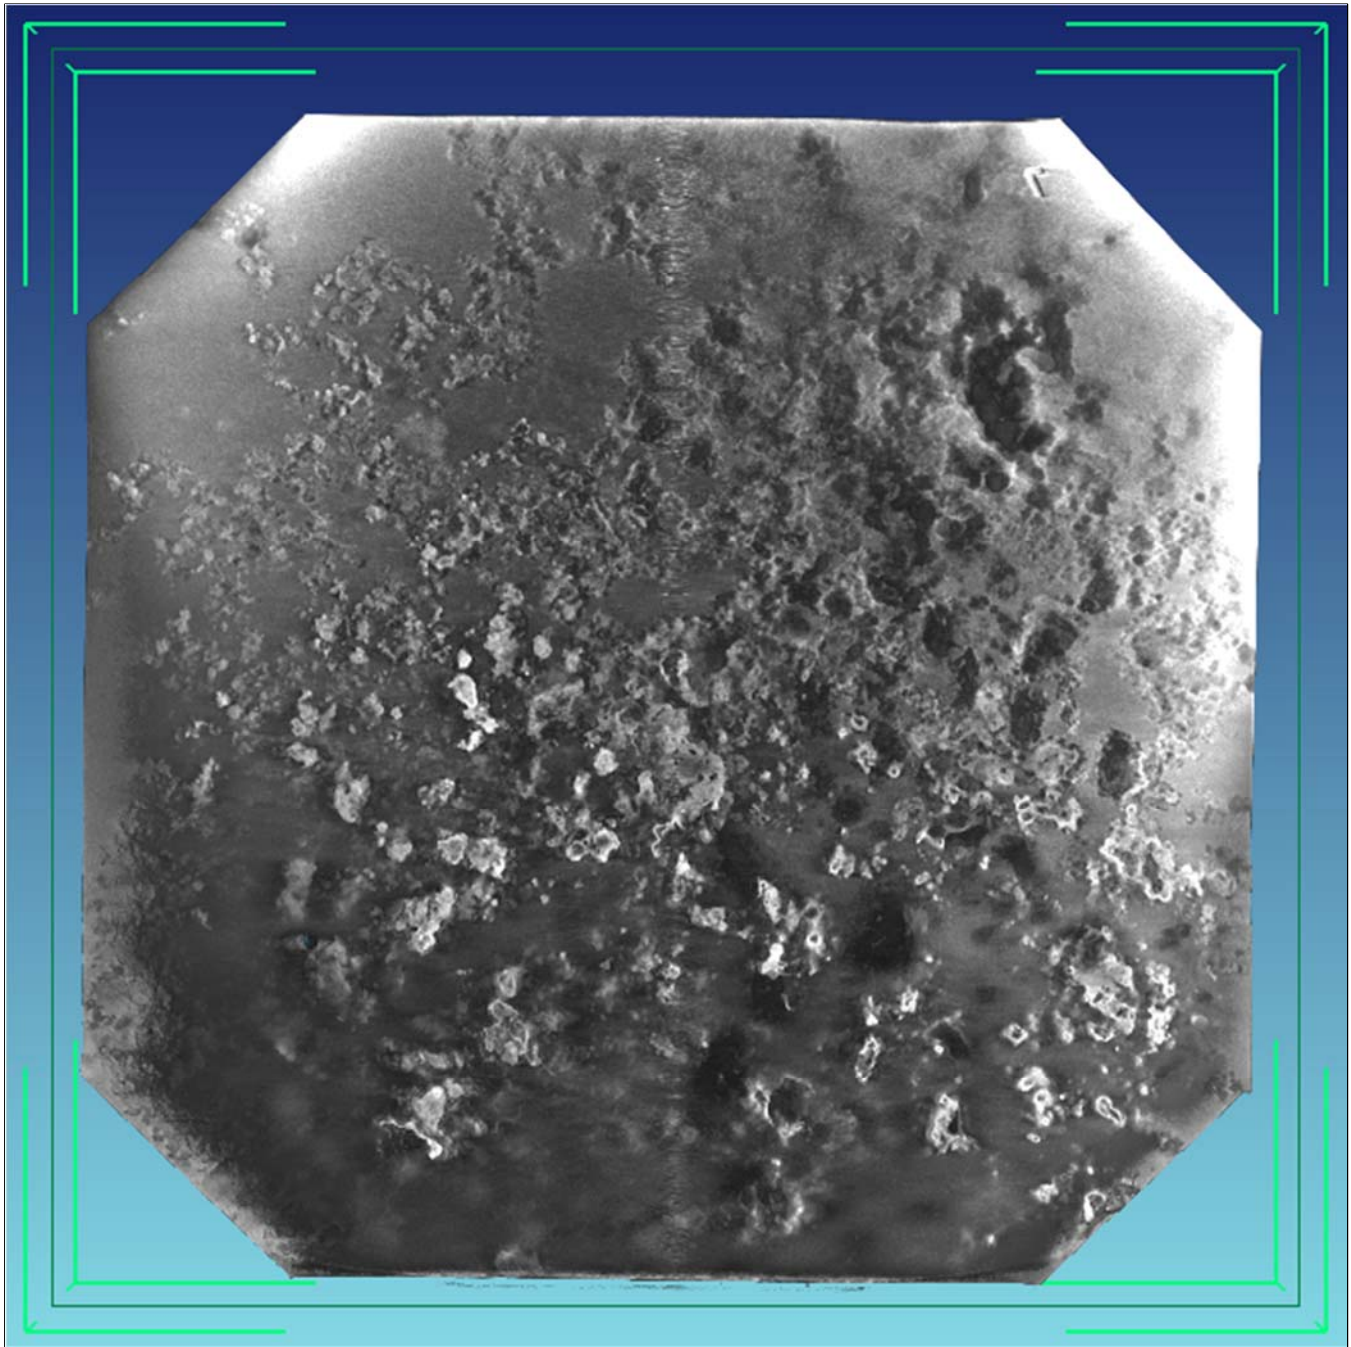
Figure 35. A representative screenshot of the CT scan performed on Coupon 6.

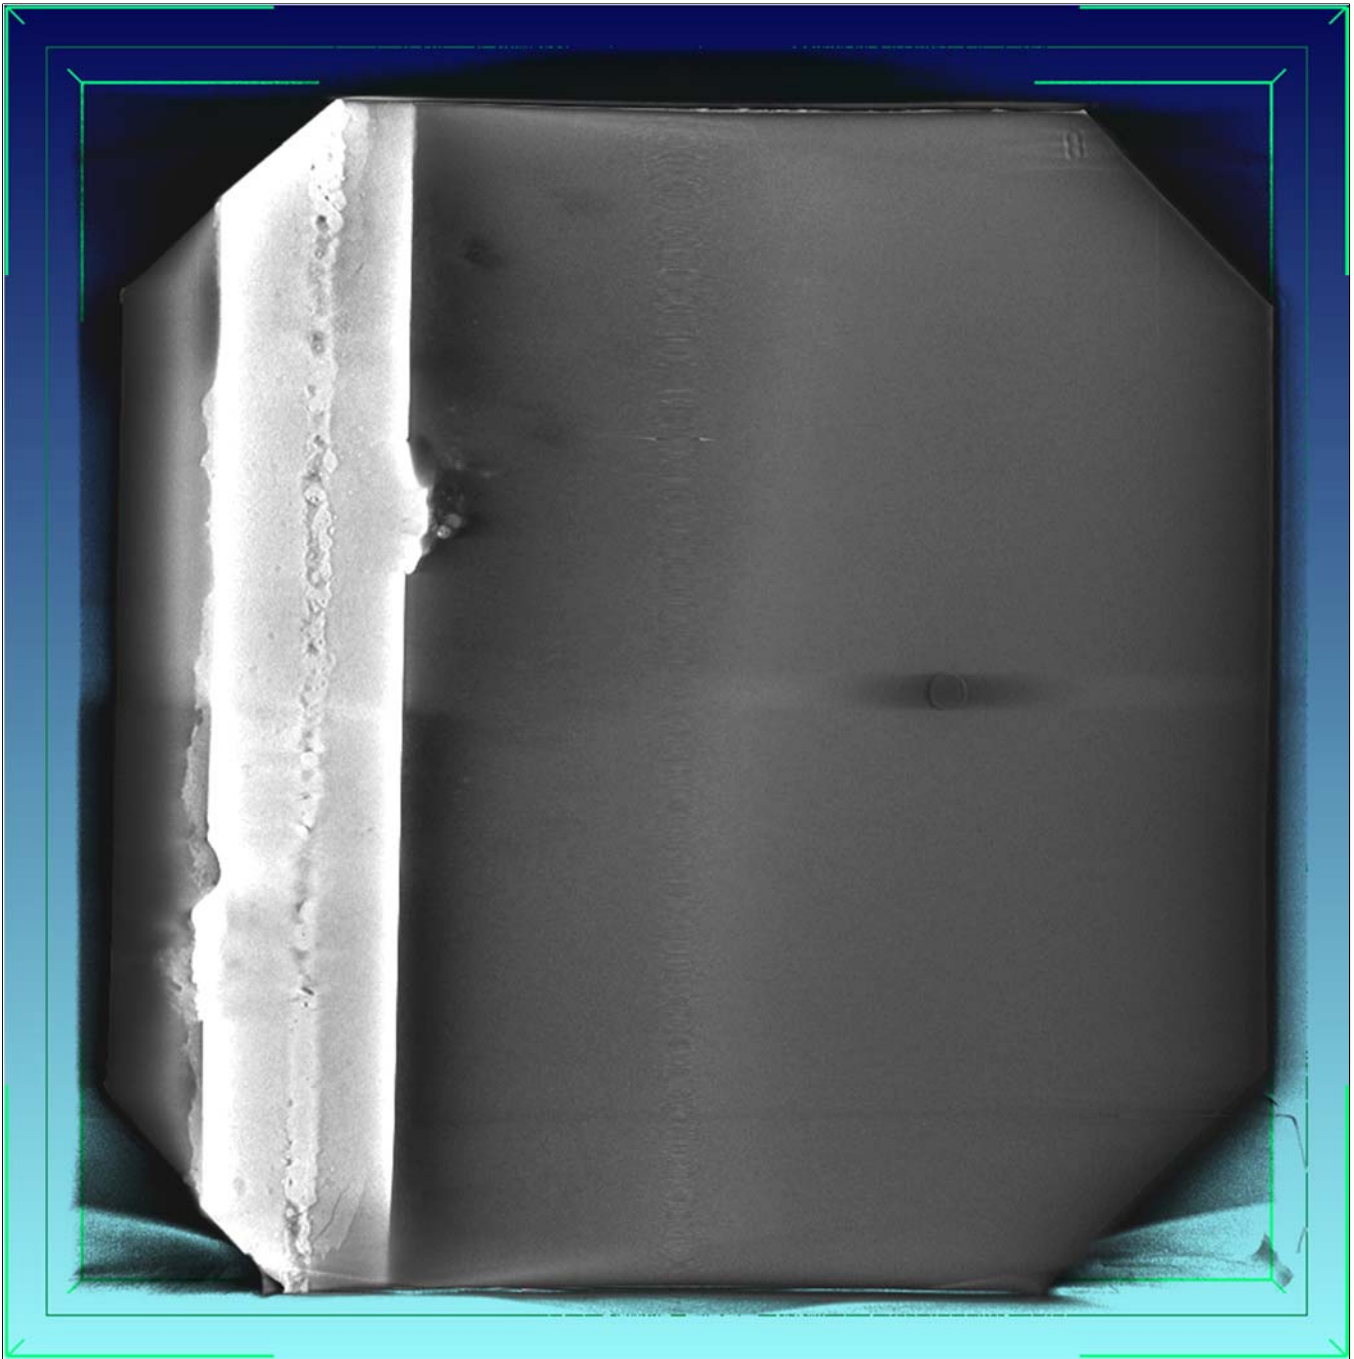
Figure 36. A representative screenshot of the CT scan performed on Coupon 7.

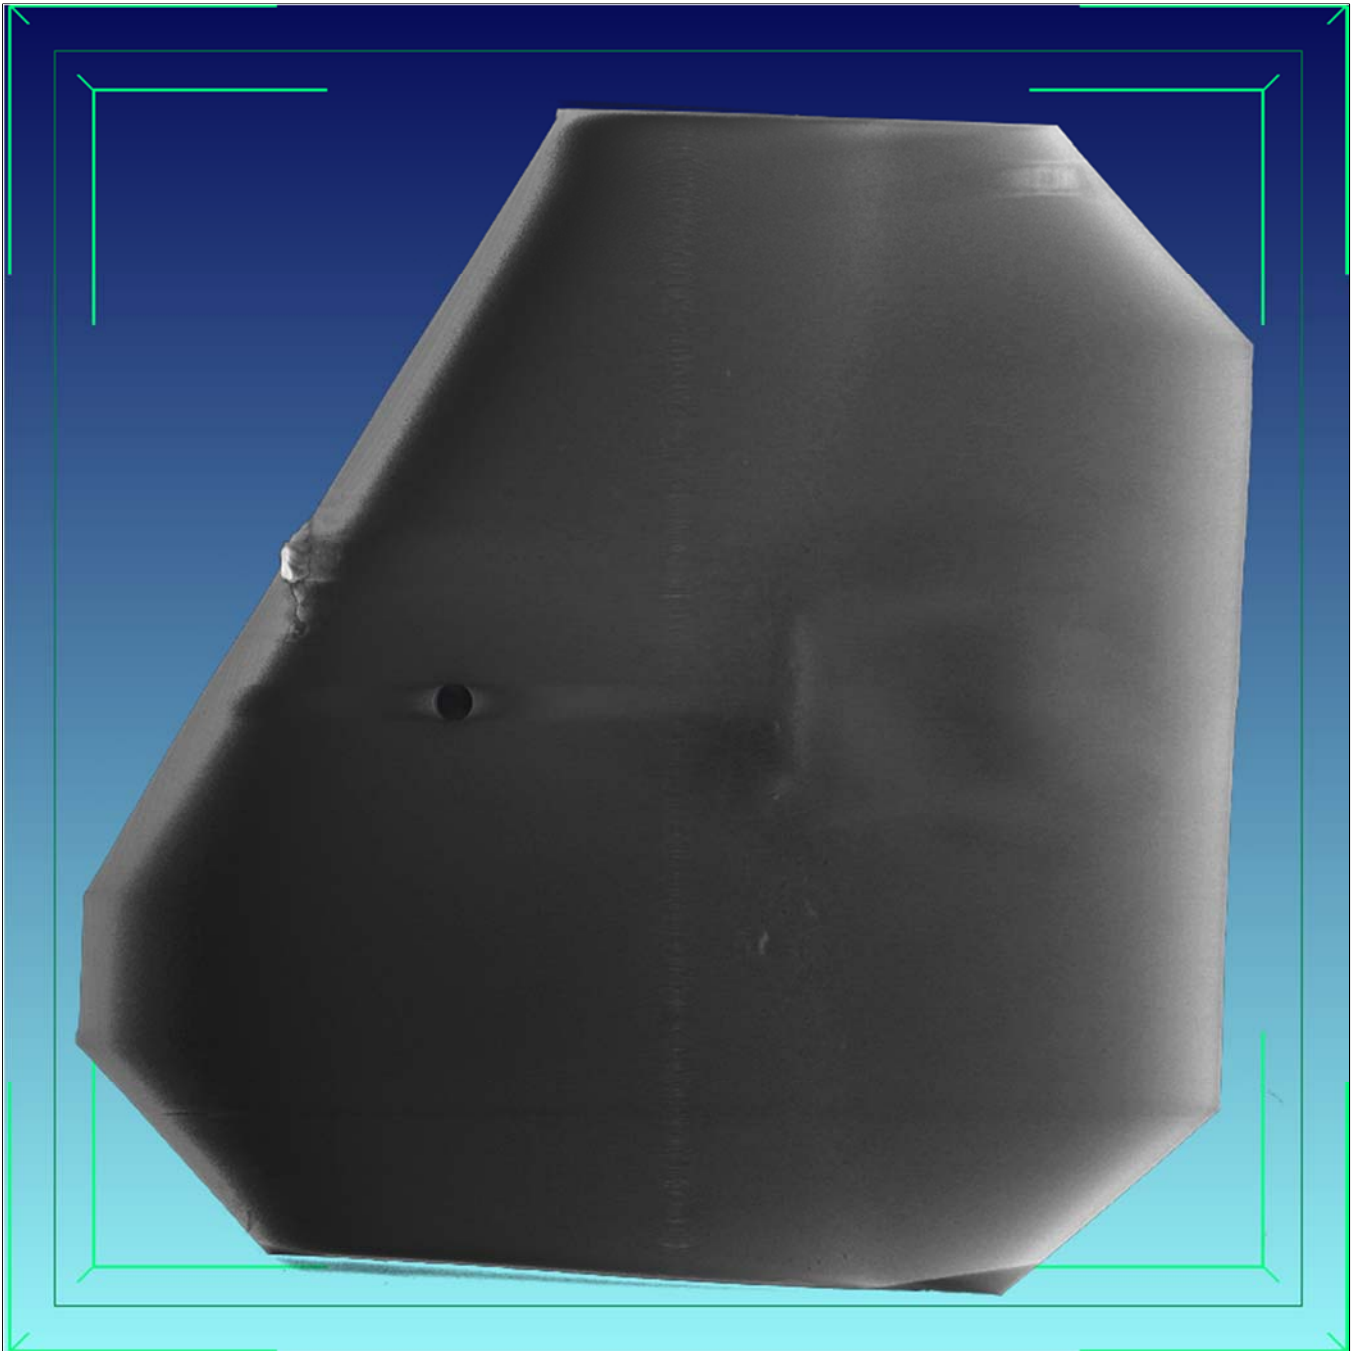
Figure 37. A representative screenshot of the CT scan performed on Coupon 8.

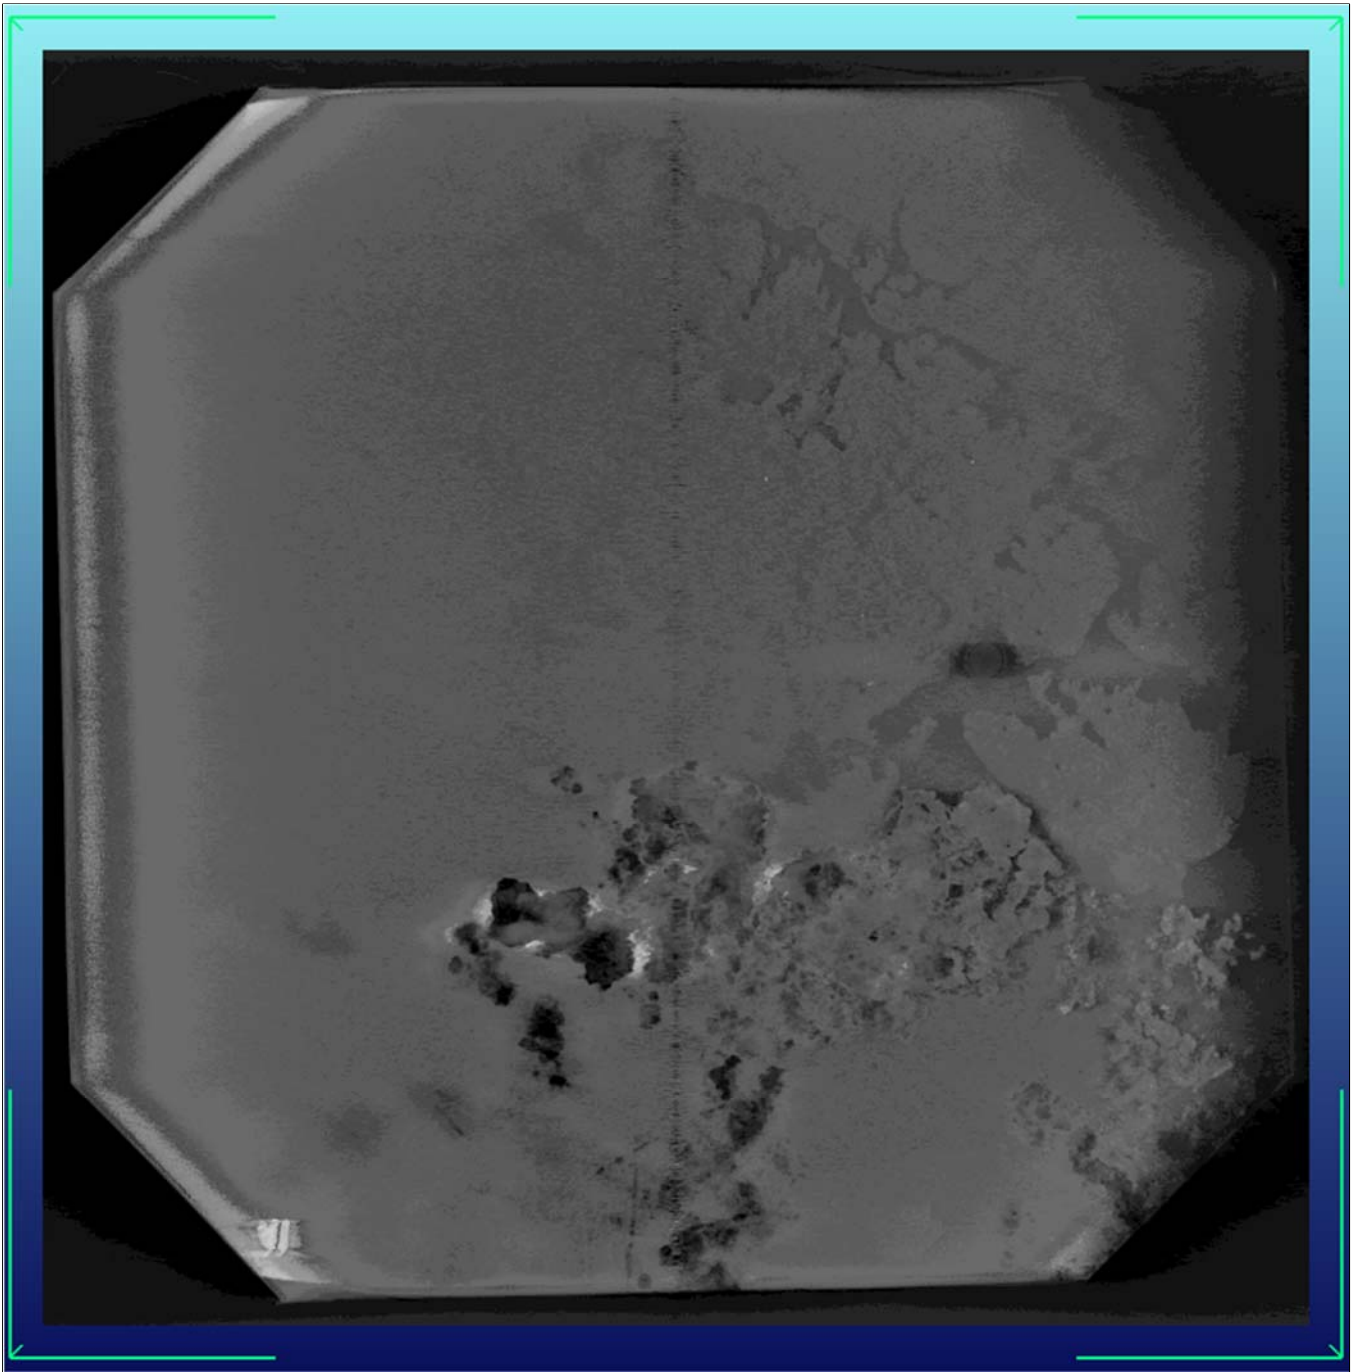
Figure 38. A representative screenshot of the CT scan performed on Coupon 10.

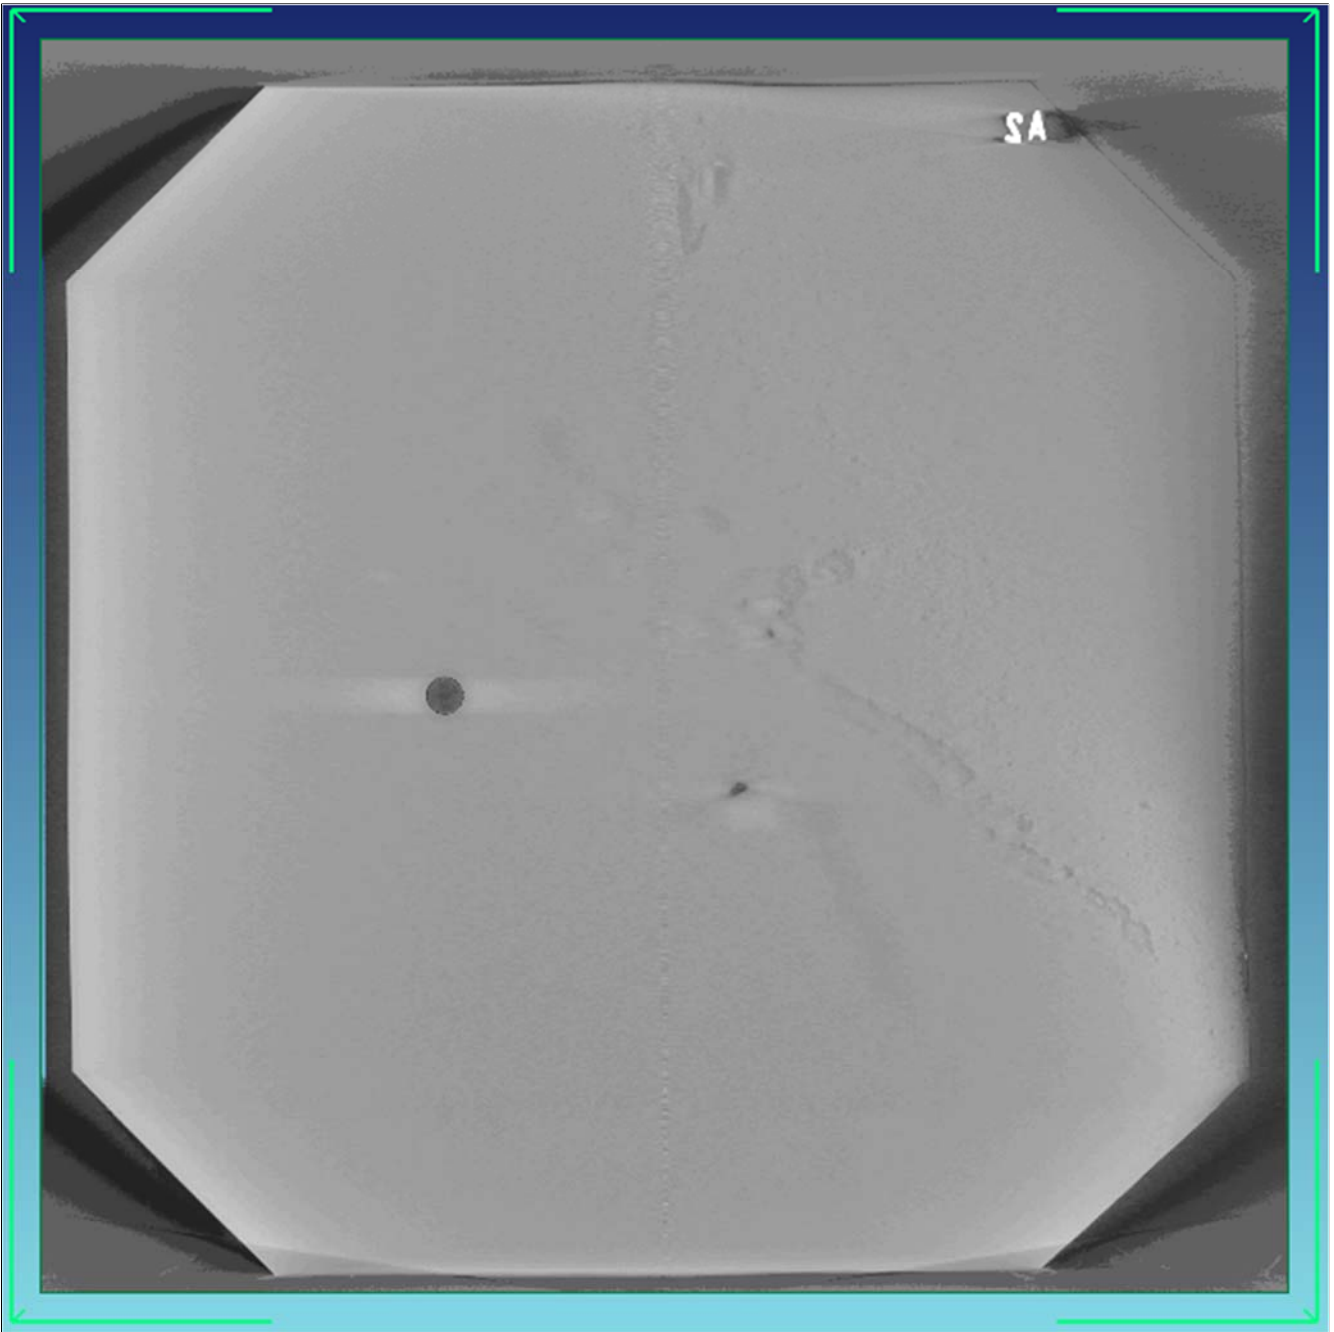
Figure 39. A representative screenshot of the CT scan performed on Coupon A1.

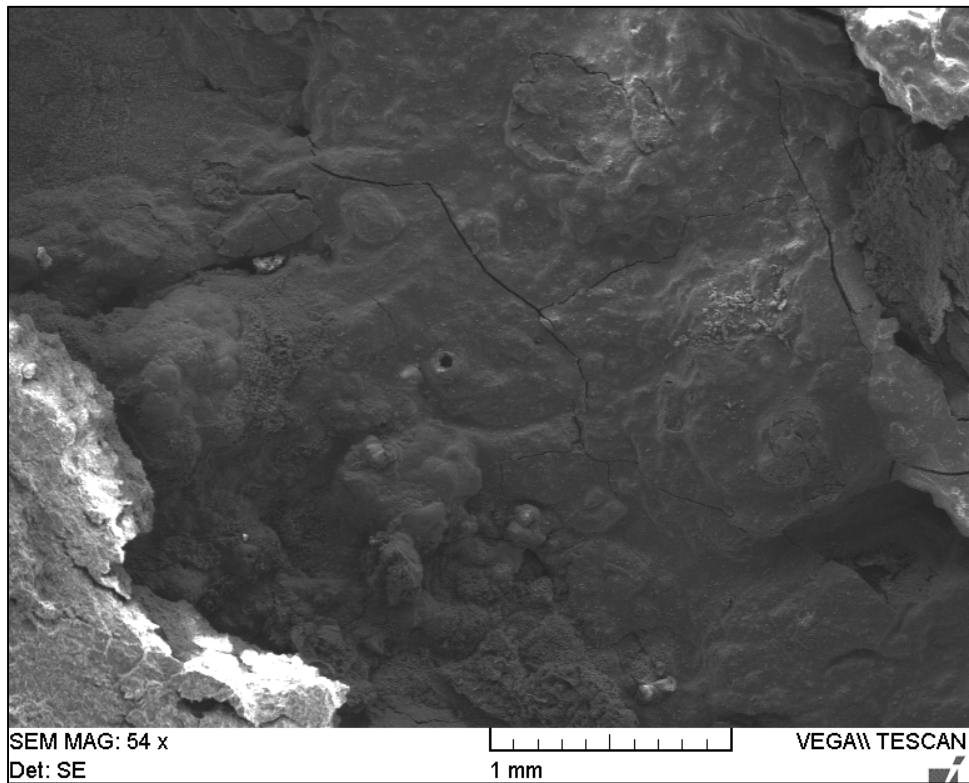
Figure 43. A representative SEM image of a pit on a specimen excised from Coupon 1 labeled as 1-3, prior to cleaning. (SEM, 32X)

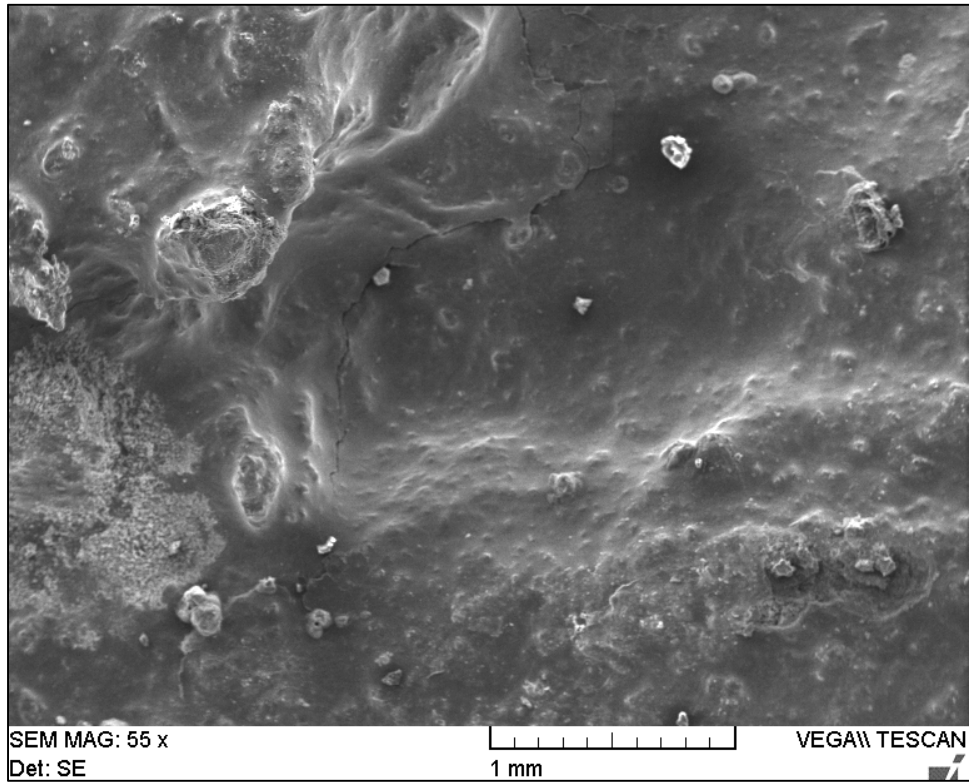
Figure 47. A representative SEM image of a pit on a specimen excised from Coupon 3 labeled as 3-1, prior to cleaning. (SEM, 32X)

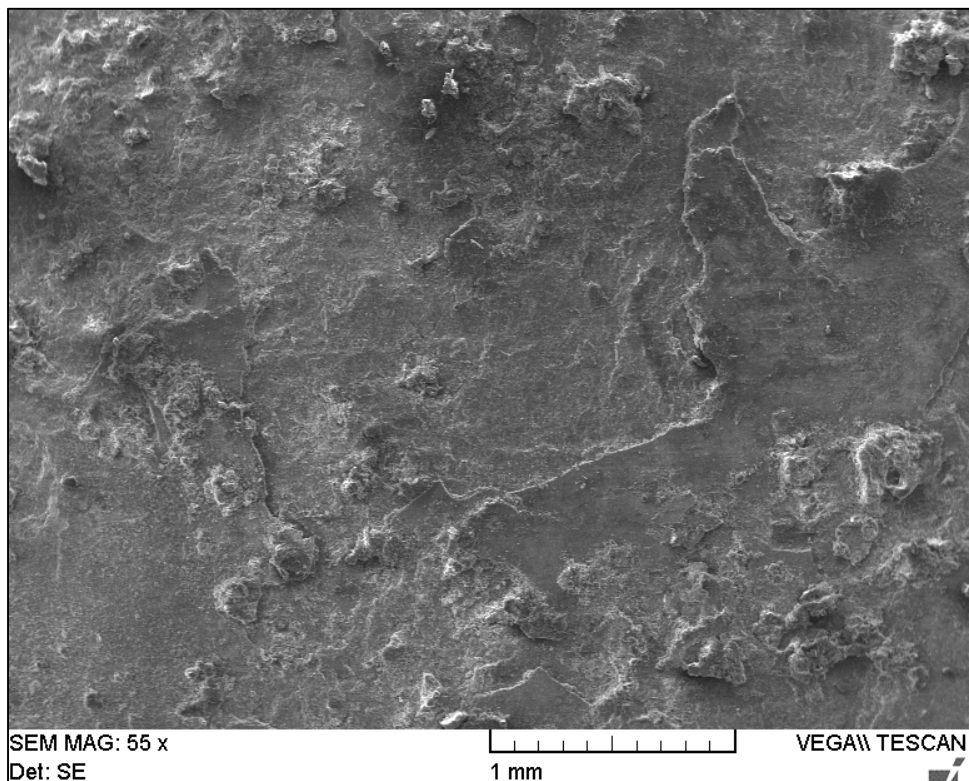
Figure 59. A representative SEM image of a pit on a specimen excised from Coupon 8 labeled as 8-1, prior to cleaning. (SEM, 53X)

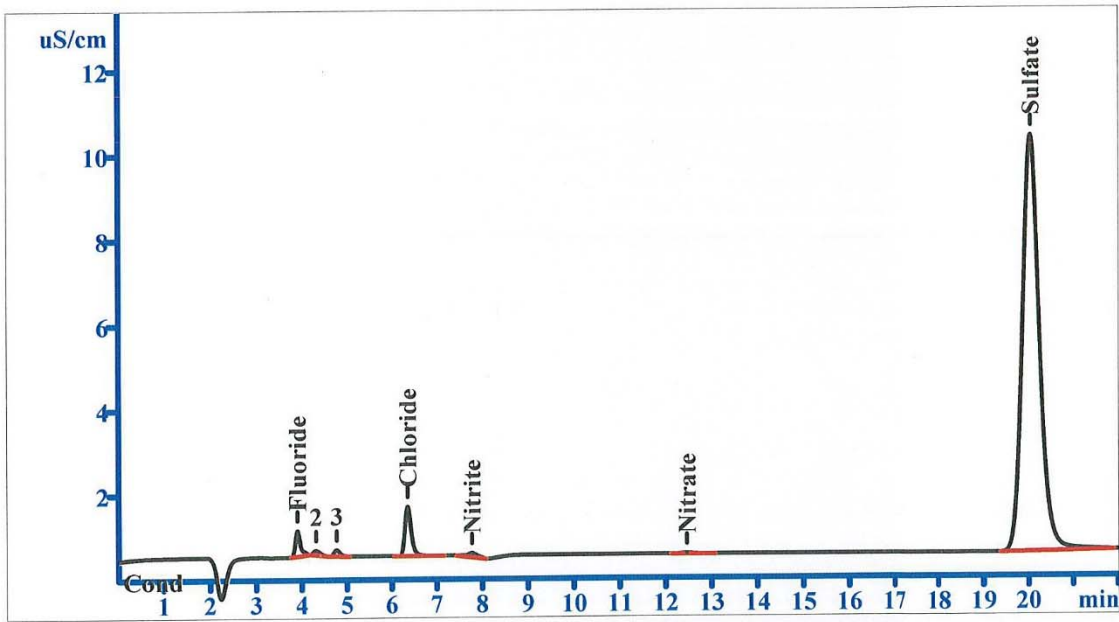
No	Retention min	Height uS/cm	Area uS/cm*sec	Conc. ppm	Name
1	3.92	0.60	4.635	24.567	Fluoride
4	6.35	1.16	11.342	78.508	Chloride
5	7.78	0.10	1.492	19.715	Nitrite
6	12.47	0.02	0.348	5.162	Nitrate
7	20.06	9.81	259.442	2190.390	Sulfate
5	22.00	11.69	277.260	2318.341

Figure 106. The ion chromatogram generated from a concrete sample removed from Coupon 7.

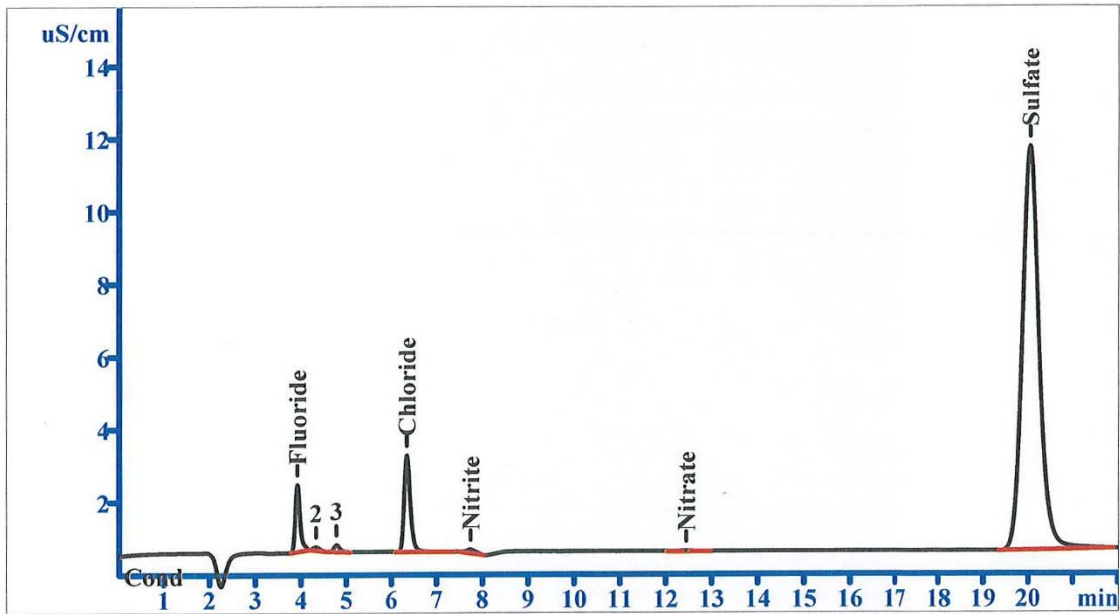
No	Retention min	Height uS/cm	Area uS/cm*sec	Conc. ppm	Name
1	3.92	1.84	13.713	70.024	Fluoride
4	6.34	2.65	25.697	171.359	Chloride
5	7.75	0.10	1.421	18.089	Nitrite
6	12.47	0.02	0.309	4.417	Nitrate
7	20.05	11.12	294.084	2392.060	Sulfate
5	22.00	15.73	335.223	2655.950

Figure 107. The ion chromatogram generated from a concrete sample removed from Coupon 8.

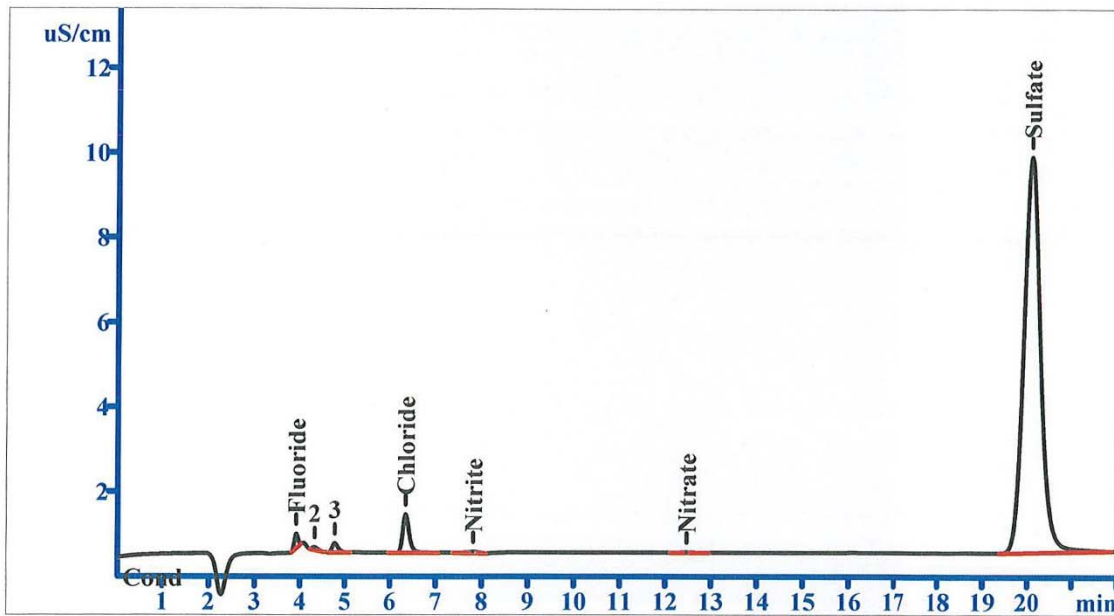
No	Retention min	Height uS/cm	Area uS/cm*sec	Conc. ppm	Name
1	3.92	0.34	1.950	10.365	Fluoride
4	6.35	0.90	8.923	61.921	Chloride
5	7.84	0.03	0.489	6.481	Nitrite
6	12.49	0.01	0.220	3.267	Nitrate
7	20.09	9.33	247.184	2092.300	Sulfate
5	22.00	10.61	258.766	2174.334

Figure 108. The ion chromatogram generated from a concrete sample removed from Coupon 10.

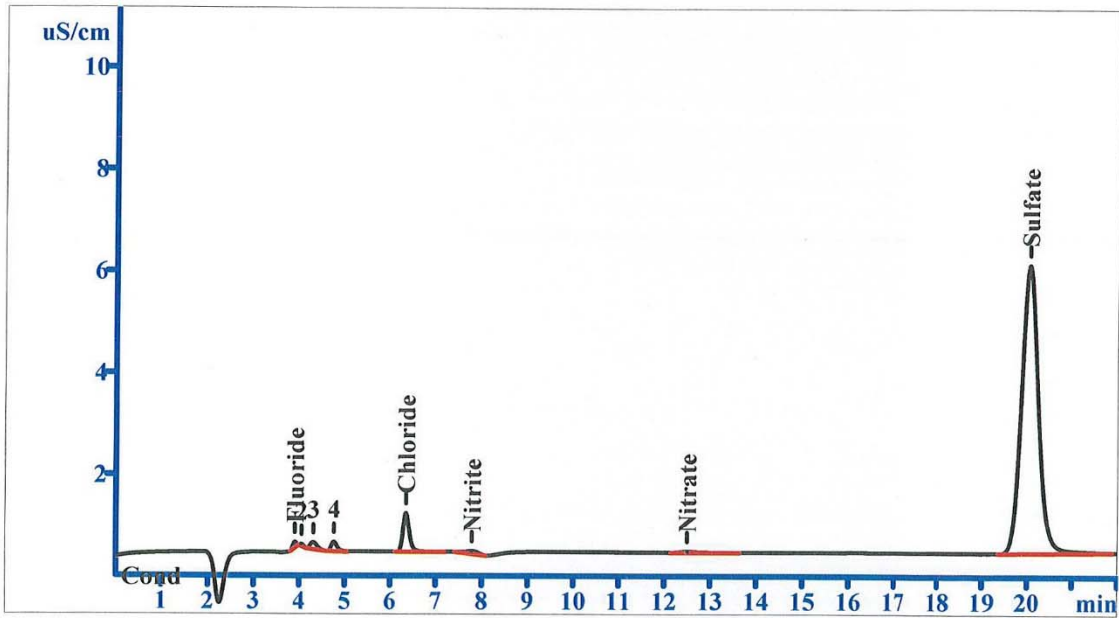
No	Retention min	Height uS/cm	Area uS/cm*sec	Conc. ppm	Name
1	3.91	0.11	0.617	3.277	Fluoride
5	6.36	0.78	7.603	52.710	Chloride
6	7.82	0.06	1.132	14.978	Nitrite
7	12.50	0.02	0.412	6.112	Nitrate
8	20.06	5.68	149.697	1265.856	Sulfate
5	22.00	6.64	159.460	1342.933

Figure 109. The ion chromatogram generated from a concrete sample removed from Coupon A1.

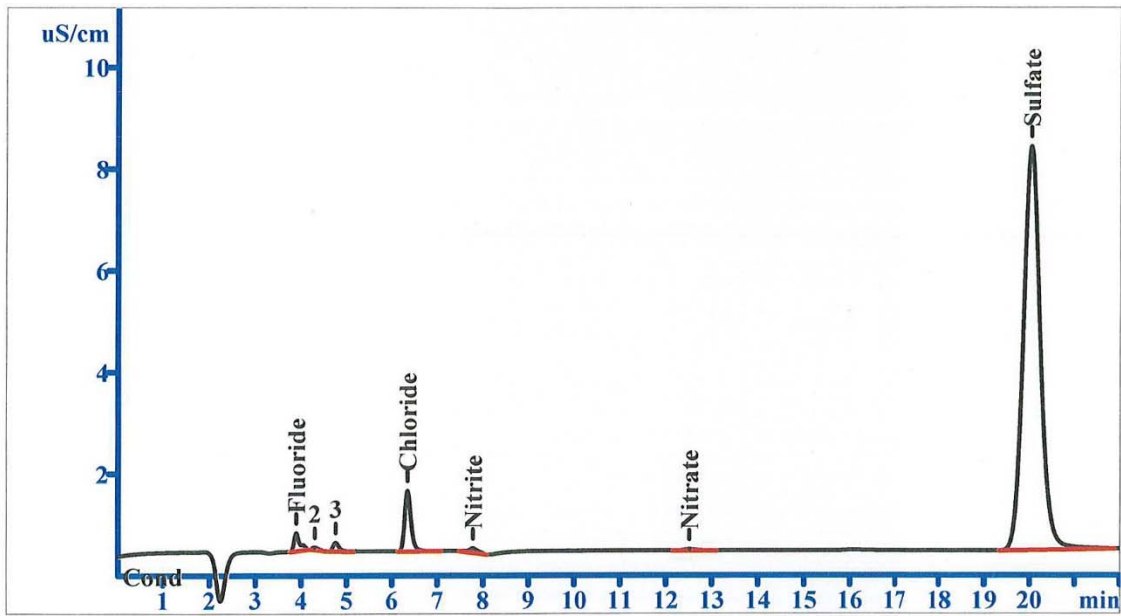
No	Retention min	Height uS/cm	Area uS/cm*sec	Conc. ppm	Name
1	3.92	0.35	3.097	16.357	Fluoride
4	6.36	1.19	11.606	80.052	Chloride
5	7.79	0.09	1.276	16.801	Nitrite
6	12.51	0.03	0.518	7.652	Nitrate
7	20.05	7.94	208.478	1753.979	Sulfate
5	22.00	9.59	224.975	1874.840

Figure 110. The ion chromatogram generated from a concrete sample removed from Coupon A2.

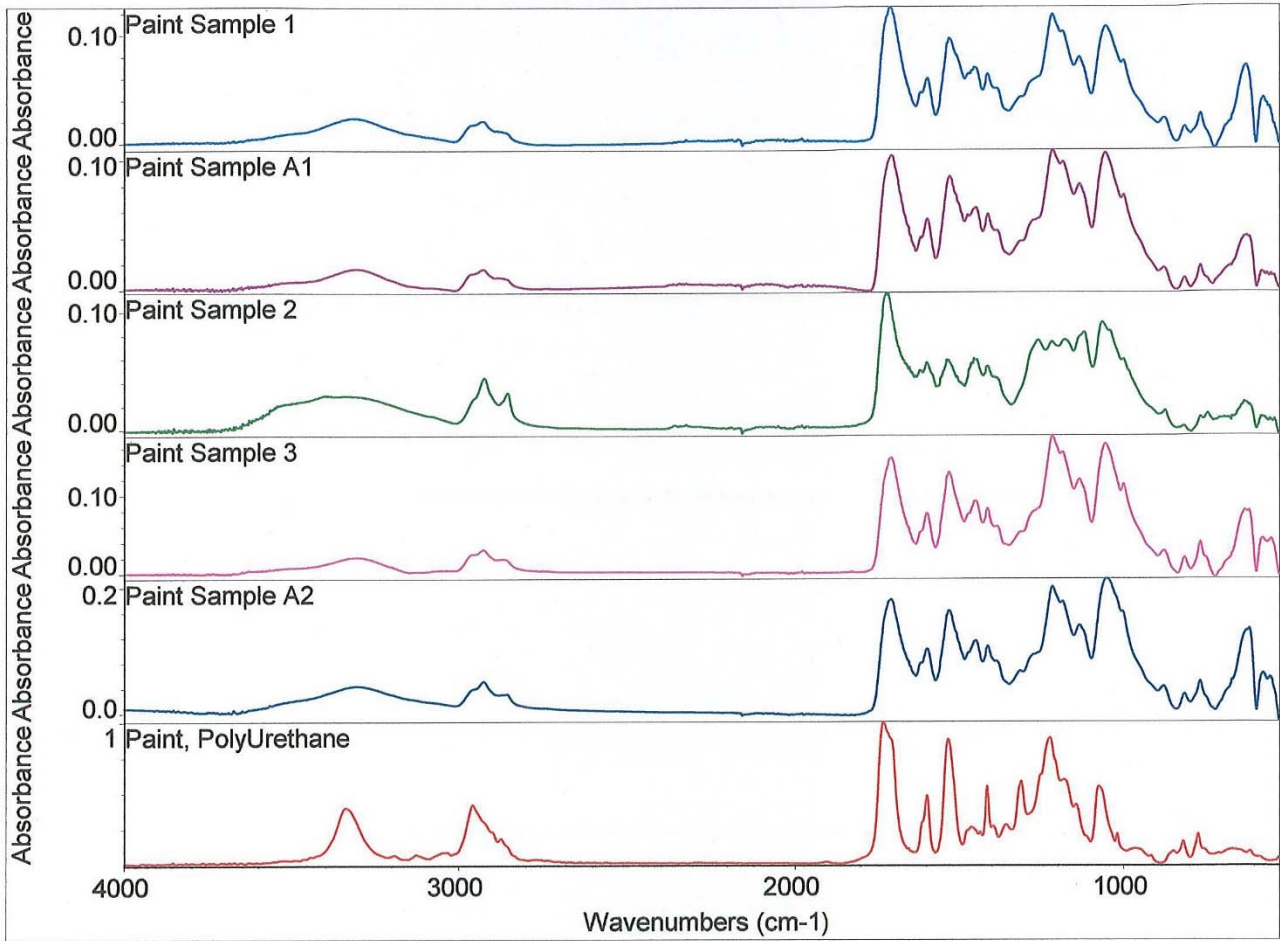
Fourier transform infrared (FTIR) spectroscopy was performed on paint samples removed from each coupon using Attenuated Total Reflectance (ATR) with a diamond crystal. All paint samples were identified as polyurethane enamel. The resulting FTIR spectra of the samples and the best matches from the spectral FTIR library of standards for polyurethane enamel are provided as Figures 111 and 112.

Figure 111. The FTIR spectra generated from a paint samples removed from the exterior surfaces of Coupons 1, A1, 2, A2 and 3 the best matches from the spectral FTIR library of standards for polyurethane enamel.
