SUBJECT: ADMINISTRATIVE ORDER ON CONSENT (AOC) STATEMENT OF WORK (SOW) SECTION 5 CORROSION AND METAL FATIGUE PRACTICES, DESTRUCTIVE TESTING RESULTS REPORT, RED HILL BULK FUEL STORAGE FACILITY (RED HILL), JOINT BASE PEARL HARBOR-HICKAM, OAHU, HAWAII

As identified in Red Hill Bulk Fuel Storage Facility Scope of Work for Destructive Testing Administrative Order on Consent (AOC) and Statement of Work (SOW) Section 5.3.2, the purpose of this effort is to verify the findings of the Corrosion and Metal Fatigue Practices Report, using destructive testing on at least one tank at the Facility.

In 2018, ten coupons were removed from Tank 14, so that a metallurgical and corrosion analysis of the coupons could be undertaken, with the primary aim of validating non-destructive examination (NDE) results. The steel coupons, concrete powder samples, and corrosion product were submitted to a certified third-party laboratory to perform this analysis.

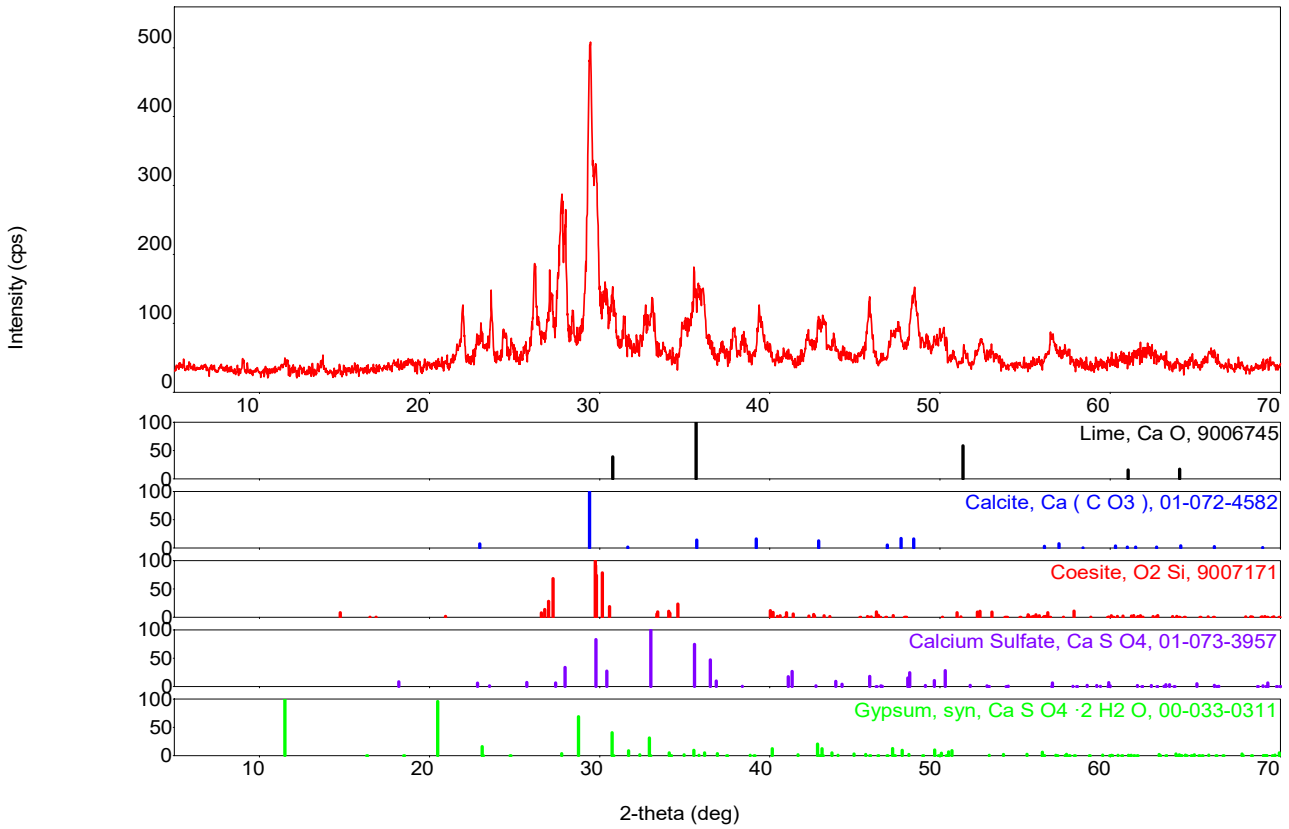
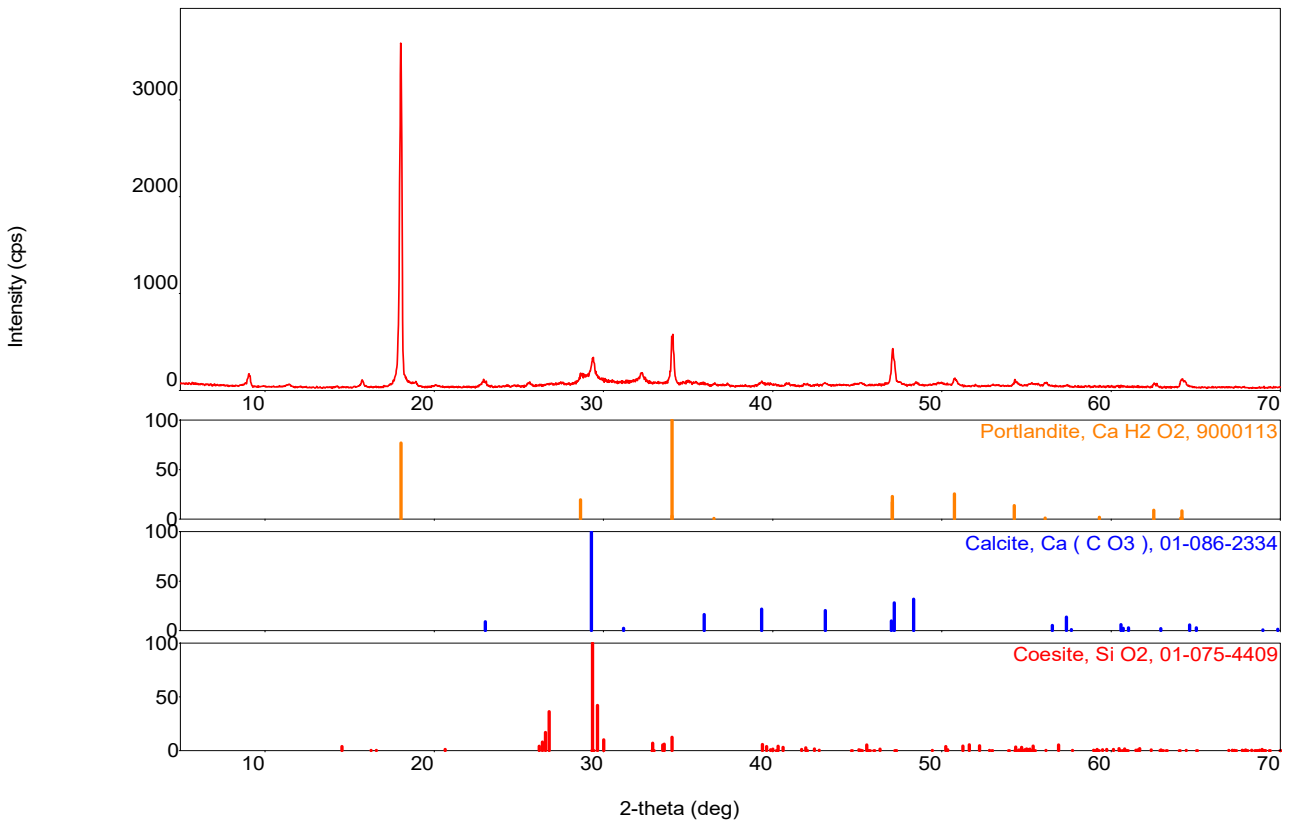
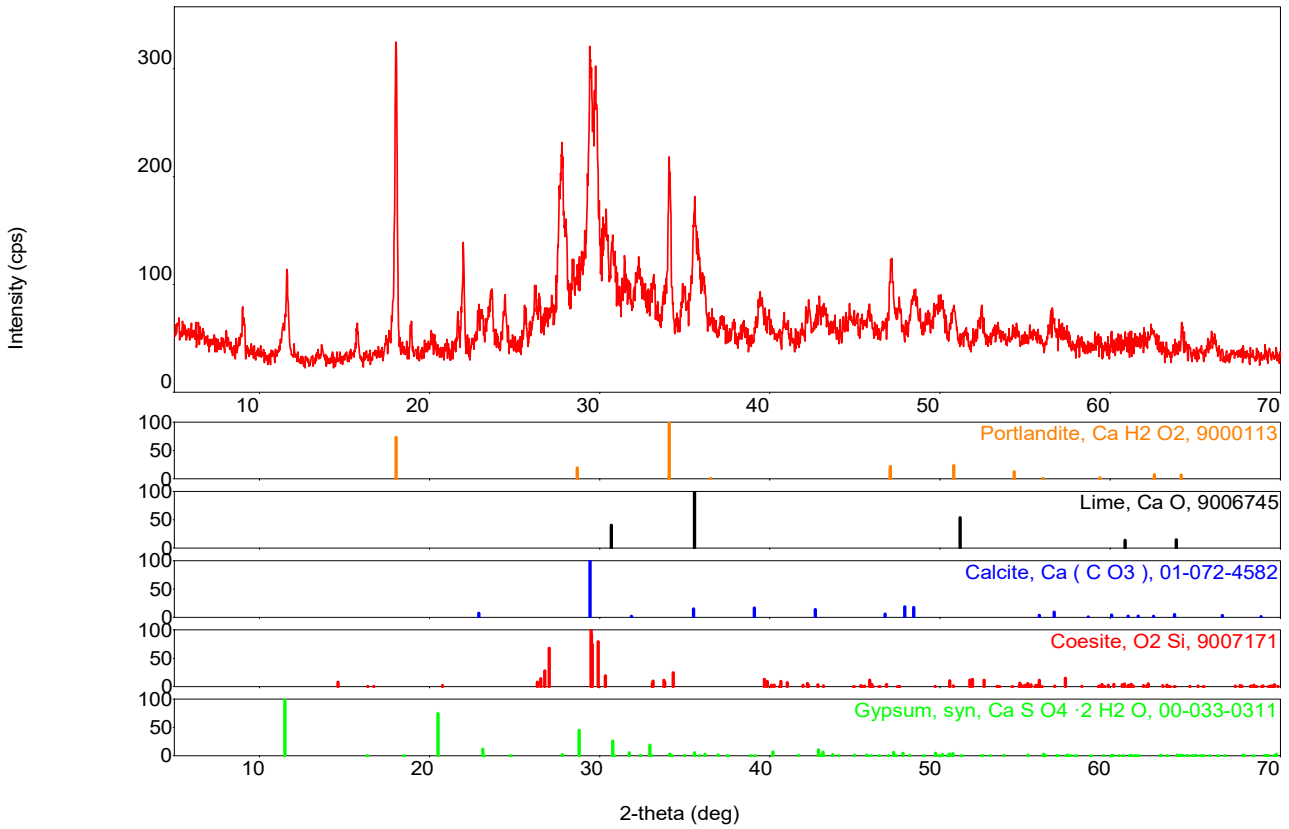
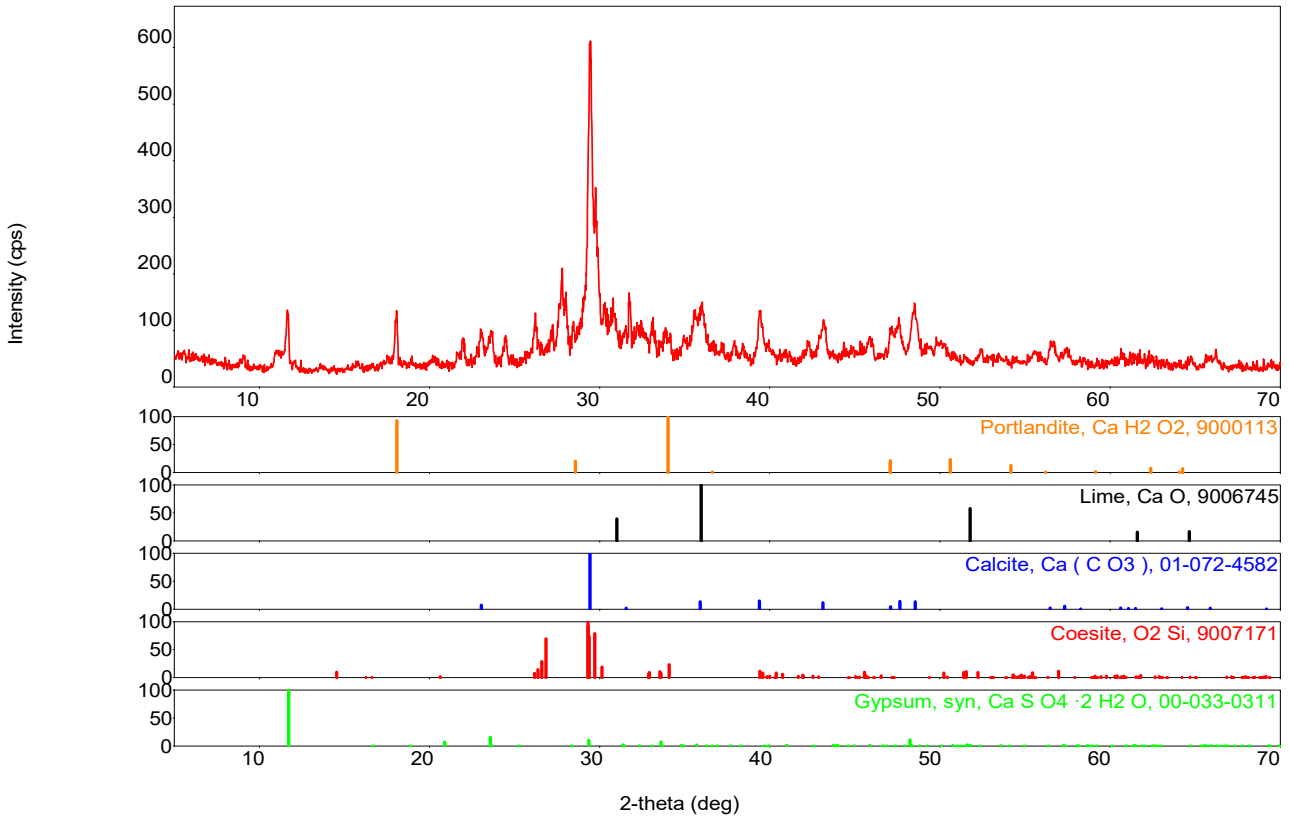
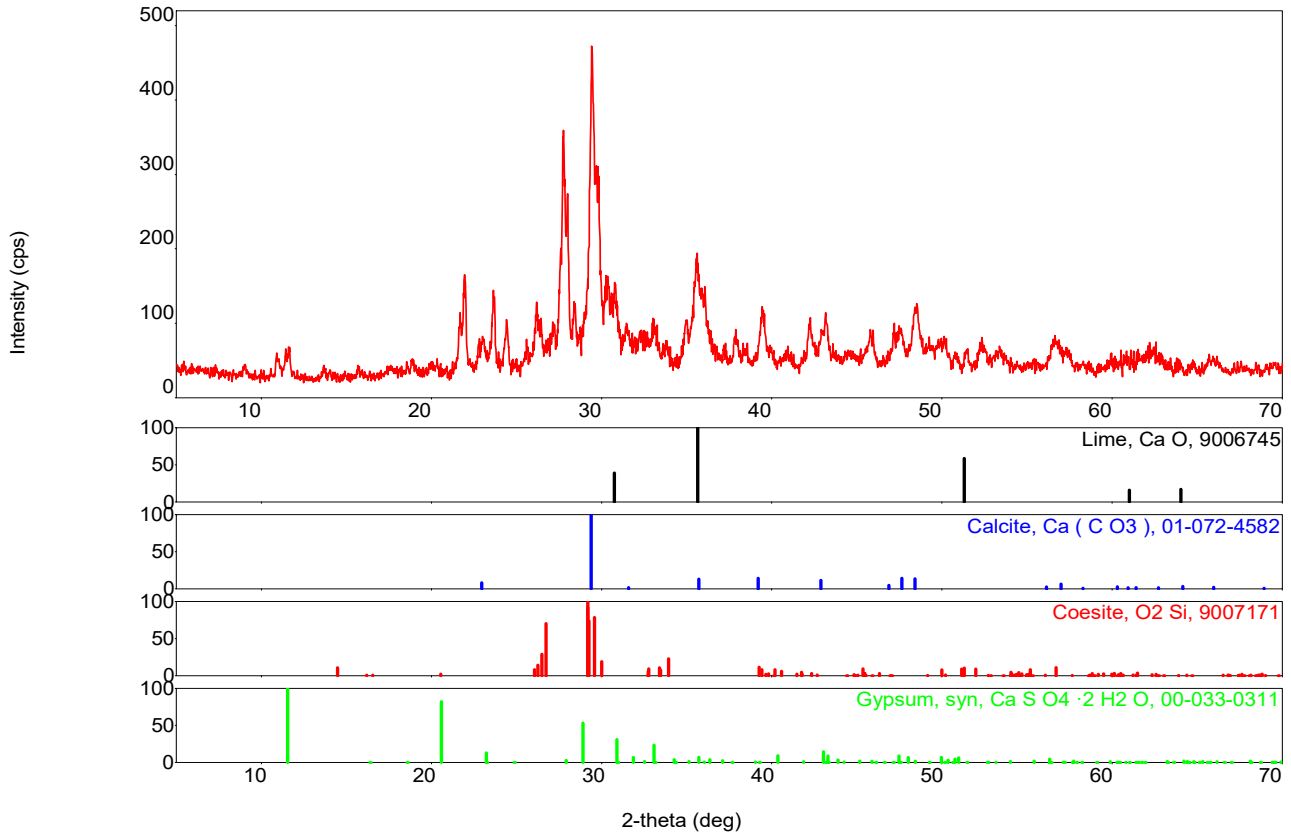
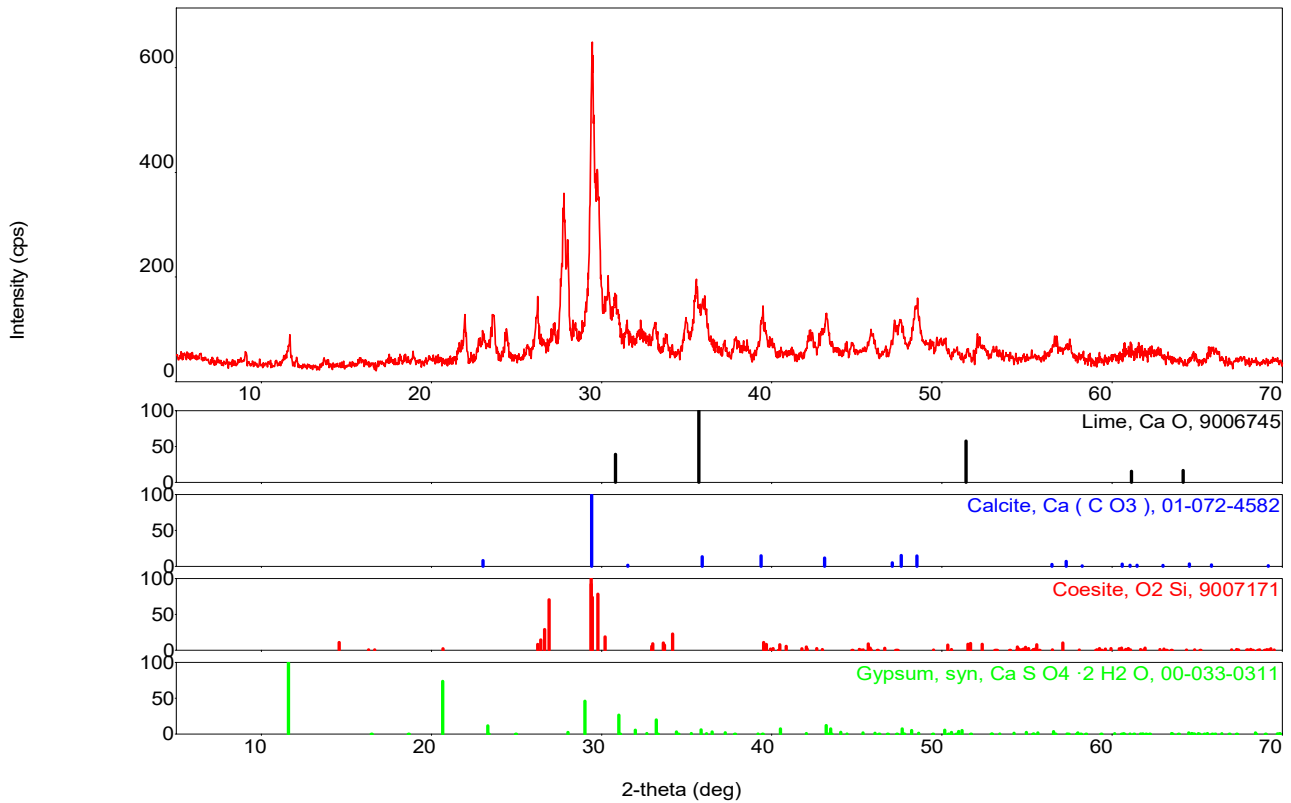
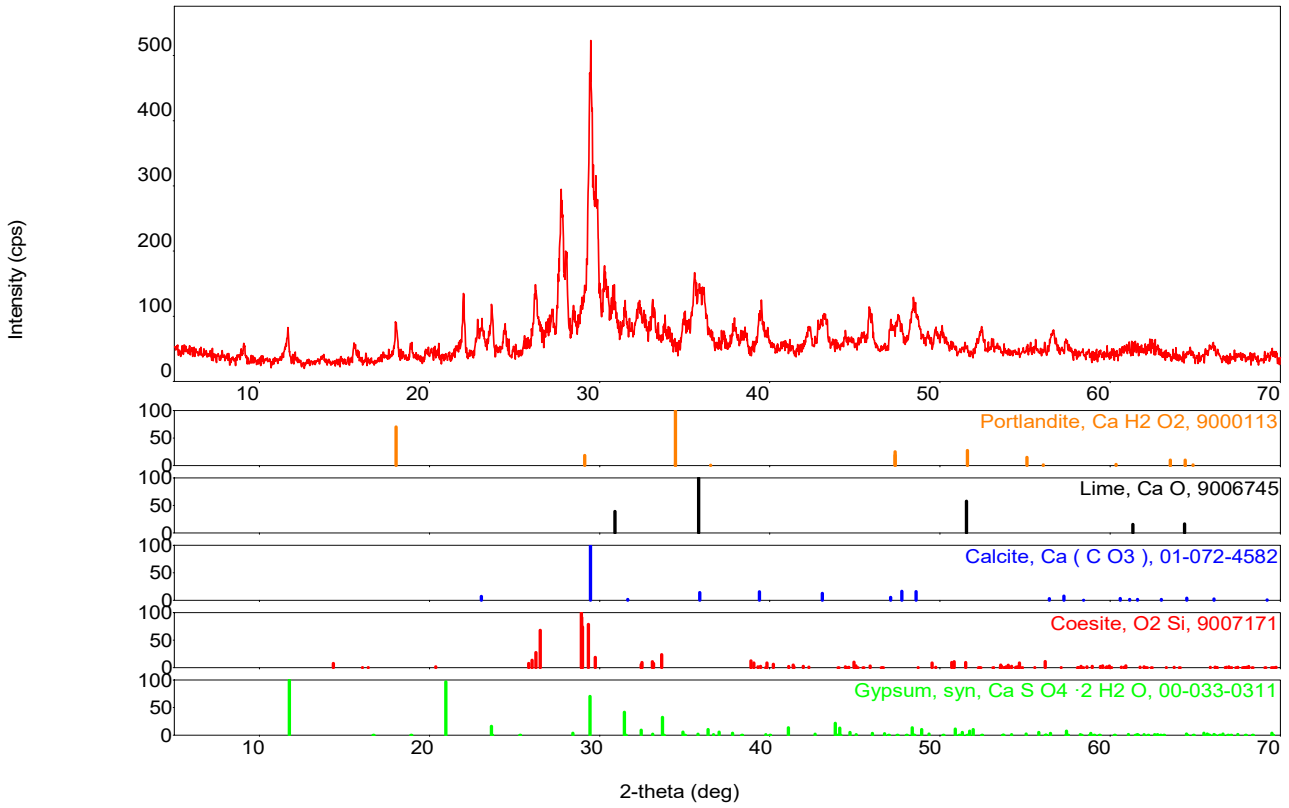
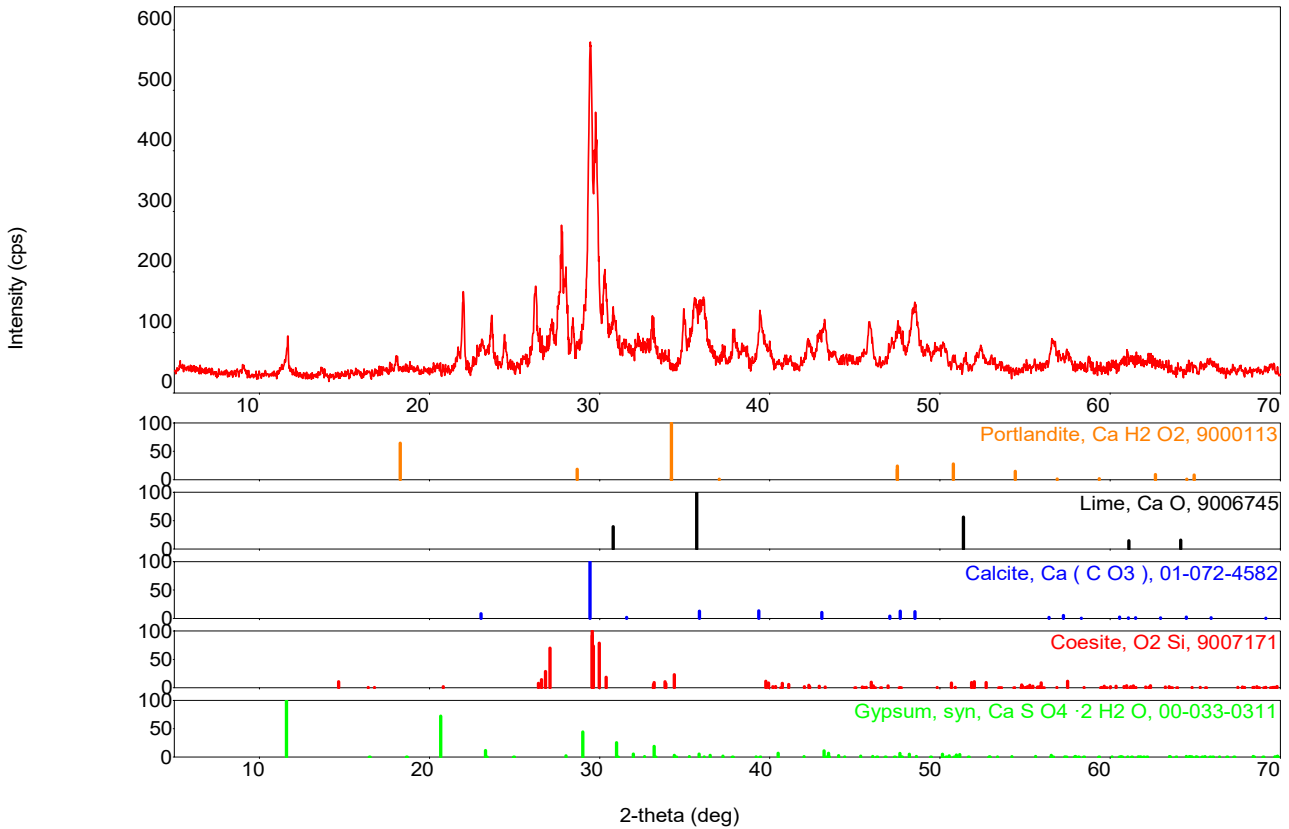
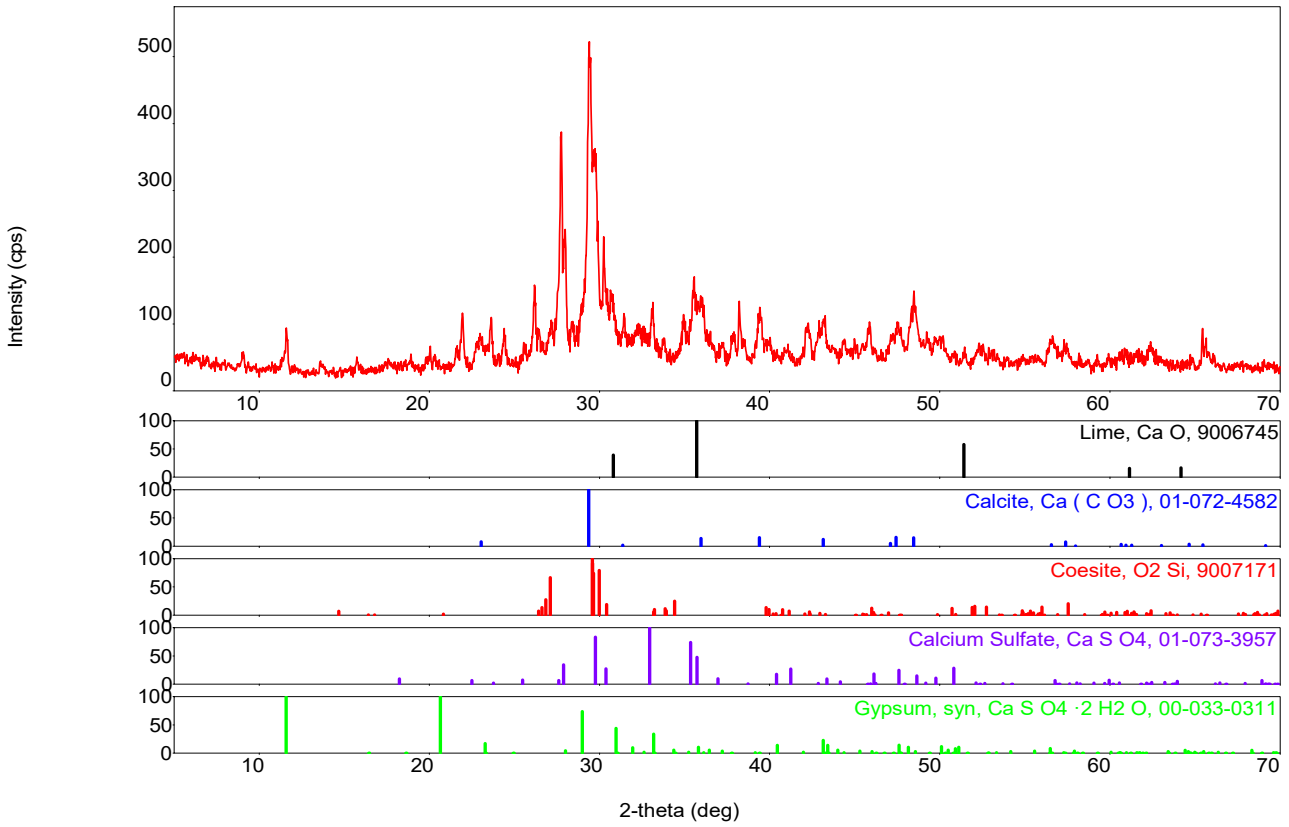
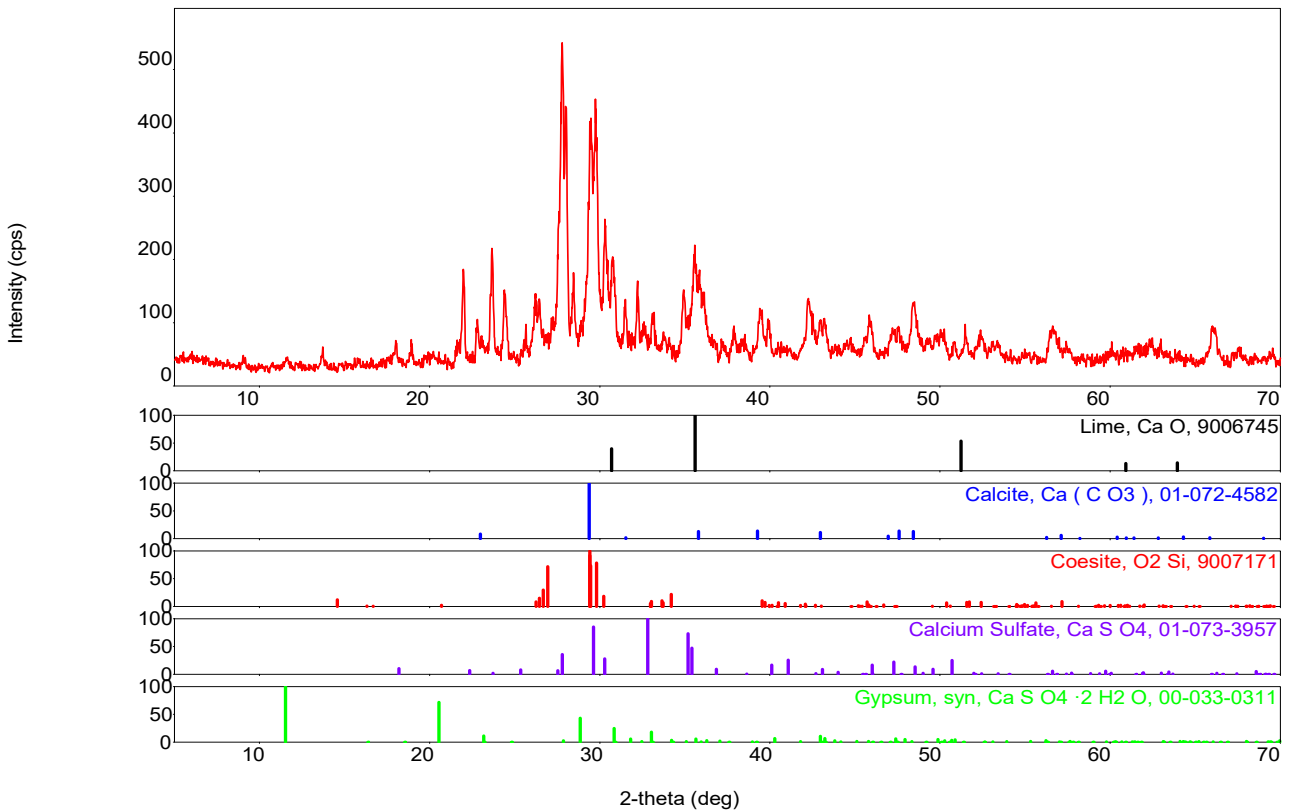
X-Ray Diffraction Spectroscopy (XRD) analysis of the concrete samples revealed the presence of the following crystalline phases: calcium oxide (lime); calcium carbonate (calcite); silicon dioxide (coesite); calcium sulfate; calcium sulfate hydrated (gypsum) and calcium hydroxide (portlandite). The results are summarized in Tables 17 and 18. The XRD diffractograms for the concrete samples are provided as Figures 113 through 122.

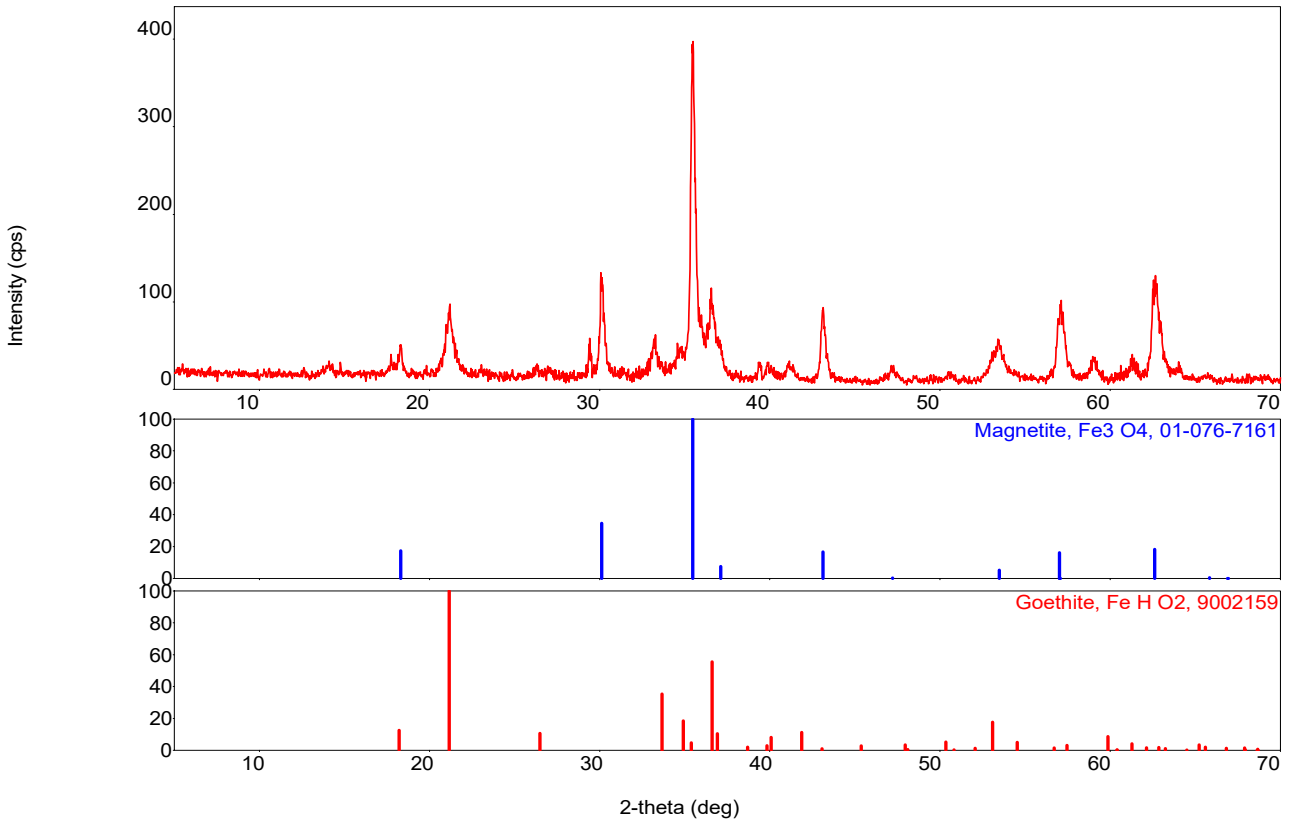
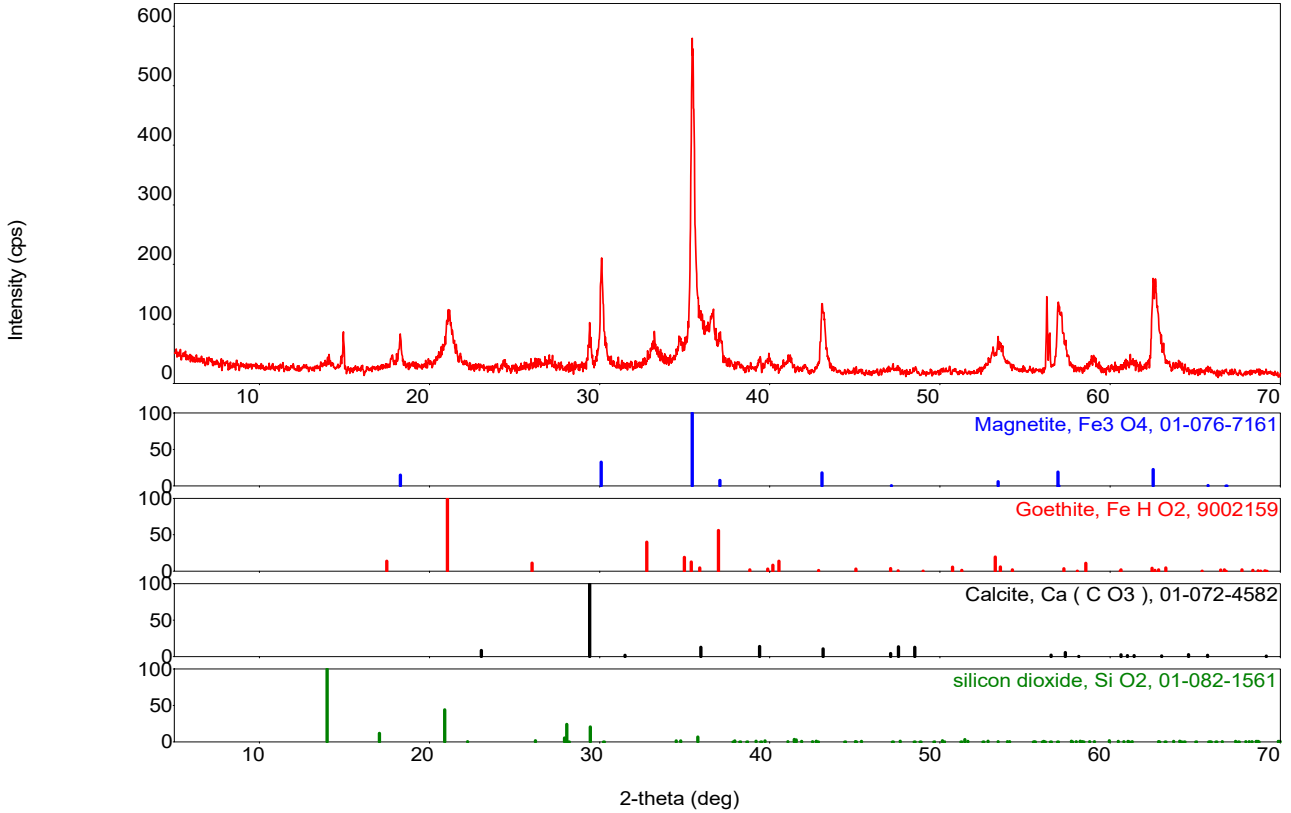
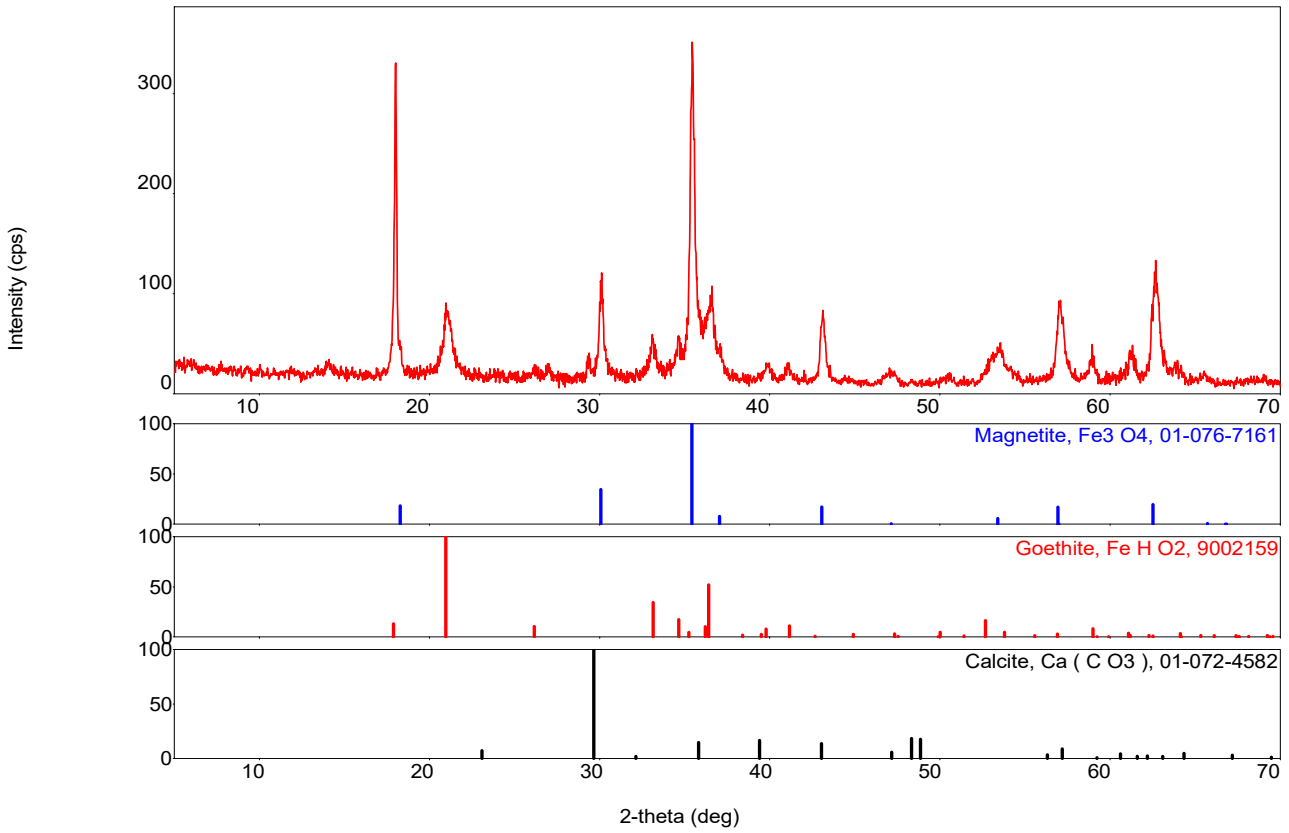
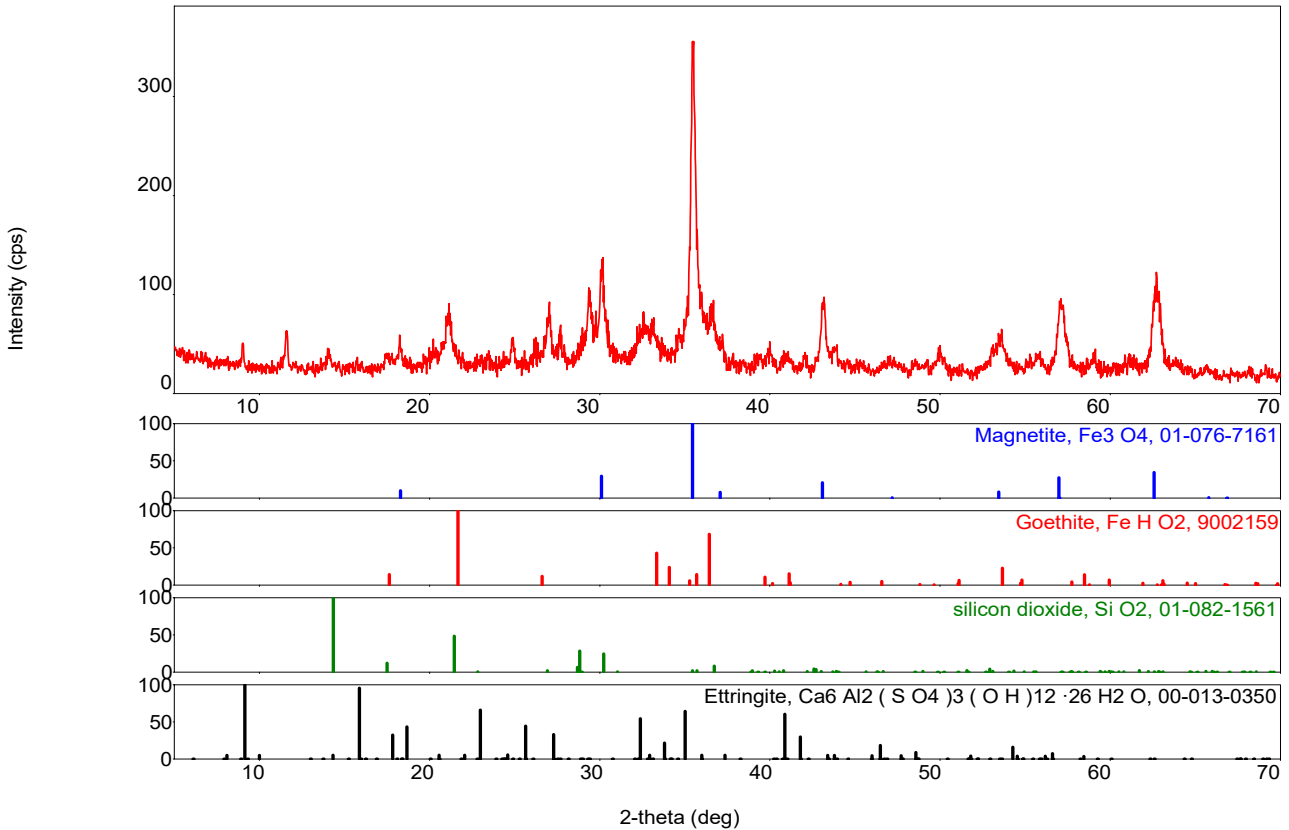
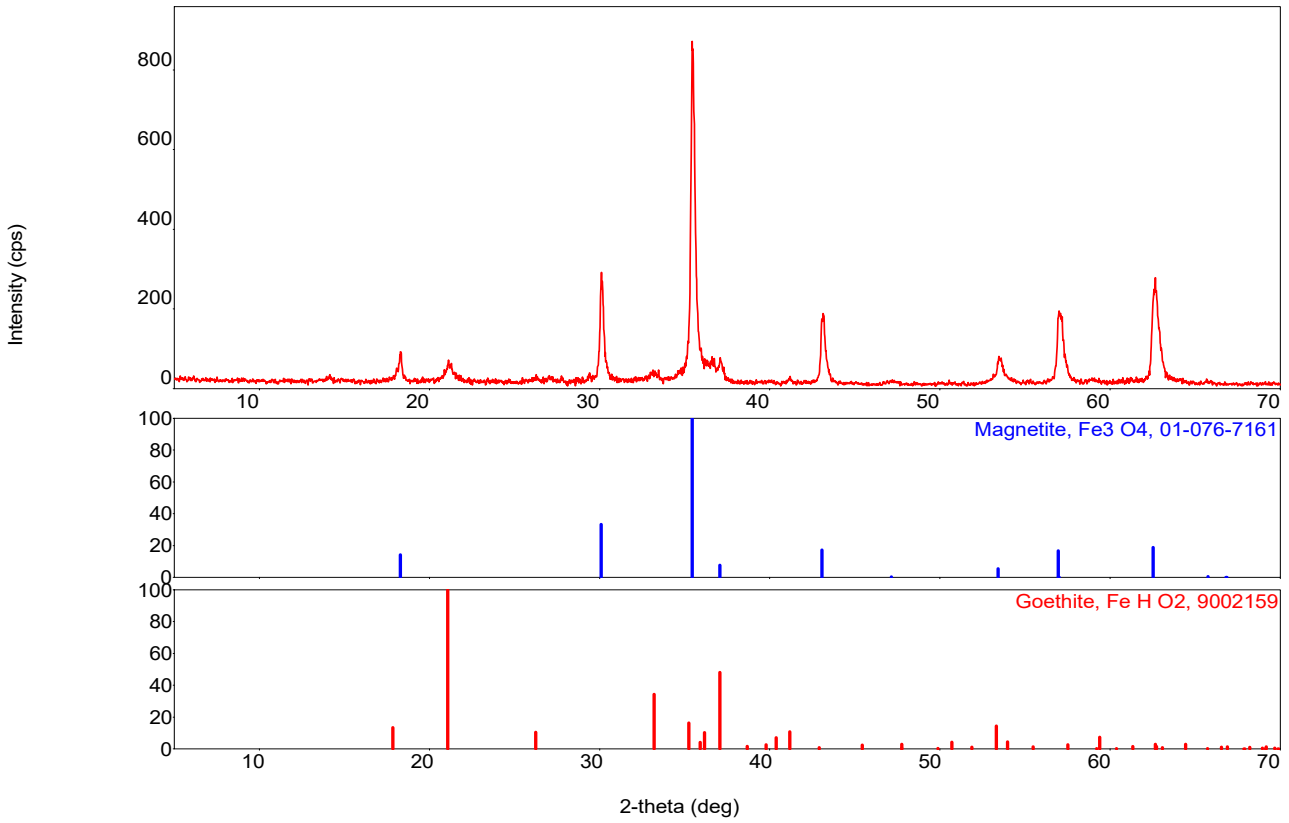
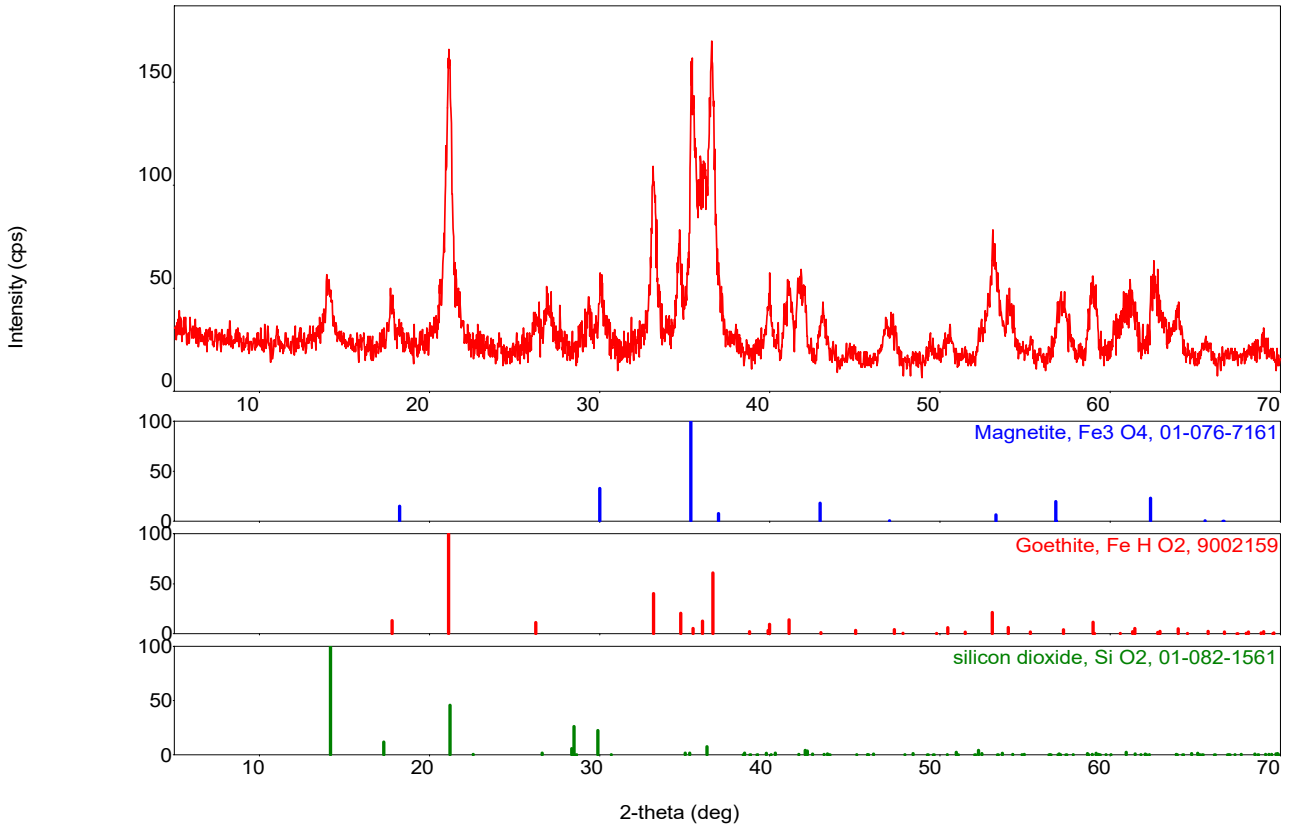
X-Ray Diffraction Spectroscopy (XRD) analysis of the corrosion product from the metal panels revealed the presence of the following crystalline phases: iron oxide (magnetite); iron hydroxide (goethite); calcium carbonate (calcite); silicon dioxide and hydrous calcium aluminum sulfate (ettringite). The results are summarized in Tables 19 and 20. The XRD diffractograms for the corrosion samples are provided as Figures 123 through 128.
