SUBJECT: ADMINISTRATIVE ORDER ON CONSENT (AOC) STATEMENT OF WORK (SOW) SECTION 5 CORROSION AND METAL FATIGUE PRACTICES, DESTRUCTIVE TESTING RESULTS REPORT, RED HILL BULK FUEL STORAGE FACILITY (RED HILL), JOINT BASE PEARL HARBOR-HICKAM, OAHU, HAWAII

As identified in Red Hill Bulk Fuel Storage Facility Scope of Work for Destructive Testing Administrative Order on Consent (AOC) and Statement of Work (SOW) Section 5.3.2, the purpose of this effort is to verify the findings of the Corrosion and Metal Fatigue Practices Report, using destructive testing on at least one tank at the Facility.

In 2018, ten coupons were removed from Tank 14, so that a metallurgical and corrosion analysis of the coupons could be undertaken, with the primary aim of validating non-destructive examination (NDE) results. The steel coupons, concrete powder samples, and corrosion product were submitted to a certified third-party laboratory to perform this analysis.

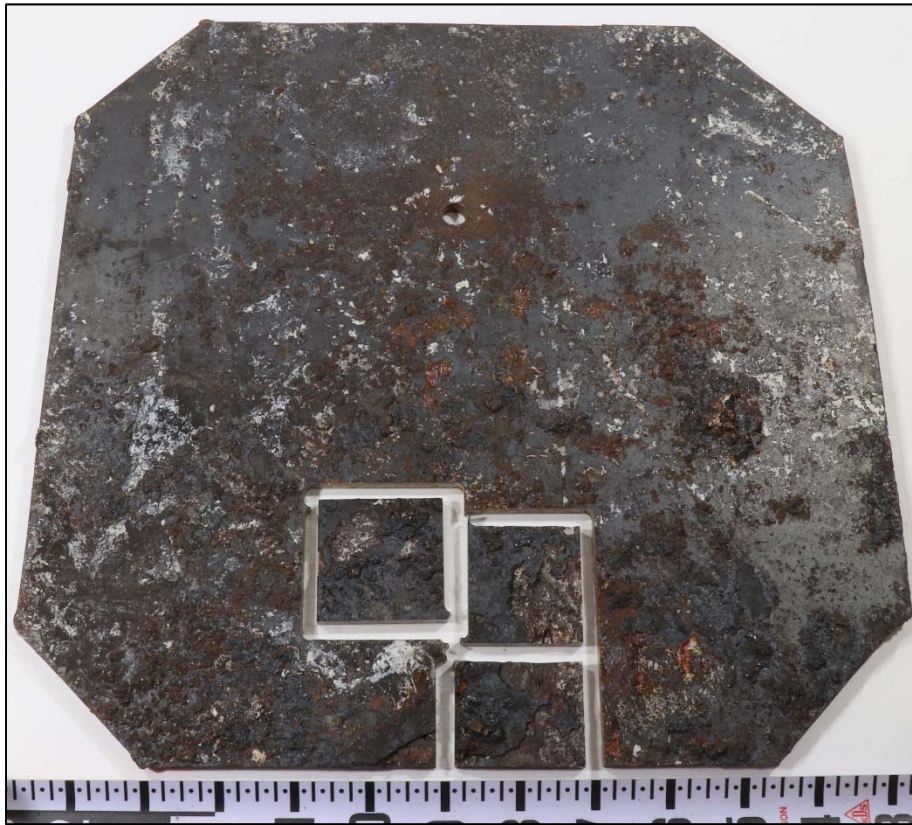
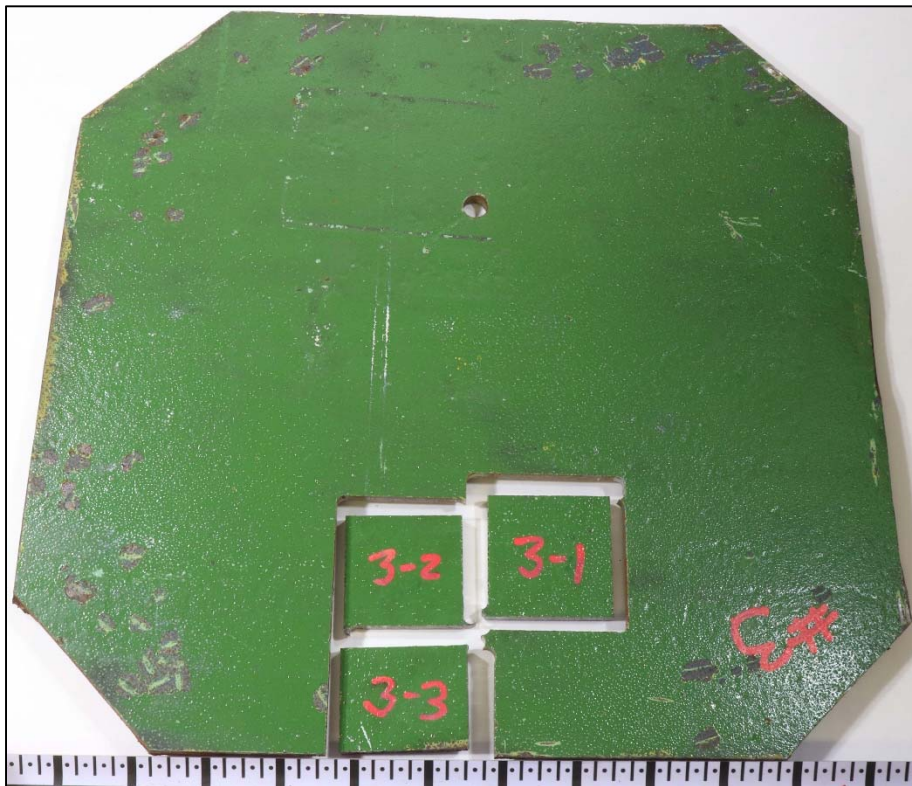
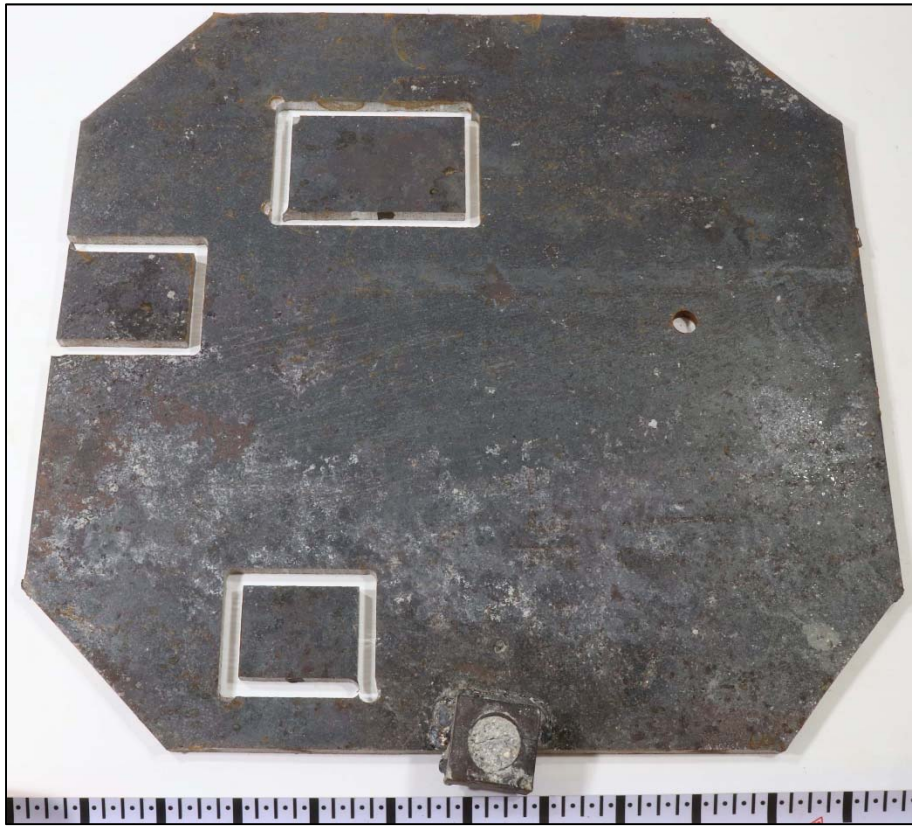
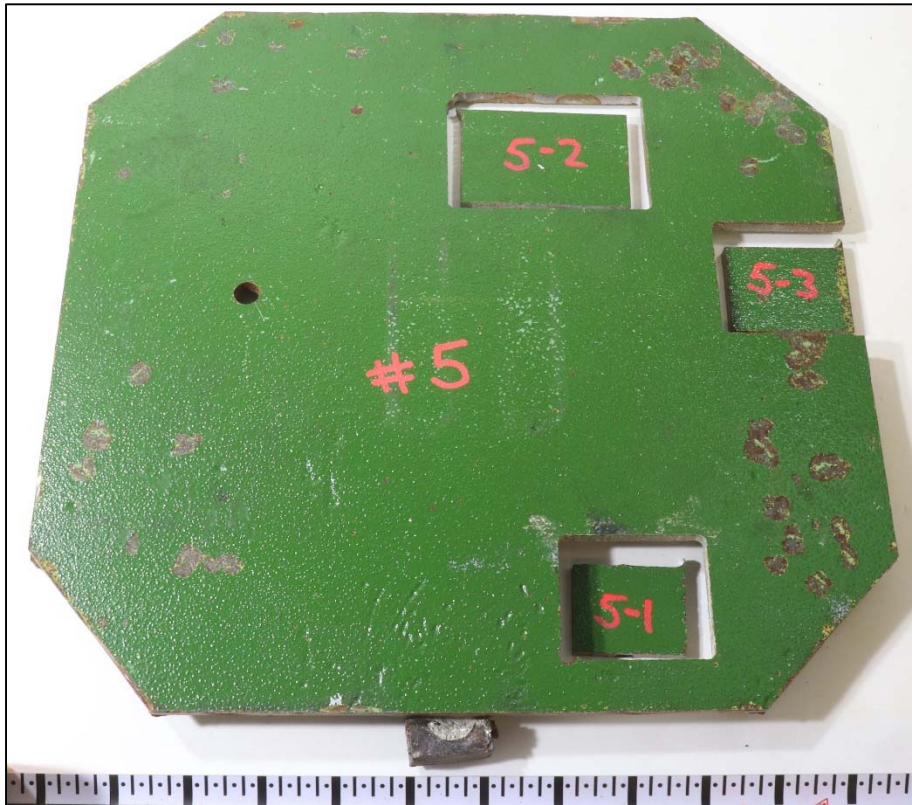
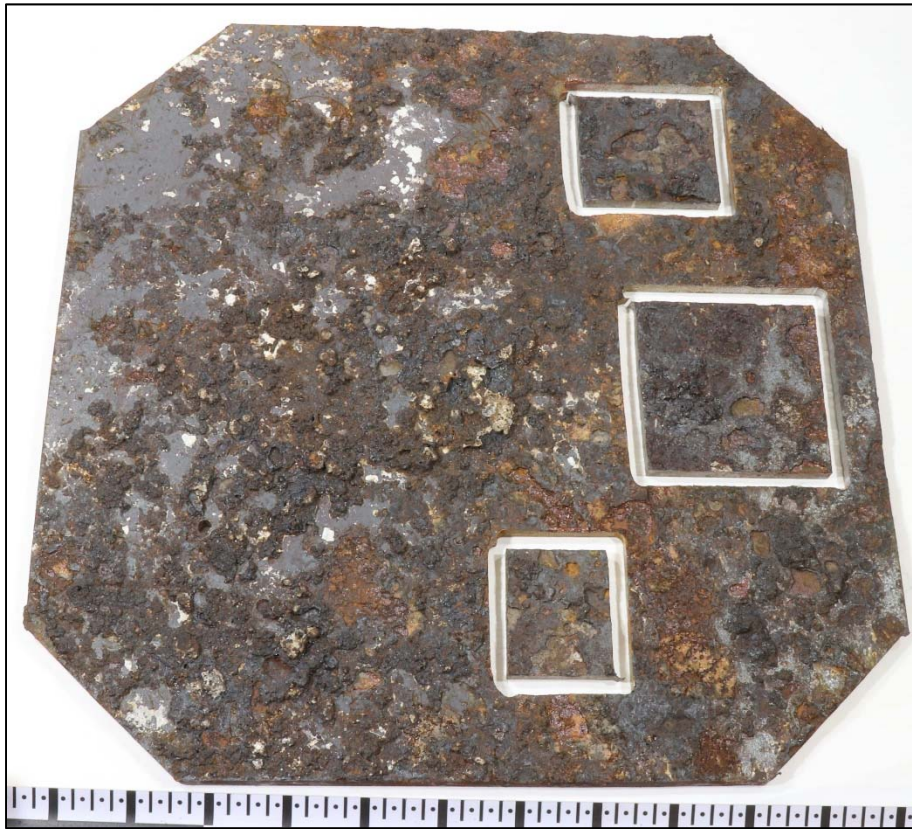
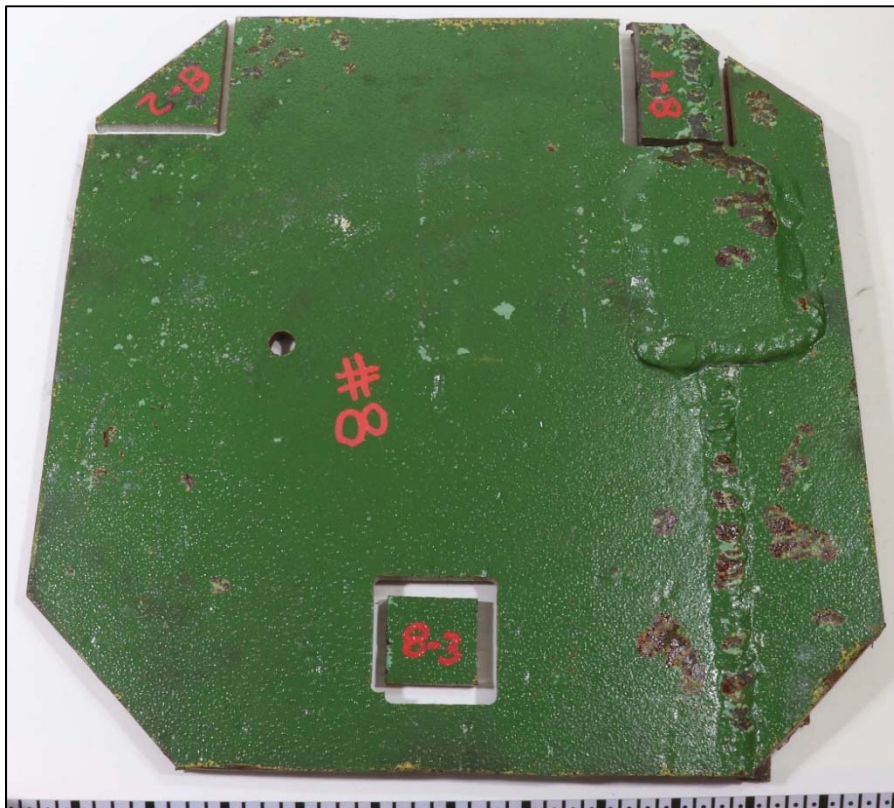
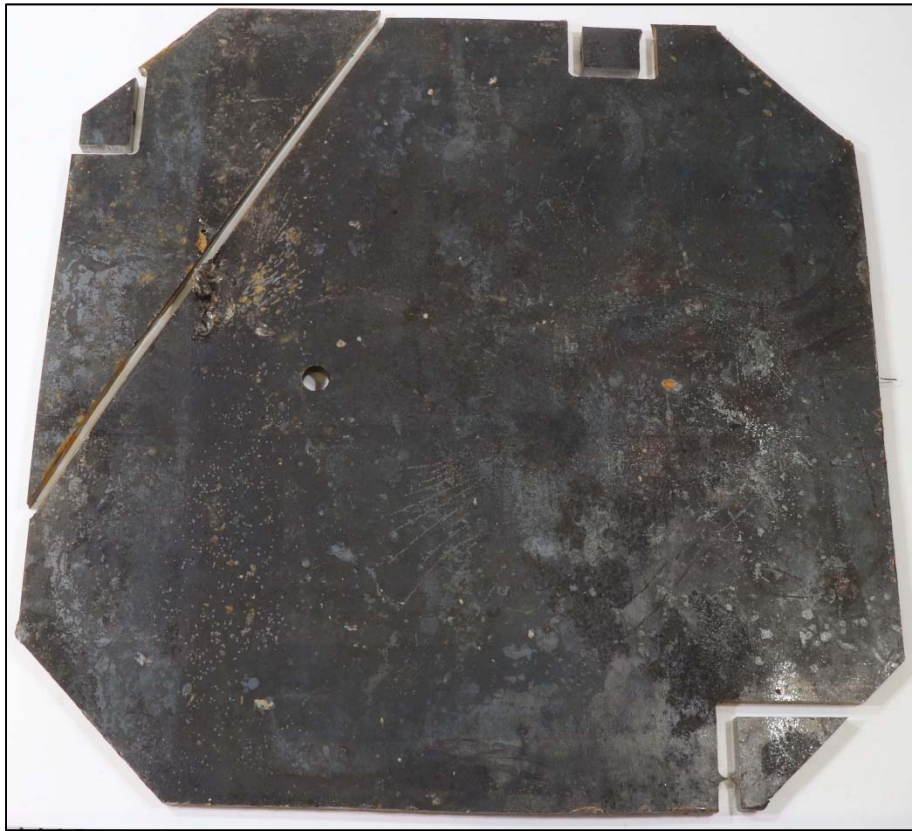
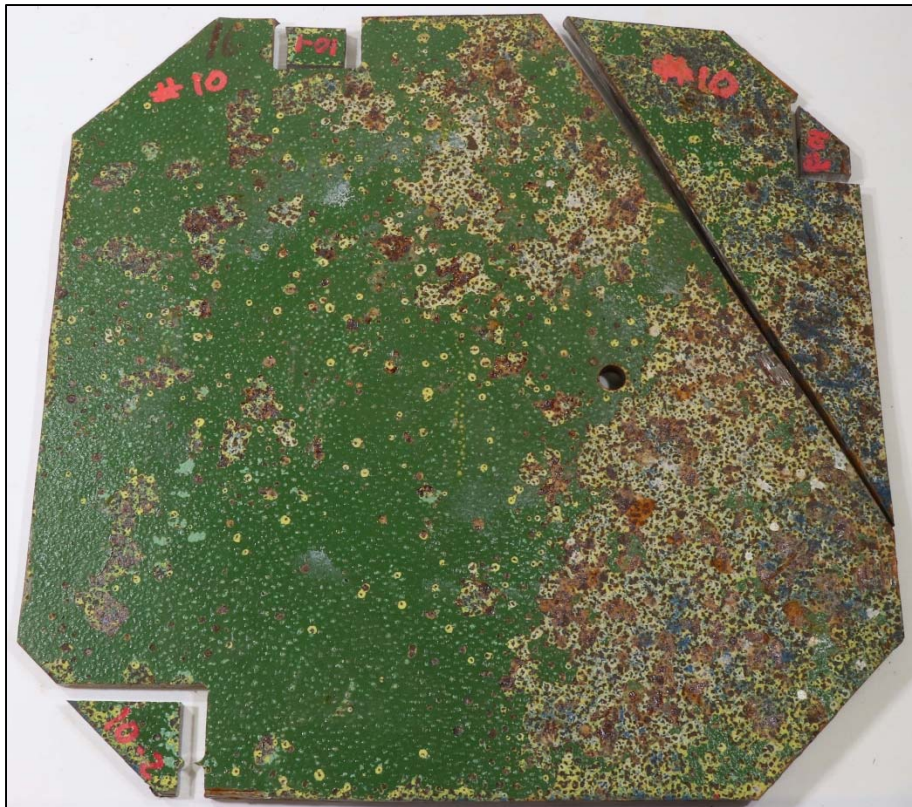
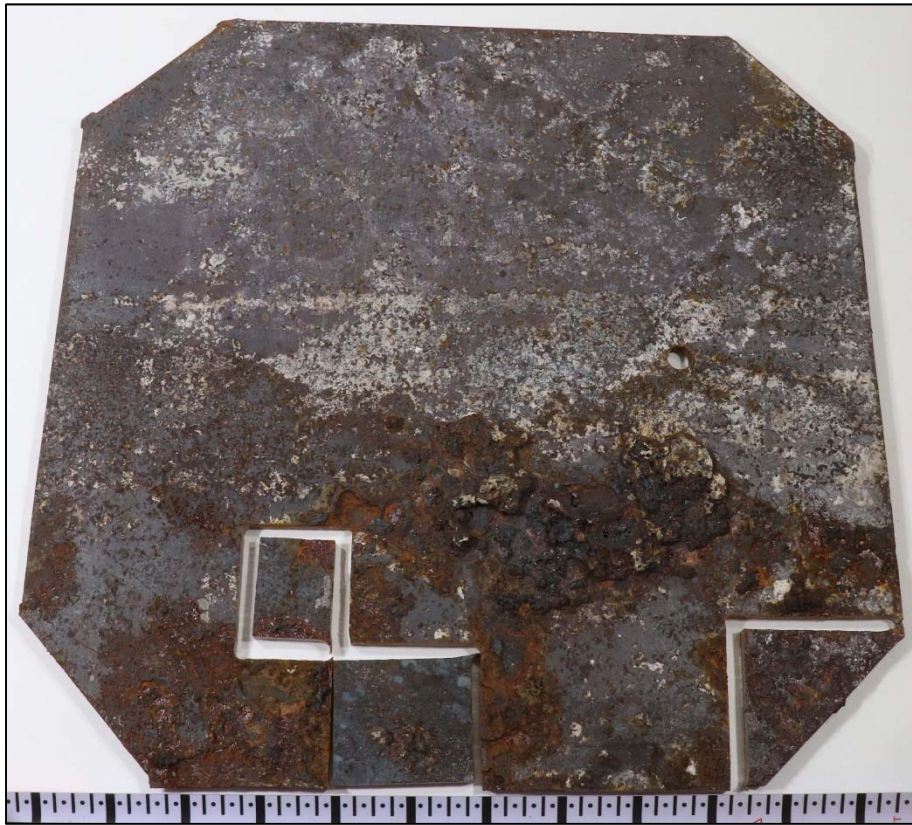
After analysis of the corrosion product and concrete, both sides of the coupons were cleaned using a CO₂ dry ice blast process by a subcontractor. Cleaning was witnessed by the report authors. The CO₂ technique was selected due to its ability to remove most of the residual concrete on the coupon surface, yet not be so aggressive as to remove base metal. Chemical cleaning as prescribed in ASTM G1-03(2011) would not have adequately cleaned the surfaces for analysis. Representative images of the panels after cleaning are provided as Figures 129 through 148. The majority of the residual concrete and loose corrosion product was removed, however the green paint could not be removed.

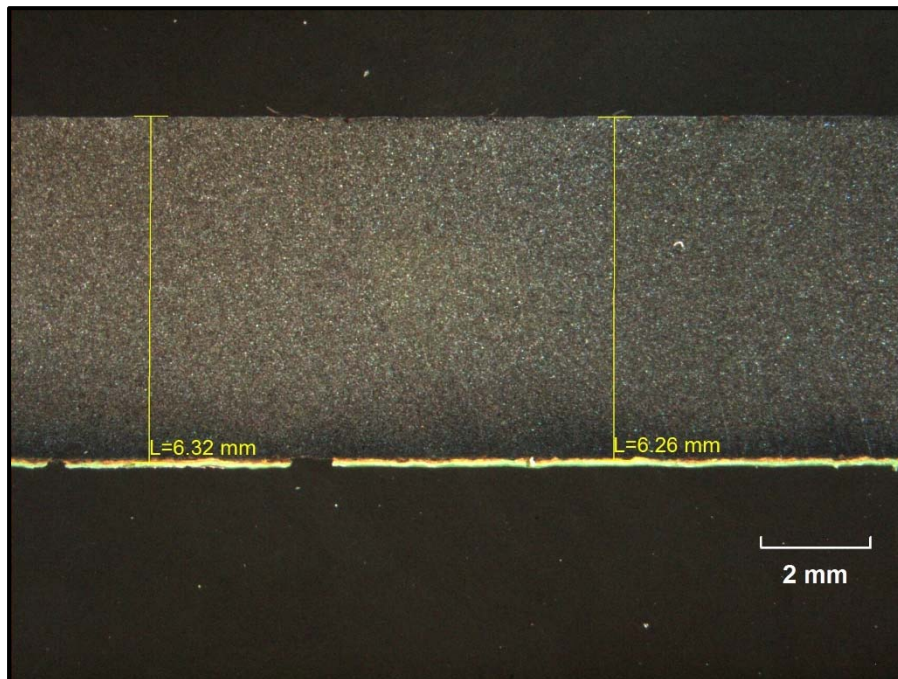
Figure 190. The prepared metallographic cross-section from Sample 5-1 is shown during examination with a stereomicroscope. No significant corrosion was observed. (7X)

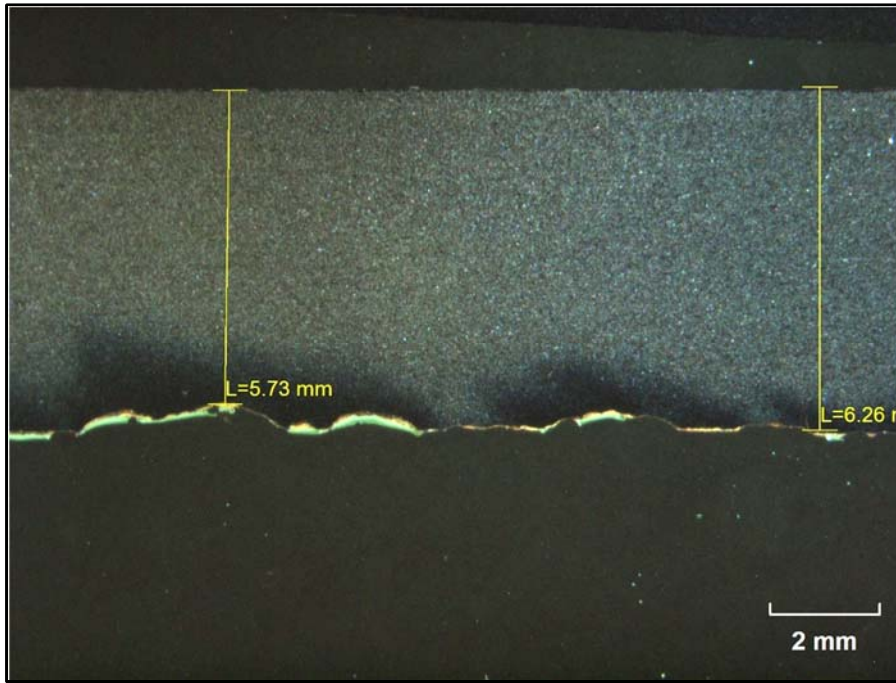
Figure 191. The prepared metallographic cross-section from Sample 5-4 is shown during examination with a stereomicroscope. The thickest remaining wall is shown. Note that the reduction in wall thickness was due to a depression on the painted face of the specimen. (7X)

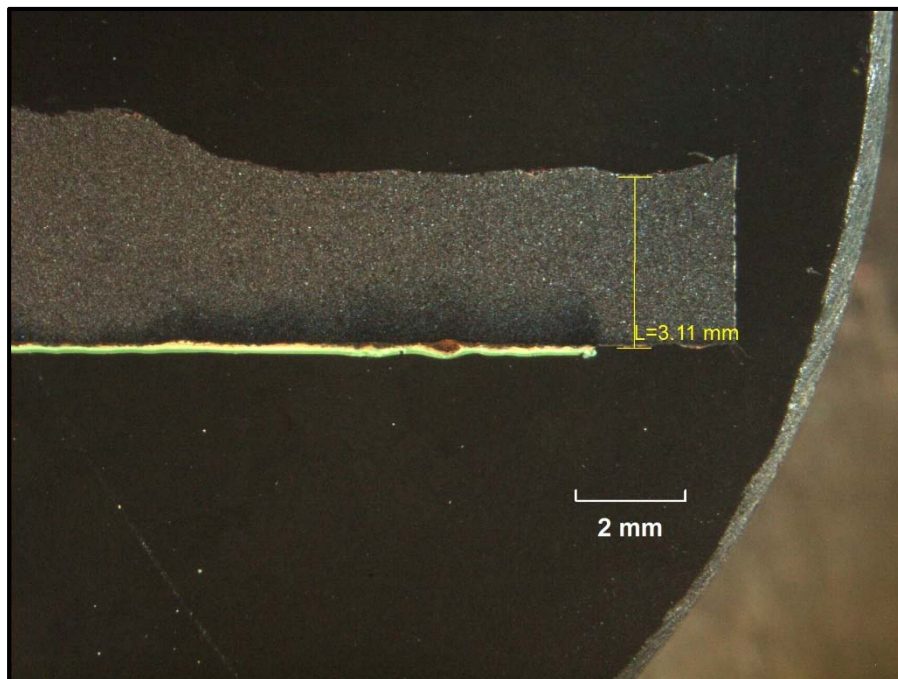
Figure 204. The prepared metallographic cross-section from Sample A1-4 is shown during examination with a stereomicroscope. The thickness remaining underneath the deepest observed pit is shown. (7X)

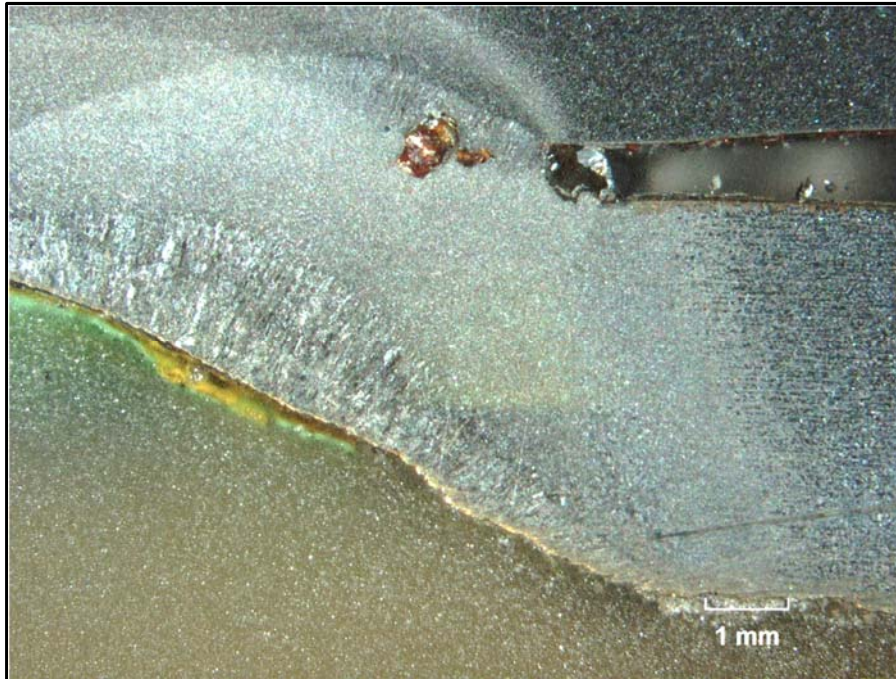
Figure 211. The left-hand feature in Figure 210 is shown at higher magnification. The weld indication (arrow) appeared to be an area of porosity.

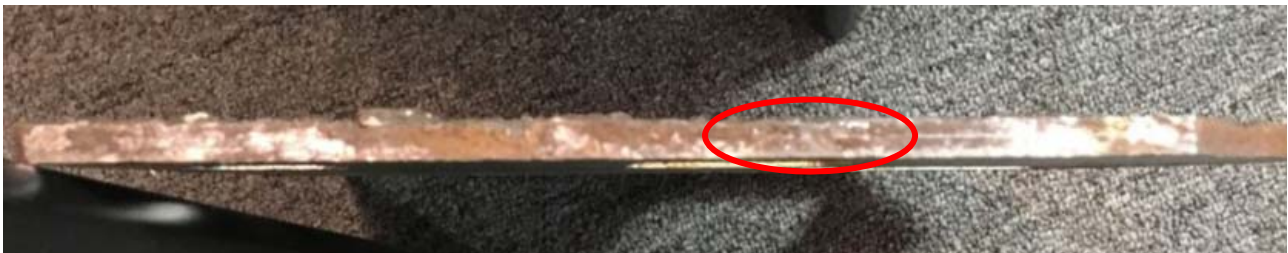
Figure A-2. The same edge of Coupon #7 is shown on 3/20/19 after laboratory testing by IMR and subsequent storage. The red circle corresponds to the same area shown in Figure A-1. Note that the left ~1/4 of the coupon was consumed for mechanical testing, etc., but the area-of-concern remained intact.

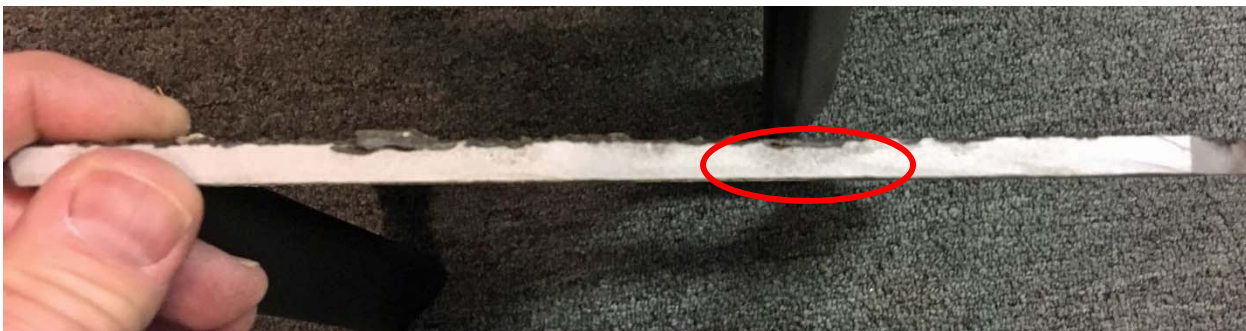
Figure A-3. The same area is shown after sandblasting on 3/20/19. A slight shadowing was observed in the area-of-concern, but no corrosion product was noted.

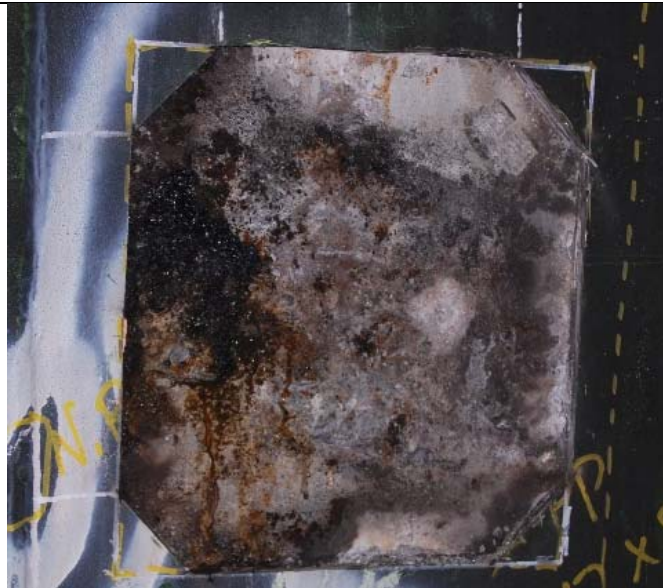
Checks	Observations	
	Exterior	Units
Void space between concrete and liner (if any)	On left side, uneven corrosion product and a 1/16-inch void. Otherwise, no voids.	
Biological Materials	None	
Wet or Dry	Mostly dry, with some damp spots	
Smell	None	
Temperature	79.3	F
Surface pH	11-12 dry areas, 7-8 in areas with corrosion product	
Structure to Electrolyte	-0.488	Volts/CSE
Concrete Resistivity	27.8 Horizontal 31.2 Vertical	K-Ohm-cm
General Condition	Good, with some corrosion products. Corrosion product was black on the left side, and brown in some other areas. Concrete was hard and difficult to drill for powder samples. Coupons required some hammering and prying to remove after cutting.

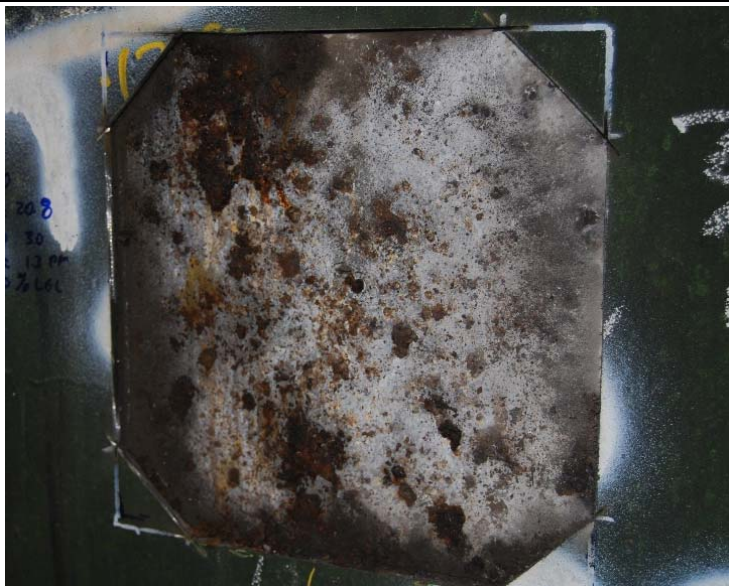
CONCRETE SAMPLE SPECIFICS		
Sample ID	8	8
Sample Location	14-BA-20-13-23-4	
Sample Dimensions	12X12 INCHES	
ON SITE VISUAL EXAMINATION		
Checks	Observations	
	Exterior	Units
Void space between concrete and liner (if any)	1/16" Void on left side, no voids in all other areas	
Biological Materials	None	
Wet or Dry	Dry	
Smell	None	
Temperature	80.0	F
Surface pH	11-12	
Structure to Electrolyte	-0.248	Volts/CSE
Concrete Resistivity	30.9 Horizontal 27.5 Vertical	k-ohm-cm k-ohm-cm
General Condition	Excellent, sound concrete with no cracks or delamination. Coupon had steel backing plate

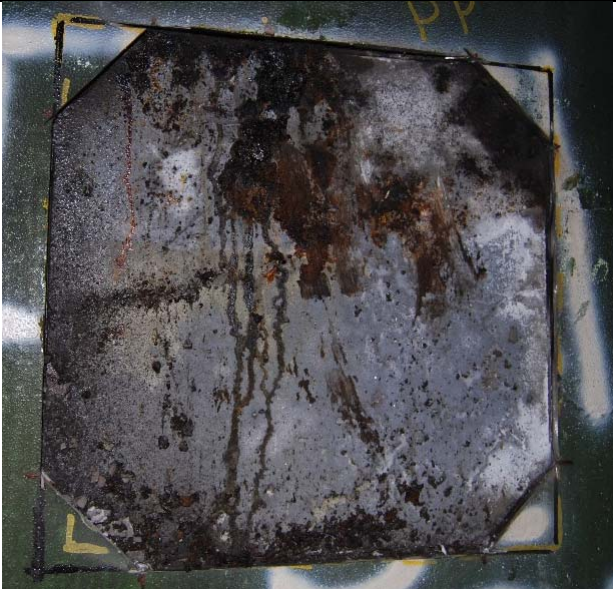
CONCRETE SAMPLE SPECIFICS		
Sample ID	A1	A1
Sample Location	14-BA-23-9-95-50	
Sample Dimensions	12X12 INCHES	
ON SITE VISUAL EXAMINATION		
Checks	Observations	
	Exterior	Units
Void space between concrete and liner (if any)	1/8" Void on left side, no voids in all other areas	
Biological Materials	None	
Wet or Dry	Mostly dry with damp areas around corrosion product	
Smell	None	
Temperature	77.5	F
Surface pH	11-12 in dry areas, 7-8 in corroded area	
Structure to Electrolyte	-0.448 (dry area) -0.432 (damp area w. corrosion products)	Volts/CSE
Concrete Resistivity	32.9 Horizontal 37.0 Vertical	k-ohm-cm
General Condition	Good condition with sound concrete, no cracks or delamination. Corrosion products are present on concrete.

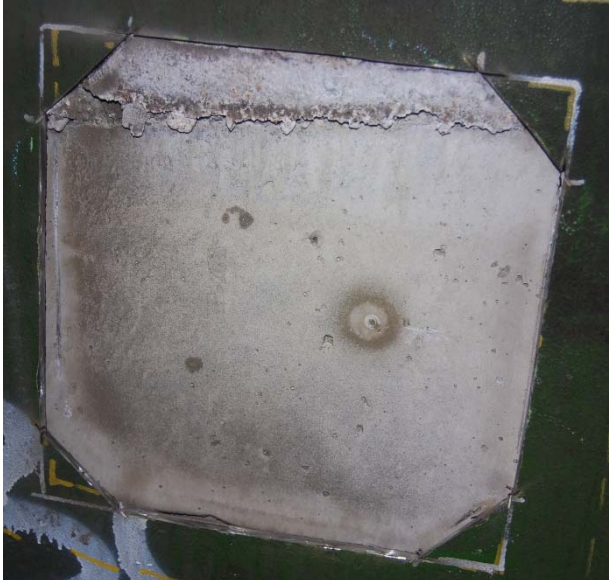
CONCRETE SAMPLE SPECIFICS		
Sample ID	A2	A2
Sample Location	14-BA-11-4-226-50	
Sample Dimensions	12X12 INCHES	
ON SITE VISUAL EXAMINATION		
Checks	Observations	
	Exterior	Units
Void space between concrete and liner (if any)	1/2" Void on left and bottom side. 1/4" void on the right side	
Biological Materials	None	
Wet or Dry	Dry	
Smell	None	
Temperature	78.4	F
Surface pH	11-12	
Structure to Electrolyte	-0.226 (middle) -0.230 (right side)	Volts/CSE
Concrete Resistivity	35.8 Horizontal 36.1 Vertical	k-ohm-cm
General Condition	Good condition with sound concrete, no cracks or delamination. There is a layer of concrete which appears to have come off. Below that layer is sound concrete.	
Provide photo documentation with a minimum resolution of 2560 x 1920 of the coupon, front and back.
