**UNITED STATES ENVIRONMENTAL
PROTECTION AGENCY
REGION IX
75 Hawthorne Street
San Francisco, CA 94105**

**STATE OF HAWAII
DEPARTMENT OF HEALTH
P. O. BOX 3378
HONOLULU, HI 96801-3378**

Re: Response to Corrosion and Metal Fatigue Practices, Destructive Testing Results Report, Red Hill Bulk Fuel Storage Facility (Red Hill), Joint Base Pearl Harbor-Hickam, Oahu, Hawaii

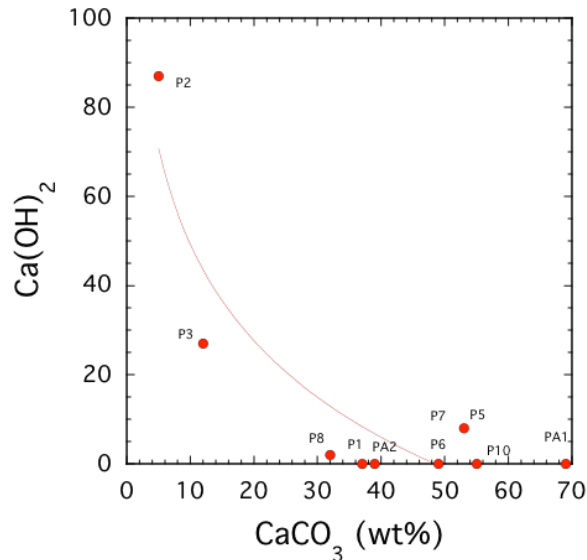
X-ray diffraction results (Table 2) [1] of the concrete powdered samples showed an average calcium carbonate content of 40.0 wt% with a standard deviation of 19.7%. The large variation in concrete composition (Table 2) could be accentuated by the small sample size. The general trend of increasing calcium carbonate with decreasing calcium hydroxide (Figure 2) was also observed. The origin of the high levels of calcium carbonate is not exactly known, but could be the result of carbonation, where carbonic acid from dissolved CO₂ gas in water reacts with calcium hydroxide in the concrete to form calcium carbonate [5]. This reaction can generally increase the strength of concrete [4, 6], but decrease its alkalinity and adversely affect the

Figure 2: Ca(OH)₂ vs CaCO₃ content in concrete behind the removed steel coupon plates. Ca(OH)₂ and CaCO₃ data from the DT Results Report [1].

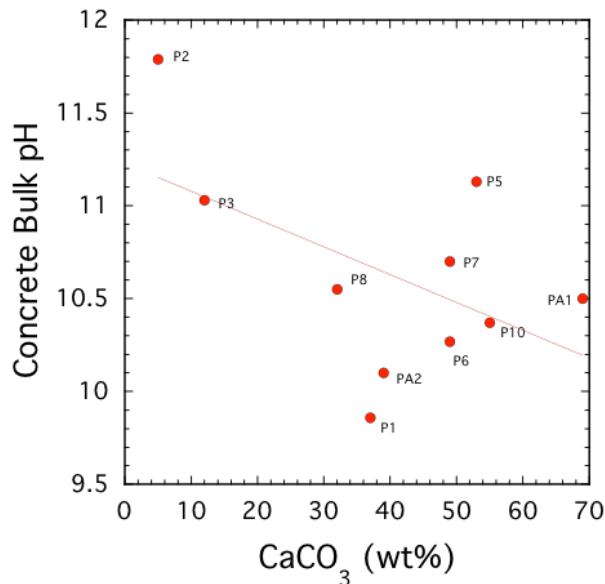
corrosion resistance of imbedded steel [4]. The pH measurements coupled with the X-ray diffraction results [1] showed 1) decreasing concrete bulk pH with increasing calcium carbonate (Figure 3) and 2) decreasing concrete bulk pH with decreasing calcium hydroxide content (Figure 4).

Figure 3: Concrete bulk pH vs CaCO₃ content in concrete behind removed steel coupon plates. Bulk pH and CaCO₃ data from the DT Results Report [1].

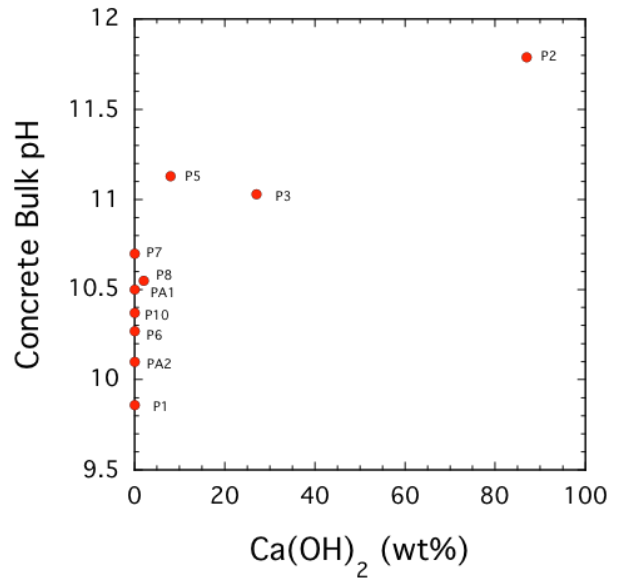
Figure 4: Concrete bulk pH vs Ca(OH)₂ content in concrete behind removed steel coupon plates. Bulk pH and CaCO₃ data from the DT Results Report [1].

The alkalinity of pore solution in fresh cement and concrete is approximately pH 13 – pH 14 [4]. As the concrete ages, the alkalinity is maintained at the pH 12 - pH 13 level [5] until the calcium hydroxide is consumed by the carbonation reaction. Once the calcium hydroxide is consumed and calcium carbonate precipitates, the pH drops further to levels where imbedded steel can corrode [4, 5]. In non-carbonated, highly alkaline concrete, the corrosion rate of steel is extremely low [4]. When the pH of the concrete falls below approximately pH 11, however, such as by carbonation, corrosion rates begin to increase [7] and passivation is lost at approximately pH 10 [3, 5]. The plot of pH values (Figure 1) shows that many values dropped below pH 11, where plain-carbon steel begins to lose passivity and its corrosion rate begins to increase [3, 5, 7].

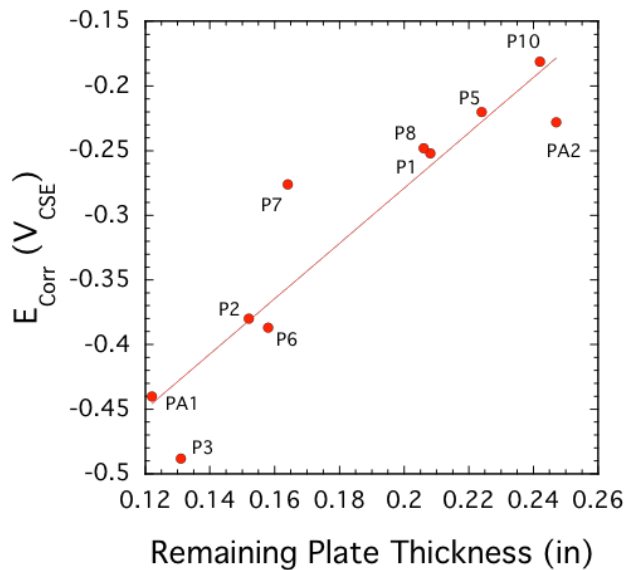
Of the potential measurements corresponding to the back side of the tank wall, only one potential was more positive than -0.2 V_{CSE}, indicating low probability of corrosion; five potentials were in the potential range of -0.20 to -0.35 V_{CSE}, indicating uncertainty of corrosion; and four potentials were more negative than -0.35 V_{CSE}, indicating high likelihood of corrosion. The reported minimum remaining plate thickness values for each plate was plotted vs the corrosion potentials (Figure 5), showing strong correlation. The more negative the corrosion potential (indicating a

higher tendency to corrode), the lower the measured remaining plate thickness. Plates P5, P10, and PA2 corresponding to the three most positive corrosion potentials ($> -0.23 V_{CSE}$) showed no or only very light surface rust (Figure 6) [1]. Plates P1 and P8 (with potentials $\approx -0.25 V_{CSE}$) showed mostly mild surface rust (Figure 6) [1]; whereas, the remaining plates PA1, P2, P3, P6, and P7 (with potentials $< -0.27 V_{CSE}$) showed significantly more severe rusting (Figure 6) [1].

Figure 5: Corrosion potential vs minimum remaining plate thickness. Data summarized from the DT Results Report [1]. Since two corrosion potential values were given for plates A1 ($-0.448 V_{CSE}$ and $-0.432 V_{CSE}$) and A2 ($-0.226 V_{CSE}$ and $-0.230 V_{CSE}$), the average value for each plate was plotted.

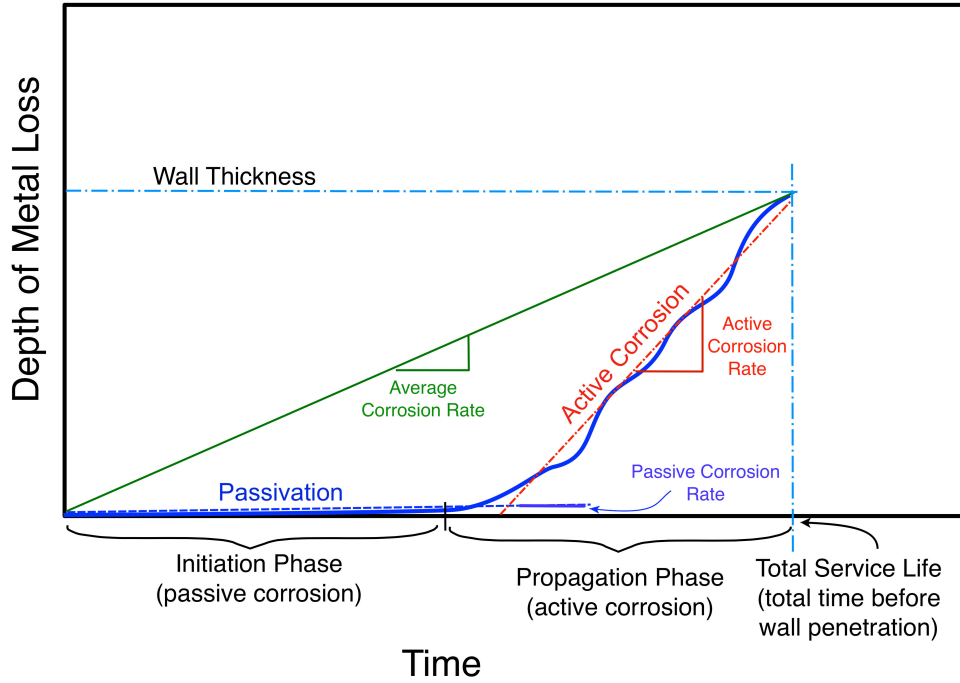
When steel corrodes in concrete, there is an initiation phase and a propagation phase (Figure 7) [4]. During the initiation phase, the steel is passive and corrodes at a very low rate. When the concrete becomes carbonated or contaminated with chlorides, the steel loses passivity and corrosion rates begin to increase in the propagation phase (Figure 7). In Figure 6, regions of the coupons that were bonded to the concrete or grout and not corroded (e.g., gray regions) were still in the initiation phase (Figure 7) and have a very low passive corrosion rate. Regions that show rust (e.g., red or brown corrosion products) are in the propagation phase and have higher

Figure 7: Initiation and propagation phases of steel corrosion in concrete. Modeled after Tuutti [10] in [4].

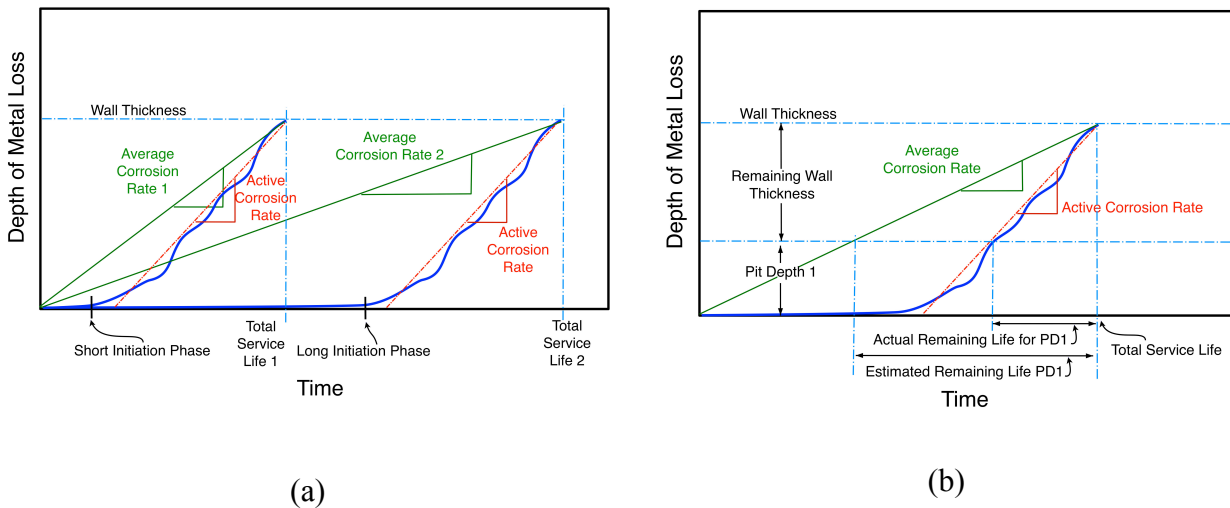
active corrosion rates. Unfortunately, knowledge of the active corrosion rate cannot be used to determine the total service life or time before penetration as the initiation phase can dominate the service life (Figure 7 and 8a) [10]. However, if the remaining wall thickness and the active corrosion rate are known, the remaining time before wall penetration can be estimated (Figure 8b).

Figure 8: Effect of initiation phase on average corrosion rates (a). Remaining life (b) based on active and average corrosion rates and pit depth 1 (PD1).

The higher historical corrosion rates could be associated with short initiation phases (Figure 8a) from regions where steel lost passivation in the early stages. Regions where the steel remain passivated and have long initiation phases (Figure 8a) will result in low average corrosion rates. Currently, any region of the tank that has back-side corrosion (i.e., rusting and remaining thickness less than the original plate thickness of 0.25”) is likely not passivated, and in the propagation stage (Figure 7). To obtain an accurate remaining life before wall penetration, realistic corrosion rates are needed. Therefore, in regions of the tank that are no longer passivated, actual measured active corrosion rates or historical corrosion rate data with a short initiation phases (Figure 8a) are needed to more accurately estimate the remaining life

(Figure 8b). If corrosion rates based on long initiation phases are used, the actual remaining life could be grossly over estimated (Figure 8b).

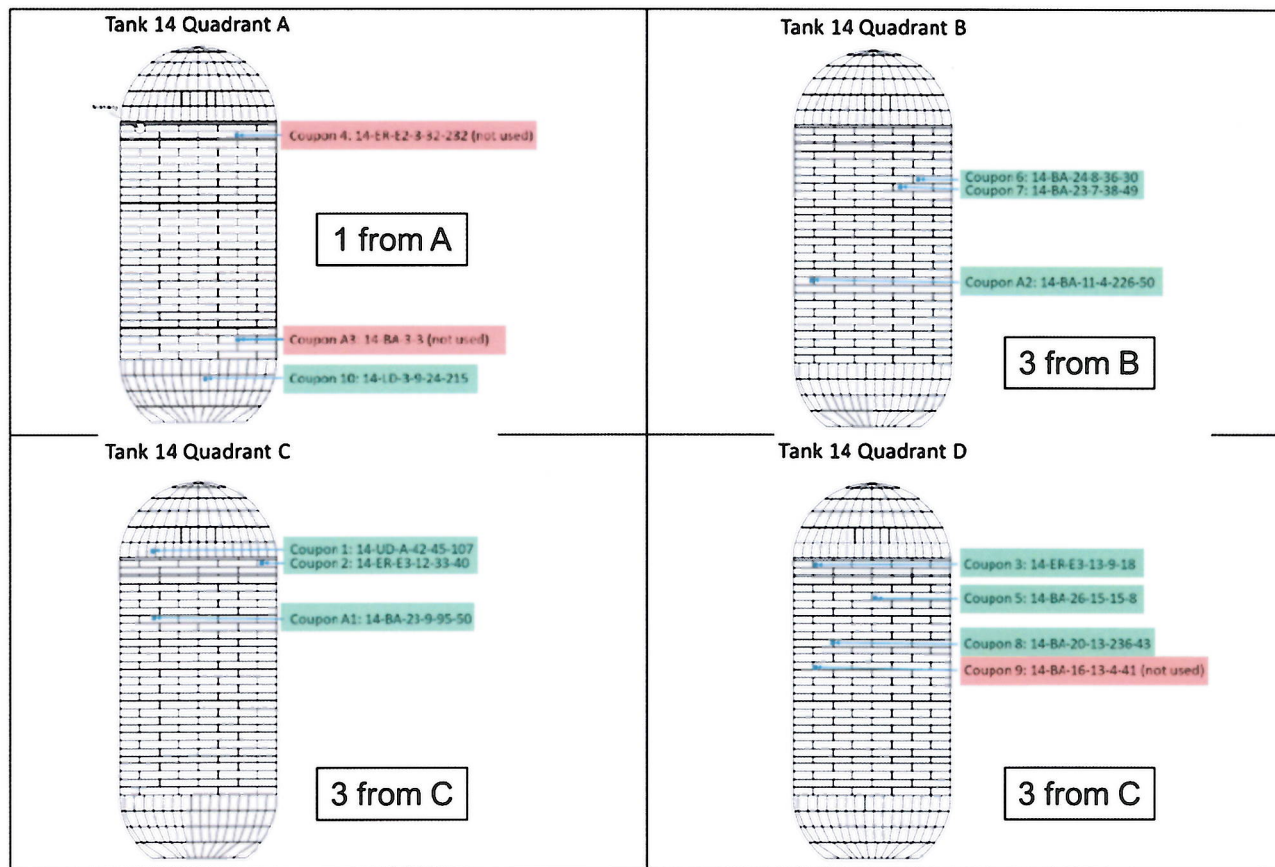
Figure 2-1 Schematic of Tank 14 Coupon Locations

within Tank 14 much less the conditions of all the tanks at the RHBFSF. Ultimately, the Navy extracted eight coupons from the tank barrel (i.e., the vertical walls), one from just inside the upper dome, and one from sloped section of the lower dome; shown below for the locations marked in green. The locations marked in red were identified as possible coupon locations but were not extracted. The BWS is not aware of any random locations selected based on the BFET scans specifically to assess the welds. The Navy's description of the NDE result at these coupon locations do not discuss the BFET result at all. Further, the BWS is not aware of any coupons extracted from the lower dome bottom plate.

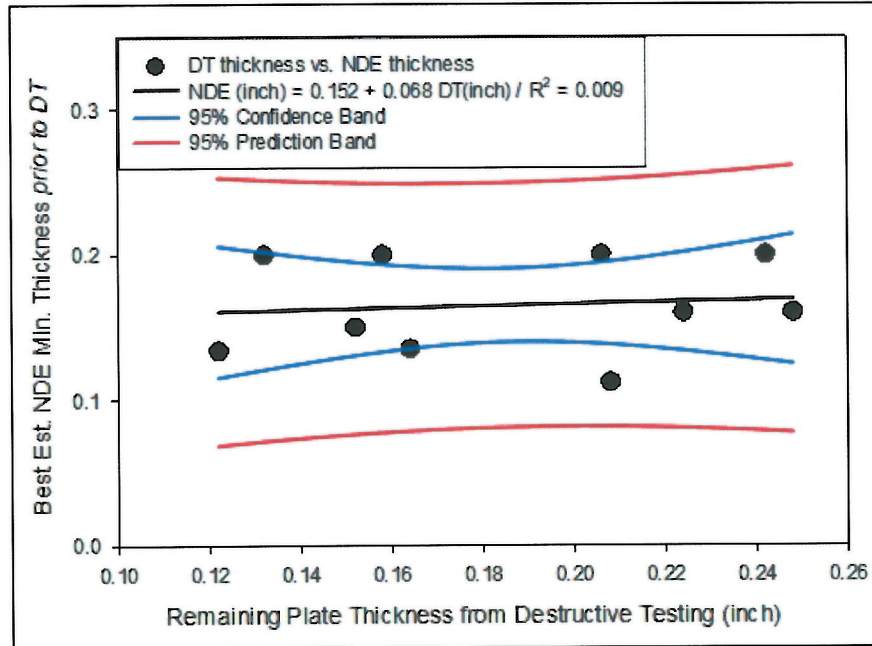
We have also plotted the actual minimum plate thickness determined from the DT against the best estimate of the coupon minimum thickness determined prior to the DT, Figure 4. To simplify, we conservatively assume the NDE-measured thickness in censored cases (i.e., the coupons for which thickness is reported as known only to be either greater or less than a specified value) were the specified bounding values. Similar analyses were also done for each NDE method treating those cases as interval-censored, and the results did not change significantly.

Figure 4 – Relationship between NDE thickness estimate prior to DT and the actual remaining thickness determined from DT.

Figure 4 clearly indicates the NDE techniques are neither accurate nor reliable. First, the slope (0.068) of the line drawn through the DT vs NDE data is very flat (close to zero), indicating the NDE results are essentially insensitive to actual corrosion depth. For comparison, if NDE was perfectly accurate, then the DT thickness would be equal to the NDE thickness and the slope of the line drawn through the data would be 1.0. Instead, the calculated slope is consistent with what one would expect if the NDE results were simply chosen at random without regard to the actual coupon thickness. Another indication is the coefficient of determination (R^2), which measures NDE accuracy by comparing the variation in NDE results to the residual variation after accounting for the actual coupon thickness (using the regression line). As noted in Figure 4, the R^2 value is effectively zero (0.009), indicating none of the observed variation in NDE-measured thickness is attributable to corresponding variation in the actual thickness of the test coupons.
