Project Title: CLEAN, INSPECT, AND REPAIR STORAGE TANKS 5 & 17
Location: PEARL NAVAL BASE – REDHILL COMPLEX, Pearl Harbor, HI
Task Order No.: N62583-09-D-0132/0003
WGS Project Number: 54118
Date: 18 Nov, 2010

**TANK 5 & 17 CLEANING, INSPECTION
AND REPAIRS PROJECT**

TANK 5 INSPECTION REPORT

**FINAL DRAFT TANK INSPECTION
& INTEGRITY REPORT**

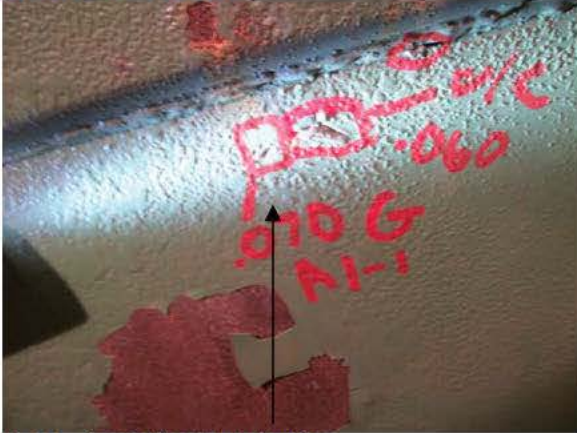
A-P1-1 GOUGE REPAIR

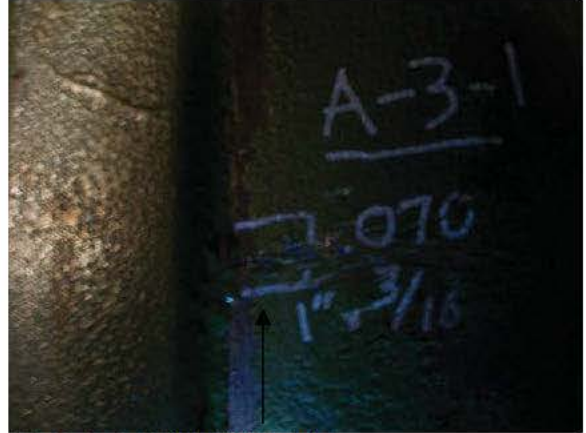
A-P3-1 GOUGE REPAIR

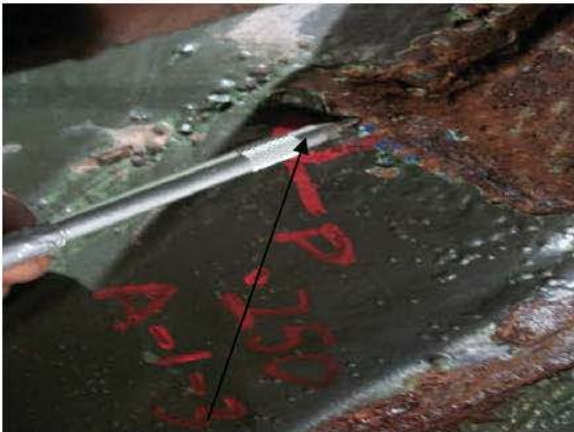
A-P1-3 WELD REPAIR- UNDERCUT

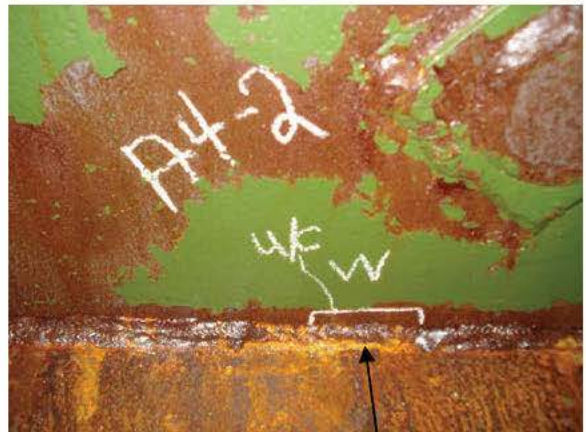
A-P4-2 WELD REPAIR - UNDERCUT

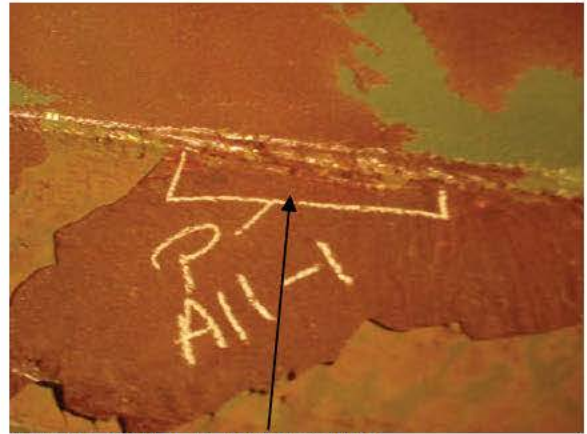
A-P11-1 WELD- POROSITY

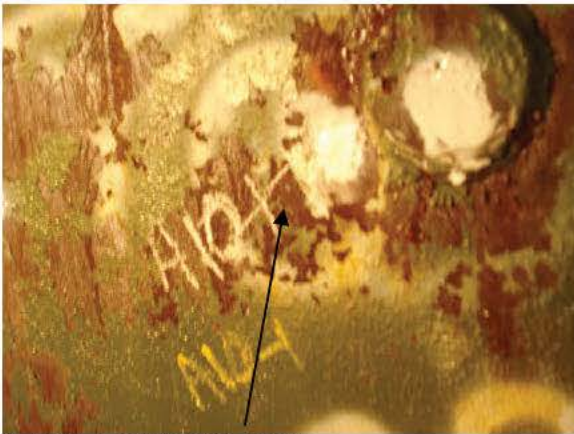
A-P10-1 DENT REPAIR

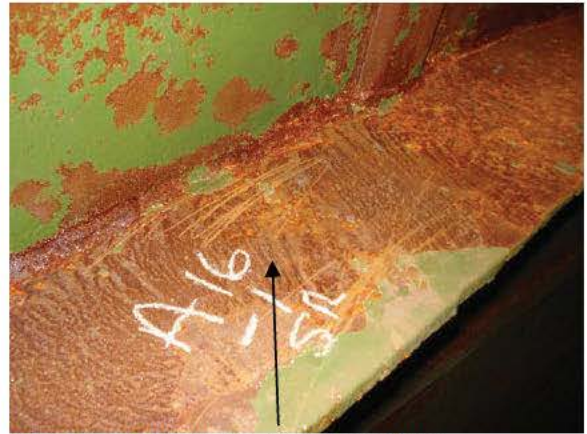
A-P16-1 MULTIPLE PIT REPAIR

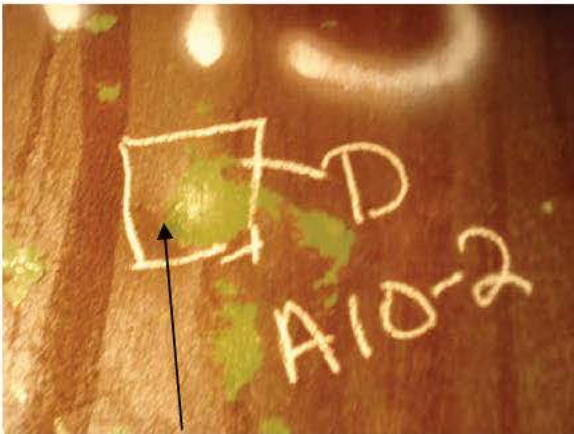
A-P10-2 DENT REPAIR

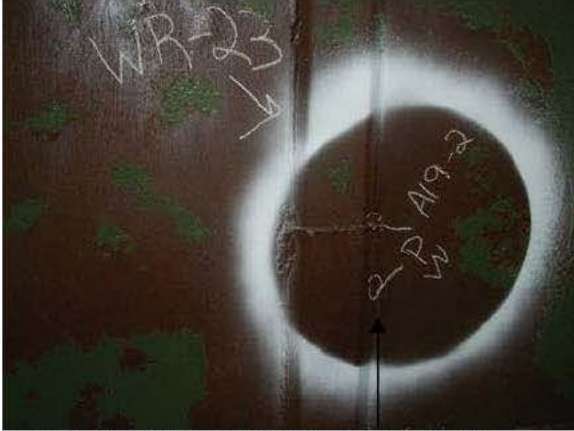
A-P19-2 WELD REPAIR- POROSITY

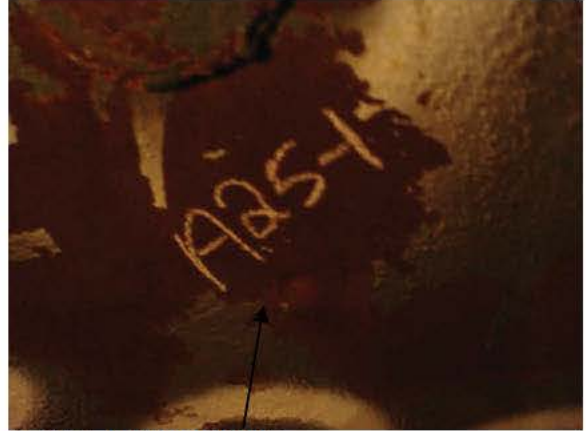
A-P25-1 PIT REPAIR

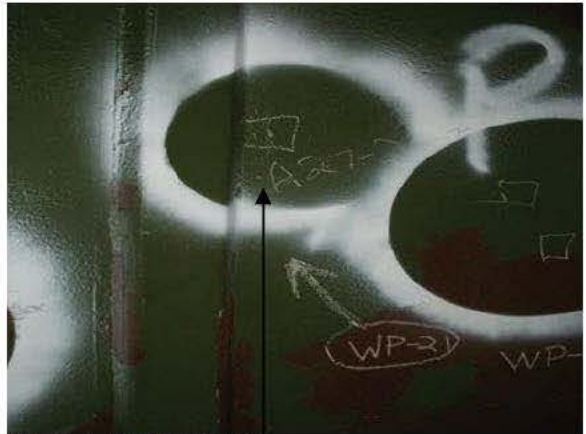
A-26-1 PIT REPAIR

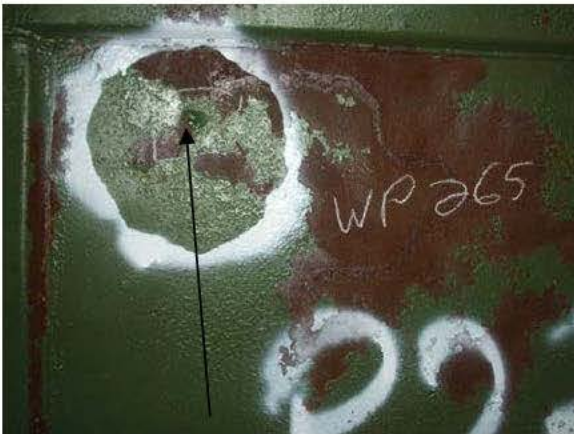
A-P23-1 PIT REPAIR

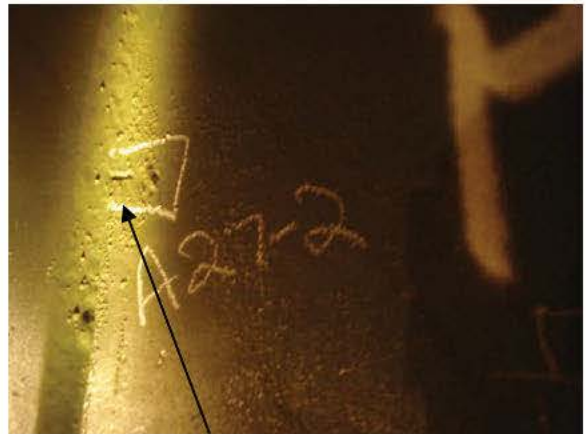
A-P27-2 PIT REPAIR

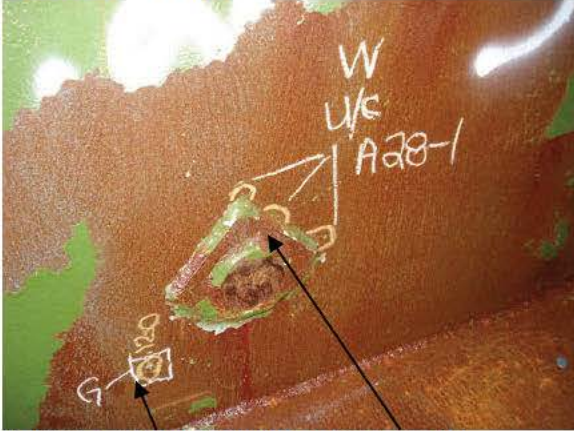
A-P28-1 GOUGE & WELD REPAIR-
UNDERCUT

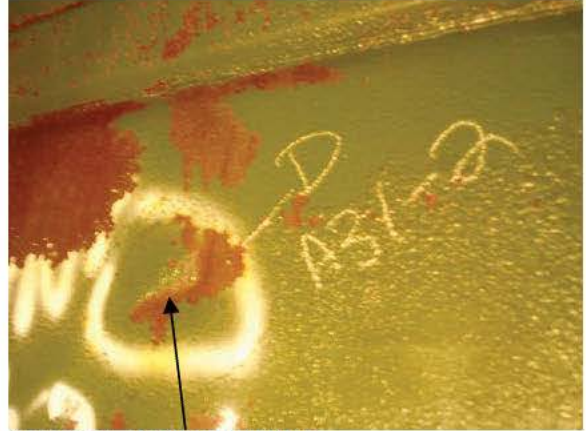
A-P31-2 DENT REPAIR

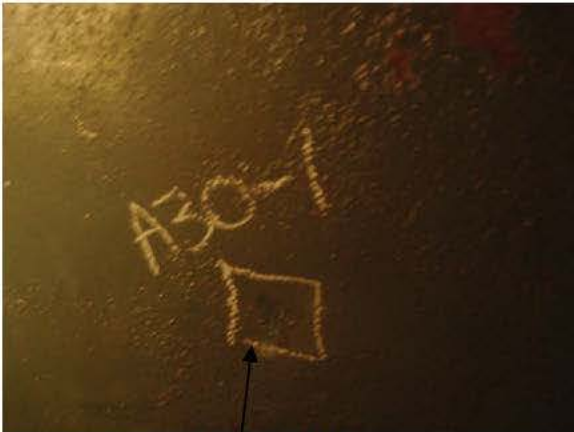
A-P30-1 GOUGE REPAIR

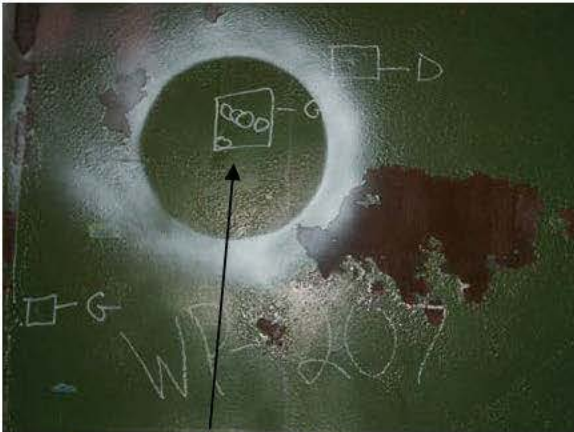
A-P37-2 GOUGE REPAIR

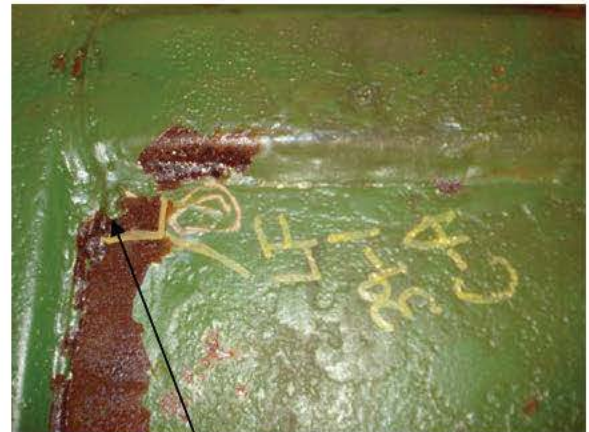
A-P36-1 GOUGE REPAIR

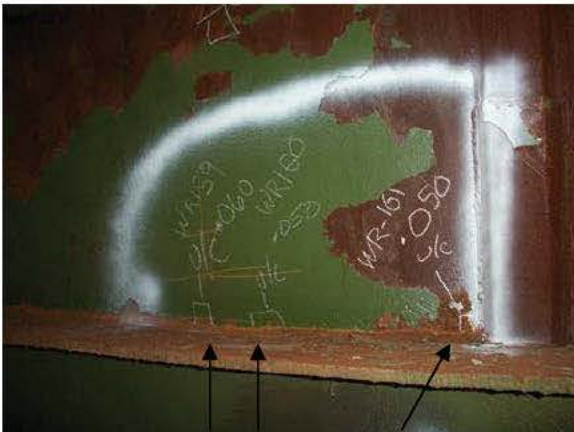
A-P39-1 WELD REPAIR- LACK OF FUSION

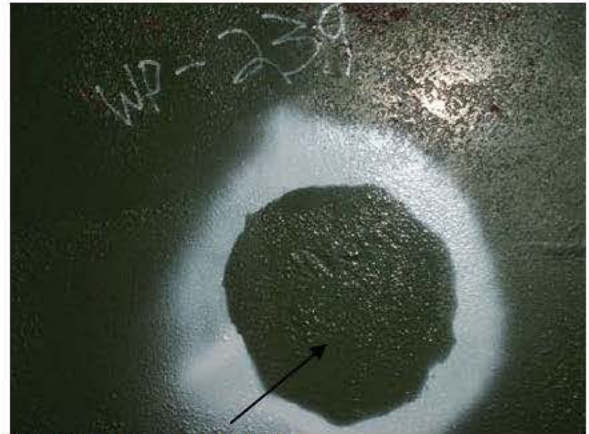
B-P24-1 PIT REPAIR

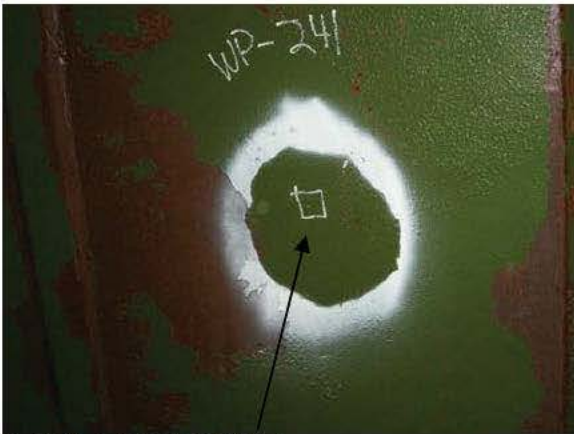
B-P30-1 PIT REPAIR

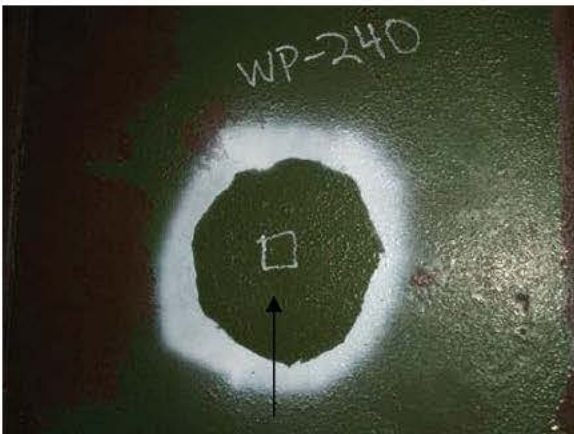
B-P33-1 DENT REPAIR

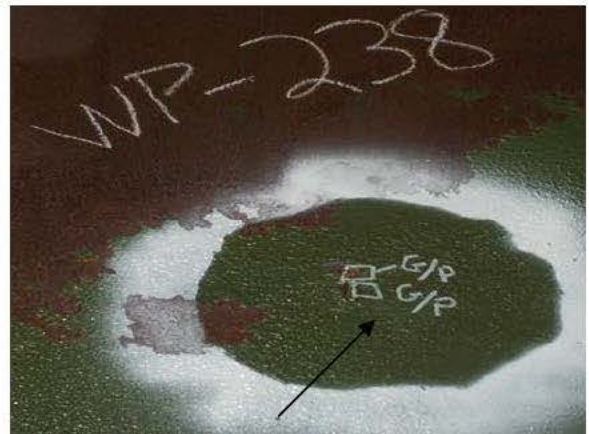
B-P27-2 PIT REPAIR

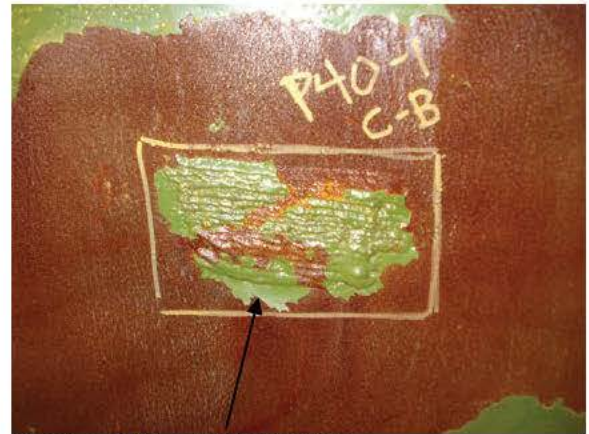
B-P38-2 GOUGE REPAIR

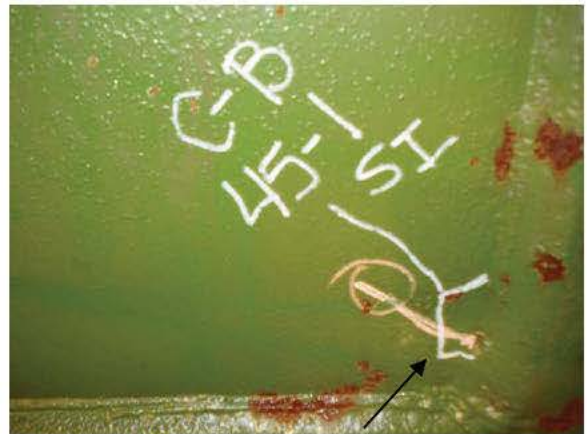
B-P43-2 DENT REPAIR

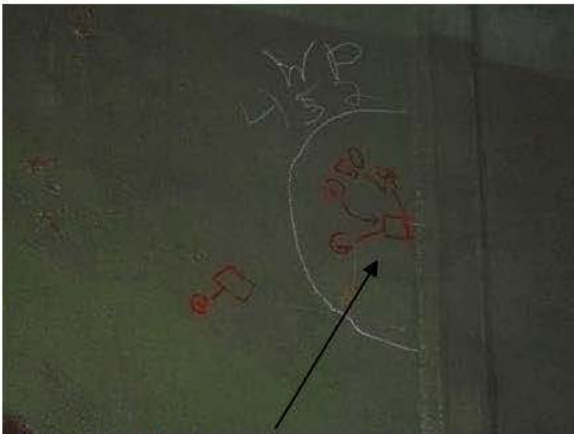
C-P10-1 GOUGE REPAIR

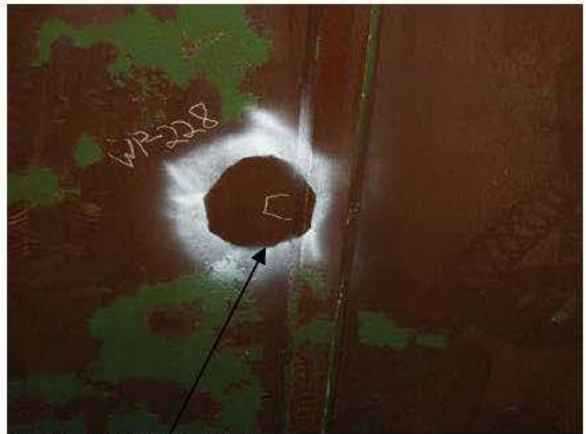
C-1-1 GOUGE REPAIR

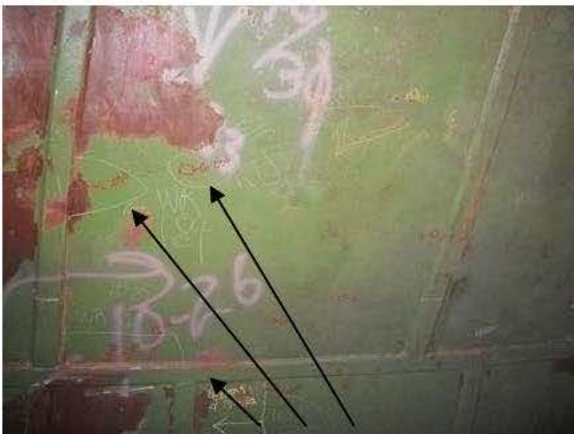
C-P8-1 PIT REPAIR

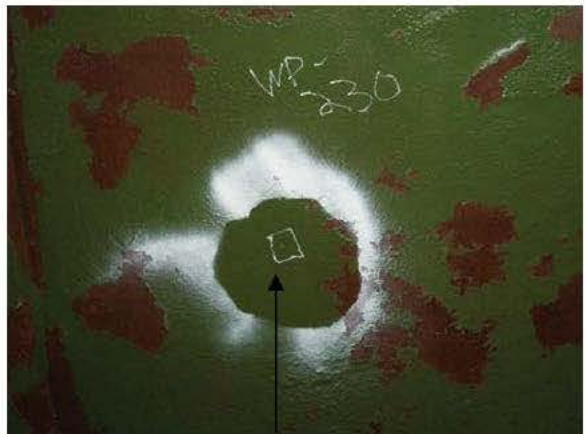
C-1-2 GOUGE & WELD REPAIR-
UNDERCUT

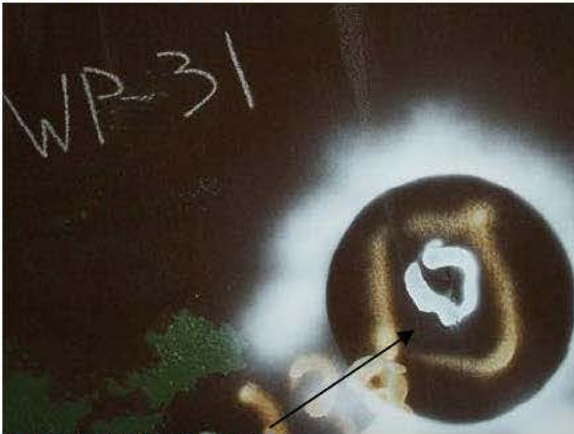
UPPER DOME

C-P11-1 PIT REPAIR

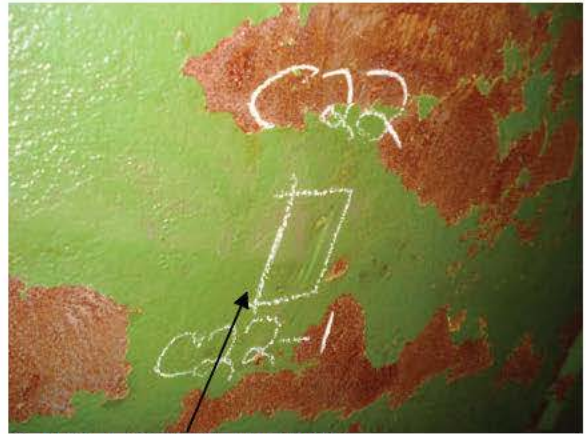
C-P16-1 PIT REPAIR

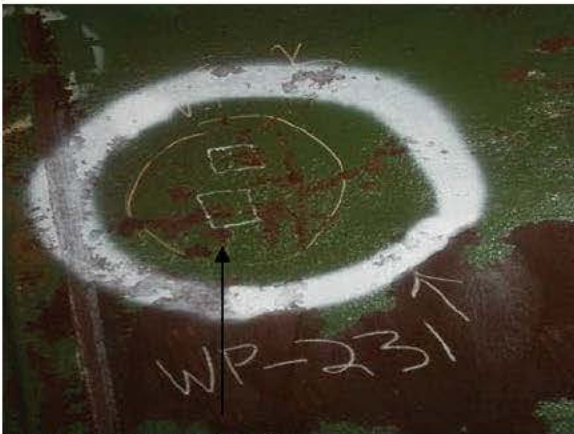
C-P22-1 GOUGE REPAIR

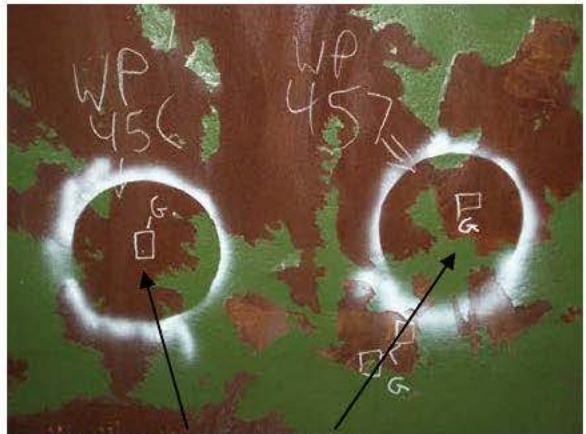
C-P16-2 PIT REPAIRS

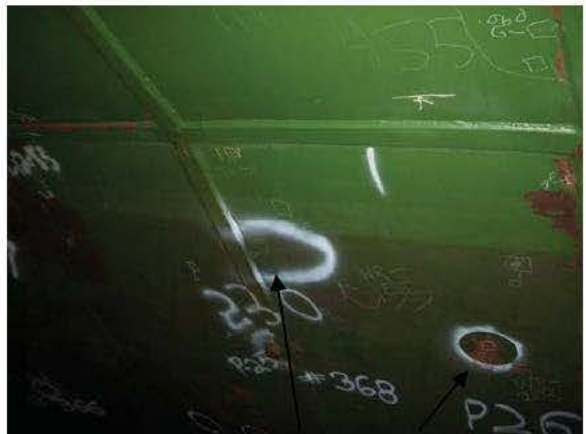
C-P20-1 WELD REPAIR- LACK OF FUSION

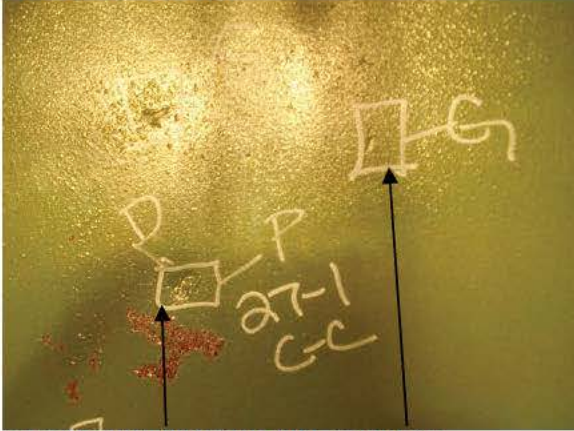
UPPER DOME

C-P26-1 GOUGE & WELD REPAIR- UNDERCUT

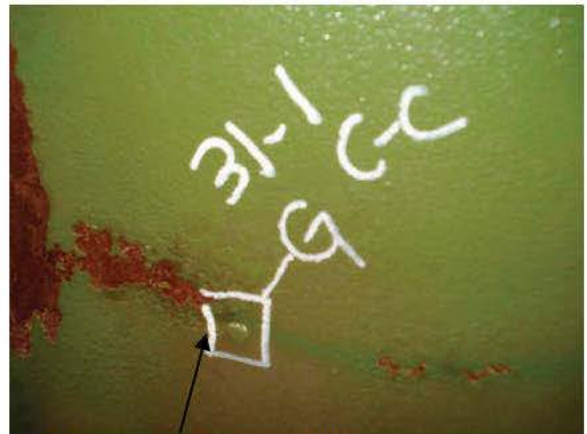
C-P28-1 GOUGE REPAIR

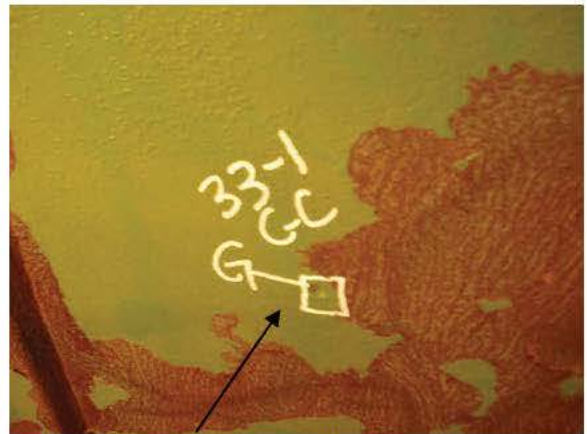
C-P33-1 GOUGE REPAIR

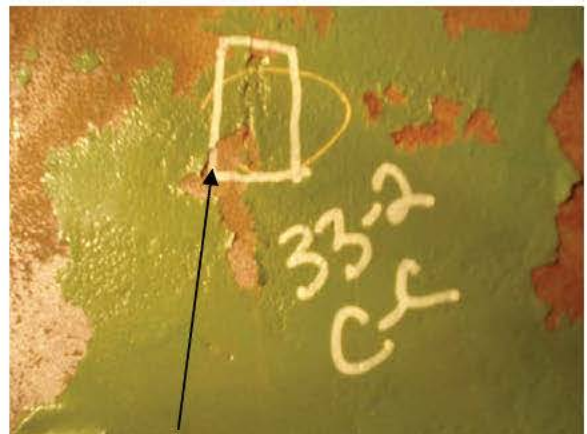
C-P33-2 GOUGE REPAIR

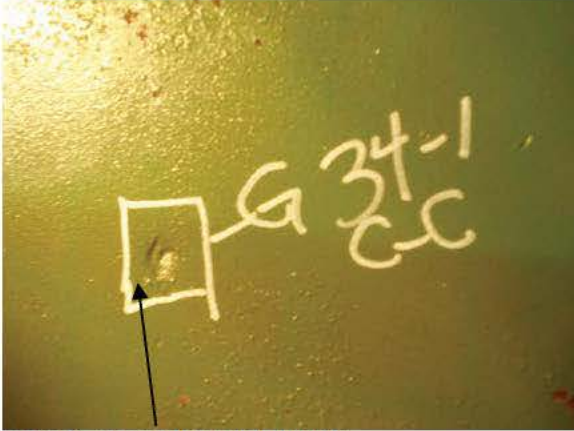
C-P34-1 GOUGE REPAIR

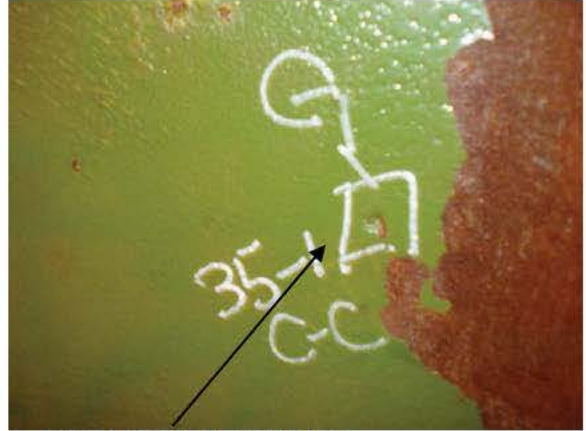
C-P35-1 GOUGE REPAIR

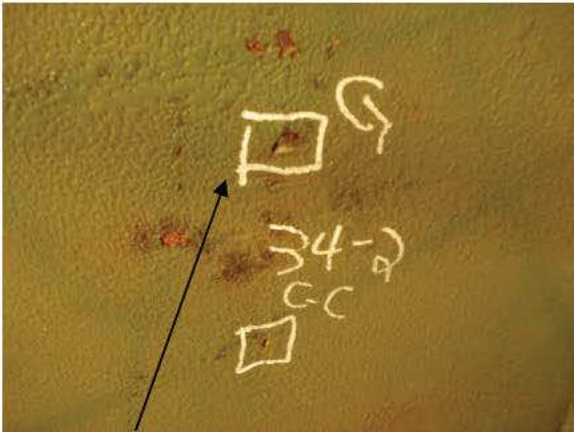
C-P34-2 GOUGE REPAIR

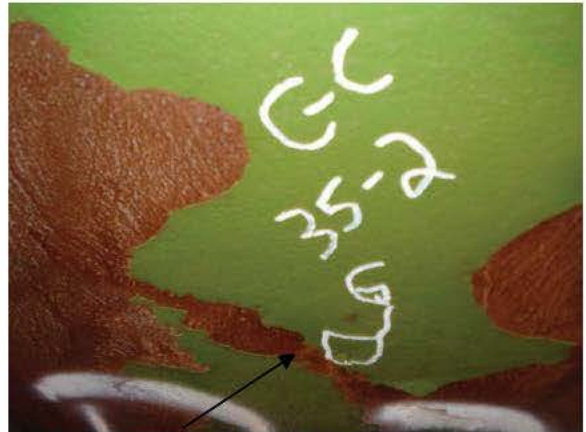
C-P35-2 GOUGE REPAIR

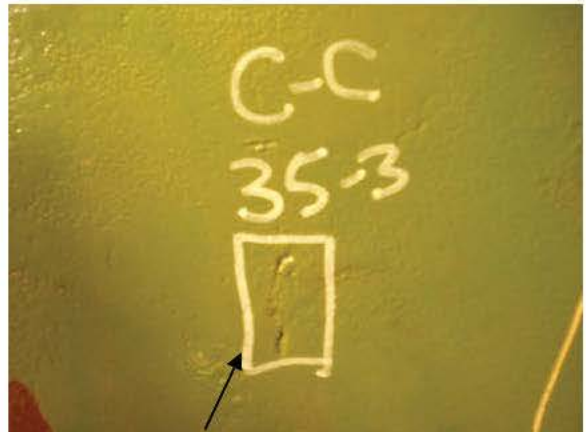
C-P35-3 GOUGE REPAIR

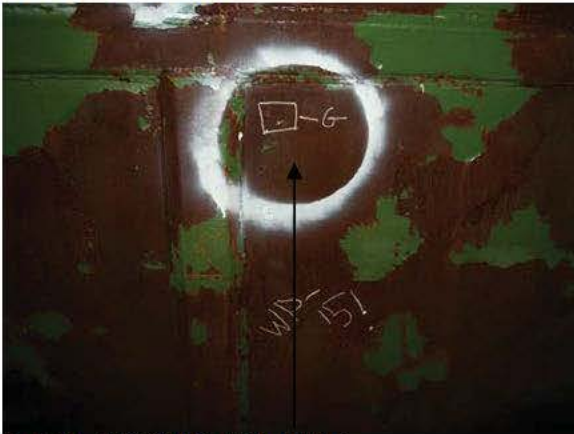
C-P38-1 GOUGE REPAIR

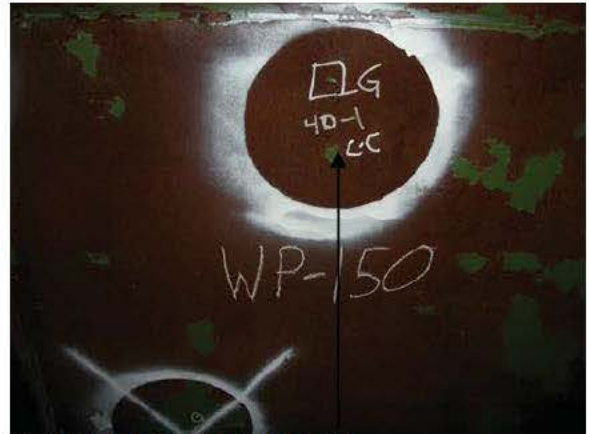
C-P40-1 GOUGE REPAIR

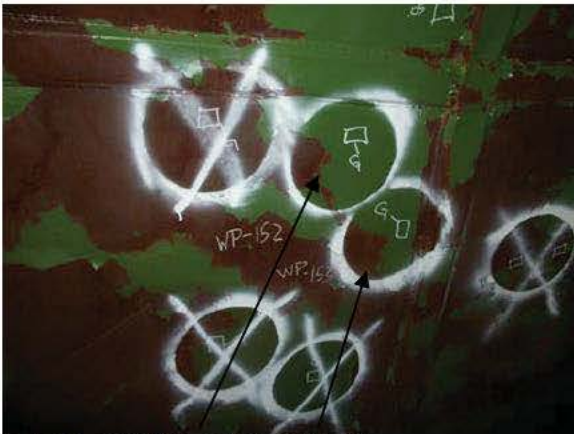
C-P38-2 GOUGE REPAIRS

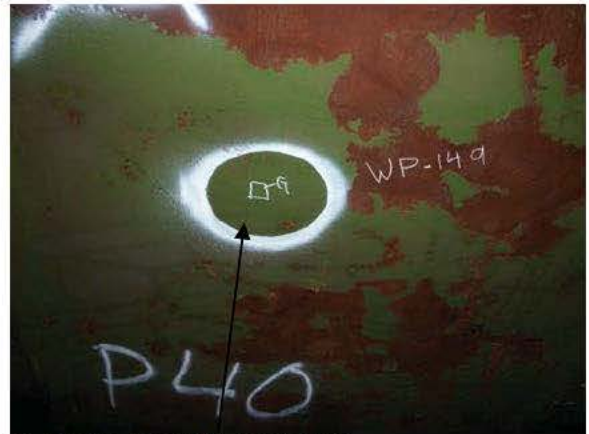
C-P40-2 GOUGE REPAIR

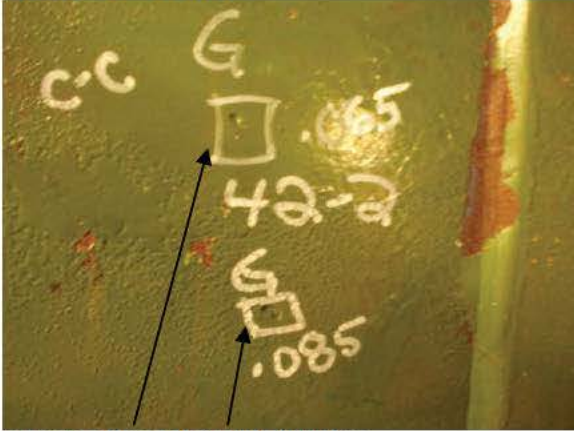
C-P42-2 GOUGE REPAIRS

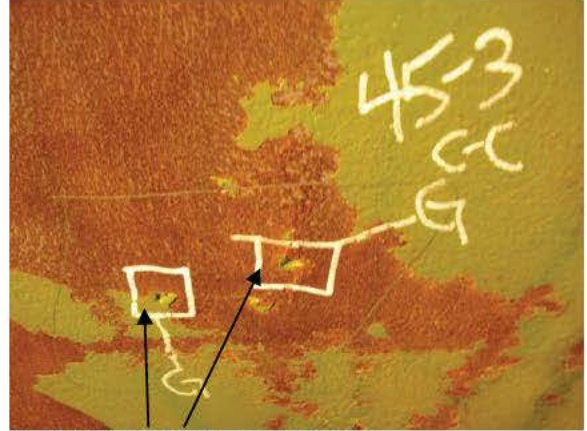
C-P45-3 GOUGE REPAIRS

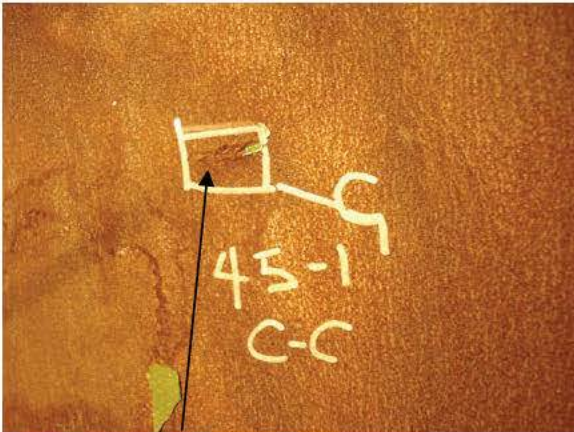
C-P45-1 GOUGE REPAIR

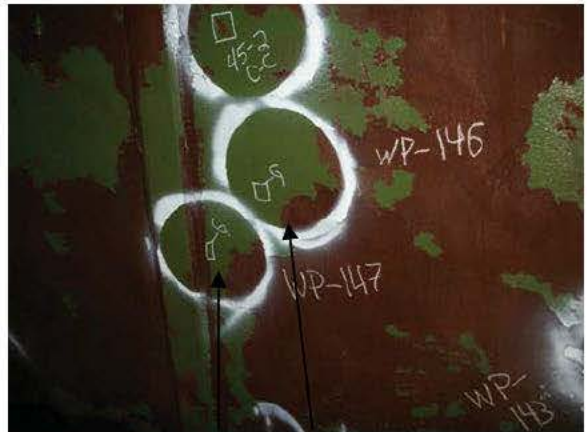
C-P45-4 GOUGE REPAIRS

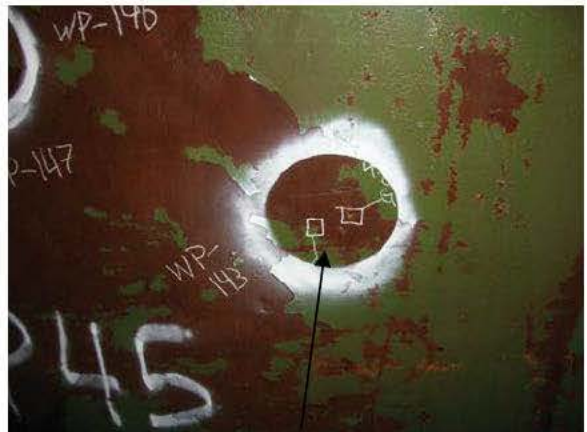
C-P45-5 GOUGE REPAIRS

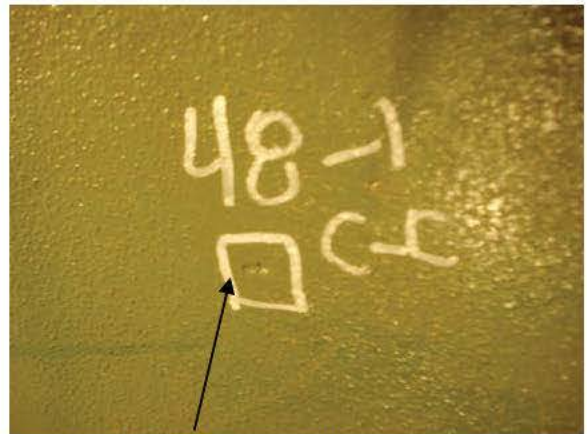
C-P48-1 GOUGE REPAIR

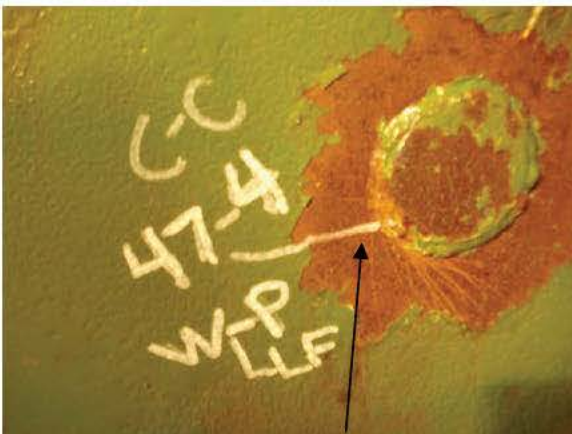
C-P47-4 WELD REPAIR- LACK OF FUSION

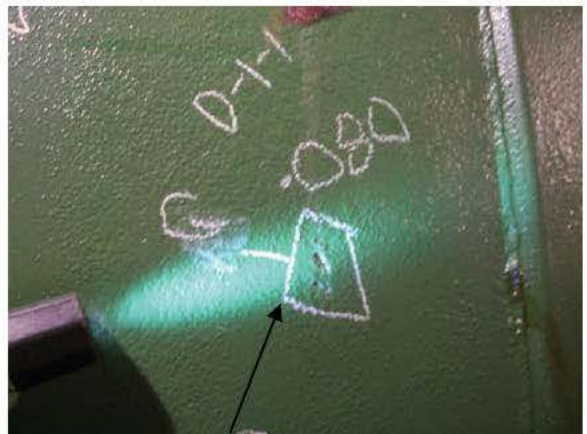
D-P1-1 GOUGE REPAIR

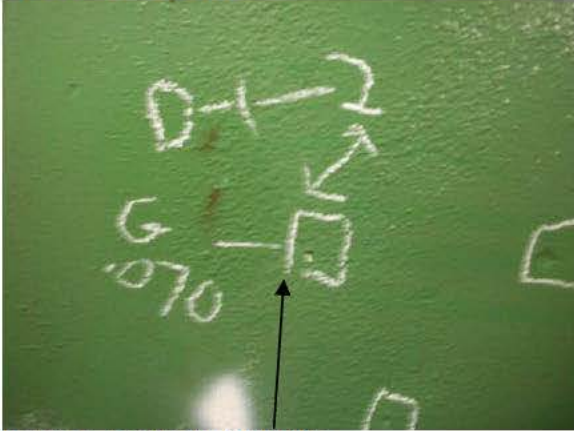
D-P1-2 GOUGE REPAIR

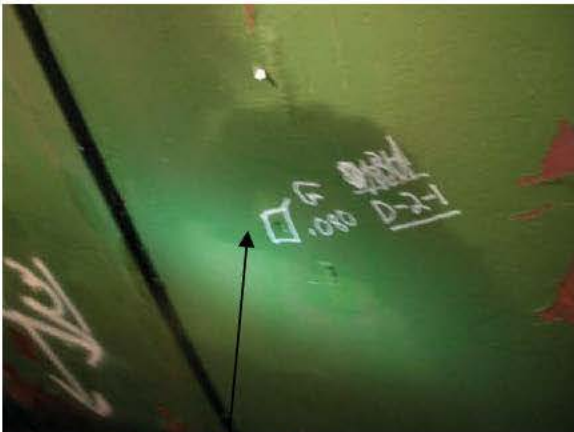
D-P2-1 GOUGE REPAIR

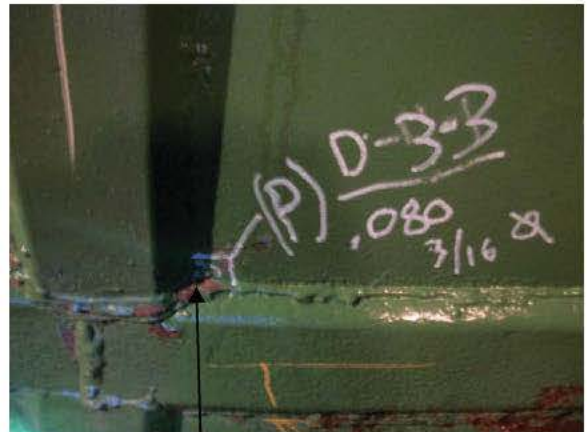
D-P3-3 GOUGE REPAIR

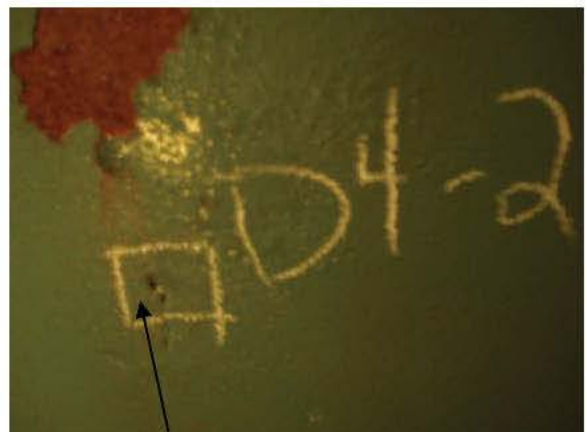
D-P4-2 GOUGE REPAIR

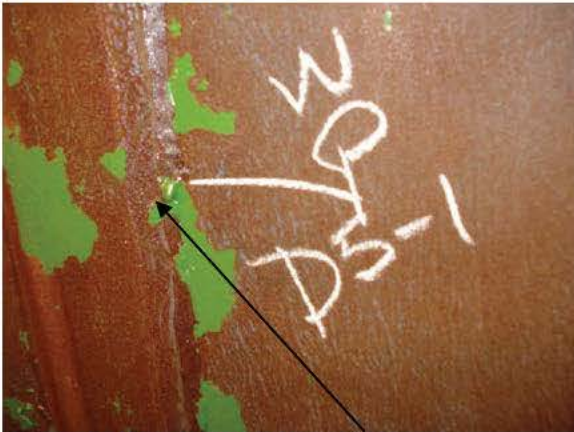
D-P5-1 WELD REPAIR- POROSITY

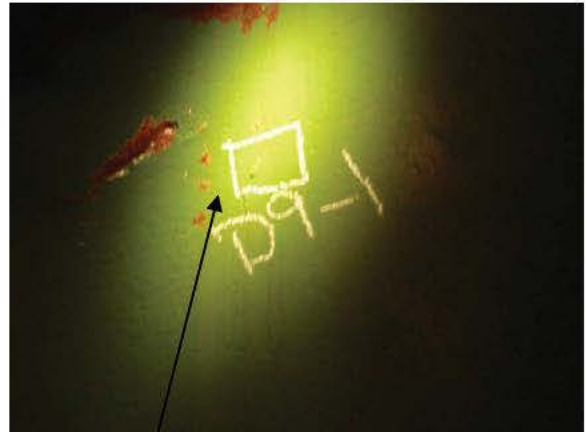
D-P9-1 GOUGE REPAIR

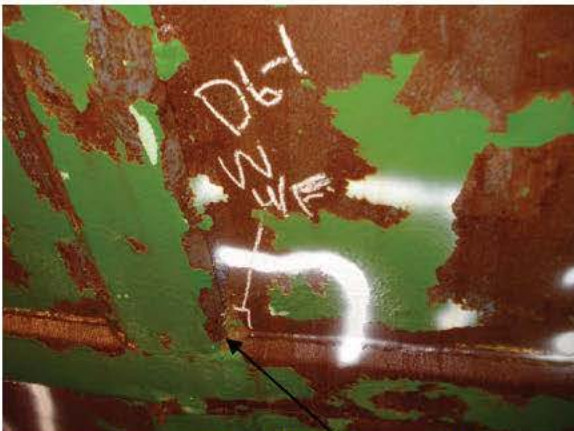
D-P6-1 WELD REPAIR- UNDERFILL

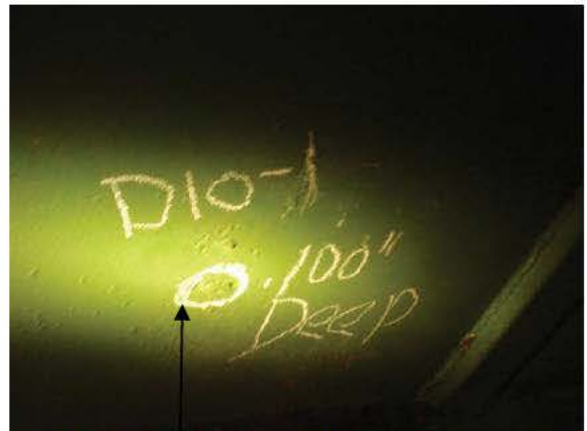
D-P10-1 GOUGE REPAIR

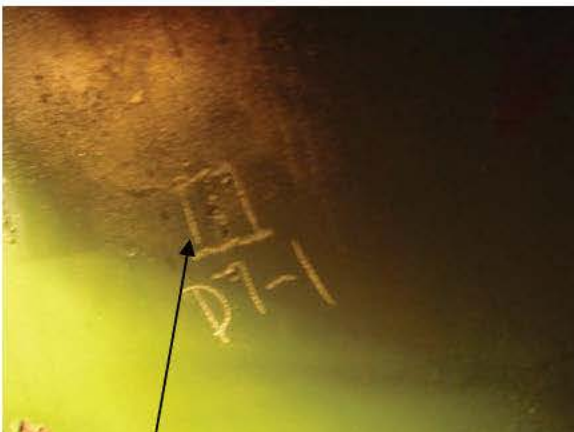
D-P7-1 GOUGE REPAIR

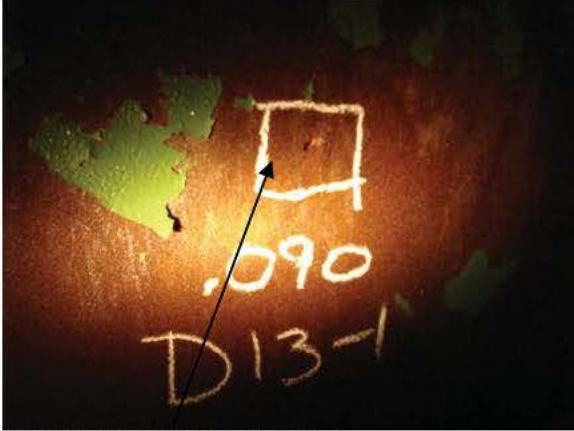
D-P13-1 GOUGE REPAIR

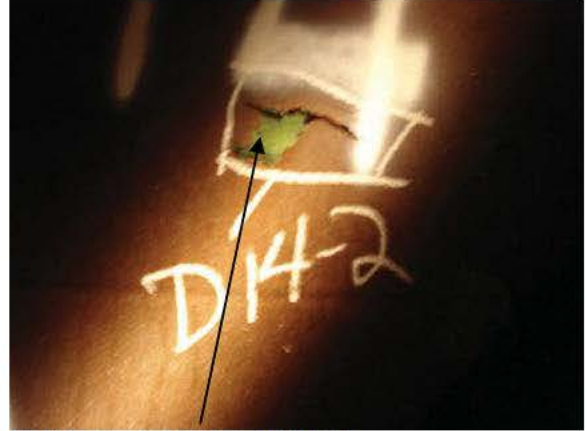
D-P14-2 GOUGE REPAIR

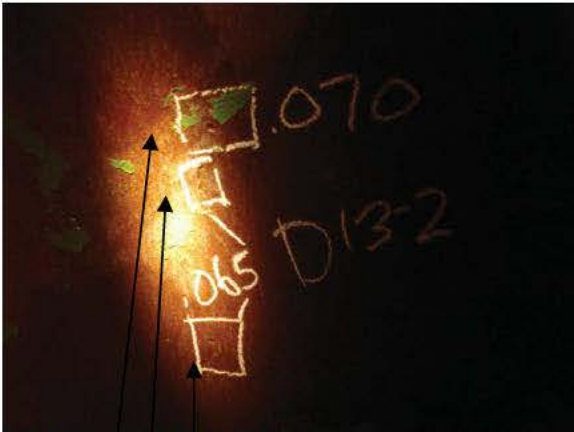
D-P13-2 GOUGE REPAIRS

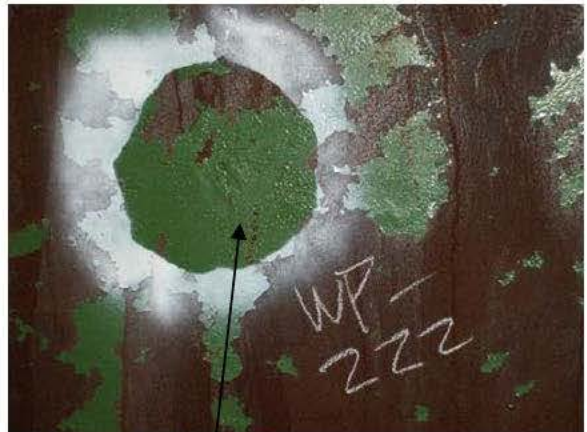
D-P16-1 PIT REPAIR

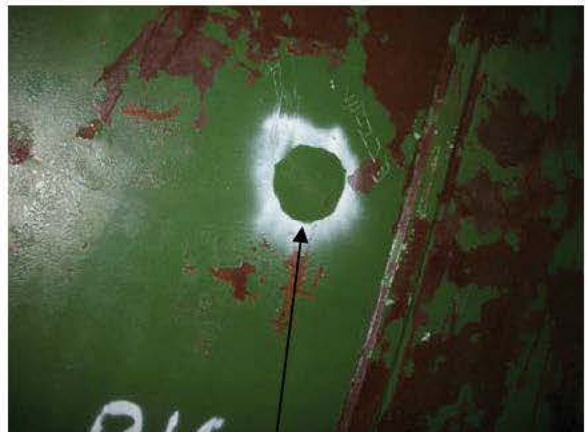
D-P16-2 GOUGE REPAIR

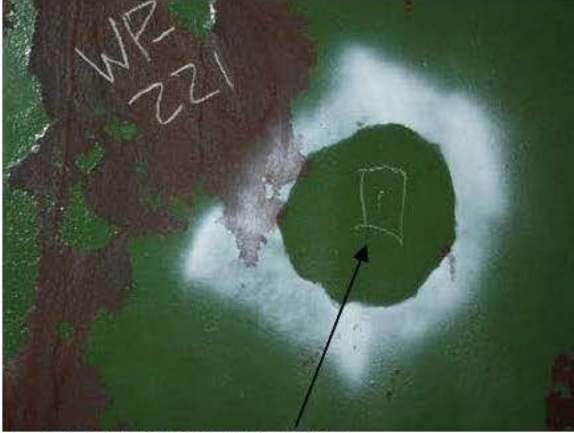
D-P17-1 GOUGE REPAIR

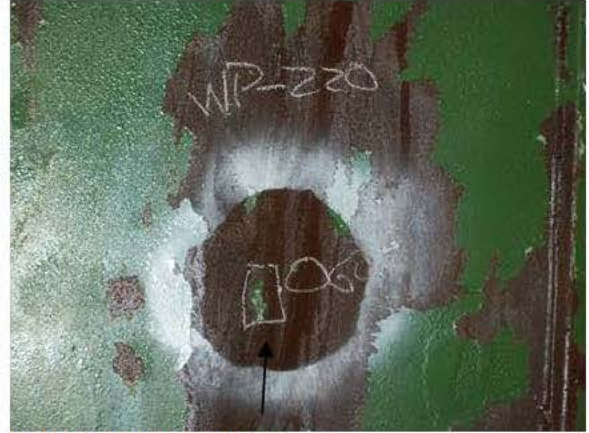
D-P19-1 PIT REPAIR

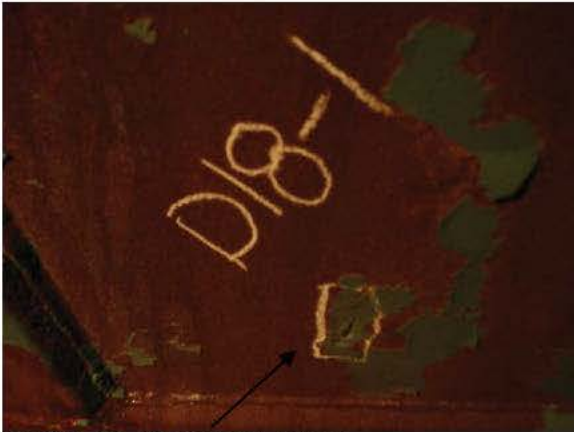
D-P18-1 GOUGE REPAIR

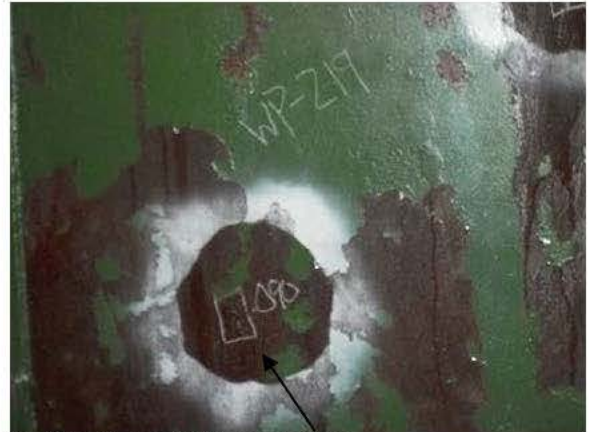
D-P19-2 GOUGE REPAIR

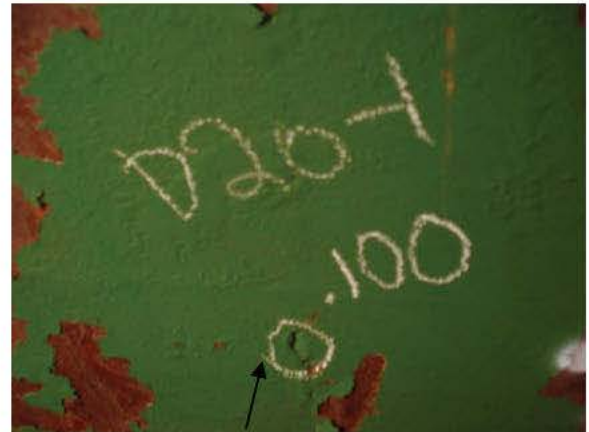
D-P20-1 GOUGE REPAIR

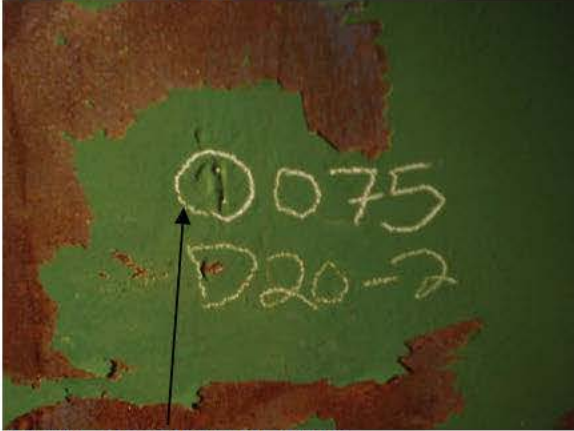
D-P20-2 GOUGE REPAIR

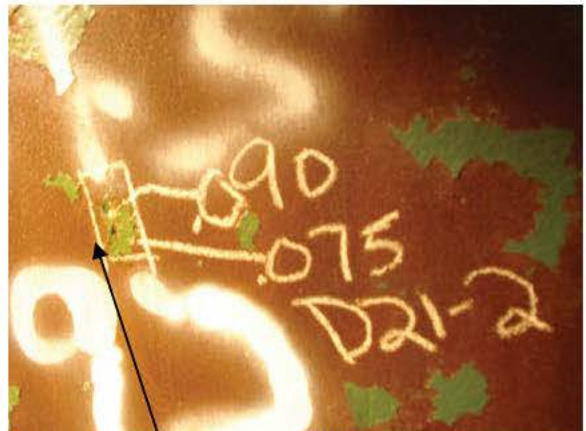
D-P21-2 GOUGE REPAIRS

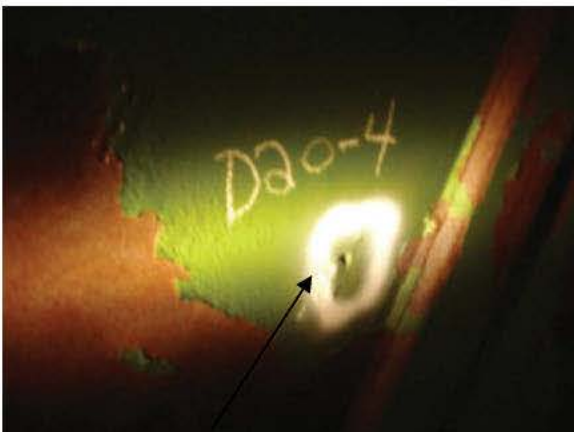
D-P20-4 GOUGE REPAIR

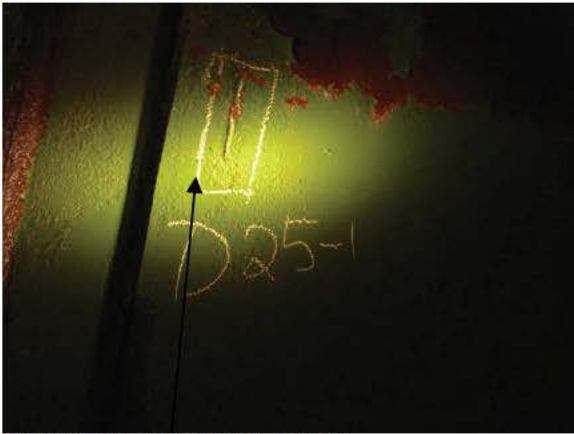
D-P25-1 GOUGE REPAIR

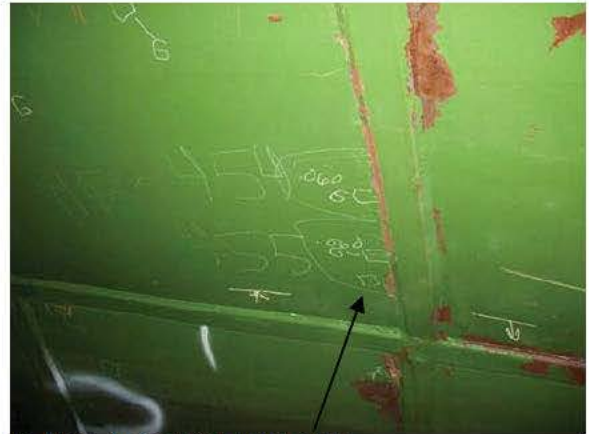
D-P26-1 GOUGE REPAIR

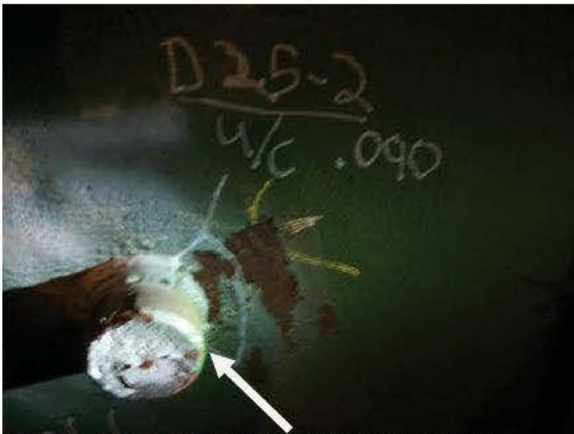
D-P25-2 WELD REPAIR-UNDERCUT

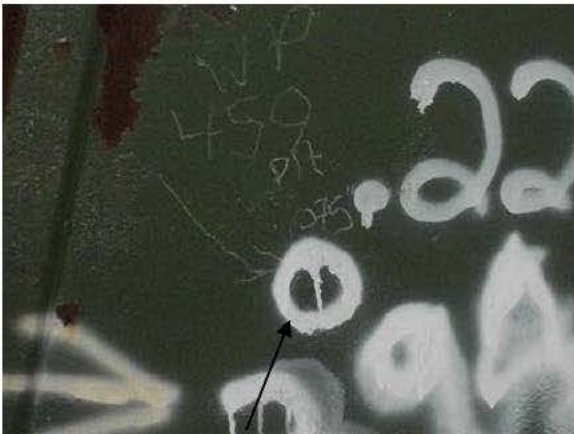
D-P25-3 PIT REPAIR

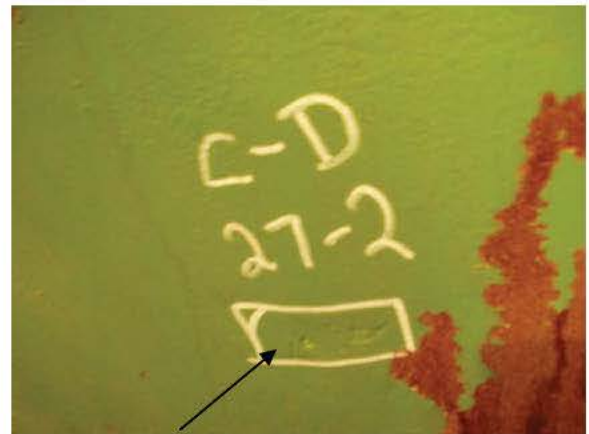
D-P27-2 GOUGE REPAIR

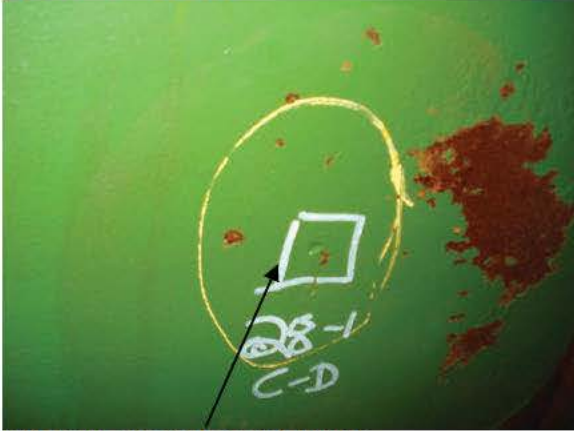
RD-P28-1 GOUGE REPAIR

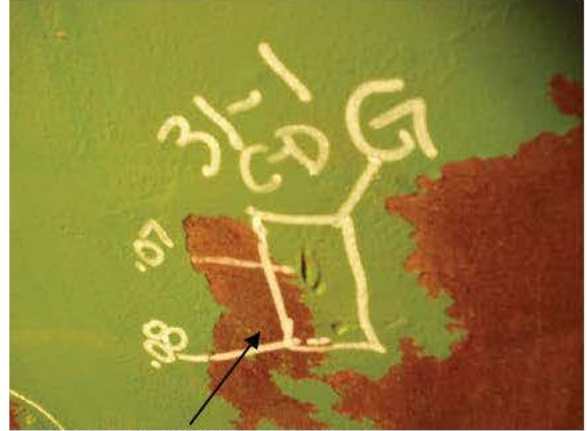
D-P31-1 GOUGE REPAIRS

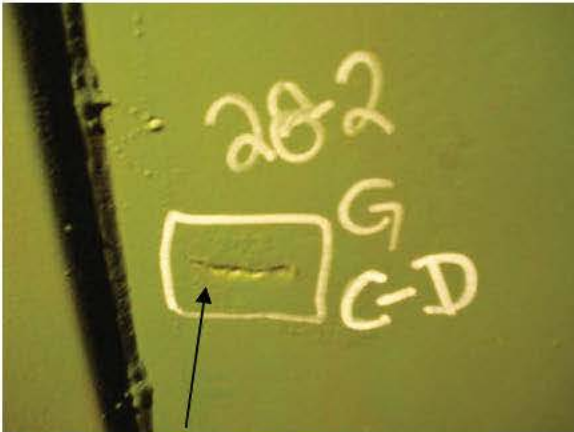
D-P28-2 GOUGE REPAIR

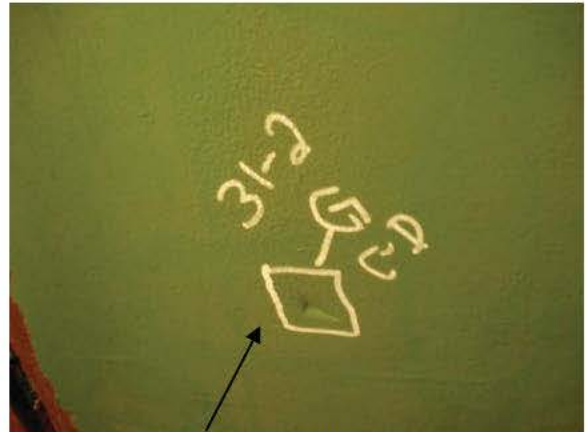
D-P31-2 GOUGE REPAIR

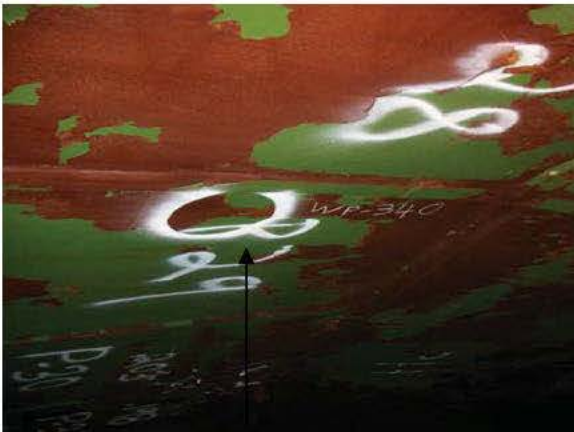
D-P29-1 GOUGE REPAIR

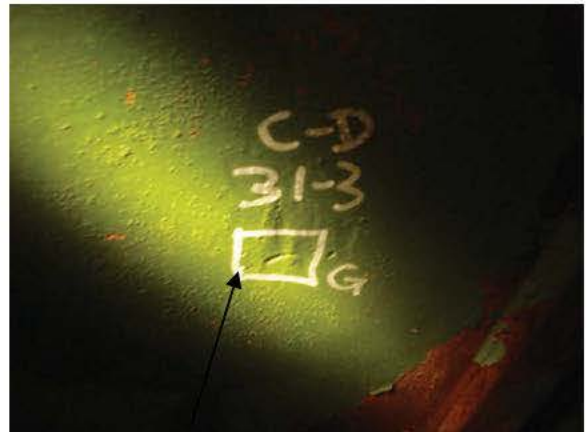
D-P31-3 GOUGE REPAIR

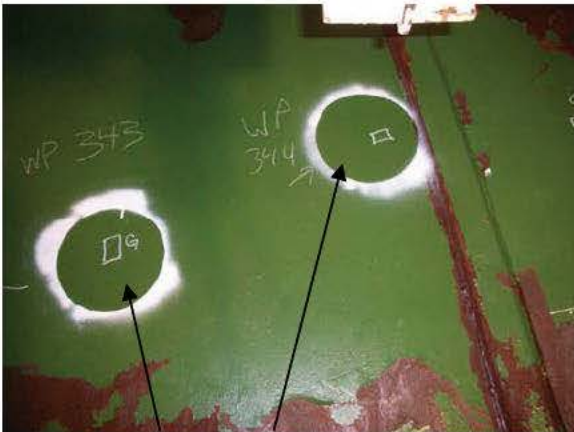
D-P32-1 GOUGE REPAIRS

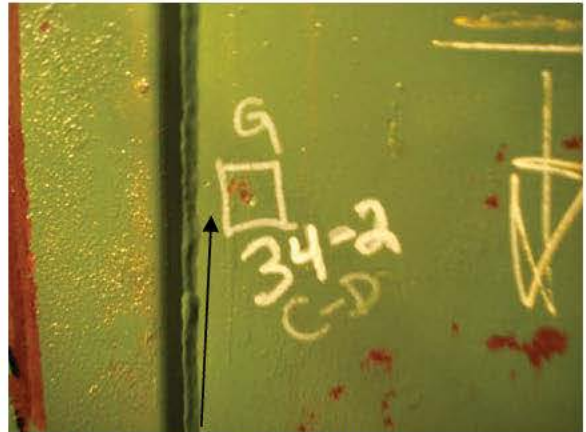
RD-P34-2 GOUGE REPAIR
