Project Title: CLEAN, INSPECT, AND REPAIR STORAGE TANKS 5 & 17
Location: PEARL NAVAL BASE – REDHILL COMPLEX, Pearl Harbor, HI
Task Order No.: N62583-09-D-0132/0003
WGS Project Number: 54118
Date: 18 Nov, 2010

**TANK 5 & 17 CLEANING, INSPECTION
AND REPAIRS PROJECT**

TANK 5 INSPECTION REPORT

**FINAL DRAFT TANK INSPECTION
& INTEGRITY REPORT**

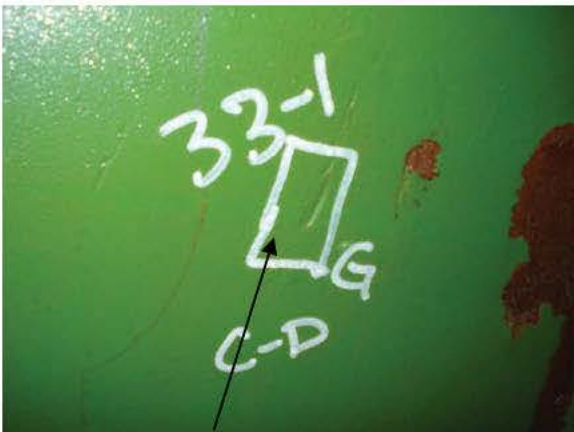
D-P33-1 GOUGE REPAIR

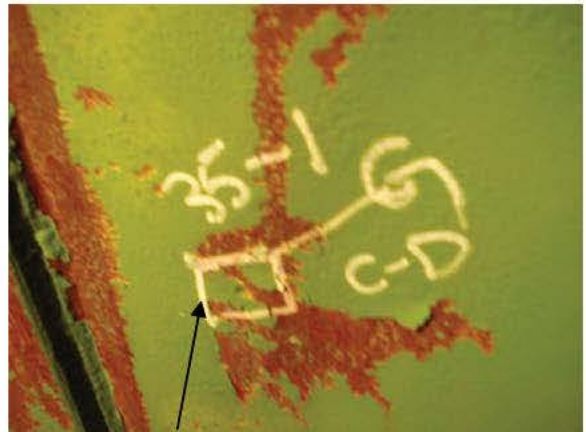
D-P35-1 GOUGE REPAIR

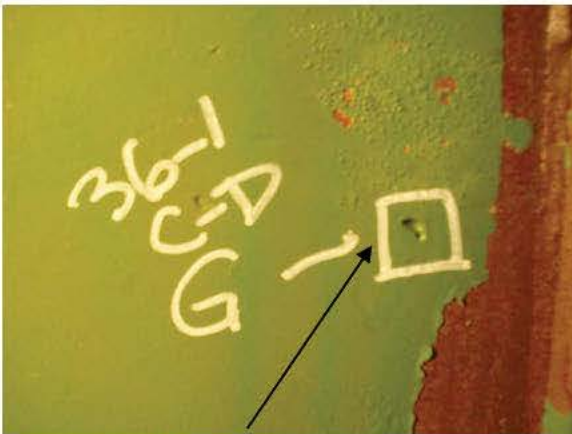
D-P36-1 GOUGE REPAIR

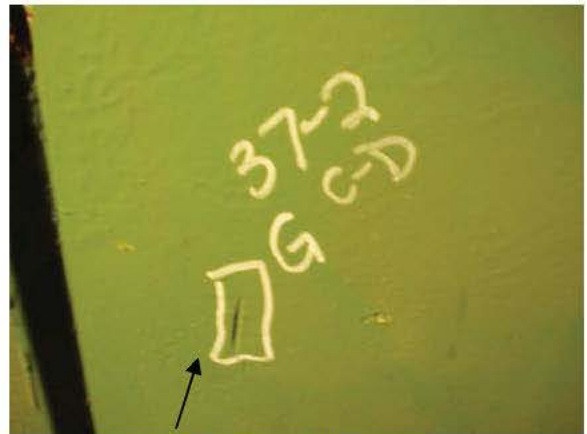
D-P37-2 GOUGE REPAIR

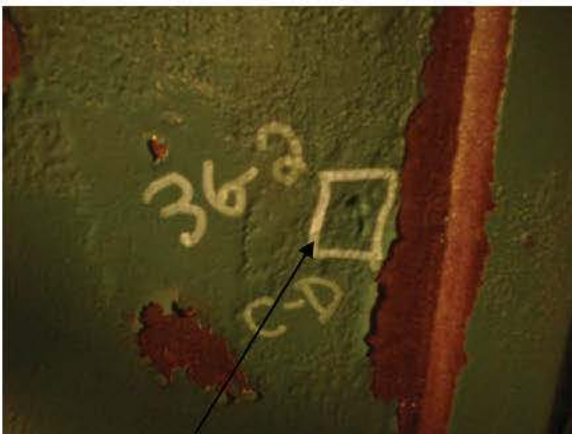
D-P36-2 GOUGE REPAIR

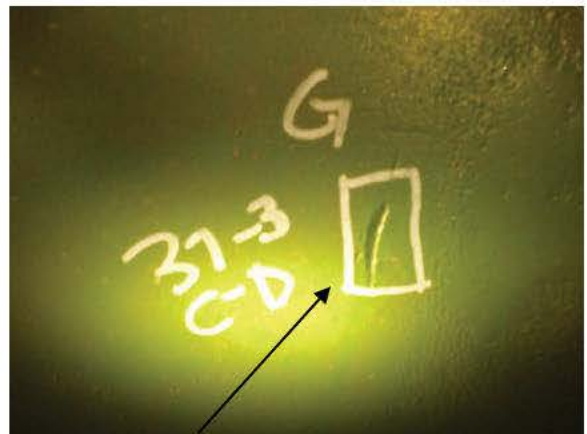
D-P37-3 GOUGE REPAIR

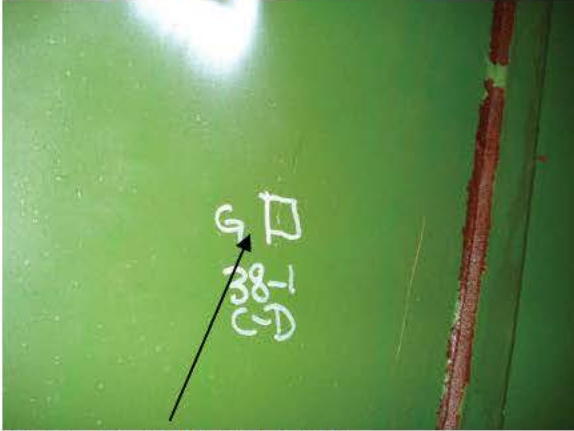
D-P38-1 GOUGE REPAIR

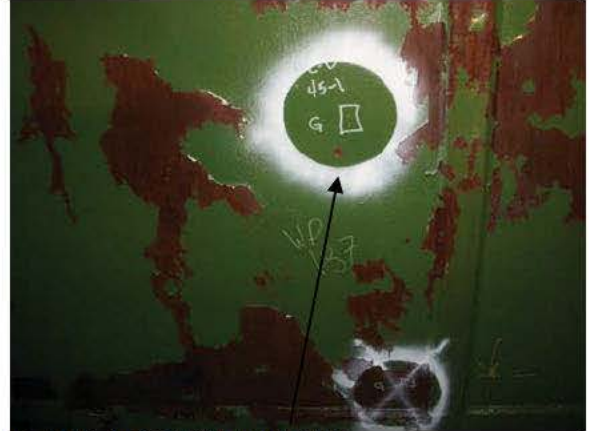
D-P45-1 GOUGE REPAIR

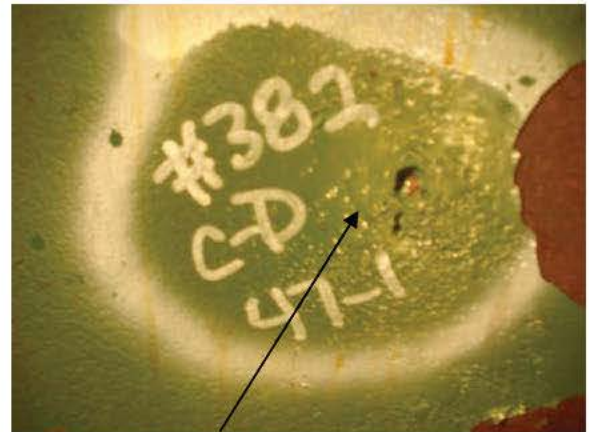
D-P47-1 GOUGE REPAIR

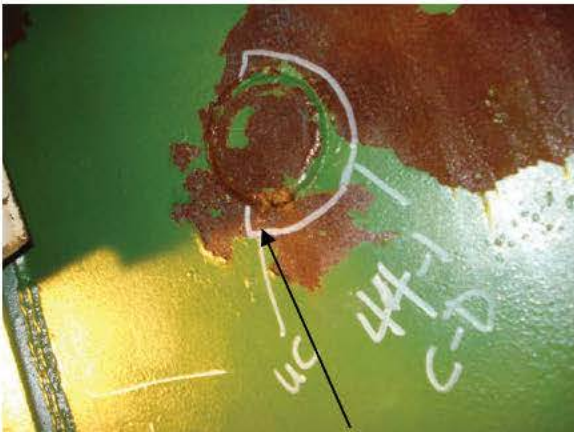
D-P44-1 WELD - UNDERCUT

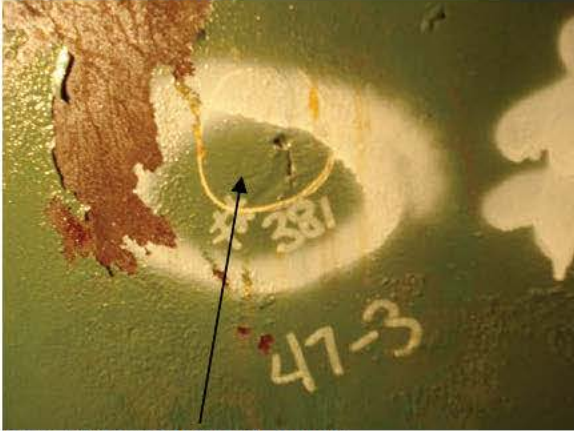
D-P47-3 GOUGE REPAIR

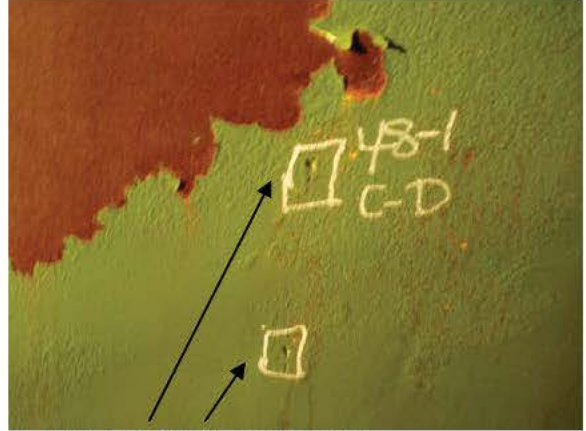
D-P48-1 GOUGE REPAIRS

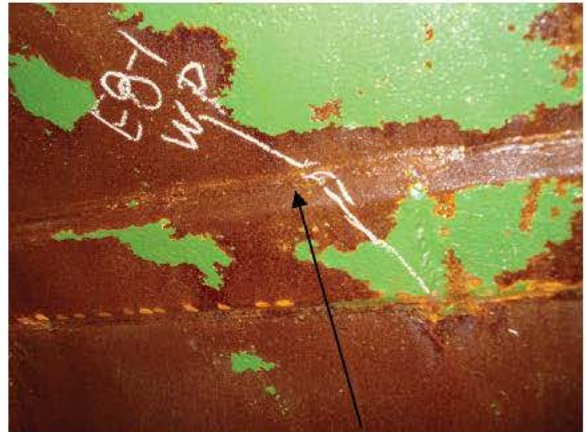
E-P8-1 WELD REPAIR- POROSITY

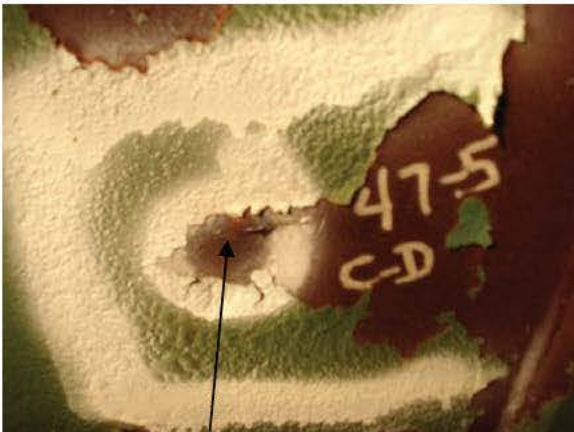
RD-P47-5 GOUGE REPAIR

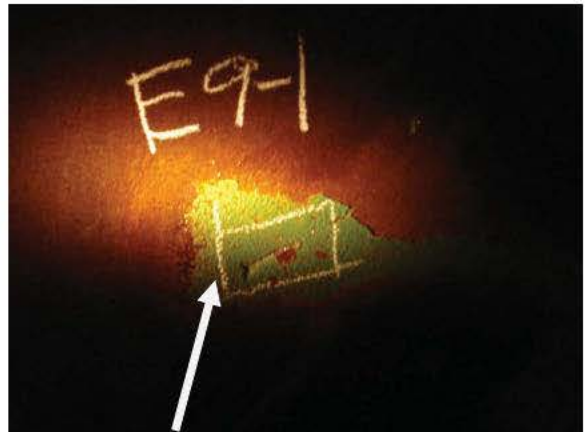
E-P9-1 GOUGE REPAIR

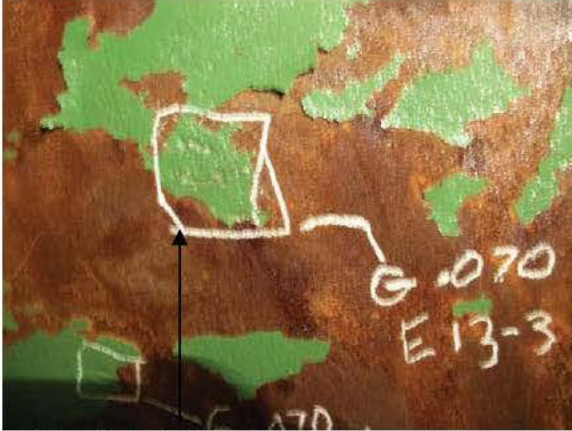
E-P13-3 GOUGE REPAIR

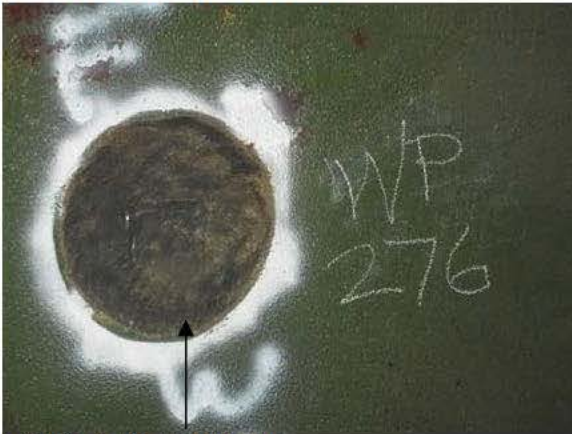
E2-P3-1 PIT REPAIR

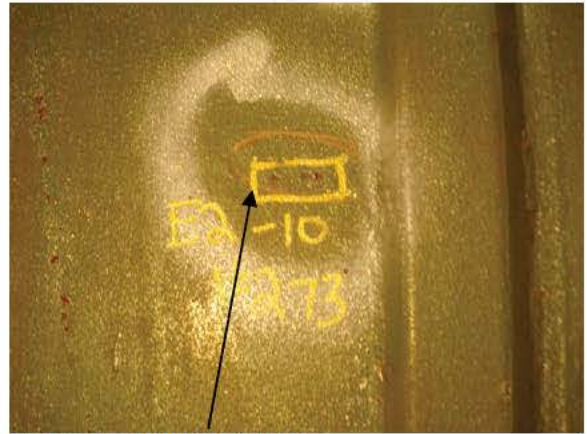
E2-P10-1 PIT REPAIR

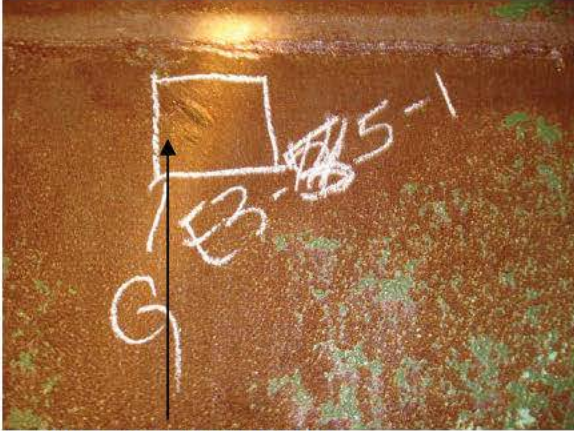
E3-P5-1 GOUGE REPAIR

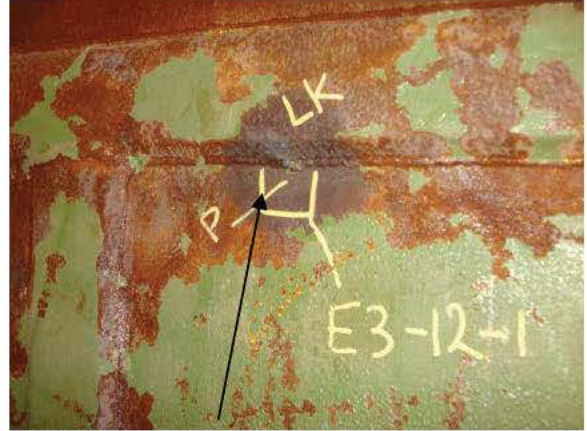
E3-P12-1 WELD REPAIR- LEAK

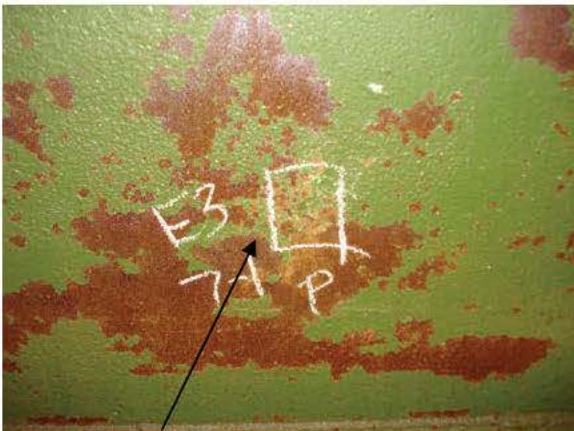
E3-P7-1 PIT REPAIR

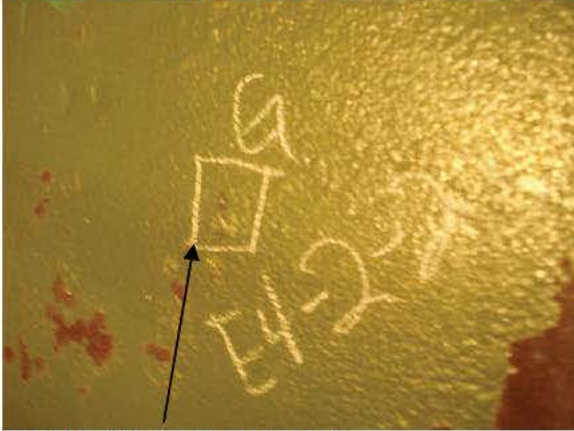
E4-P2-2 GOUGE REPAIR

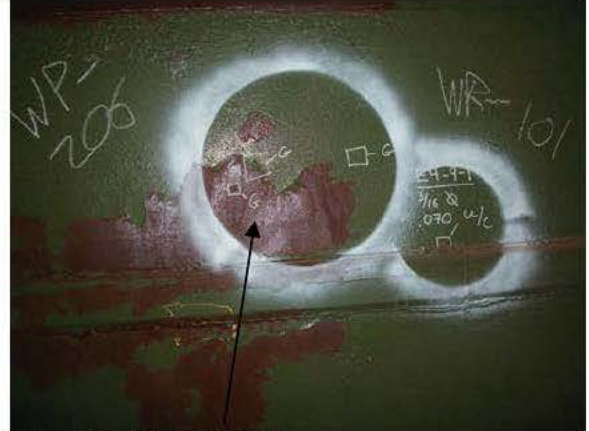
E4-P9-2 PIT REPAIR

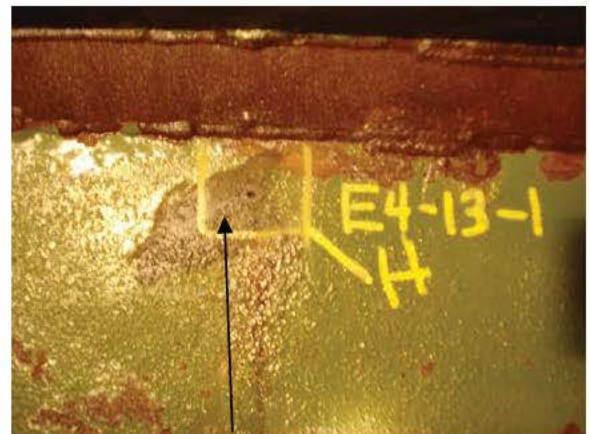
E4-P13-1 HOLE REPAIR

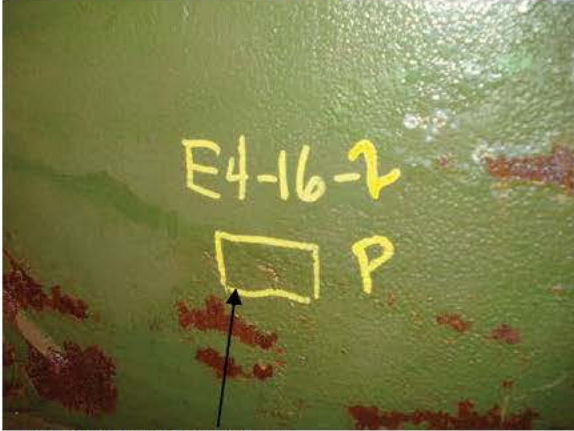
E4-P16-2 PIT REPAIR

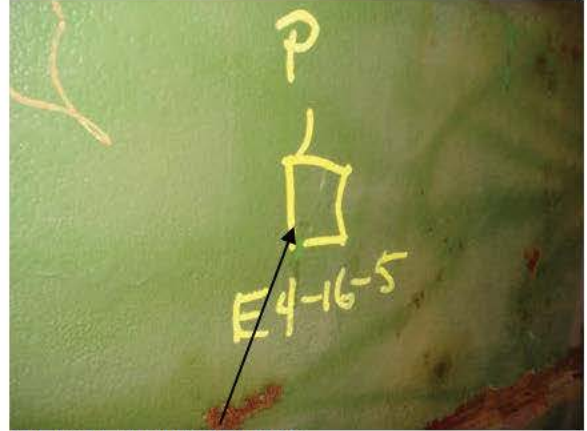
E4-P16-5 PIT REPAIR

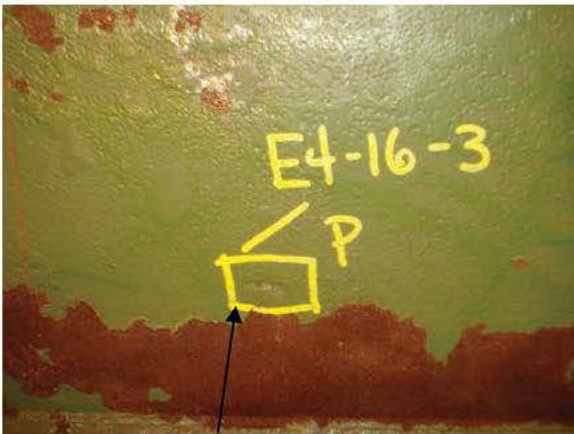
E4-P16-3 PIT REPAIR

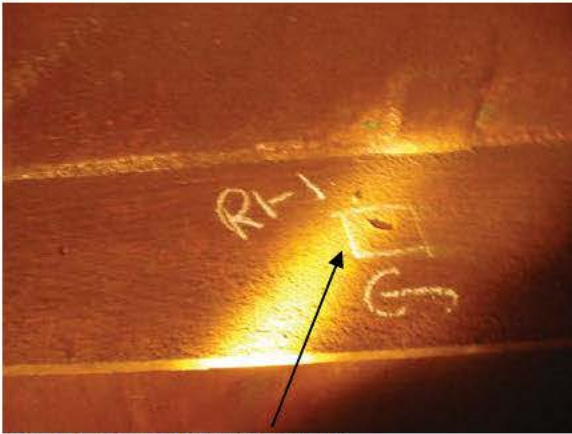
R1-P1-1 GOUGE REPAIR

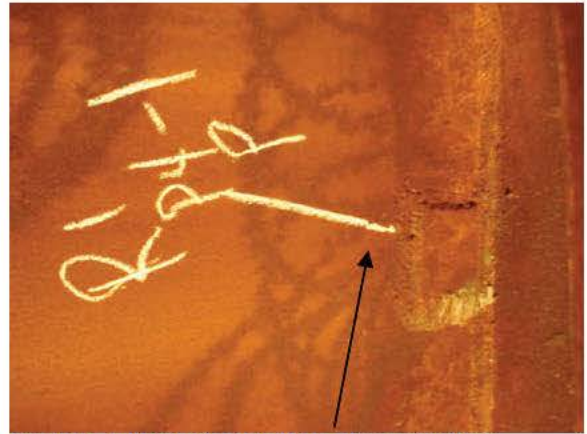
R1-P4-1 WELD REPAIR- POROSITY

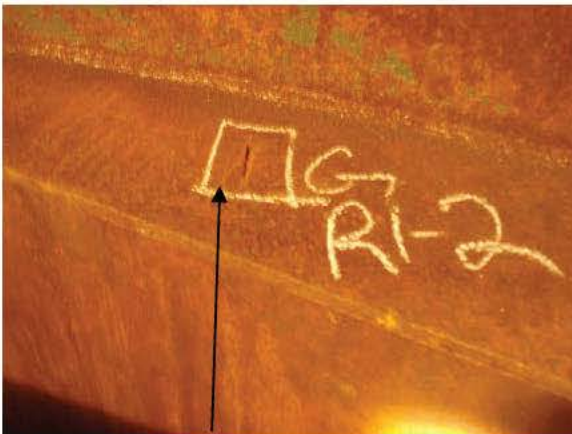
R1-P2-1 GOUGE REPAIR

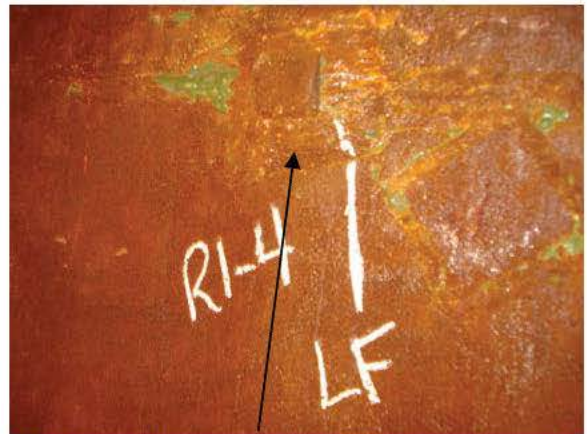
R1-P4-2 WELD REPAIR- LACK OF FUSION

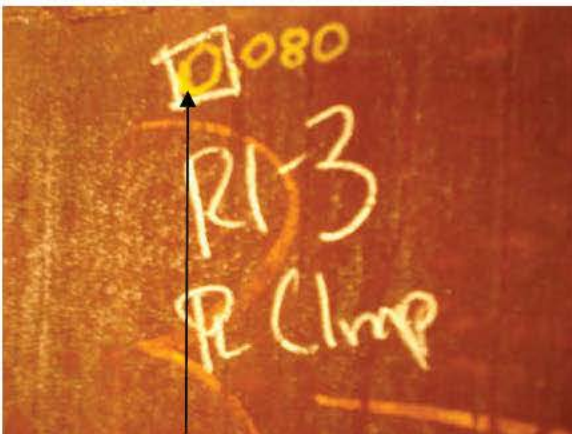
R1-P3-1 PLATE CLAMP REPAIR

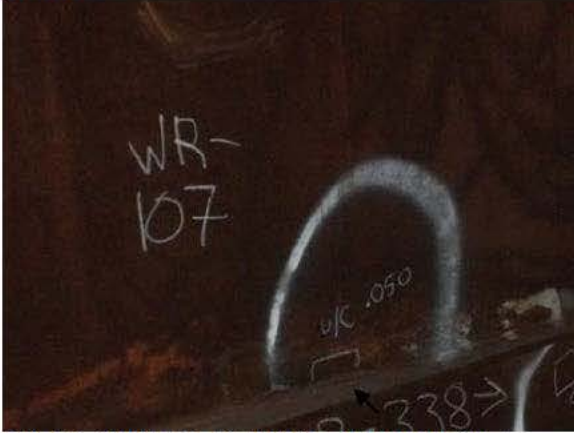
R1-P8-2 WELD REPAIR- UNDERCUT

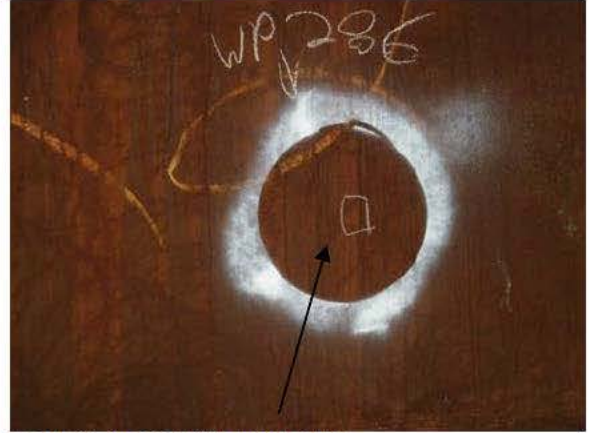
R2-P2-1 GOUGE REPAIR

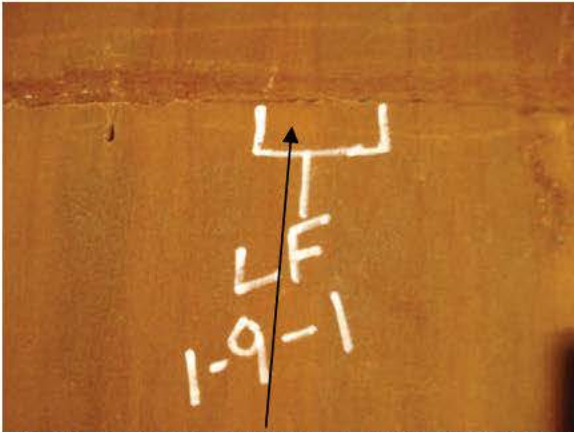
R1-P9-1 WELD REPAIR- LACK OF FUSION

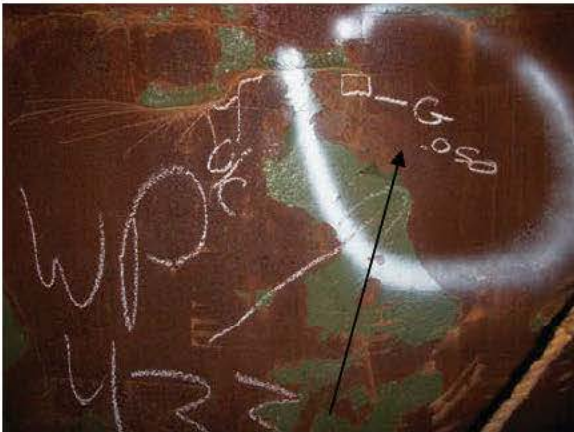
R1-P16-1 GOUGE REPAIR

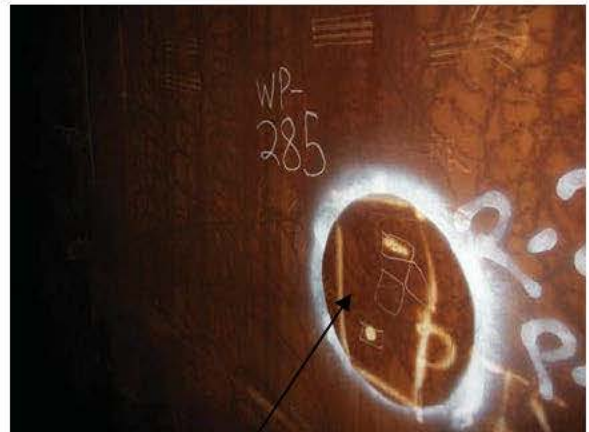
R2-P8-2 PIT REPAIRS

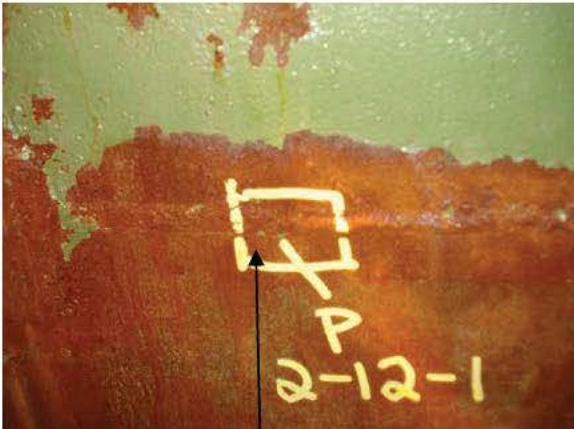
R2-P12-1 WELD REPAIR- POROSITY

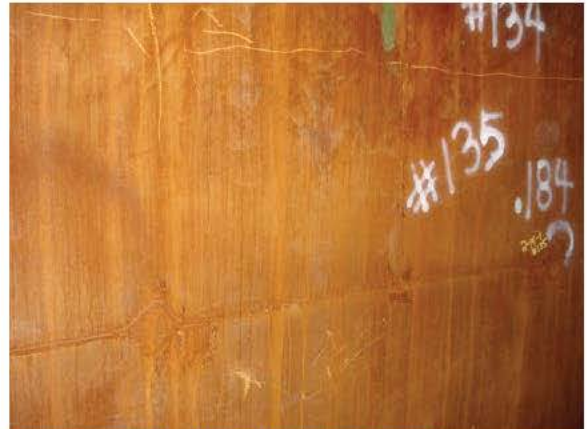
R2-P14-3 GENERAL CONDITION

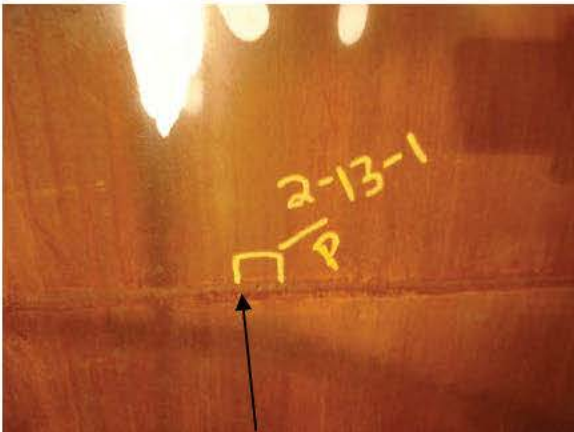
R2-P13-1 WELD REPAIR- POROSITY

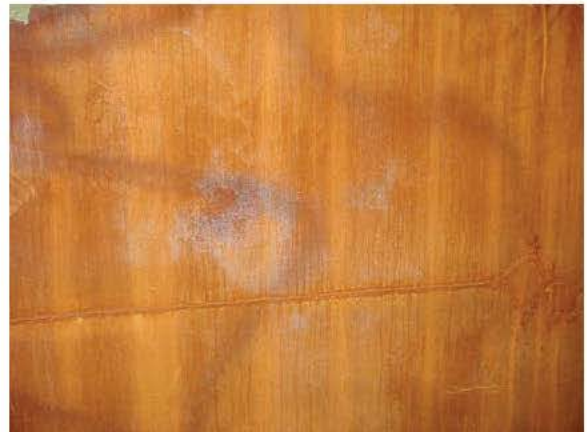
R2-P14-4 GENERAL CONDITION

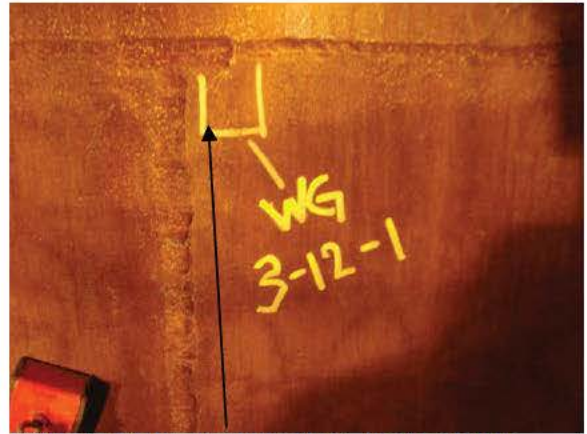
R3-P12-1 WELD REPAIR- POROSITY

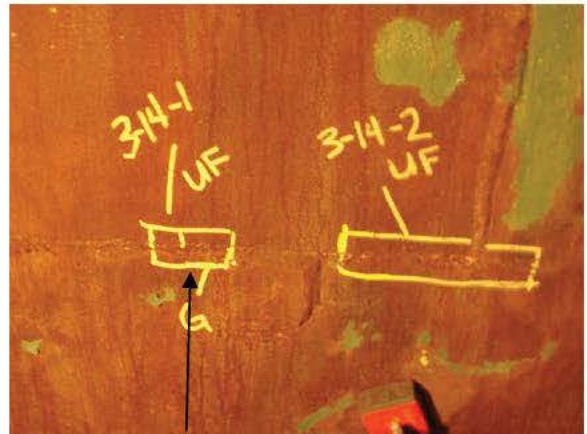
R3-P14-2 GOUGE REPAIR

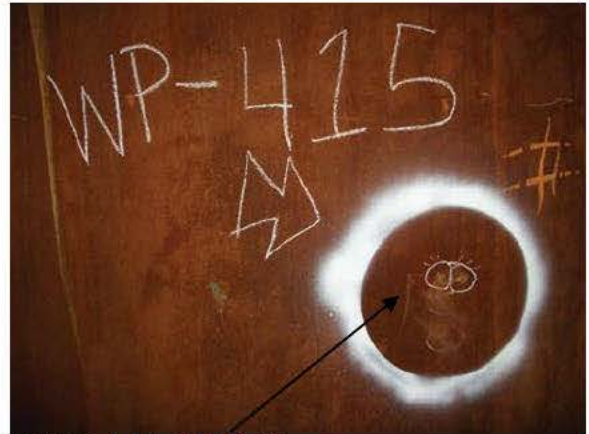
R5-P9-1 PIT REPAIR

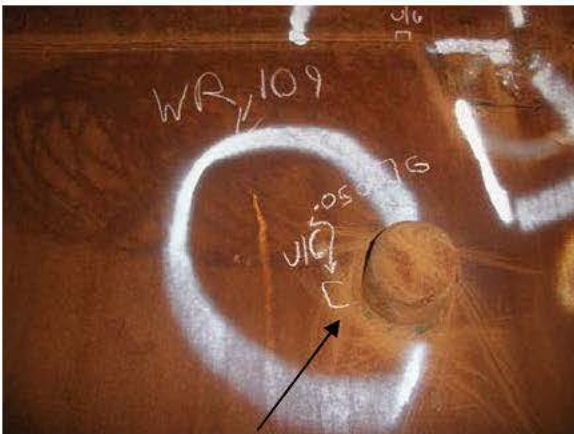
R5-P8-2 WELD REPAIR- UNDERCUT

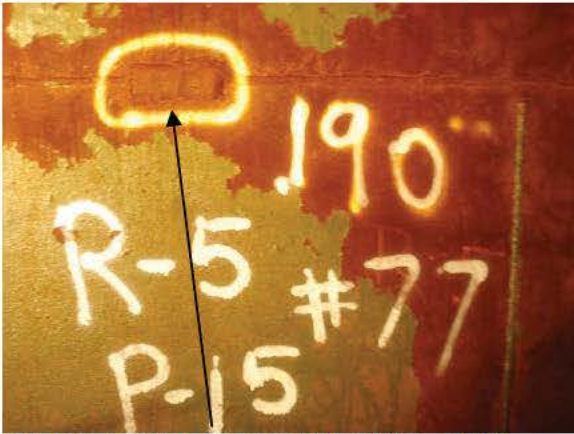
R5-P15-2 WELD REPAIR- UNDERFILL

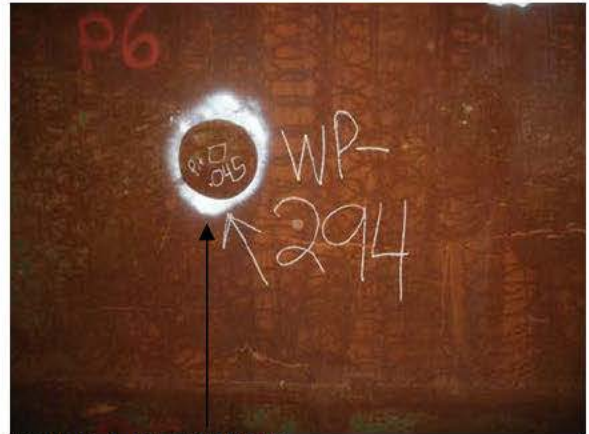
R6-P6-1 PIT REPAIR

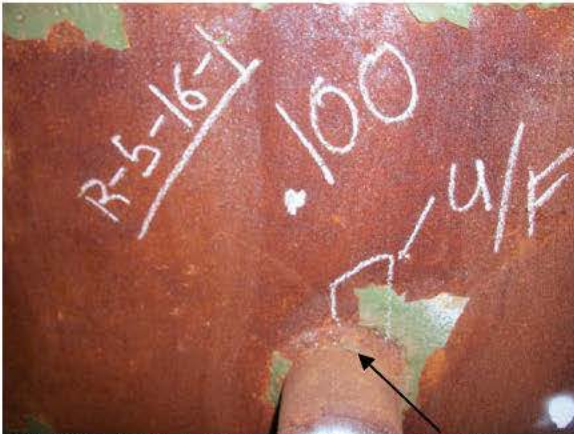
R5-P16-1 WELD REPAIR- UNDERFILL

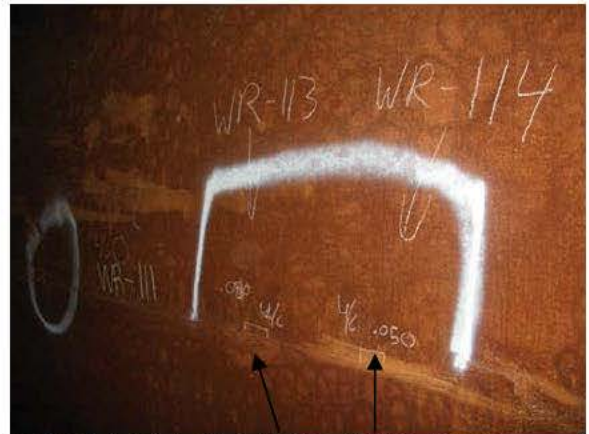
R6-P8-1 WELD REPAIR- UNDERCUT

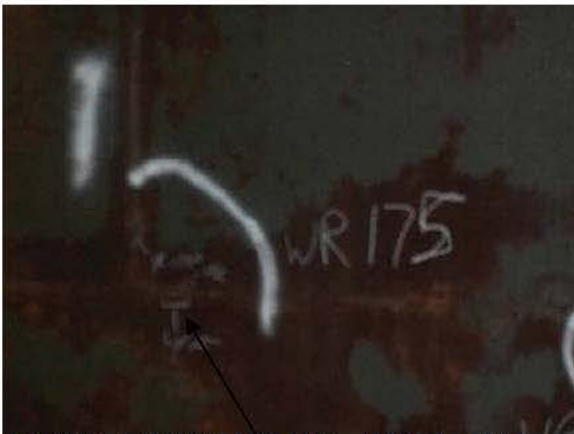
R6-P1P-1 WELD REPAIR- UNDERCUT

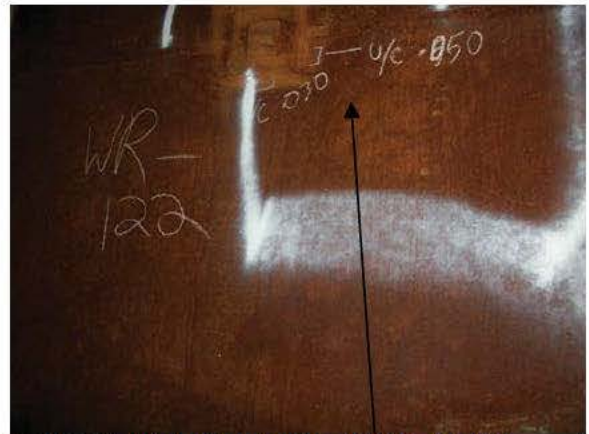
R6-P8-2 WELD REPAIR- UNDERCUT

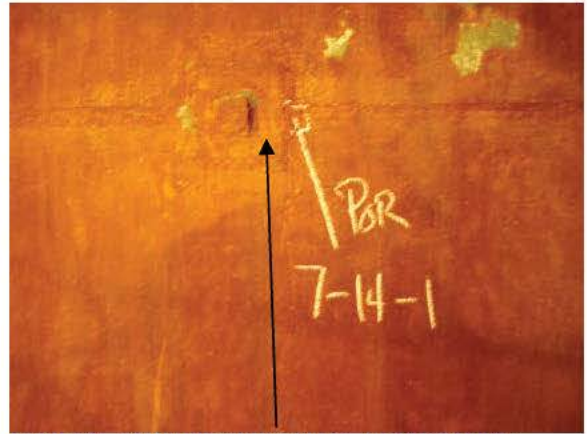
R7-P14-1 WELD REPAIR- POROSITY

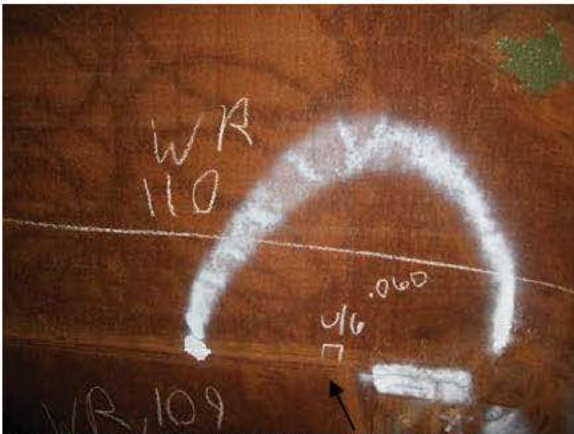
R6-P9-1 WELD REPAIR- UNDERCUT

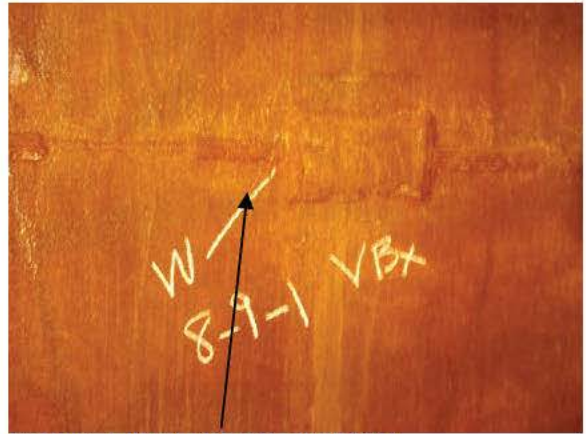
R8-P9-1 WELD UNIFORMITY

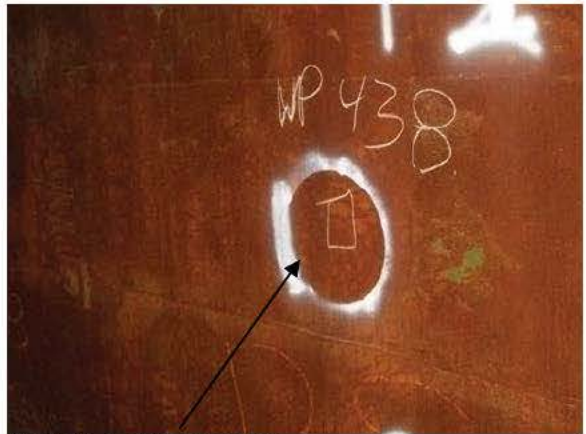
R9-P1-1 PIT REPAIR

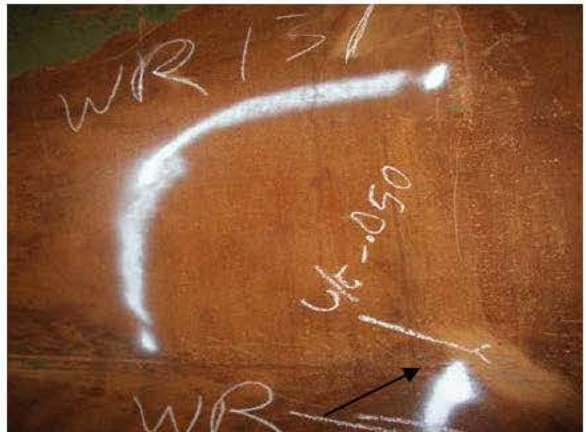
R10-P8-1 WELD REPAIR- UNDERCUT

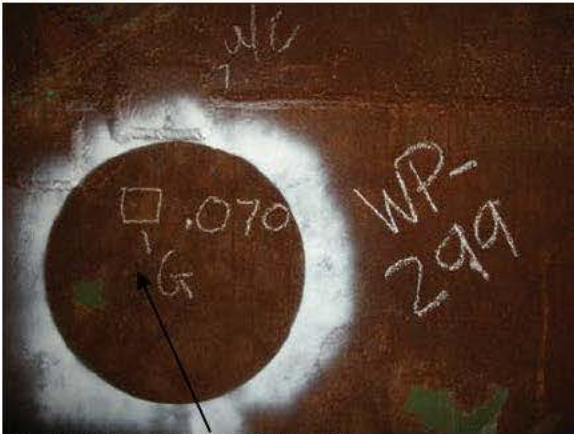
R10-P8-2 GOUGE REPAIR

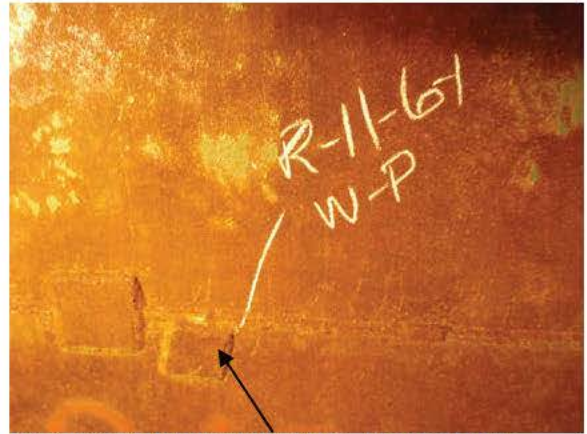
R11-P6-1 WELD REPAIR- POROSITY

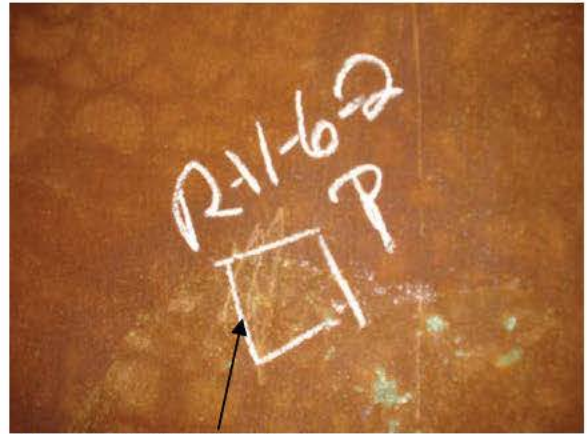
R11-P6-2 PIT REPAIR

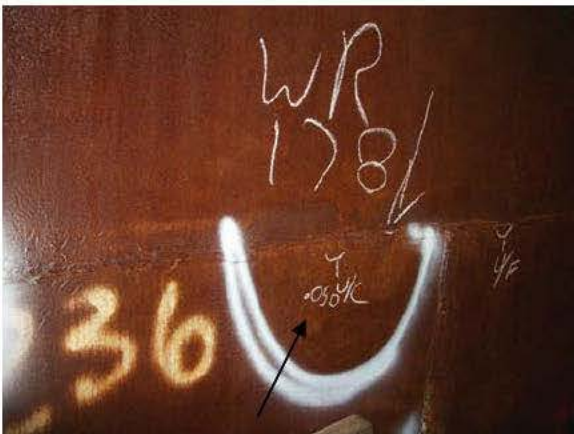
R10-P16-1 WELD REPAIR- UNDERCUT

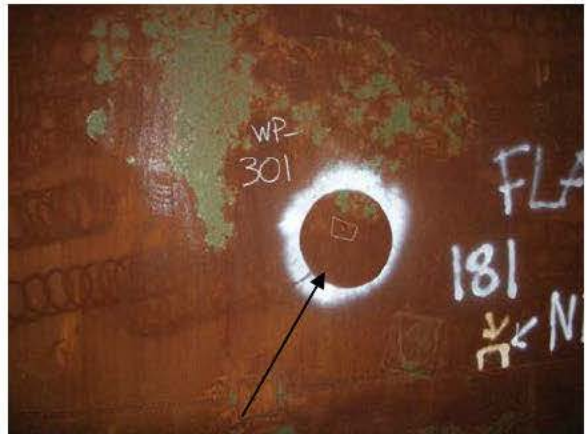
R11-P6-3 PIT REPAIR

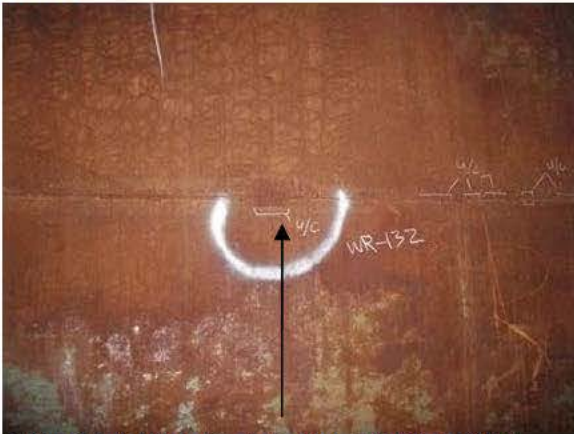
R11-P7-1 WELD REPAIR- UNDERCUT

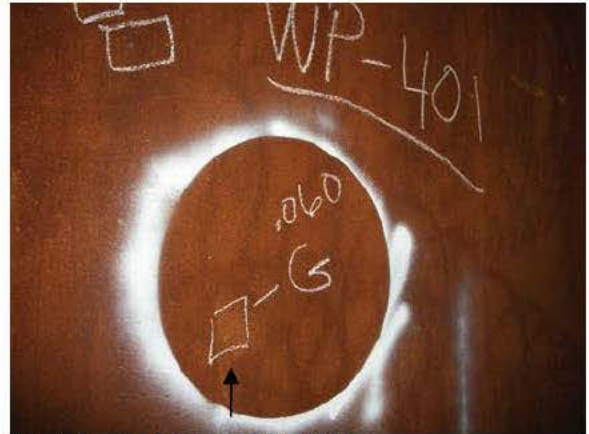
R11-P8-3 GOUGE REPAIR

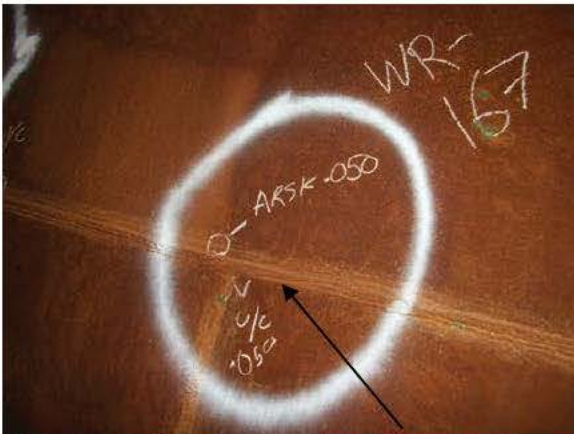
R11-P8-1 WELD REPAIR- UNDERCUT

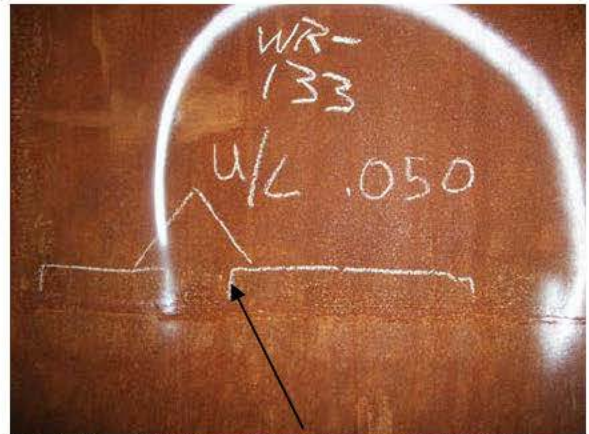
R11-P8-4 WELD REPAIR- UNDERCUT

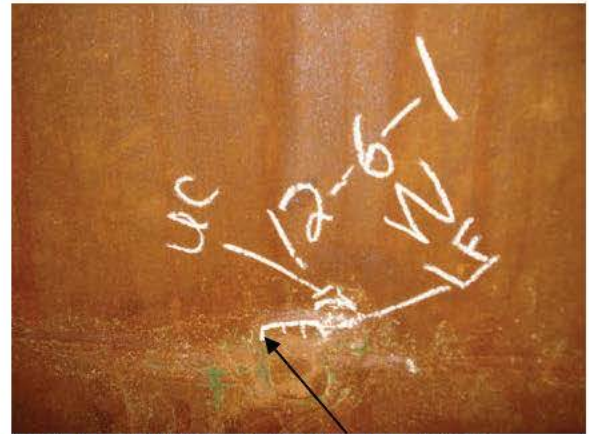
R12-P6-1 WELD REPAIR- LACK OF FUSION

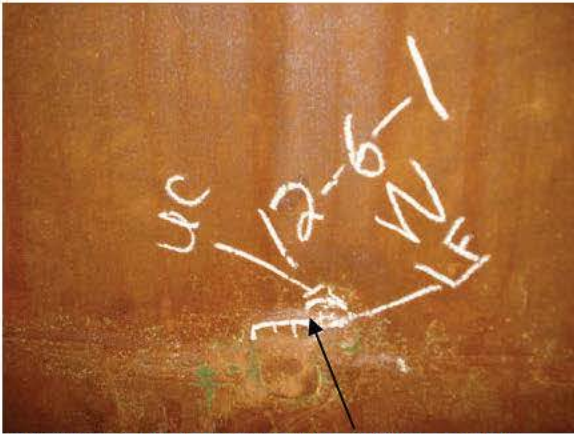
R12-P6-2 WELD REPAIR- UNDERCUT

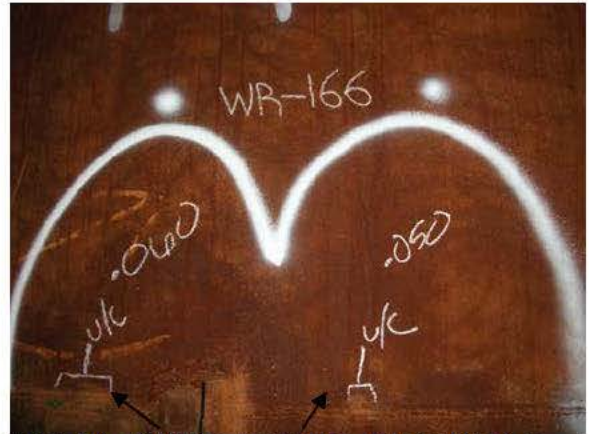
R12-P9-1 WELD REPAIR- UNDERCUTS

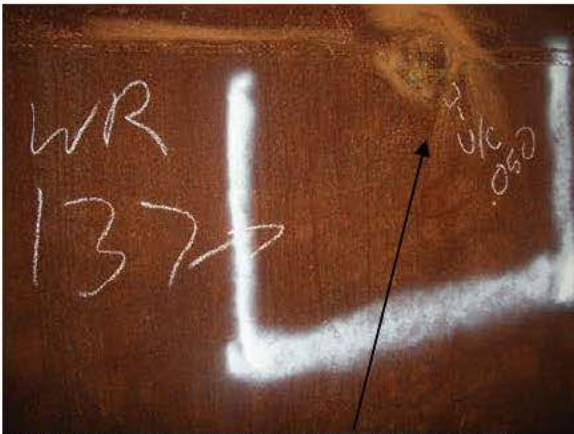
R12-P8-1 WELD REPAIR- UNDERCUT

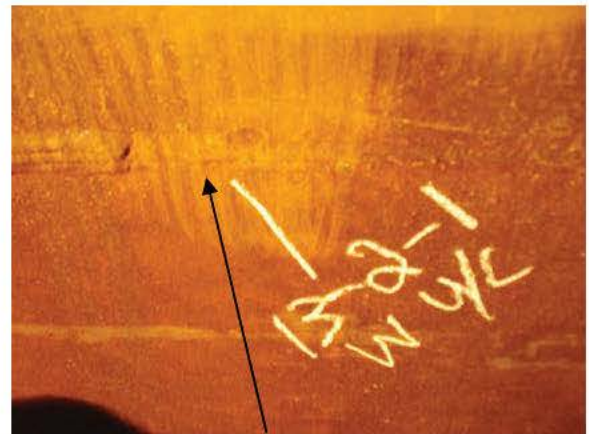
R13-P2-1 WELD REPAIR- UNDERCUT

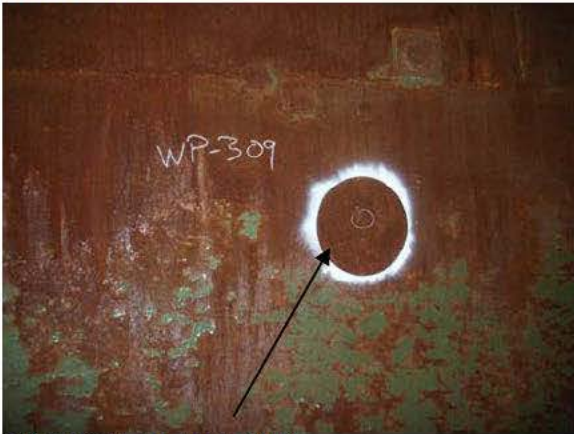
R13-P2-2 PIT REPAIR

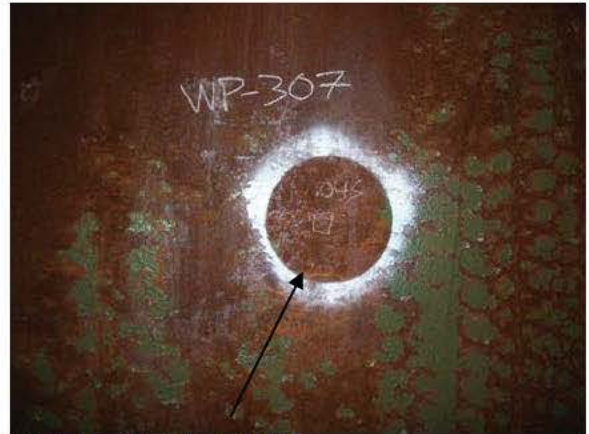
R13-P4-3 PIT REPAIR

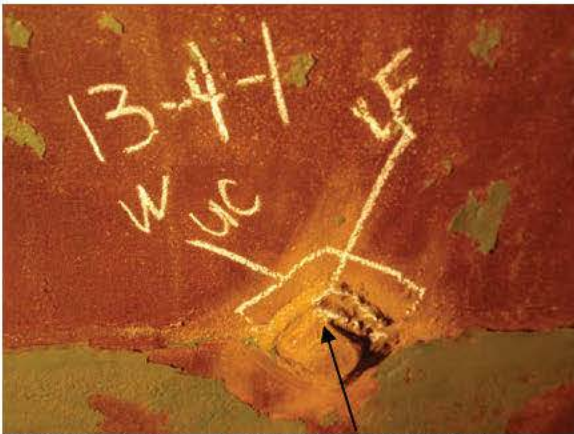
R13-P4-1 WELD REPAIR- LACK OF FUSION

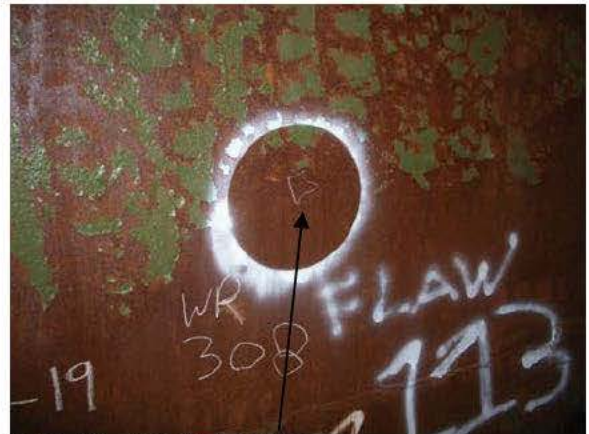
R13-P4-4 PIT REPAIR

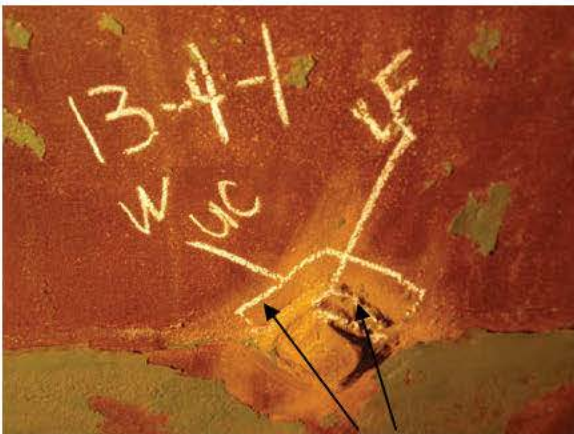
R13-P4-2 WELD REPAIR- UNDERCUT

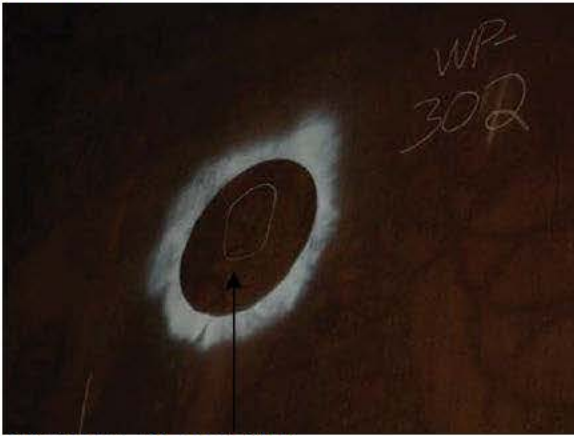
R13-P7-2 PIT REPAIR

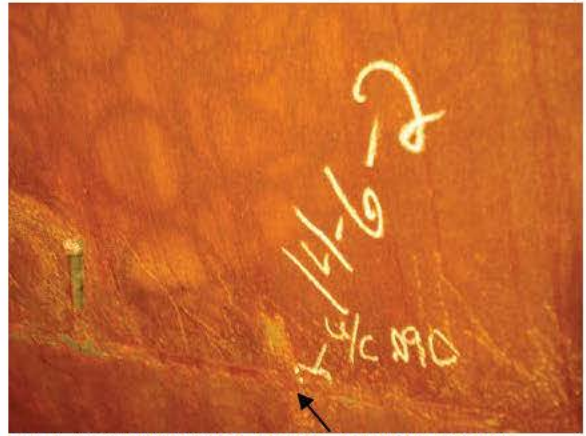
R14-6-2 WELD REPAIR- UNDERCUT

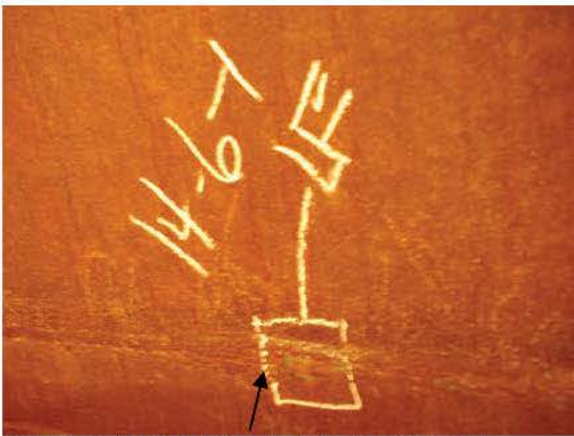
R14-P6-1 WELD REPAIR- LACK OF FUSION

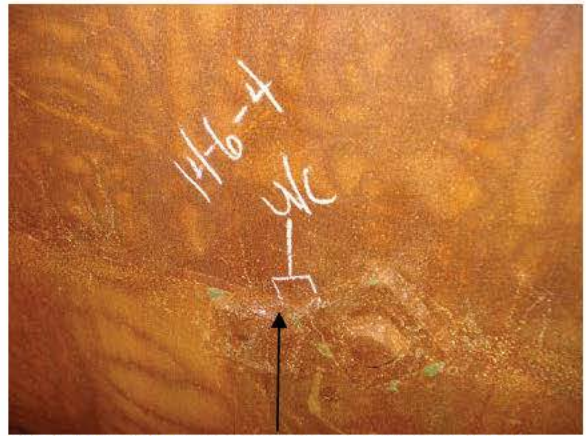
R14-P6-4 WELD REPAIR- UNDERCUT

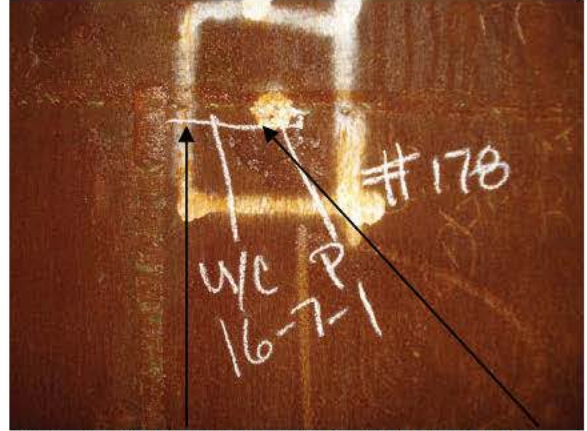
R16-P7-1 WELD REPAIR- UNDERCUT, POROSITY

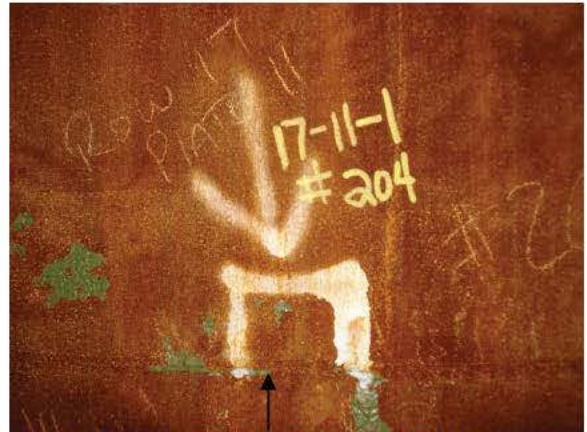
R17-P11-1 WELD REPAIR- UNDERCUT

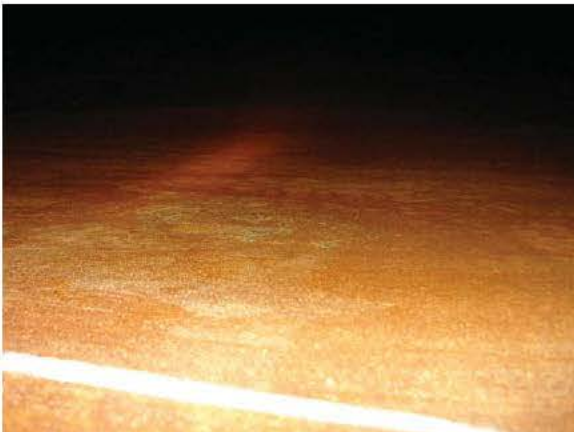
R16-1 GENERAL CONDITION

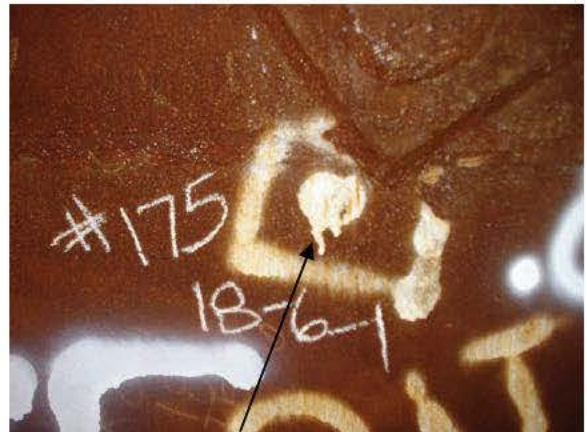
R18-P6-1 GOUGE REPAIR

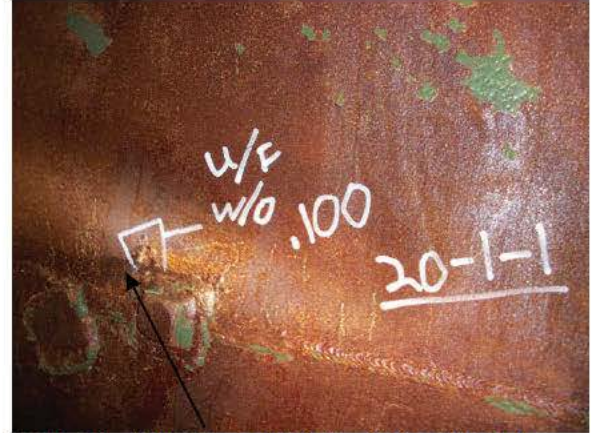
R20-P1-1 WELD REPAIR- UNDERFILL

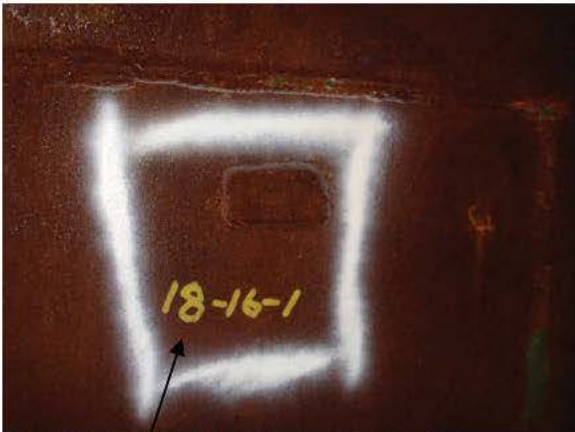
R18-P16-1 GENERAL CONDITION

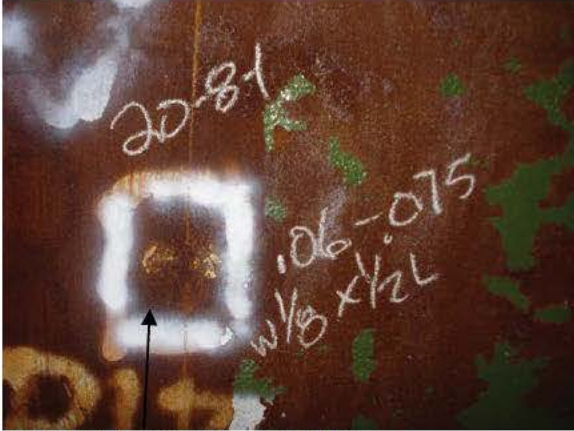
R20-P8-1 GOUGE REPAIR

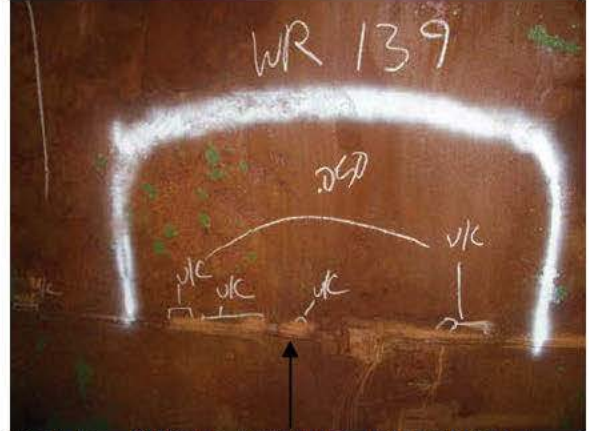
R20-P8-4 WELD REPAIR- UNDERCUT

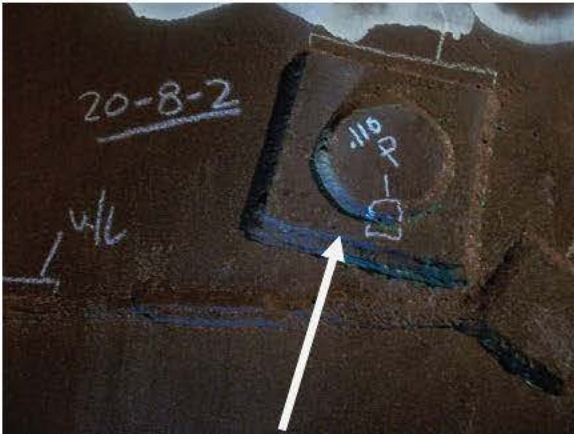
R20-P8-2 WELD REPAIR-POROSITY

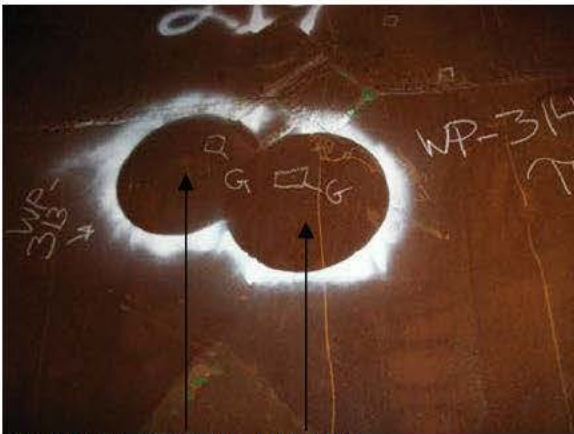
R20-P8-3 GOUGE REPAIR
