Project Title: CLEAN, INSPECT, AND REPAIR STORAGE TANKS 5 & 17
Location: PEARL NAVAL BASE – REDHILL COMPLEX, Pearl Harbor, HI
Task Order No.: N62583-09-D-0132/0003
WGS Project Number: 54118
Date: 18 Nov, 2010

**TANK 5 & 17 CLEANING, INSPECTION
AND REPAIRS PROJECT**

TANK 5 INSPECTION REPORT

**FINAL DRAFT TANK INSPECTION
& INTEGRITY REPORT**

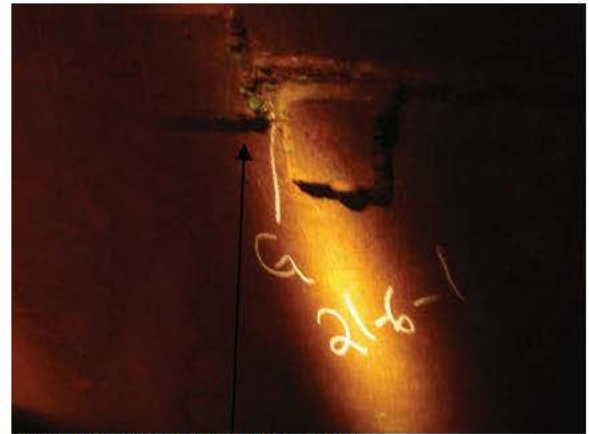
R21-P6-1 GOUGE REPAIR

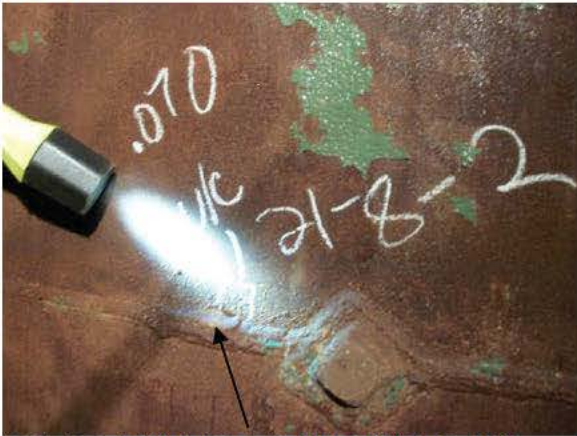
R21-P8-2 WELD REPAIR- UNDERCUT

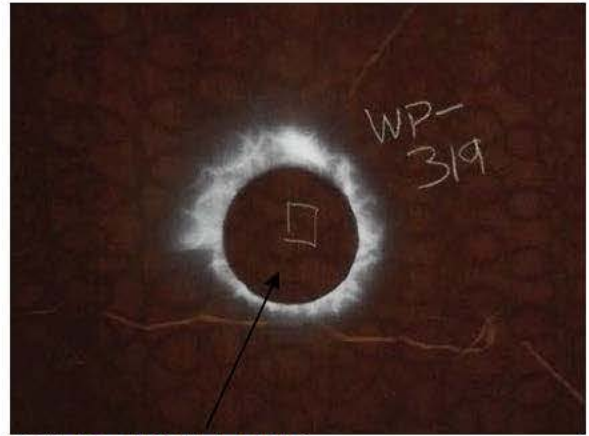
R22-P2-1 PIT REPAIR

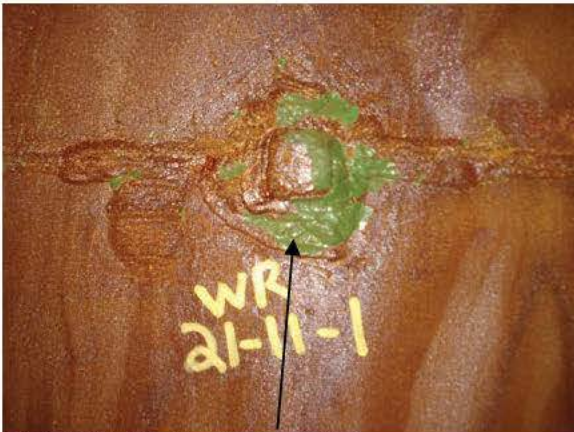
R21-P11-1 EXCESS WELD REINFORCEMENT

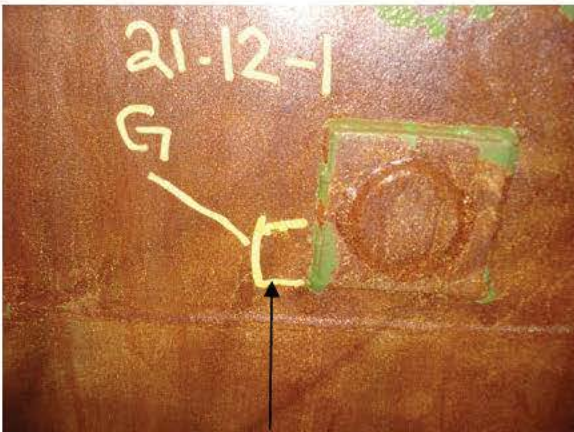
R21-P12-1 GOUGE REPAIR

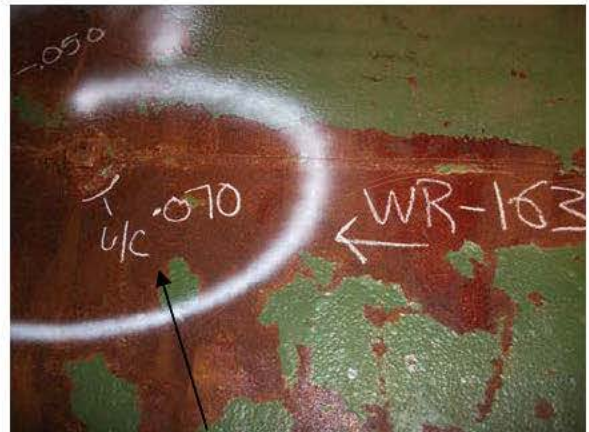
R22-P9-2 WELD REPAIR- UNDERCUT

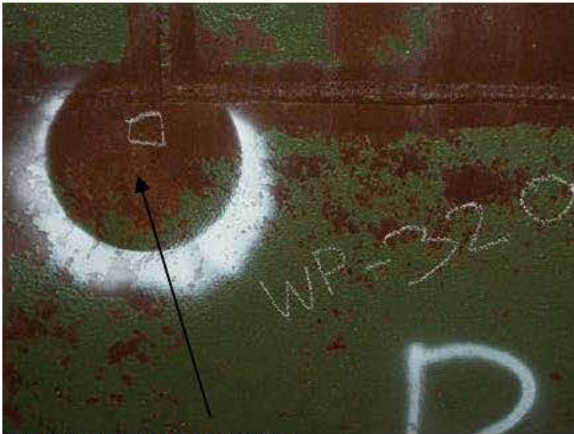
R23-P4-1 PIT REPAIR

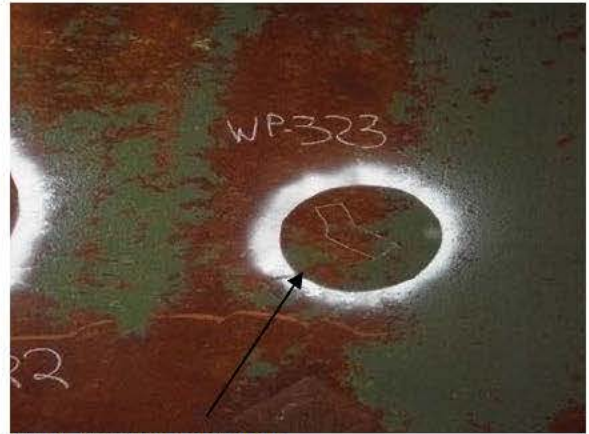
R24-5-2 PIT REPAIR

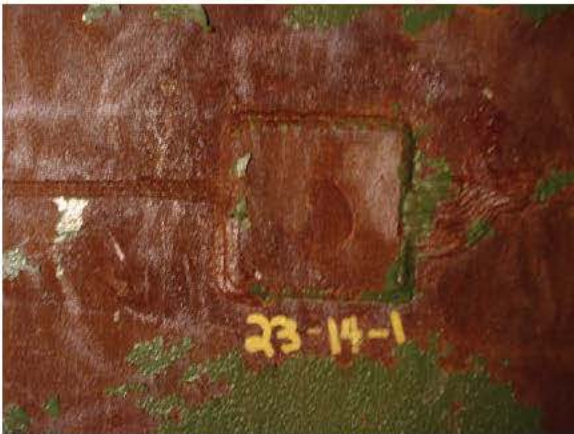
R23-P14-1 GENERAL CONDITION

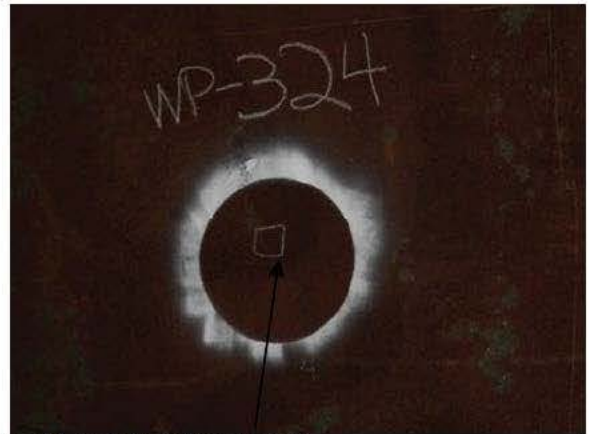
R24-P7-1 PIT REPAIR

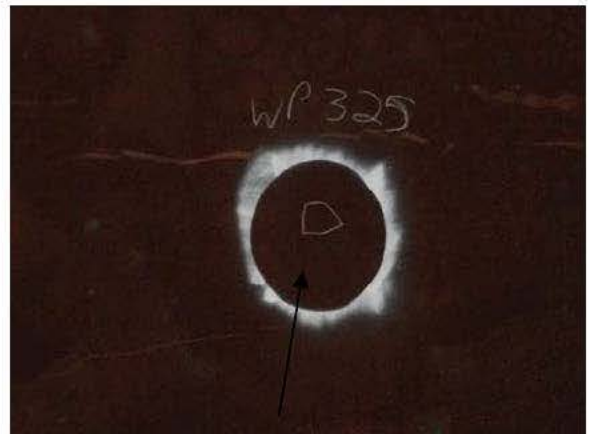
R24-P7-2 PIT REPAIR

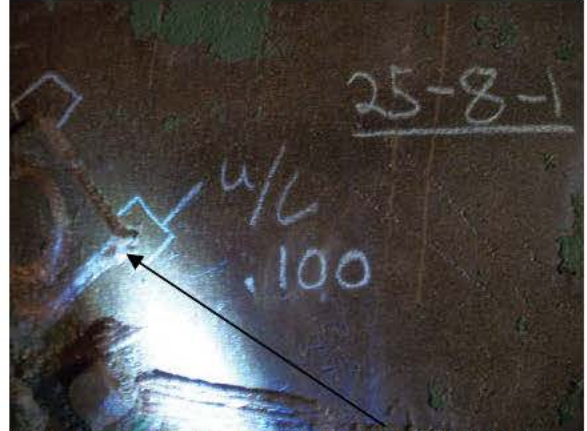
R25-P8-1 WELD REPAIR- UNDERCUT

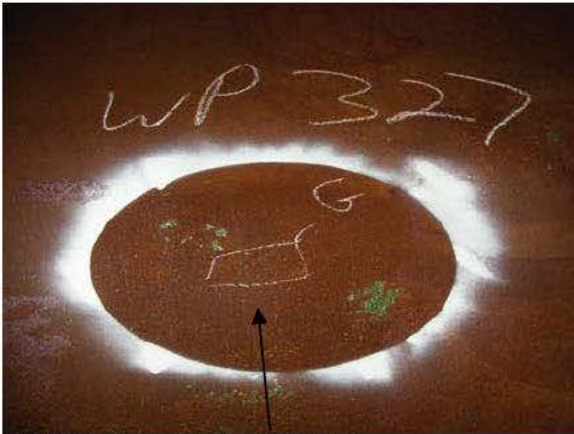
R27-P3-1 WELD REPAIR- LACK OF FUSION

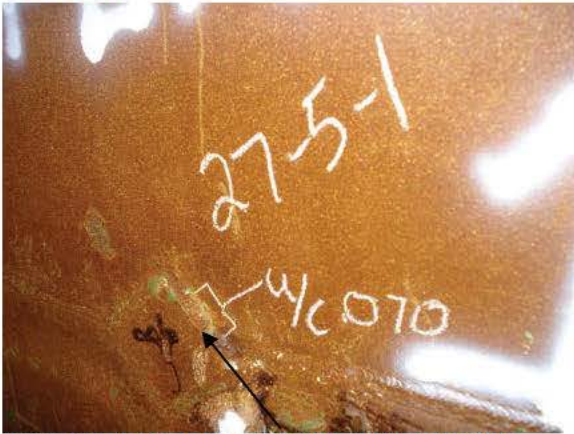
R27-P5-1 WELD REPAIR- UNDERCUT

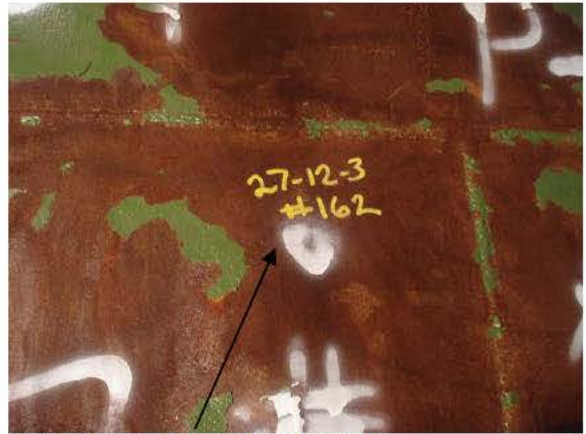
R27-P12-3 GOUGE REPAIR

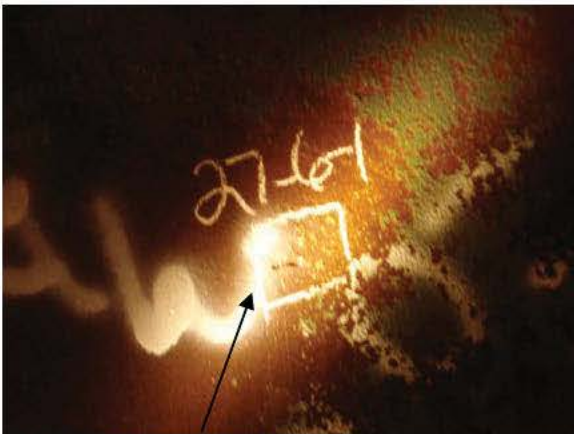
R27-P6-1 PIT REPAIR

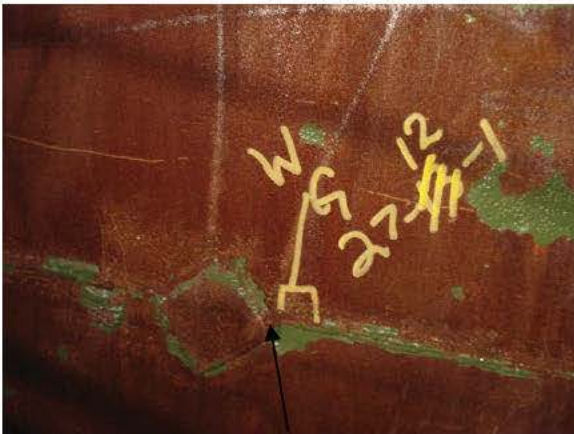
R27-P12-1 GOUGE REPAIR

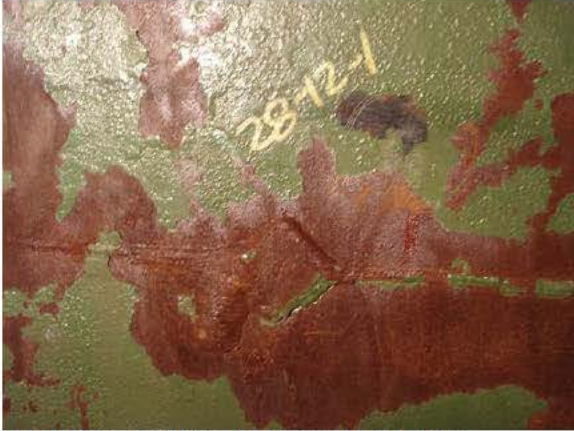
R28-P12-1 GENERAL CONDITION

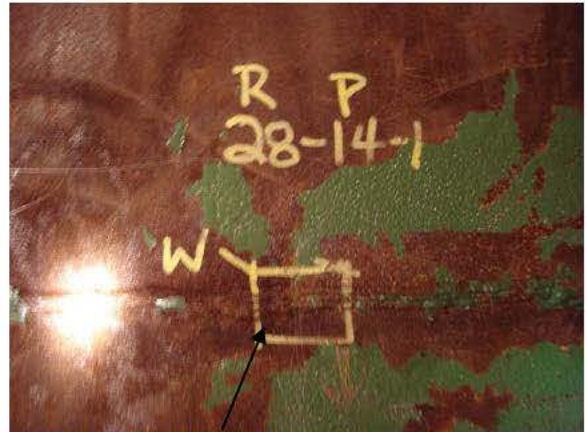
R28-P14-1 WELD REPAIR- LACK OF FUSION

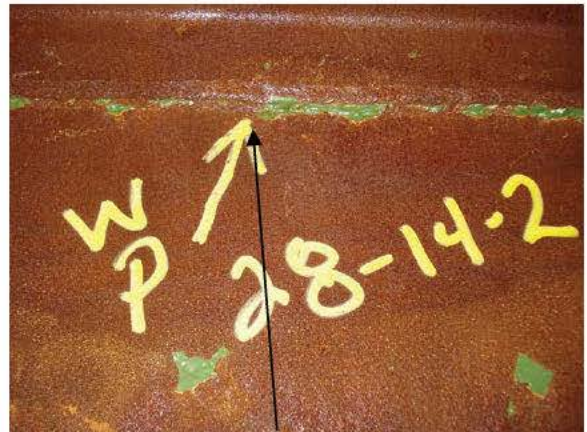
R28-P14-2 WELD REPAIR- POROSITY

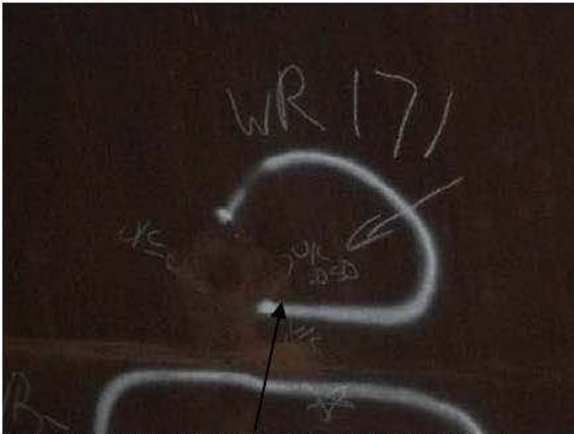
C4-P1-1 WELD REPAIR- UNDERCUT

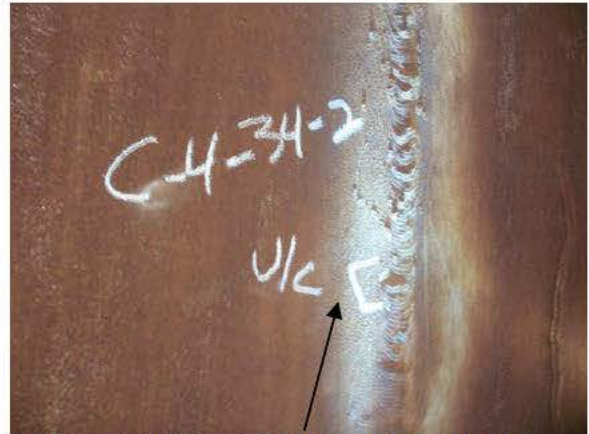
C4-P34-2 WELD REPAIR- UNDERCUT

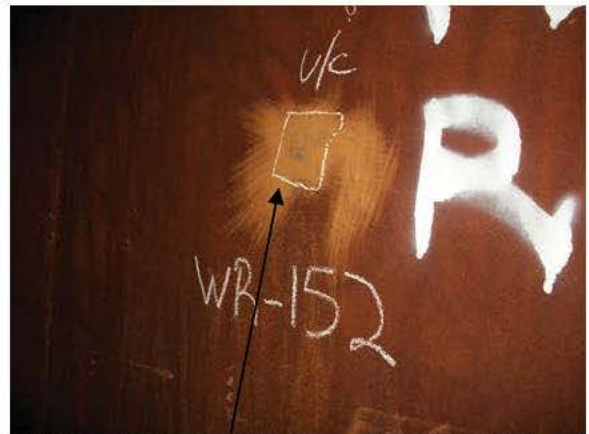
C4-P34-3 WELD REPAIR- UNDERCUT

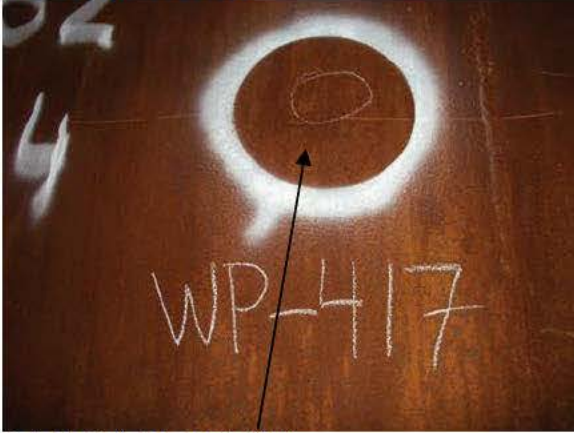
C4-P52-1 PIT REPAIR

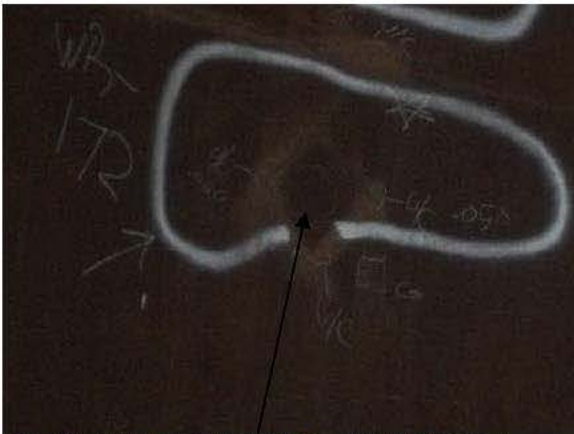
C3-P1-1 WELD REPAIR- UNDERCUT

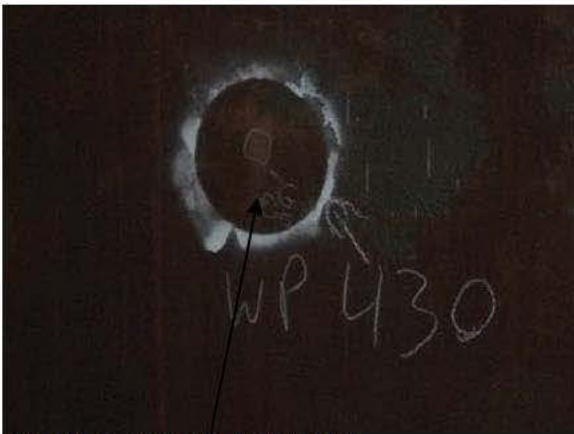
C3-P1-2 GOUGE REPAIR

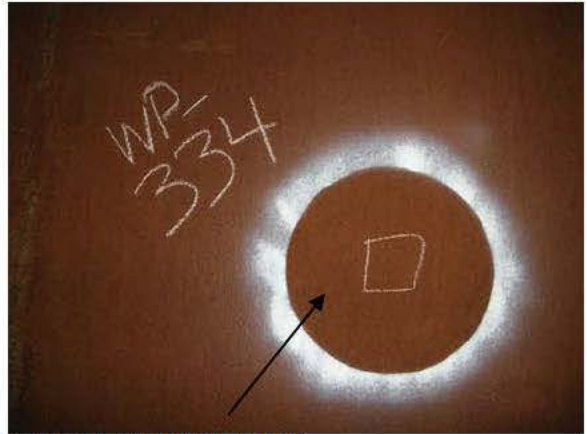
C3-P24-1 PIT REPAIR

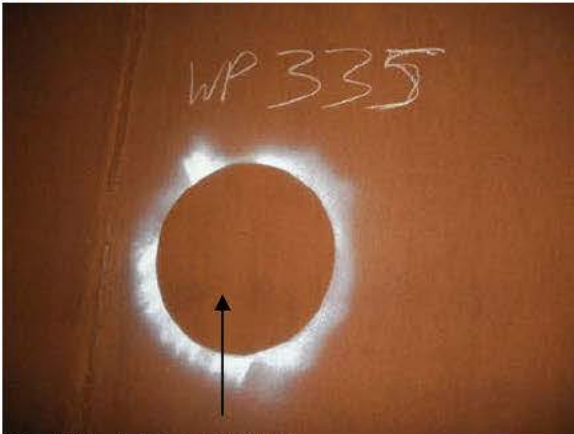
C3-P29-1 PIT REPAIR

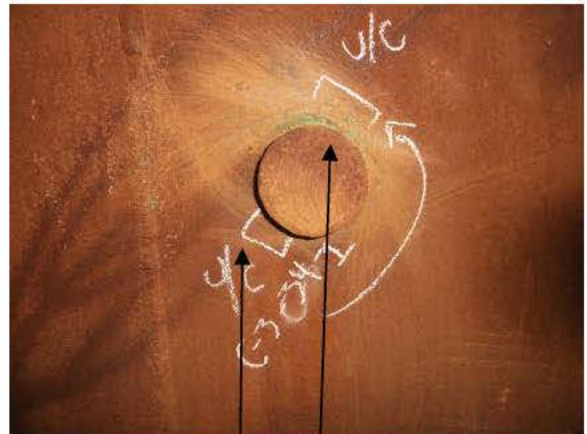
C3-P34-1 WELD REPAIR- UNDERCUT

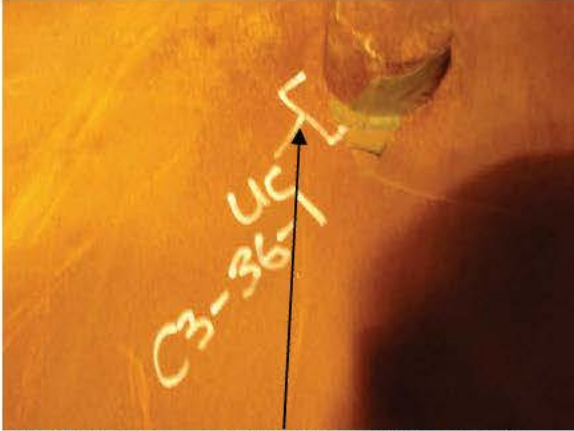
C3-P36-1 WELD REPAIR- UNDERCUT

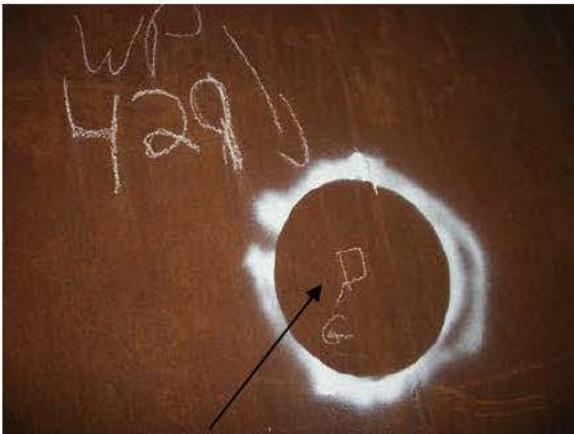
C3-P66-1 GOUGE REPAIR

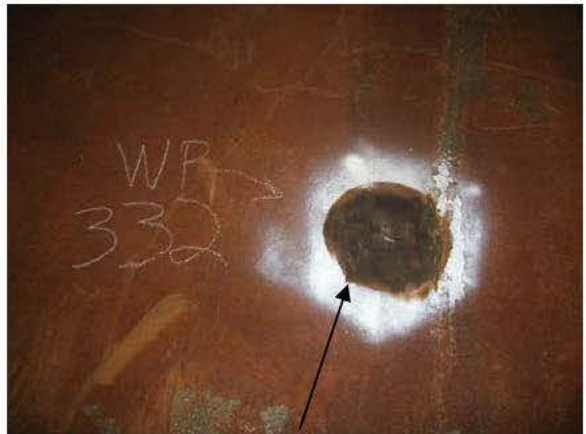
C2-P18-1 PIT REPAIR

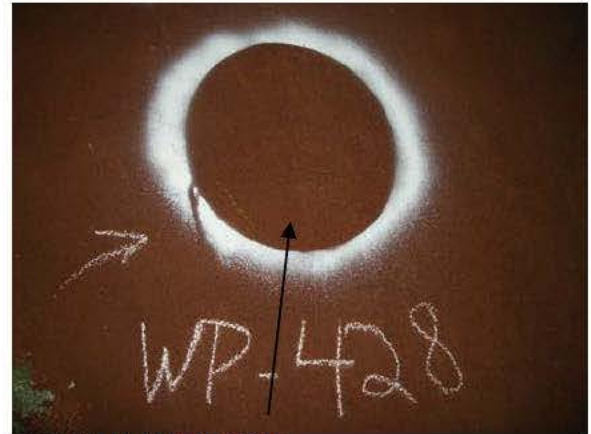
C2-64-1 PIT REPAIR

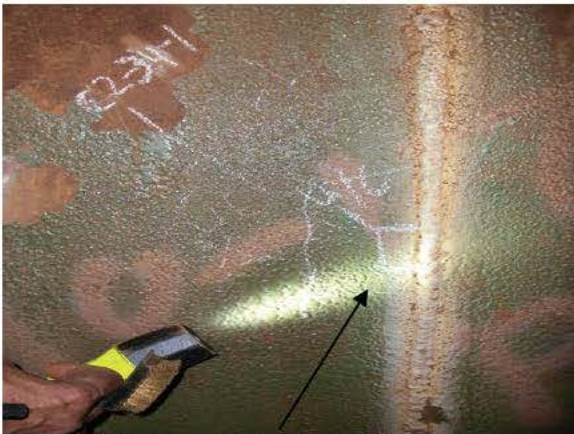
C2-P34-1 WELD- UNDERCUT

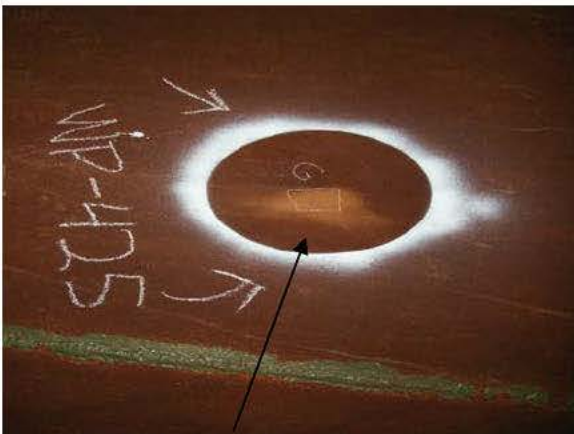
C2-P35-1 PIT REPAIR
