**RCRA FACILITY ASSESSMENT
REPORT**

**PRC Environmental Management, Inc.
October 1993**

**RCRA FACILITY ASSESSMENT REPORT
SOUTHERN PACIFIC
TRANSPORTATION COMPANY
HOUSTON, TEXAS
TXD000820266**

October 1993

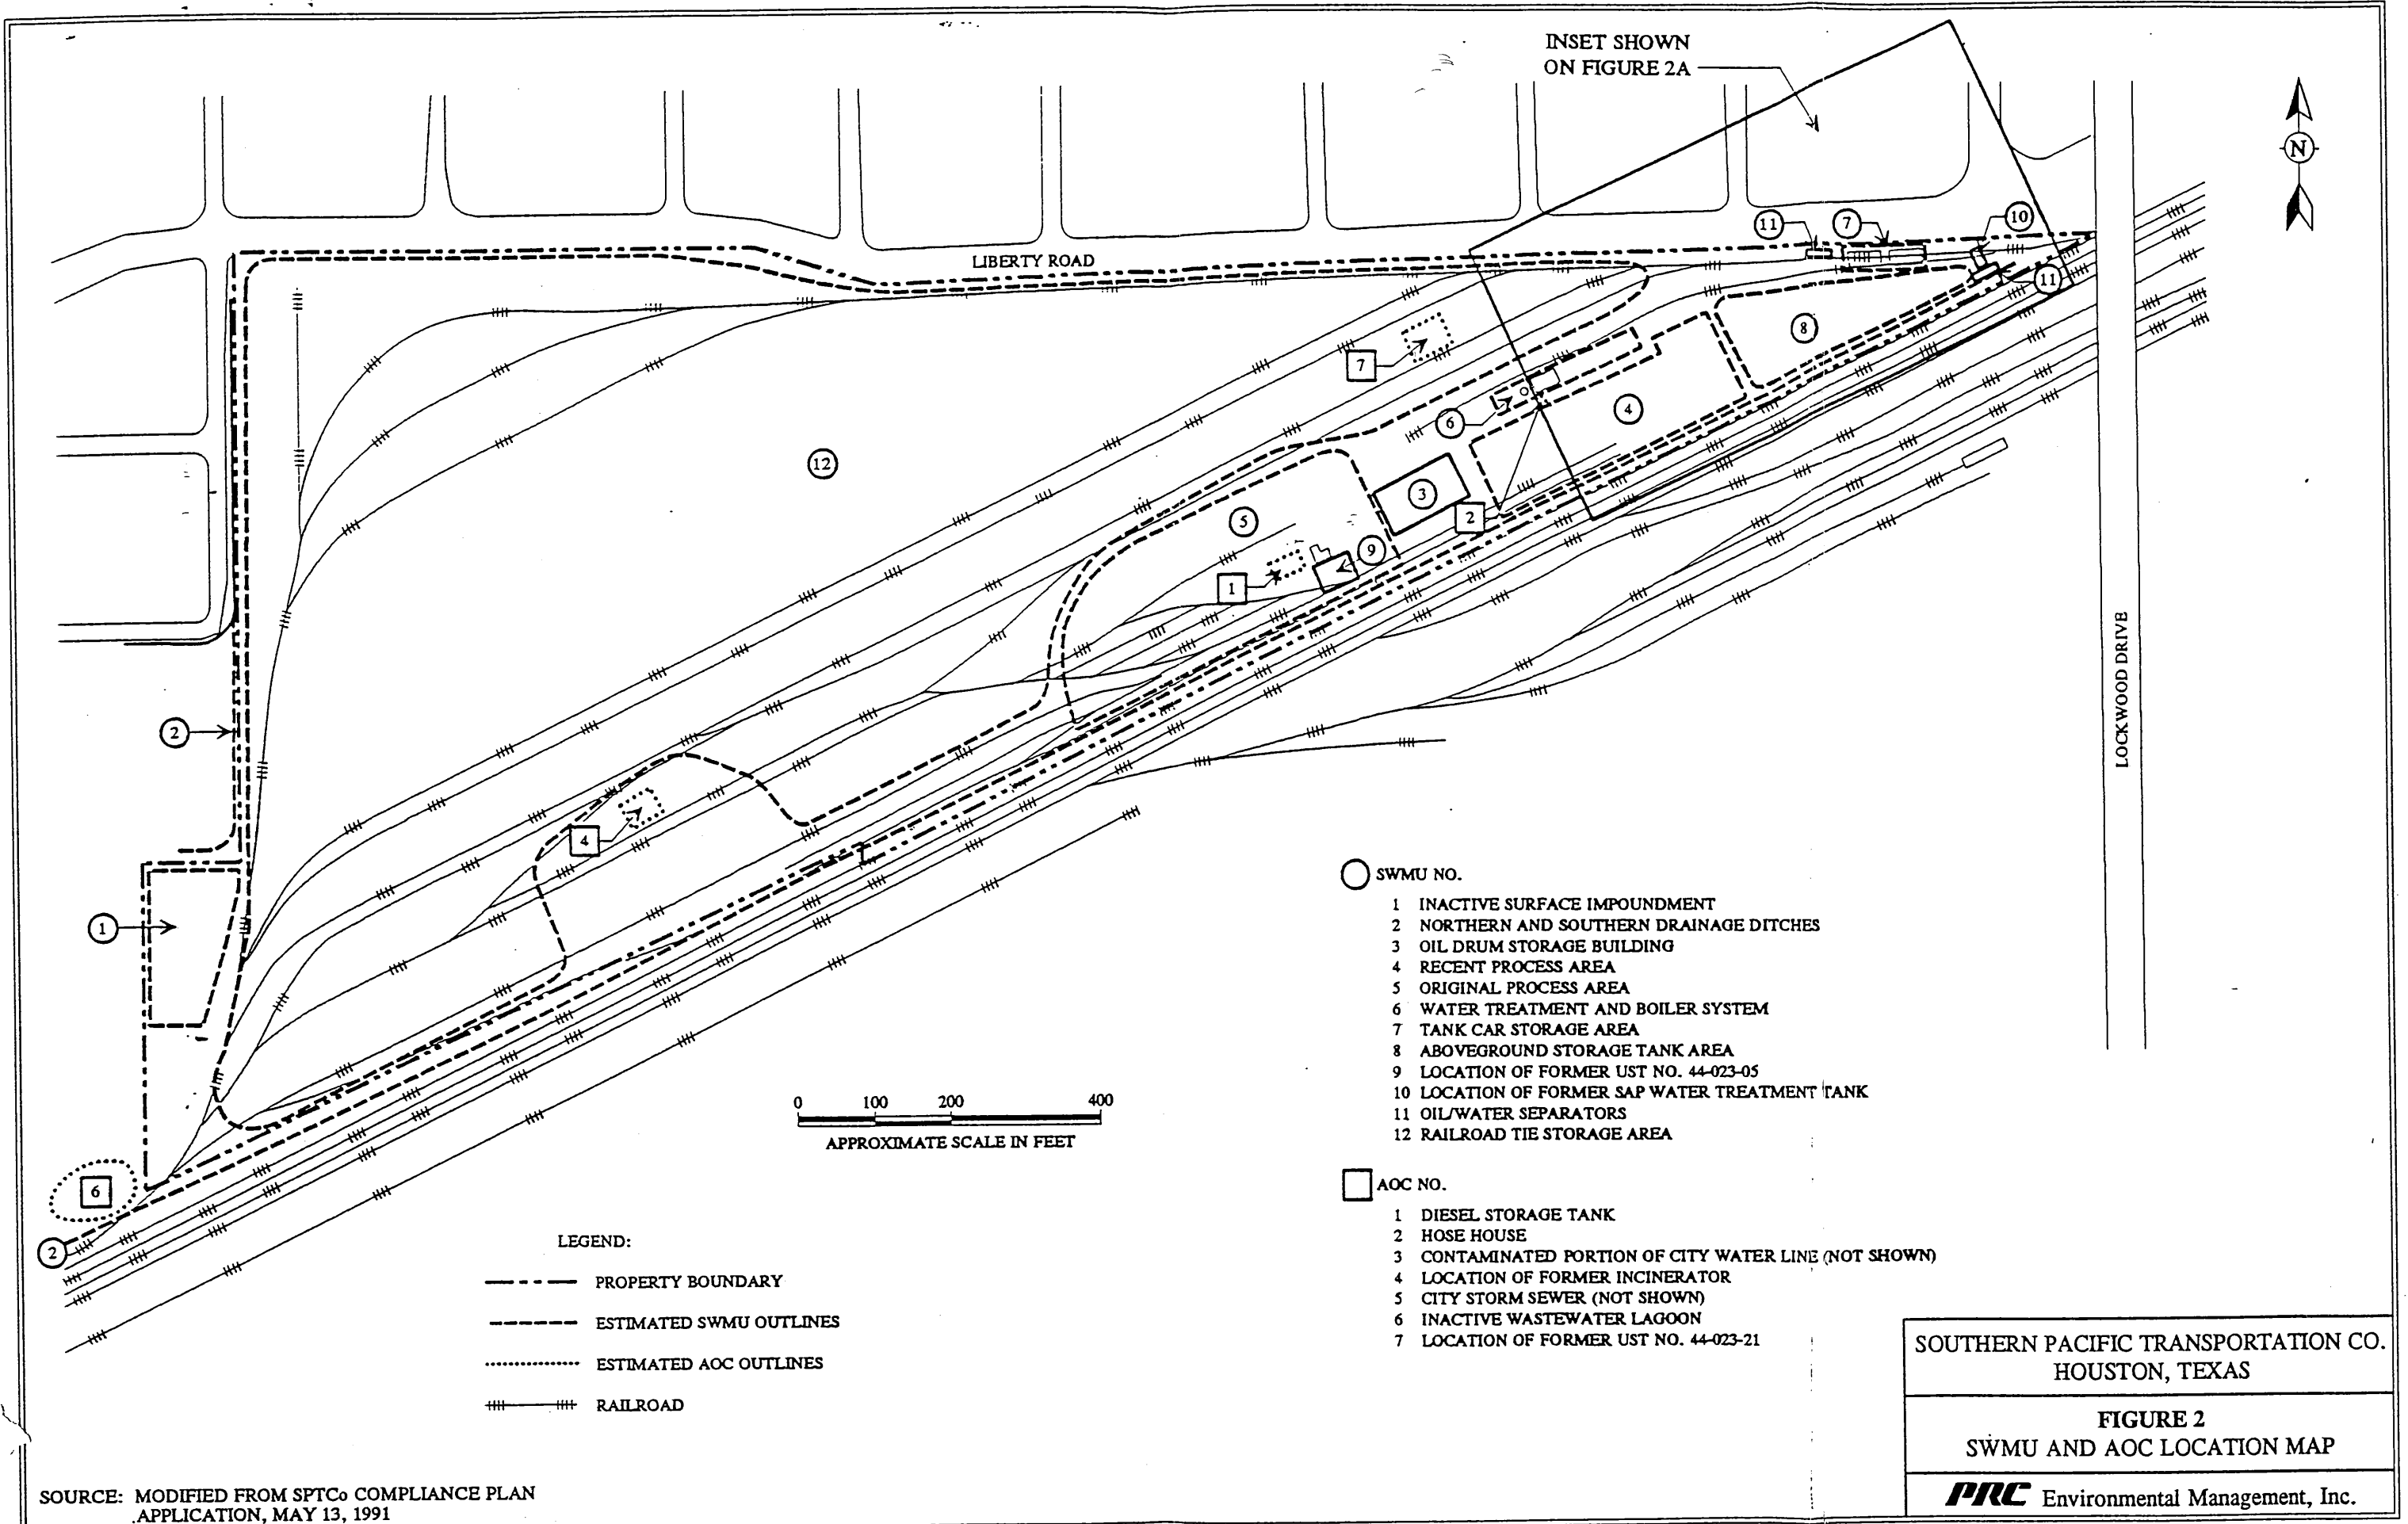
FIGURE 2
SWMU AND AOC LOCATION MAP

As a result of this RFA, 12 SWMU have been identified at the SPTCo site in Houston, Texas. The definition of a SWMU adopted in this RFA reflects current EPA policy, as stated in the RFA guidance document (U.S. EPA, 1986). Table 2 summarizes the regulatory and operating status of all SWMUs identified at the SPTCo facility. Only one RCRA-permitted unit - the inactive surface impoundment (SWMU No. 1) - has been identified at this facility. In addition to the 12 SWMUs, 7 AOCs were identified, based on the VSI and information subsequently received from SPTCo. Table 3 lists the AOCs. Photographs of the SWMUs and AOCs are in the Appendix. SWMU and AOC locations are in Figures 2 and 2a.

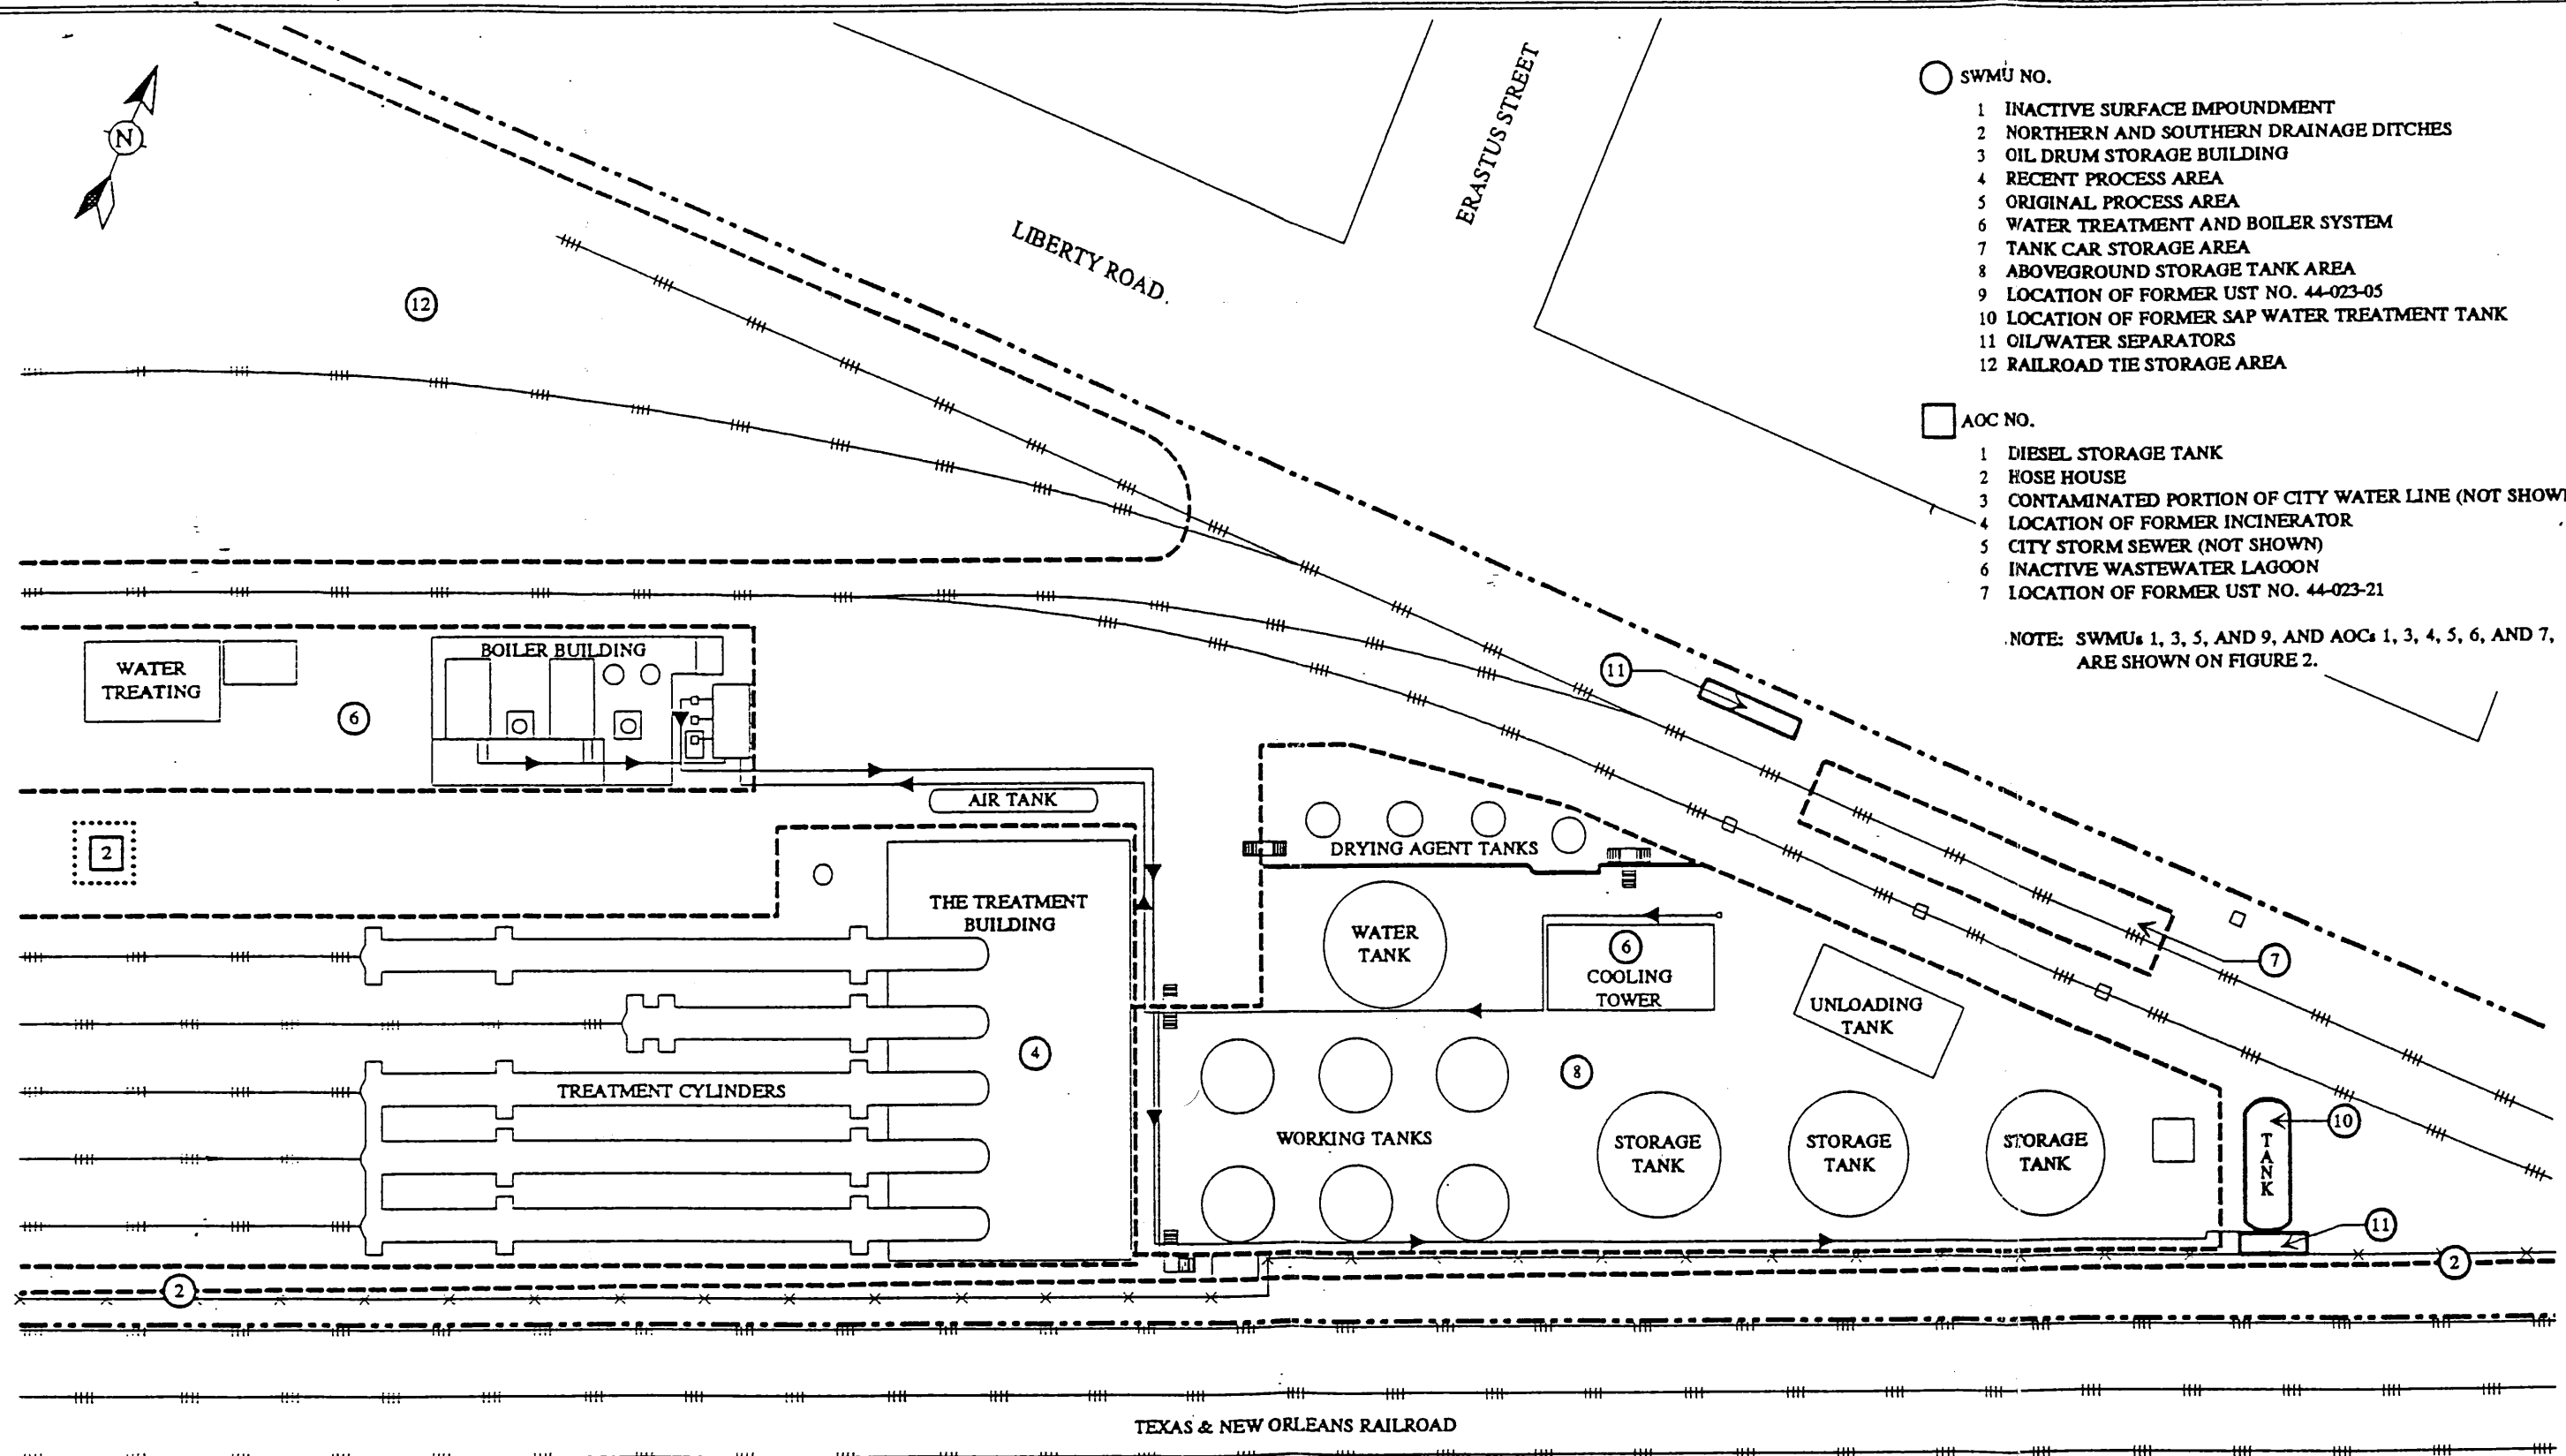
FIGURE 2A
DETAILED SWMU AND AOC LOCATION MAP

NOTE: SWMUs 1, 3, 5, AND 9, AND AOCs 1, 3, 4, 5, 6, AND 7, ARE SHOWN ON FIGURE 2.
