**DEPARTMENT OF NATURAL RESOURCES AND ENVIRONMENTAL CONTROL**

**RCRA CORRECTIVE ACTION  
LONG-TERM STEWARDSHIP INSPECTION**

**FACILITY:** (Former) Atlantic Coast Environmental, Inc.  
225 (State) College Road  
Dover, Delaware 19904

**DATE OF ASSESSMENT:** October 29, 2021

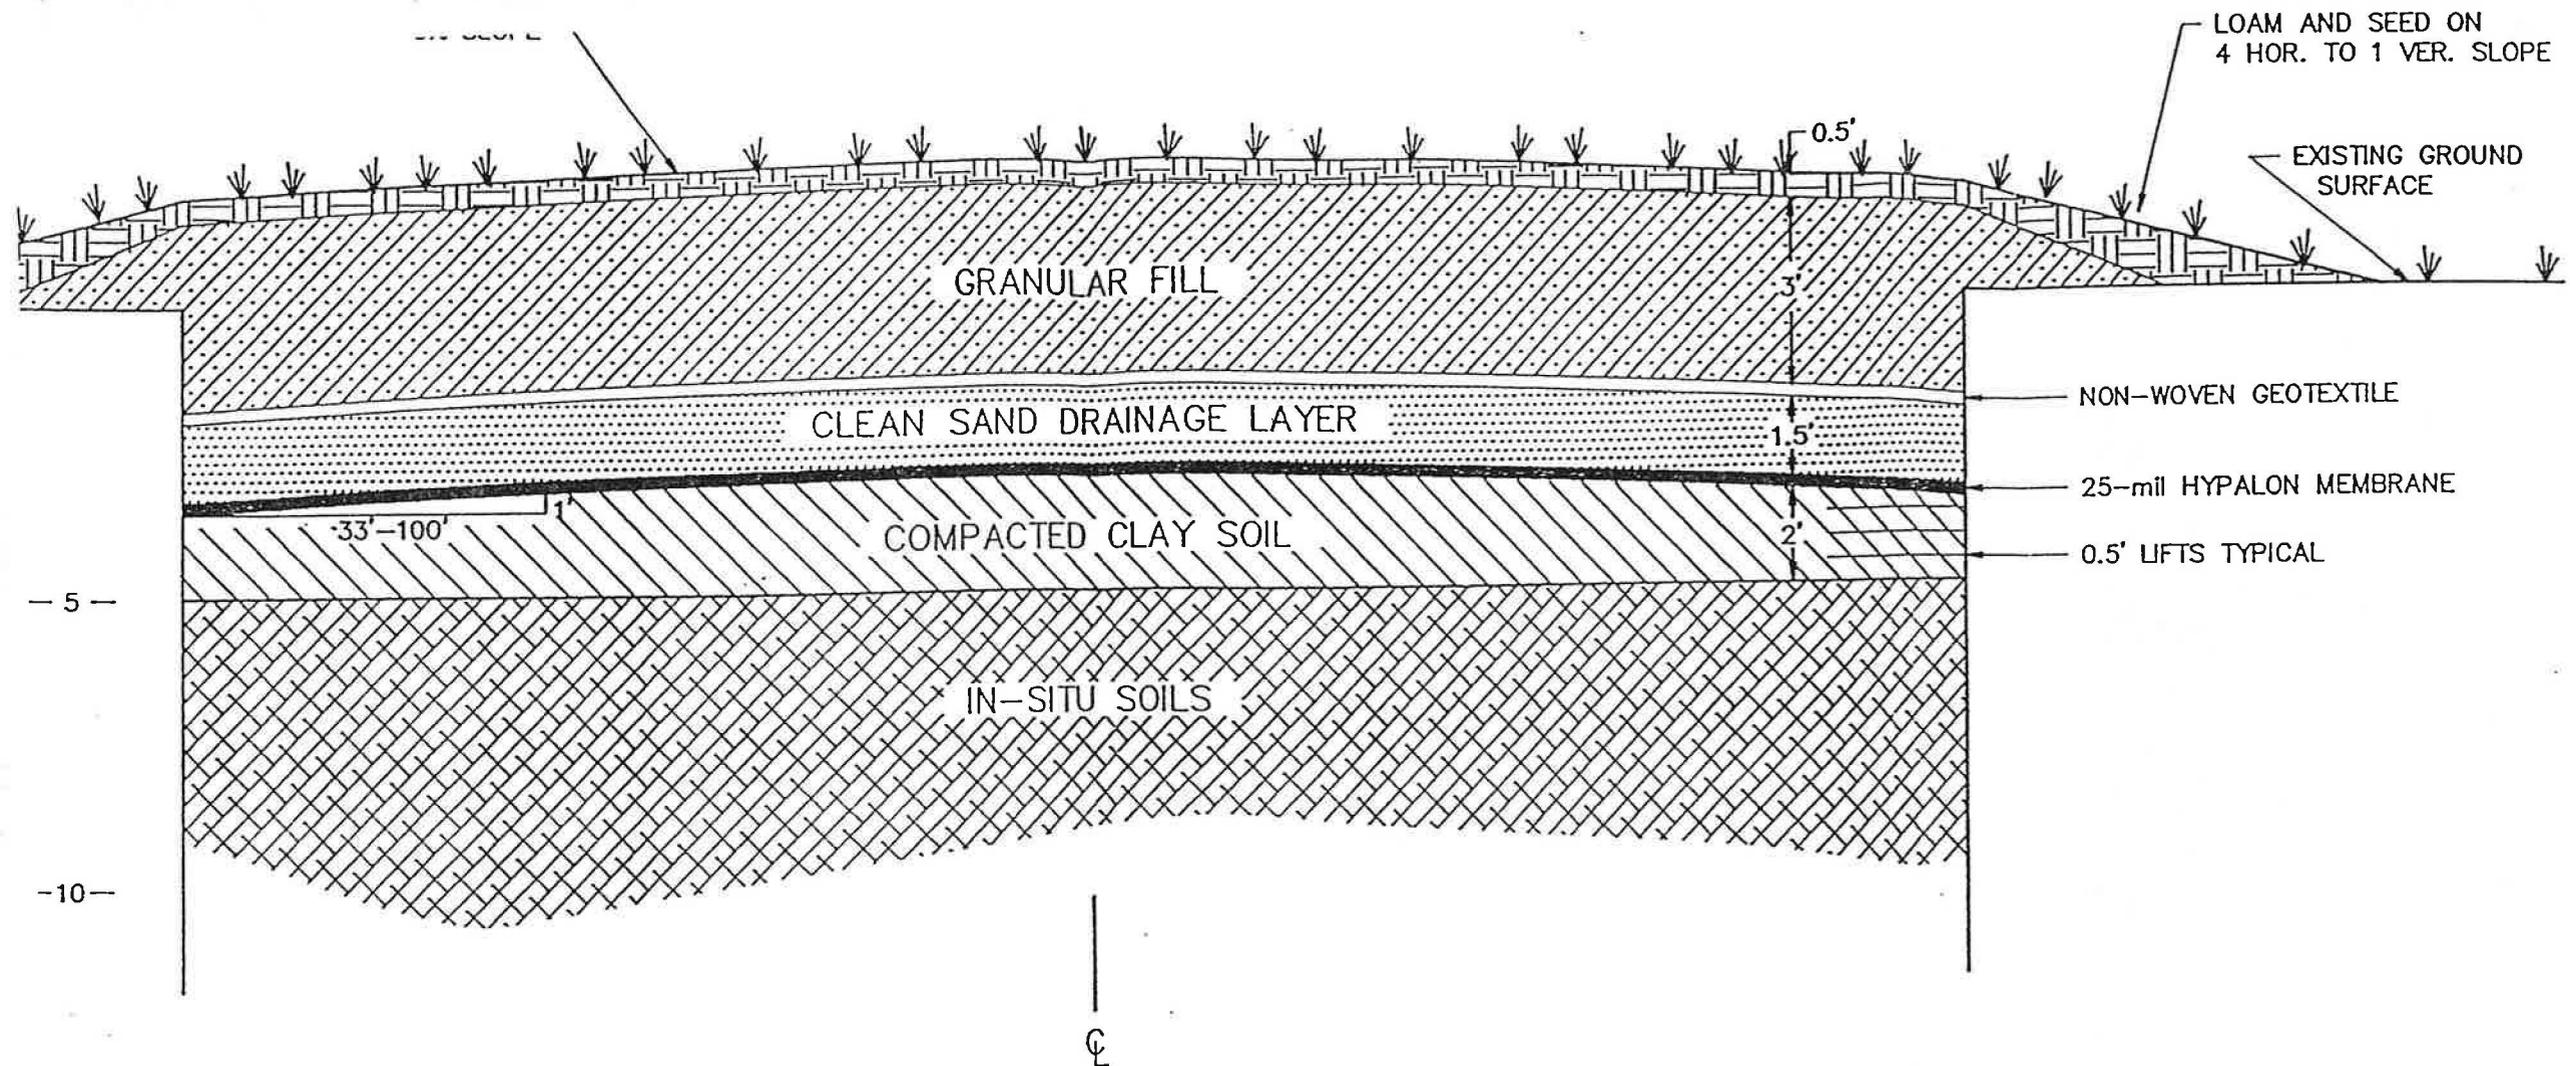
CLIENT:	
			ATLANTIC COAST ENVIRONMENTAL	
			TITLE:	
			WASTE PILE CLOSURE CROSS-SECTION	
DATE:	DRAWN:	CHECKED:	PROJECT:	
5/11/88	D.J.P.	G.M.G.	ACE	
SCALE:	FILE NO.:	YED:	FIGURE NO.:	PROJECT NO.:
NONE	D.J.P.	100%

*An 40-foot by 40-foot cap was constructed at the facility over an area which included the location of the former Waste Pile Storage Unit measuring 20-feet by 40-feet. A 7-foot-thick cap was constructed consisting of a 2.0 foot thickness of compacted clay, a 30 mil Hypalon membrane, non-woven geotextile, an 1.5-foot-thick sand drainage layer, and 3.5 feet of imported backfill. A vegetative cover was established by seeding upon completion of the cap construction. The vegetative cover was observed to be well established during following site visit.*
