U.S. EPA Construction Inspection Training Course

Module 5: 2022 Construction General Permit (CGP)

Site Inspections

Site 1, Part 1

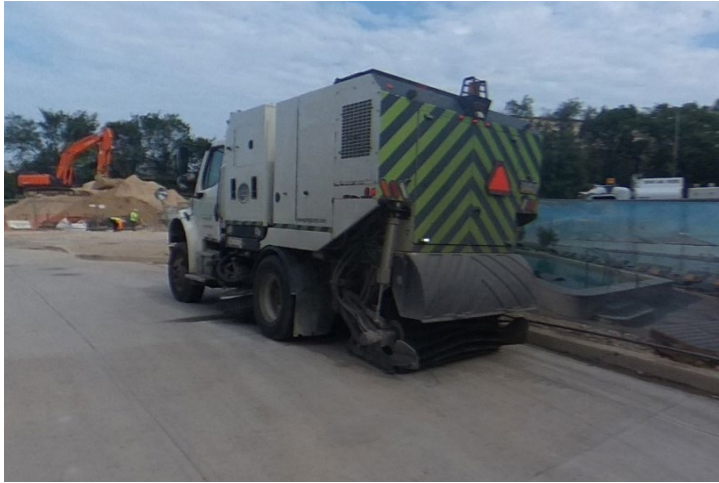
Figure 8-4. Street sweeper on Main Street, near the construction entrance.

It's good to see a street sweeper on this public road because there are many construction vehicles that come and go from the site. Even though the site has a stabilized construction entrance, some sediment inevitably gets tracked out by the frequent trucks moving excavated fill off-site. The operator of this site arranged for a street sweeper to come by this area twice a day to minimize sediment track-out, and it seems to be working well! This part of the street doesn't have any evidence of track-out. If you observe a similar construction entrance scenario at a site you inspect in the future, then you may want to recommend that the operator of the project arrange for a street sweeper to keep adjacent roadways free of sediment.

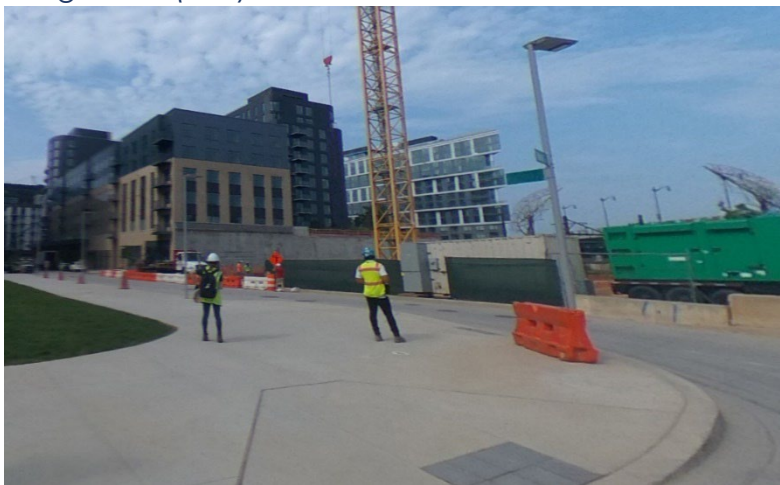
Figure 9-4. View of First Street at the intersection with Main Street.

When you are standing outside of the construction entrance, think about which way stormwater would flow along the ground. It may be a little difficult to tell in this virtual environment, but the road gently slopes down to First Street. During a storm event, this is the direction that stormwater from the site would likely flow. Understanding how stormwater flows on and off a site is important because it can help you determine where pollutants in stormwater originate and where they may end up. It's important to also remember that grading may change as construction progresses, which will impact how stormwater flows. Later in this virtual inspection, you will inspect the curb line and storm drains along First Street for evidence of sediment accumulation. During your own site inspections, it is important to regularly inspect storm drains that may receive stormwater from the site, even if they are outside of the construction area.

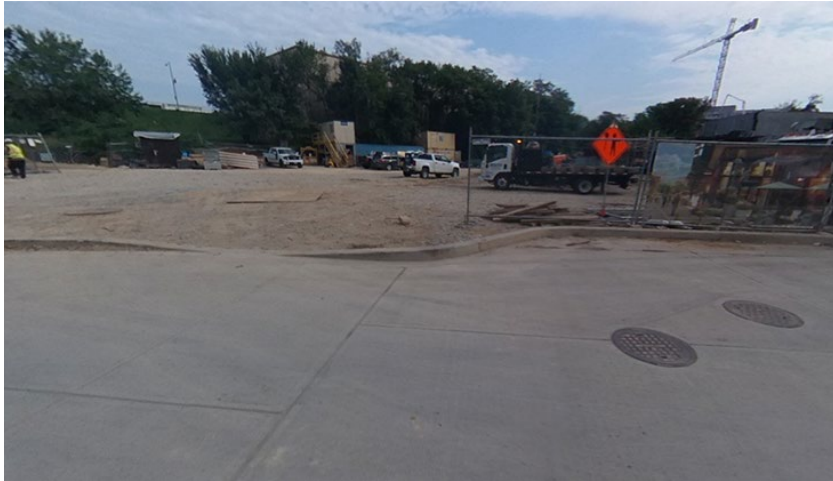
Figure 9-5. View of construction entrance on Main Street.

This section of the construction area's perimeter lacks stormwater controls. It appears that sediment has been tracked out from this location. The operator must install perimeter controls and remove the sediment accumulated in the street. Document this finding in your inspection report. This finding triggers a corrective action because a required control was never installed.

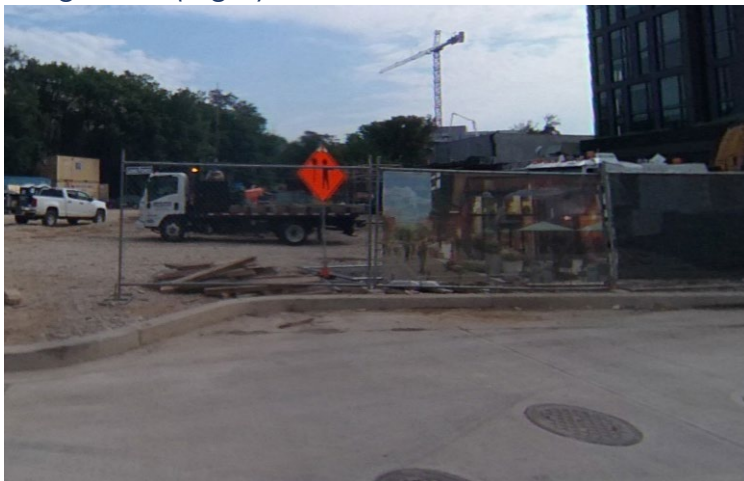
Figure 9-6. The area south of the construction entrance on Main Street.

There is some sediment accumulated in this corner of the curb line. Stormwater flowing down Main Street could push this sediment further down the road toward First Street. Document this accumulated sediment in the inspection report as a finding that requires routine maintenance. Additionally, after the inspection, communicate the finding to the operator so they can remove sediment from this area and dispose of it properly. You should also try to identify where this sediment originally came from and evaluate if additional controls are necessary to prevent further sediment accumulation.

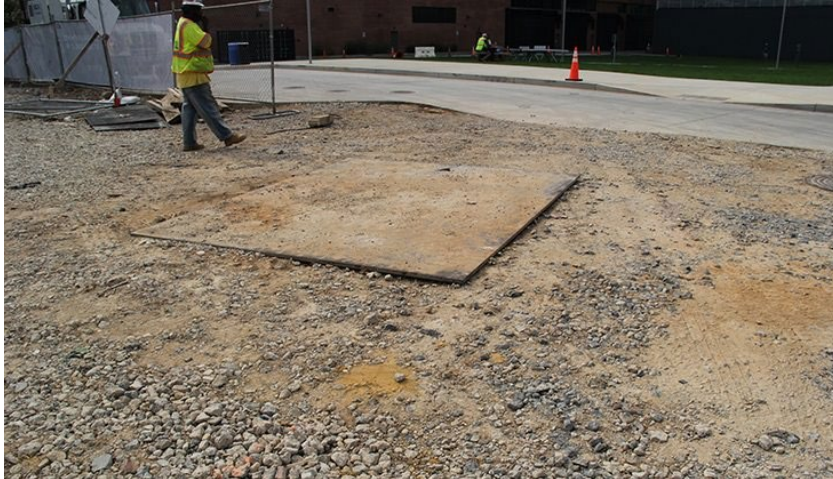
Figure 10-3. Metal plate on the construction entrance that covers buried utilities.

At this site, there is a metal plate in the middle of the site entrance that protects buried utilities. In these situations, make sure the metal plate is secure and covers the entire utilities box.

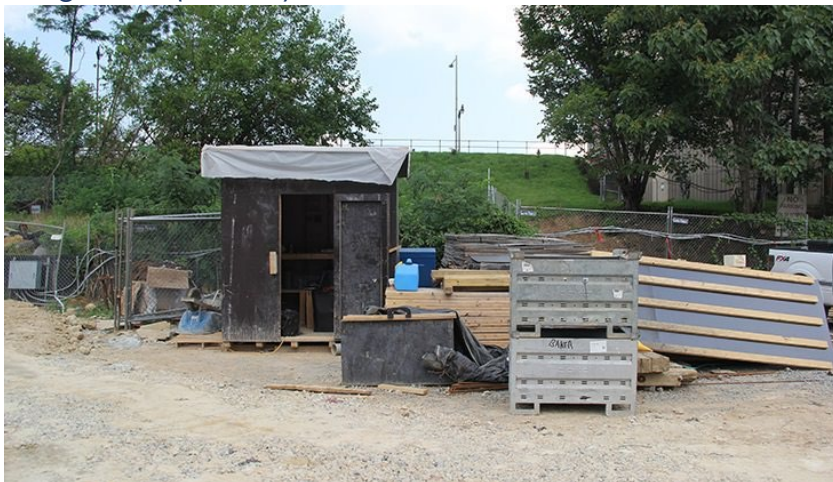
Figure 11-5. View of materials storage area near the entrance to the active construction area.

It is important to be familiar with the site! What is in the storage cabinet? On this site, subcontractors are storing soil core samples.

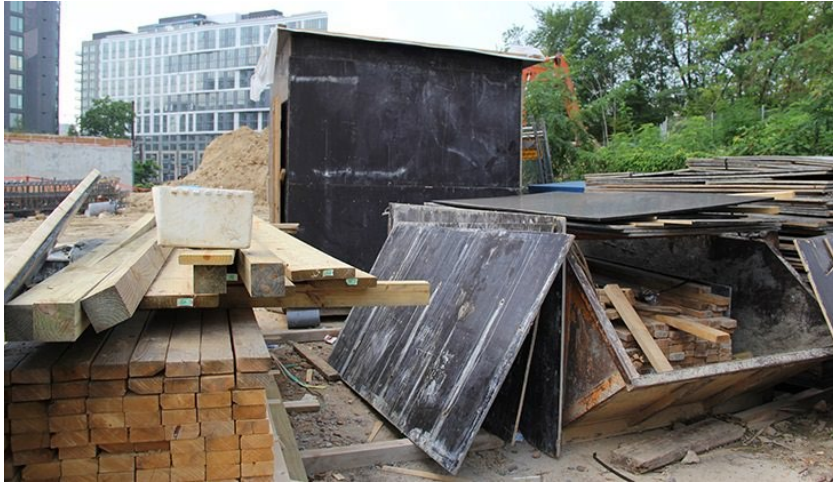
Figure 11-6. View of one side of the materials storage area.

You must make sure to always walk around and through a materials storage area to inspect for potential stormwater pollution issues such as uncovered materials or spills and leaks. These issues may not be visible from far away.

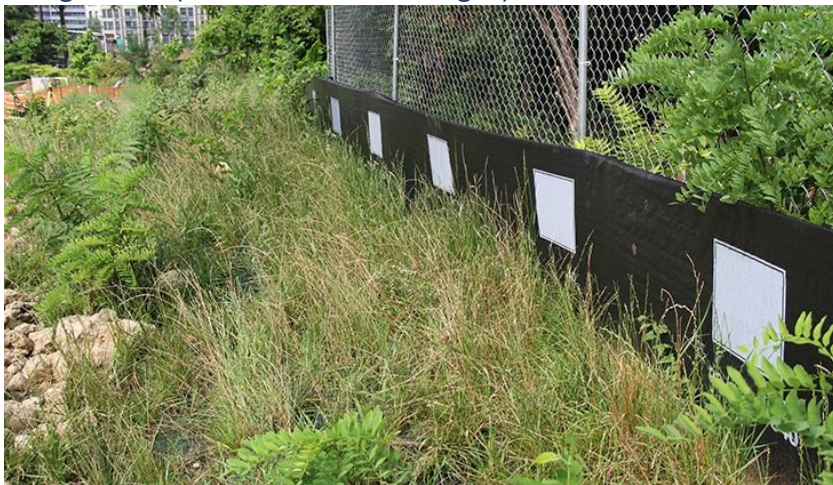
Figure 12-4. View of a section of silt fence along the site perimeter upgradient of the stockpile.

This image shows a view of the super silt fence perimeter control, which is a layer of woven geotextile fabric supported by a layer of chain link fence. For a super silt fence, or any type of perimeter control, you need to check if there is sediment accumulated to higher than one-half the above ground height of the control. You also need to check if the control is damaged or collapsing, or if stormwater is undercutting or circumventing the control. Do not forget to check

This image shows a view of the super silt fence perimeter control. This super silt fence appears to be in good condition—there isn't much sediment accumulated, there are no tears in the fabric, and the fence appears to be entrenched into the ground. However, the super silt fence appears to be installed incorrectly. This perimeter control is intended to reduce run-on, or in other words, to reduce off-site stormwater entering the construction site. The front of the super silt fence, shown here, needs to be installed facing the direction of flow. Therefore, it needs to be facing out, toward the chain link fence. Document this finding in your inspection report and state that a corrective action is triggered because the control was installed incorrectly. You need to discuss this finding with the operator immediately after the inspection so the operator can re-install the silt fence properly. During a typical site inspection, you need to walk along the length of all perimeter controls to assess their condition, but for the sake of time, we won't do that during this virtual inspection.

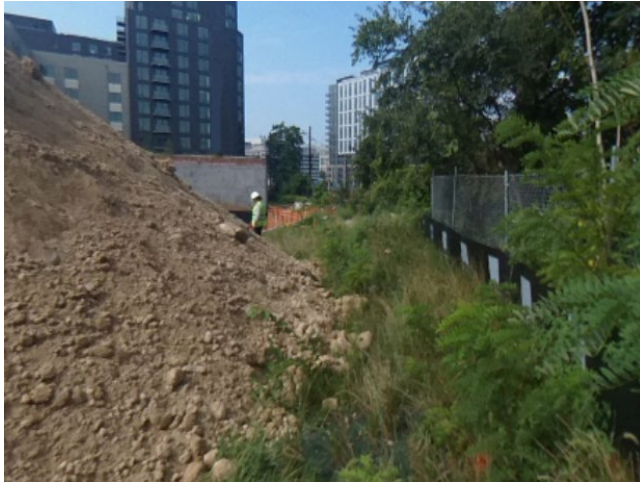
Figure 13-4. View of the soil stockpile and a section of silt fence upgradient of it.

It's good to see that the stockpile is not touching the perimeter control. The space between the stockpile and the perimeter control is stabilized with erosion control matting and vegetation. Although stormwater is flowing on-site in this area, leaving space between the stockpile and silt fence is still a good practice because it helps prevent damage to the silt fence and helps prevent sediment from leaving the site.

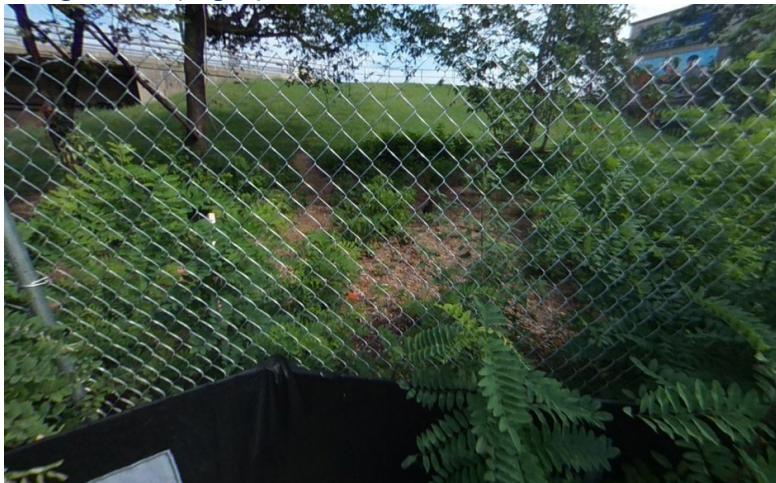
Figure 13-5. View of neighboring property.

In this area, the neighboring property is upgradient of the project site. This section of the silt fence is located further down from the section of silt fence we looked at before. Remember that this is preventing stormwater run-on from contacting the stockpile and the rest of the exposed sediment on-site. Because of this, the fence needs to be installed facing the outside of the site.
