U.S. EPA Construction Inspection Training Course

Module 5: 2022 Construction General Permit (CGP)

Site Inspections

Site 1, Part 2

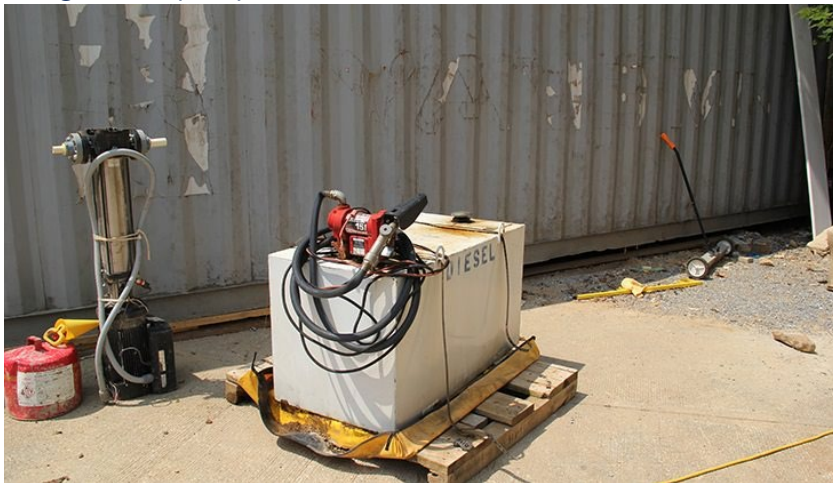
Figure 13-4. Fuel tanks by a trailer near the end of the materials storage area.

Here you see another large fuel tank. According to the SWPPP, this tank is double walled, which satisfies the CGP's secondary containment requirement for fuel containers larger than 55 gallons, which this container seems to be. It's good to see that the fuel tank is sitting on a pallet, which means that during a storm event, it won't come into contact with stormwater flow. The tank also seems to be sitting within a yellow spill containment liner. This liner would not provide adequate containment due to its small size and collapsed sides, but the operator has indicated in their SWPPP that these fuel tanks are double-walled. On their own, double-walled tanks meet the CGP's requirement for secondary containment.

It appears there is also a small red fuel container sitting on the ground beside the trailer. If this container is in use, the operator needs to store it on a spill containment pallet or similar device to capture small leaks or spills. You need to ask the operator if the container is being used. If so, document the lack of controls as findings in your inspection report. The failure to implement required controls would trigger a corrective action.

Remember to always walk all the way around whatever you are inspecting. Now that you're looking at the other side of the fuel tank, you can see that the tank is not placed entirely within the yellow spill containment lining. If this container was not double-walled, any leak from the back left corner would go directly onto the ground. However, this specific tank is double-walled, appears to be in good condition, and the ground appears clean.

Suggested Fix: If the fuel tanks are being used, then provide a spill containment pallet or similar control for containers smaller than 55 gallons, and cover or secondary containment for containers with a capacity of 55 gallons or more to minimize pollutant discharge. Also, update the SWPPP site map to reflect the large fuel storage tank's location.

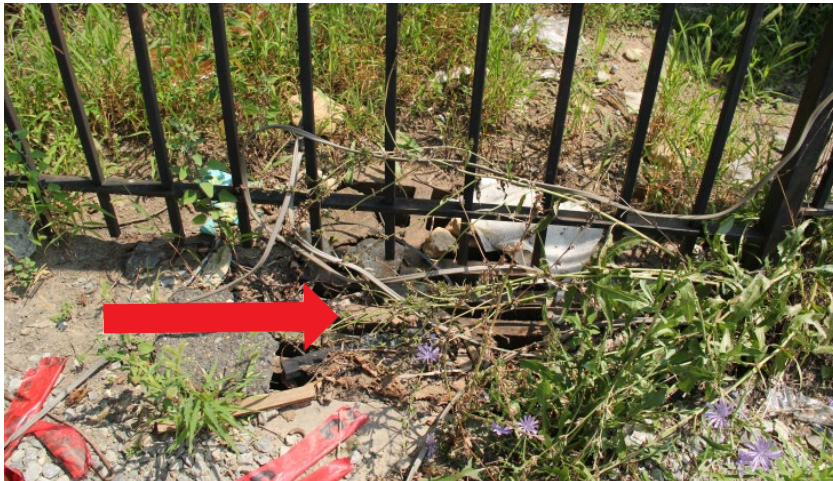
Figure 14-4. View of storm drain at the end of the materials storage area.

Uh oh—this storm drain is on the site plans, but it appears to be neglected. There does not appear to be a stormwater control at the storm drain inlet, although there is one labeled on the site map. Because a required control was never installed, this finding triggers a corrective action. Document this observation in your inspection report, and raise this concern with the operator so they can begin implementing the corrective action immediately after the inspection.

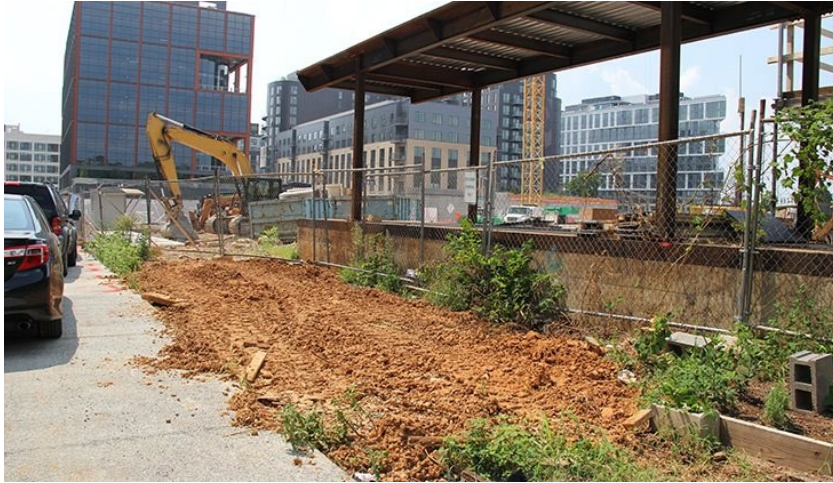
Figure 15-4. View of freshly disturbed area along Second Street.

In this area, you see a freshly disturbed patch of ground outside the site's perimeter controls. You should ask the operator what kind of work is going on here. You need to remind them to stabilize the area within the permit-required timeframes. Due to the lack of a required perimeter control, these findings trigger a corrective action. Document the finding in your inspection report and present it to the operator so they can initiate corrective actions immediately after the inspection.

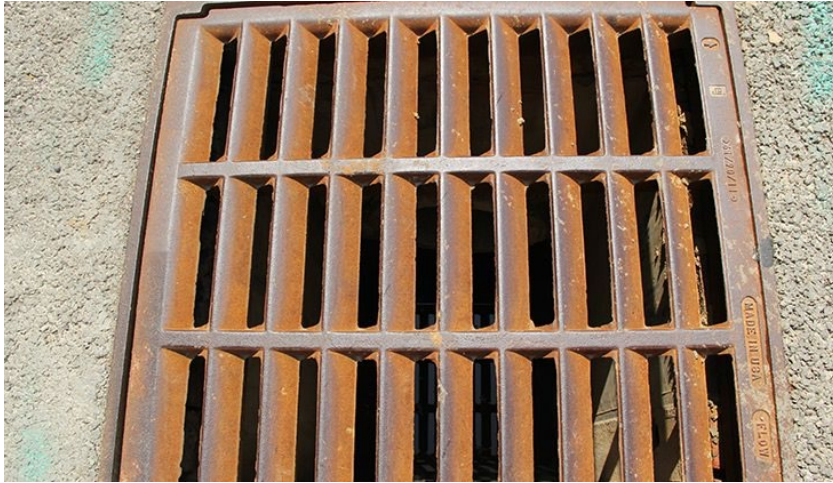
Figure 16-5. Close-up view of storm drain on Second Street.

Here is another storm drain. You must check for debris inside and around the inlet to evaluate if it needs protection measures. There isn't any noticeable sediment or debris; however, the site map states that an inlet protection measure must be installed here. Document this as a finding that triggers a corrective action in your inspection report because a required control was never installed. Raise this concern with the operator so they can begin the corrective action immediately after the inspection.

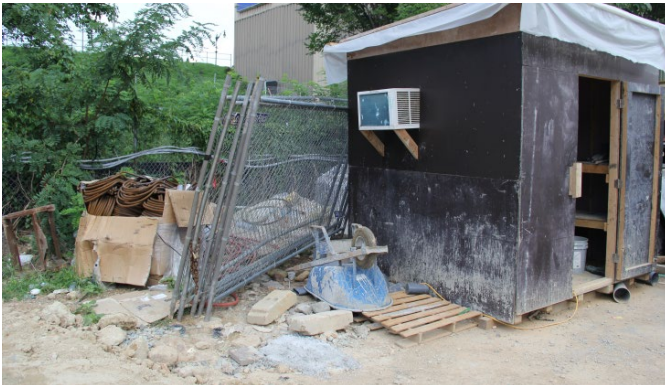
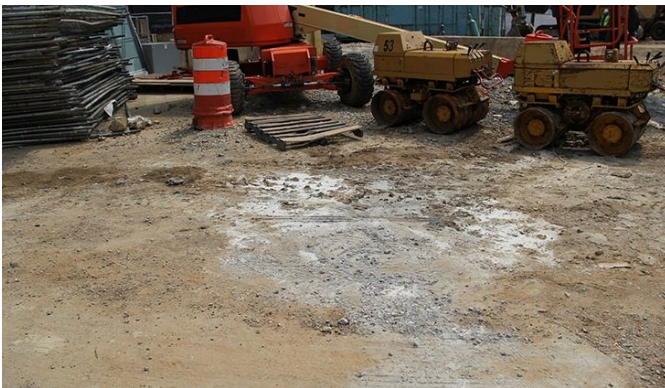
2. No designated concrete washout container, and concrete washout on the ground.

Suggested Fix: Install a concrete washout station, and clean up and properly dispose of the hardened concrete.

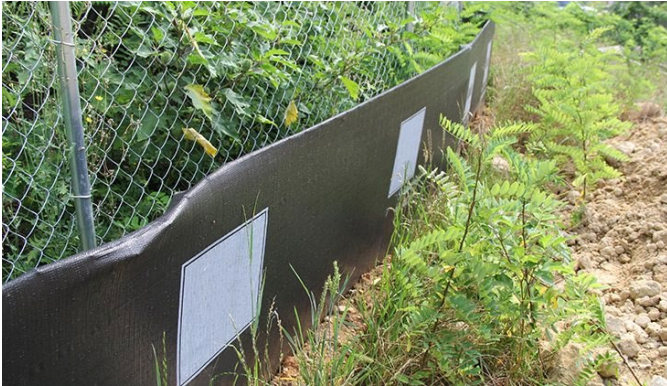
3. Silt fence installed facing the wrong direction upgradient of the stockpile.

Suggested Fix: Reinstall the silt fence facing the correct direction.

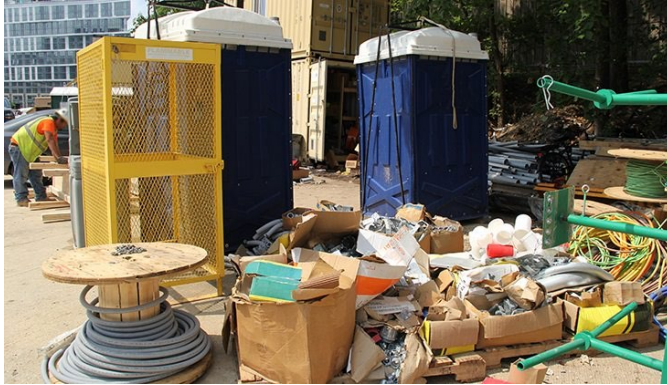
8. *Two occurrences of uncovered materials.*

Suggested Fix: Provide a cover for the sand pile and miscellaneous materials behind the portable toilets, or implement a similarly effective means to minimize the discharge of pollutants.

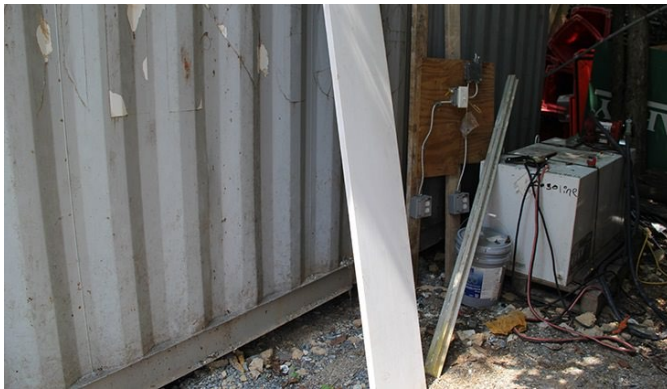
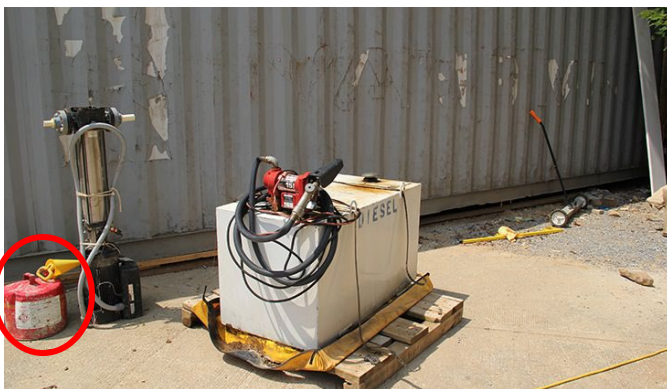
9. Fuel containers with no stormwater controls by a subcontractor trailer.

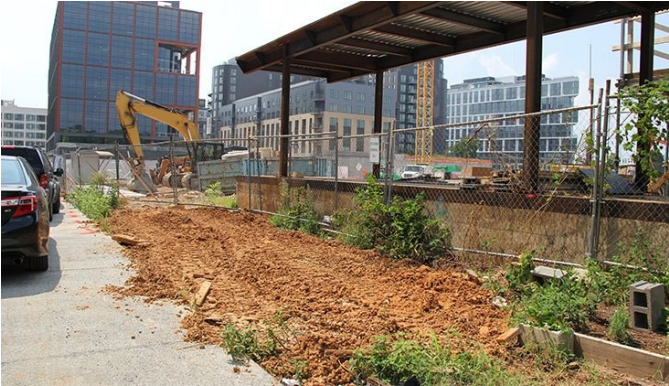
10. A freshly disturbed area with no perimeter controls along Second Street.

Suggested Fix: Install perimeter controls at this location.
