ATTACHMENT NILES-C

File Number: 24TA006	Company Name: ACCEL Schools Ohio, LLC	Company Address, City, State, Zip Code: 45 S Chestnut Avenue, Niles, Ohio 4446
Date of Inspection: April 3, 2024	Inspector-Photographer: Brandon Brewster	Number of Photographs Taken: 49
Camera Used: Canon PowerShot SX740 HS	Digital Recording Media: SD CARD	Notes: All photos date and time stamped, except Photo #1. All photos were taken at Niles Preparatory Academy located at 45 S Chestnut Avenue, Niles, Ohio 44446.

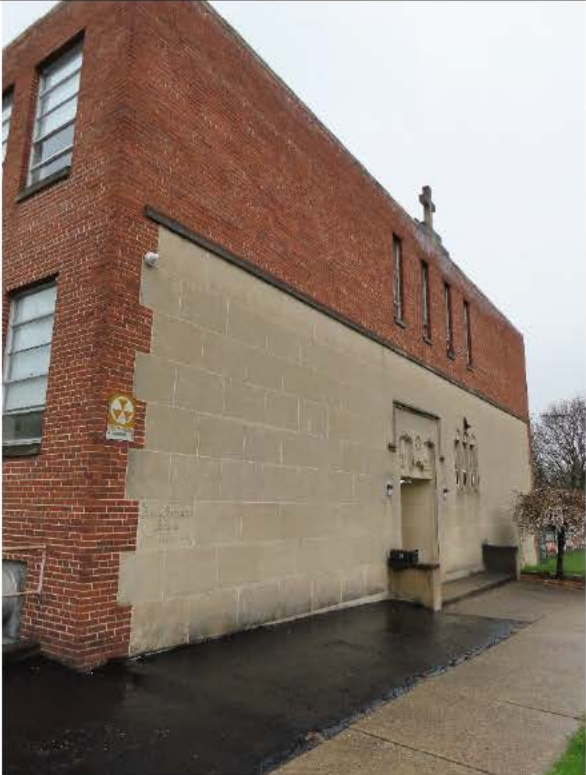
1.	Date Taken: 04/03/2024	Time Taken: 11:05 AM ET

Sample No.: 1-IMG100-0541.JPG		
	Description of Digital Image: Front view of entrance to Niles Preparatory Academy located at 45 S Chestnut Avenue, Niles, Ohio 44446.		
	Modifications: Reduced scale of photo by 50% for the purpose of inspection report.

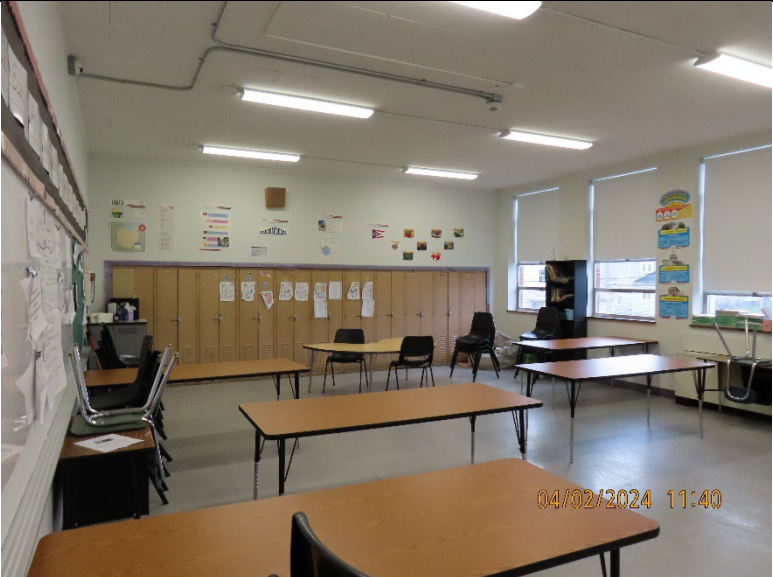
4.	Date Taken: 04/03/2024	Time Taken: 11:40 AM ET

<p>A photograph of Classroom 305, an upper-level classroom. The room features several rows of wooden desks and black chairs. In the background, there are wooden lockers and a whiteboard. The walls are decorated with various educational posters and notices. A timestamp in the bottom right corner of the photo reads "04/02/2024 11:40".</p>
	Sample No.: 4-IMG100-00544.JPG		
	Description of Digital Image: Upper Level – Classroom 305		
	Modifications: Reduced scale of photo by 50% for the purpose of inspection report.

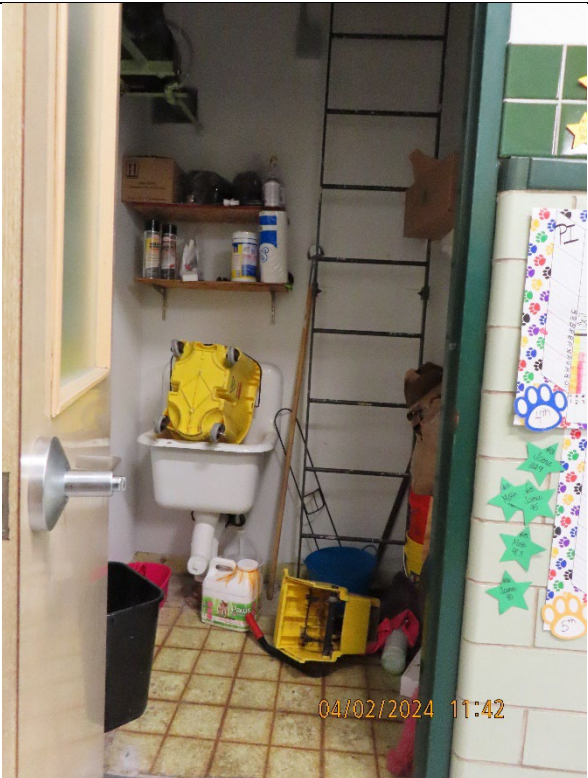
5.	Date Taken: 04/03/2024	Time Taken: 11:42 AM ET

<p>A photograph of a custodial closet. The room has yellow laminated flooring. A white toilet is visible in the center, with a yellow bucket on top. To the right, there is a metal ladder leaning against the wall. On the left, there are shelves with various cleaning supplies. A black trash bin is on the floor. The wall is decorated with colorful stars and paw prints. A timestamp in the bottom right corner of the photo reads "04/02/2024 11:42".</p>
	Sample No.: 5-IMG100-00545.JPG		
	Description of Digital Image: Upper Level – Custodial Closet		
	Modifications: Reduced scale of photo by 50% for the purpose of inspection report.

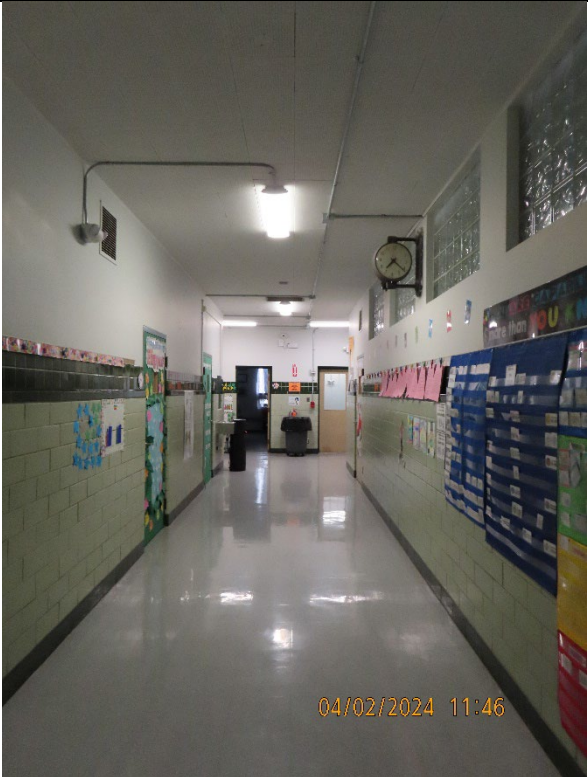
8.	Date Taken: 04/03/2024	Time Taken: 11:46 AM ET

Sample No.: 8-IMG100-00548.JPG		
	Description of Digital Image: Upper Level – Hallway		
	<p>The hallway contained 1x1 acoustical ceiling tile, tiled walls, 12x12 gray floor tile.</p> <p>Modifications: Reduced scale of photo by 50% for the purpose of inspection report.</p>

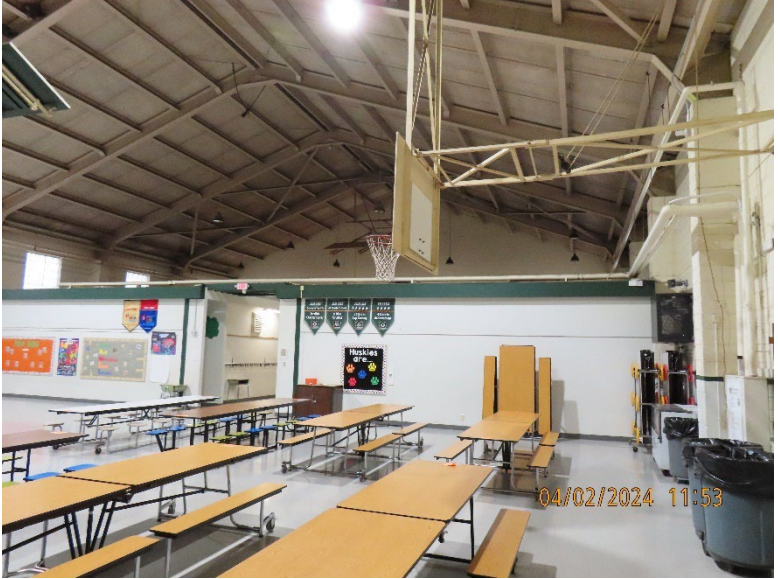
12.	Date Taken: 04/03/2024	Time Taken: 11:53 AM ET

Sample No.: 12-IMG100-00552.JPG		
	Description of Digital Image: Main Level – Gymnasium		
	<p>A large multi-purpose gymnasium located on the Mail level that housed activities for a gym, stage, cafeteria, and four enclosed classrooms. The area shown in the photo has tables set up for school occupants to sit in the gymnasium.</p>		
Modifications: Reduced scale of photo by 50% for the purpose of inspection report.

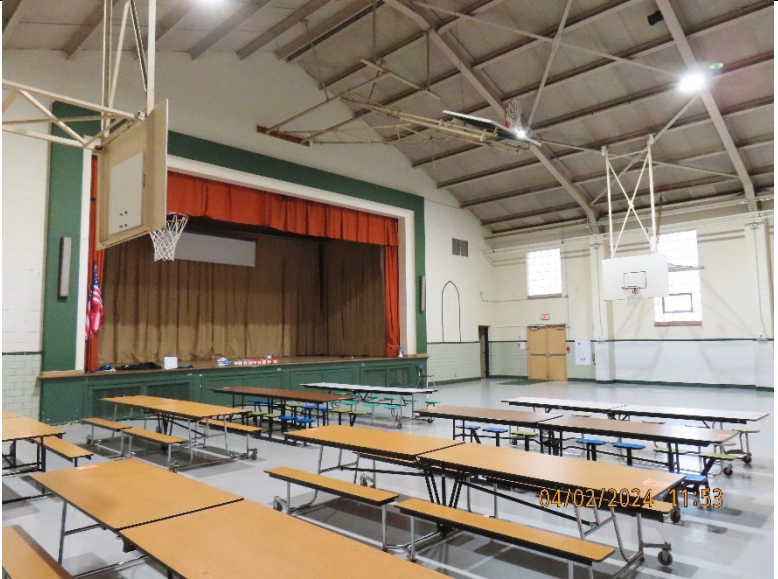
13.	Date Taken: 04/03/2024	Time Taken: 11:53 AM ET

Sample No.: 13-IMG100-00553.JPG		
	Description of Digital Image: Main Level – Gymnasium		
	<p>A large multi-purpose gymnasium located on the Mail level that housed activities for a gym, stage, cafeteria, and four enclosed classrooms. The area shown in the photo is where the stage is located in the northside of the gymnasium.</p>		
Modifications: Reduced scale of photo by 50% for the purpose of inspection report.

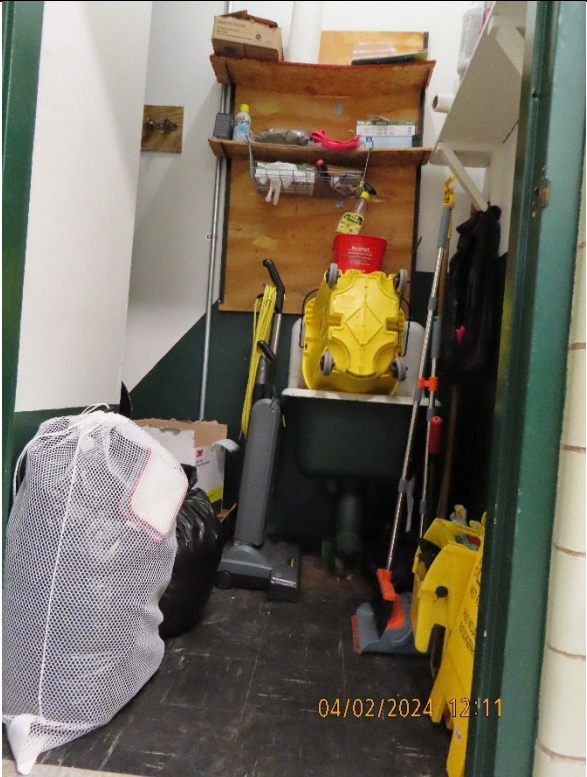
25.	Date Taken: 04/03/2024	Time Taken: 12:11 PM ET

Sample No.: 25-IMG100-00565.JPG		
	Description of Digital Image: Main Level – Custodial Closet		
	<p>A custodial closet located across classroom 200 stored various cleaning items, and contained brown and white-striped 9x9 floor tile.</p>		
Modifications: Reduced scale of photo by 50% for the purpose of inspection report.

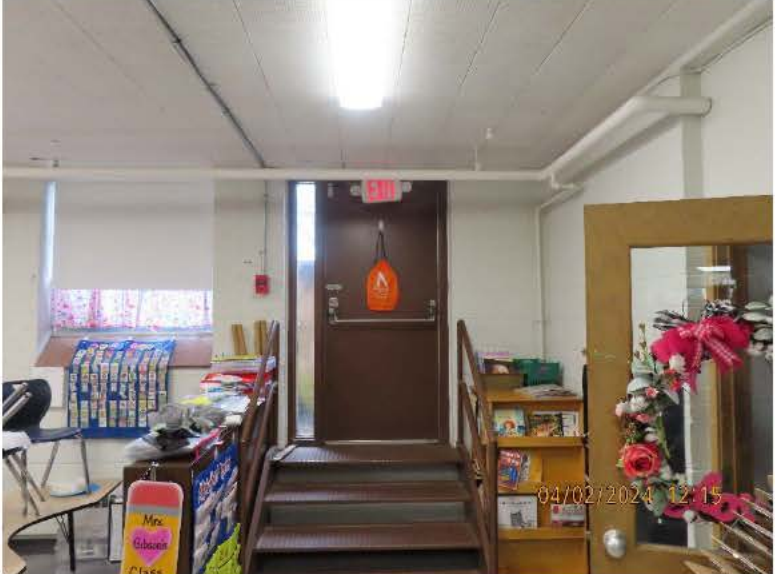
27.	Date Taken: 04/03/2024	Time Taken: 12:15 PM ET

Sample No.: 27-IMG100-00567.JPG		
	Description of Digital Image: Lower Level – Classroom 100		
	The classroom contained 1x1 acoustical ceiling tile, 12x12 gray floor tile, and pipe insulation attached to the ceiling and surrounding the classroom.		
Modifications: Reduced scale of photo by 50% for the purpose of inspection report.

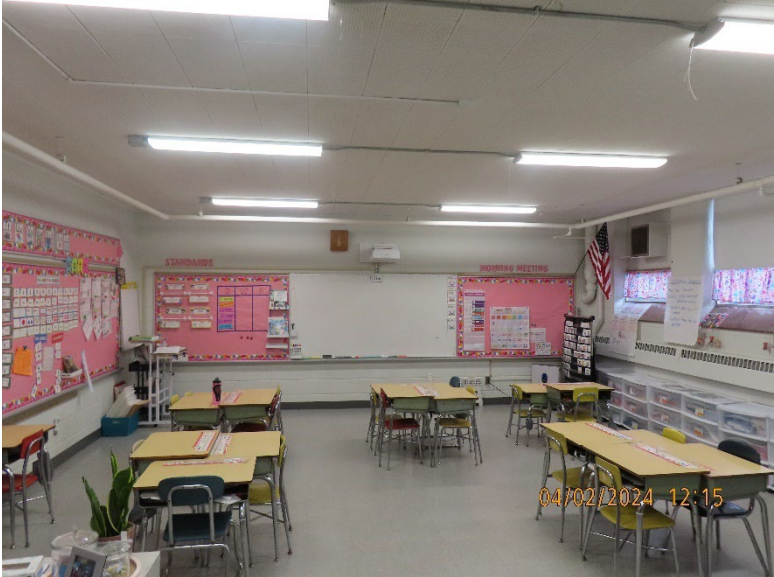
28.	Date Taken: 04/03/2024	Time Taken: 12:15 PM ET

Sample No.: 28-IMG100-00568.JPG		
	Description of Digital Image: Lower Level – Classroom 100		
<p>The classroom contained 1x1 acoustical ceiling tile, 12x12 gray floor tile, and pipe insulation attached to the ceiling and surrounding the classroom.</p>			
<p>Modifications: Reduced scale of photo by 50% for the purpose of inspection report.</p>

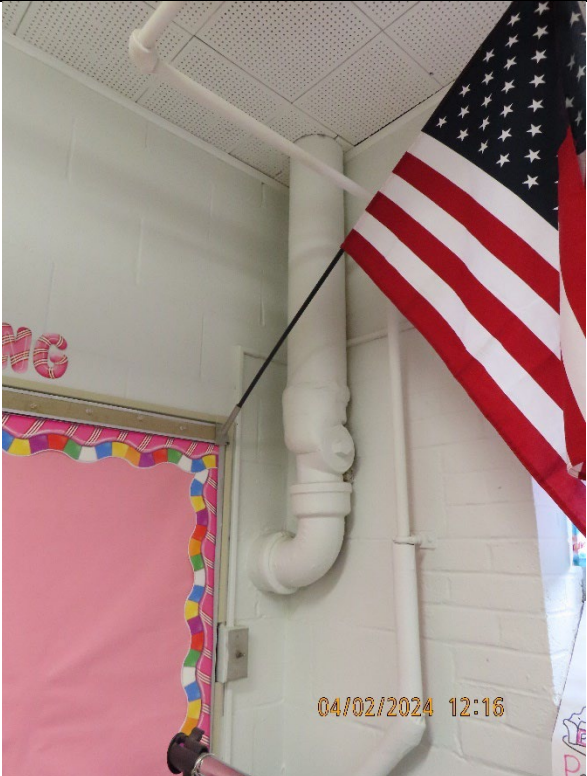
29.	Date Taken: 04/03/2024	Time Taken: 12:16 PM ET

Sample No.: 29-IMG100-00569.JPG		
	Description of Digital Image: Lower Level – Classroom 100		
<p>The classroom contained 1x1 acoustical ceiling tile, 12x12 gray floor tile, and pipe insulation attached to the ceiling and surrounding the classroom.</p>			
<p>Modifications: Reduced scale of photo by 50% for the purpose of inspection report.</p>

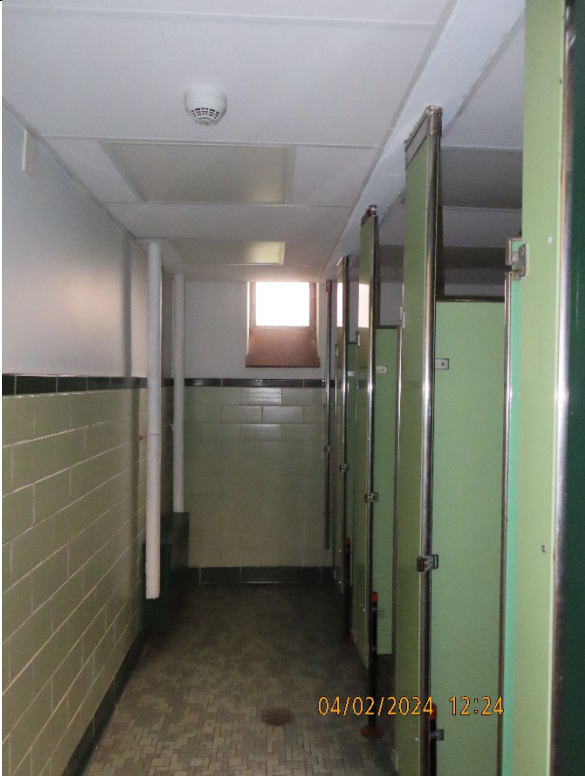
37.	Date Taken: 04/03/2024	Time Taken: 12:24 PM ET

Sample No.: 37-IMG100-00577.JPG		
	Description of Digital Image: Lower Level – Boys and Girls Bathroom		
	<p>The boys and girls bathroom contained insulated pipe risers from the heat exchanger box.</p>		
Modifications: Reduced scale of photo by 50% for the purpose of inspection report.

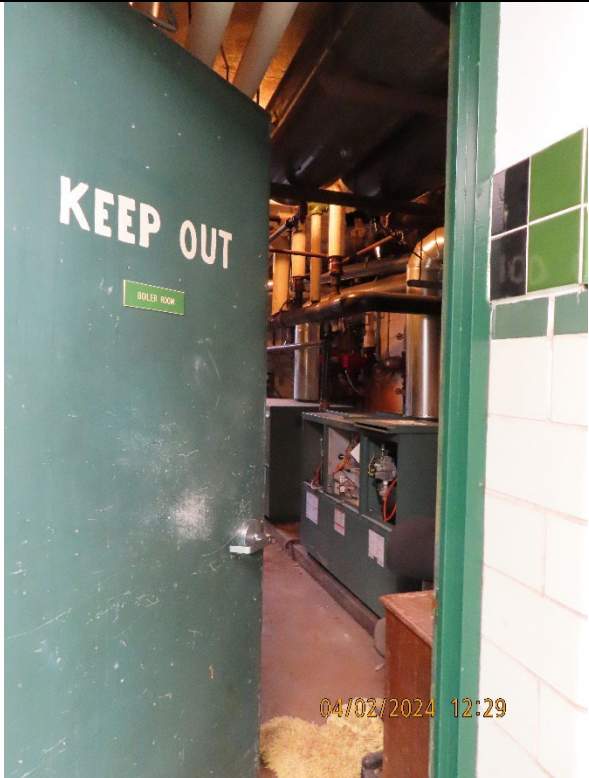
38.	Date Taken: 04/03/2024	Time Taken: 12:29 PM ET

Sample No.: 38-IMG100-00578.JPG		
	Description of Digital Image: Lower Level – Boiler Room		
	<p>The boiler room entrance door is identified as a “Fyrgard” fire door by The Richmond Fireproof Door Co.</p> <p>Modifications: Reduced scale of photo by 50% for the purpose of inspection report.</p>

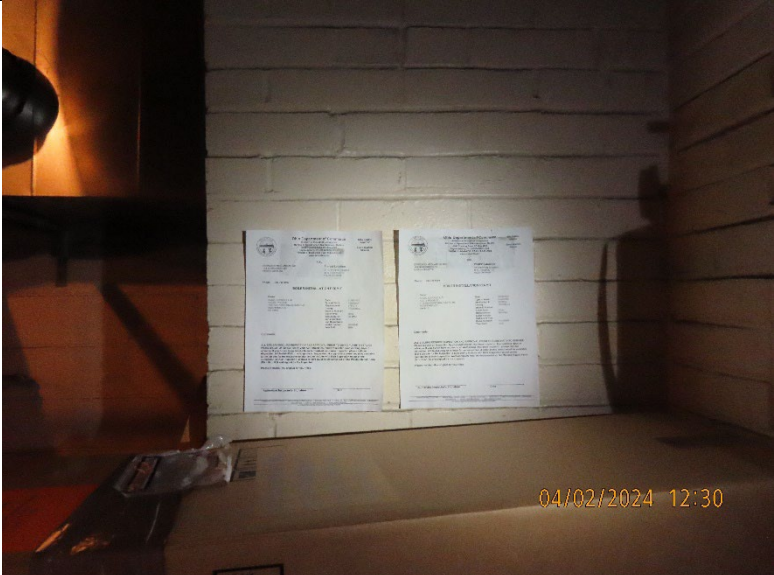
39.	Date Taken: 04/03/2024	Time Taken: 12:30 PM ET

Sample No.: 39-IMG100-00579.JPG		
	Description of Digital Image: Lower Level – Boiler Room		
	<p>Immediately to the right side of the entrance boiler room were two boiler permits stating that the boiler had been installed on January 8, 2021.</p> <p>Modifications: Reduced scale of photo by 50% for the purpose of inspection report.</p>

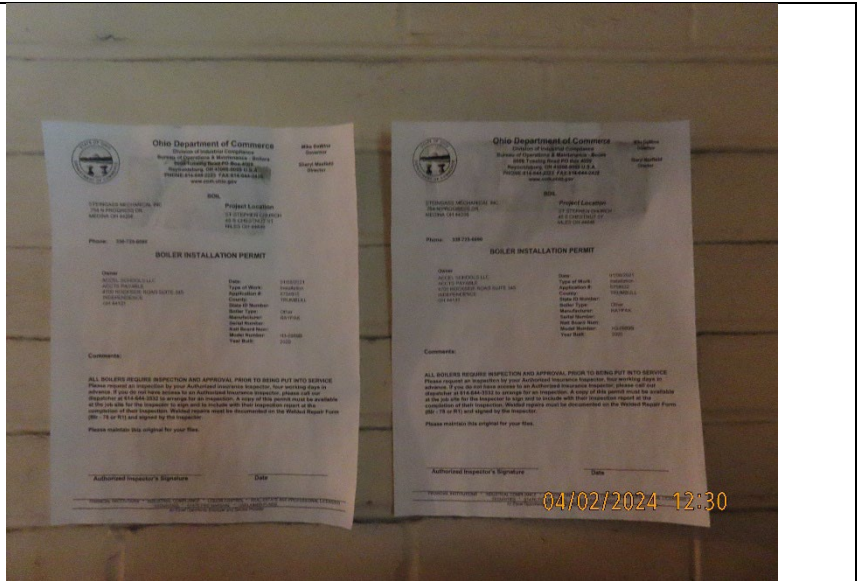
40.	Date Taken: 04/03/2024	Time Taken: 12:30 PM ET
	Sample No.: 40-IMG100-00580.JPG	
	Description of Digital Image: Lower Level – Boiler Room	
<p>Immediately to the right side of the entrance boiler room were two boiler permits stating that the boiler had been installed on January 8, 2021.</p>		
<p>Modifications: Reduced scale of photo by 50% for the purpose of inspection report.</p>

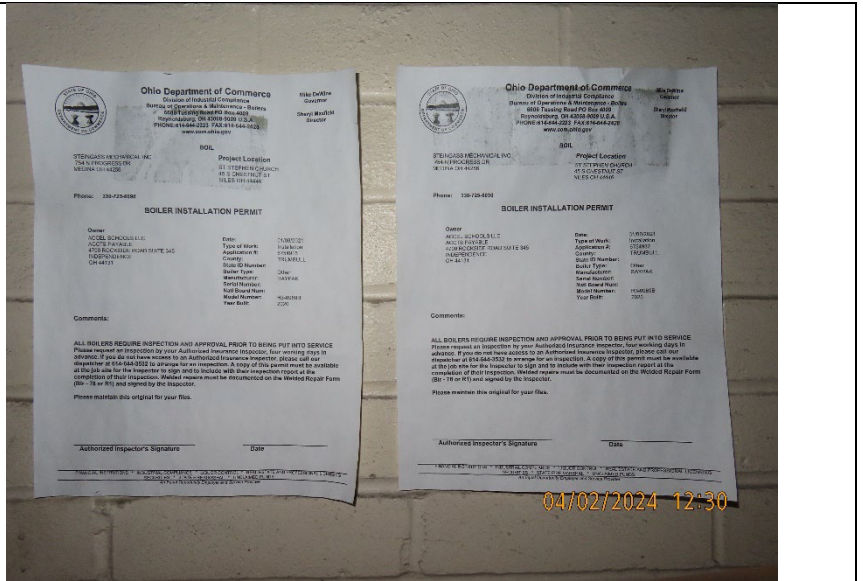
41.	Date Taken: 04/03/2024	Time Taken: 12:30 PM ET
	Sample No.: 41-IMG100-00581.JPG	
	Description of Digital Image: Lower Level – Boiler Room	
<p>Immediately to the right side of the entrance boiler room were two boiler permits stating that the boiler had been installed on January 8, 2021.</p>		
<p>Modifications: Reduced scale of photo by 50% for the purpose of inspection report.</p>

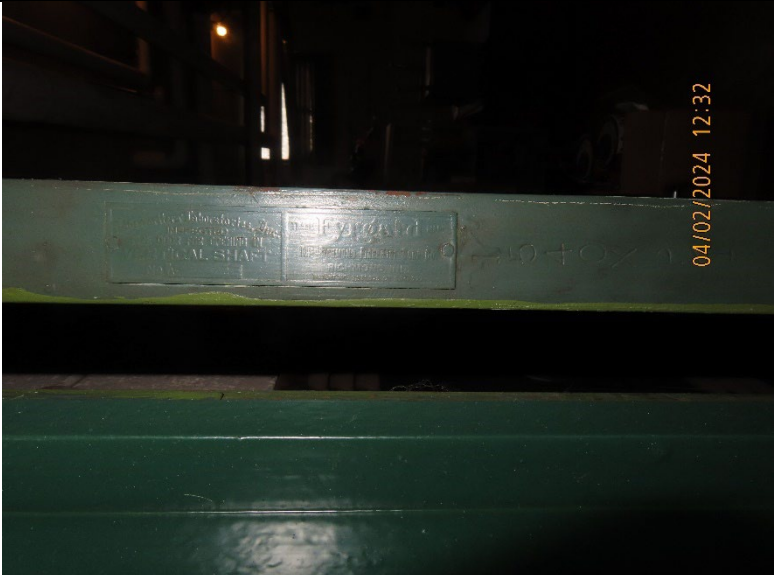
42.	Date Taken: 04/03/2024	Time Taken: 12:32 PM ET

Sample No.: 42-IMG100-00582.JPG		
	Description of Digital Image: Lower Level – Boiler Room		
	<p>The boiler room entrance door is identified as a “Fyrgard” fire door by The Richmond Fireproof Door Co.</p>		
Modifications: Reduced scale of photo by 50% for the purpose of inspection report.

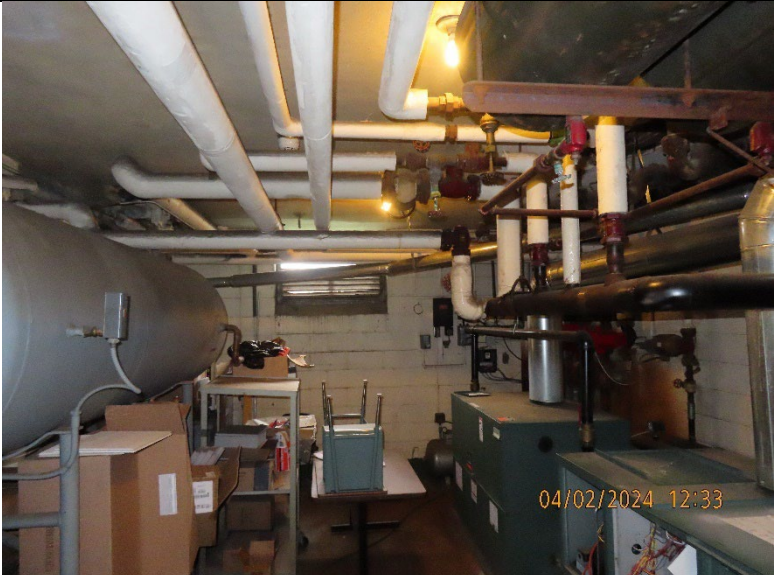
43.	Date Taken: 04/03/2024	Time Taken: 12:33 PM ET

Sample No.: 43-IMG100-00583.JPG		
	Description of Digital Image: Lower Level – Boiler Room		
	<p>The boiler room contained a new boiler system and other stored custodial equipment.</p>		
Modifications: Reduced scale of photo by 50% for the purpose of inspection report.

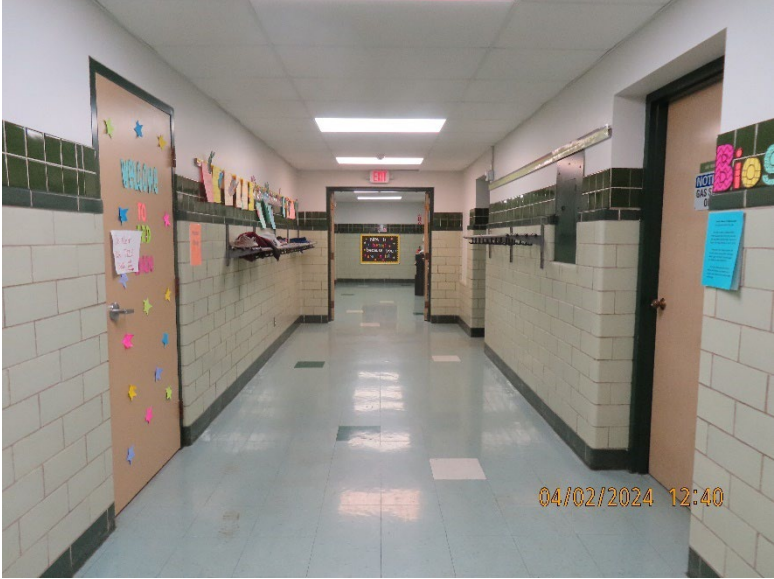
48.	Date Taken: 04/03/2024	Time Taken: 12:40 PM ET

Sample No.: 48-IMG100-00588.JPG		
	Description of Digital Image: Lower Level – Hallway		
	<p>The Lower Level’s hallway contained different ceiling tiles and floor tiles compared to the hallways in the Upper Level and Main Level. The Lower Level’s hallway had drop-down ceiling tiles and light blue floor tiles.</p>		
Modifications: Reduced scale of photo by 50% for the purpose of inspection report.

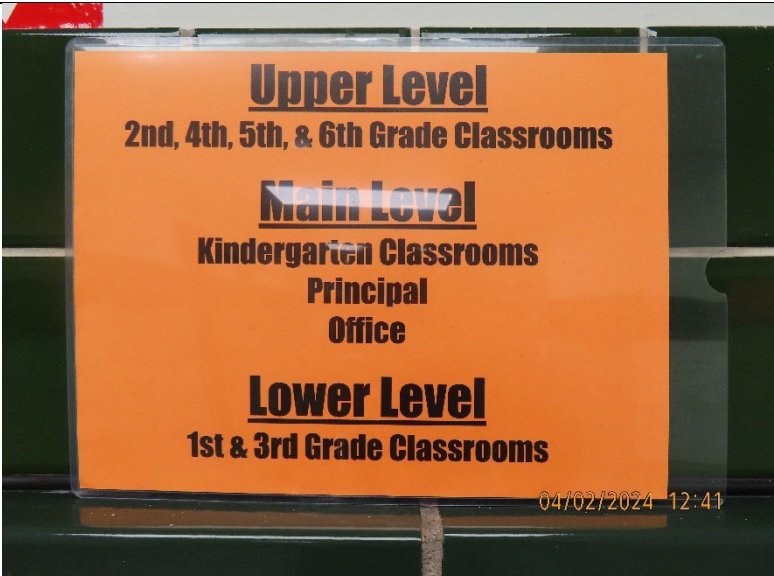
49.	Date Taken: 04/03/2024	Time Taken: 12:41 PM ET

Sample No.: 41-IMG100-00589.JPG		
	Description of Digital Image: Lower Level – Hallway		
	<p>A sign posted in the hallway identifying which level each grade level is housed in the school building.</p>		
Modifications: Reduced scale of photo by 50% for the purpose of inspection report.
