YAE - ATTACHMENT B

File Number: 24TA002	LEA Name: ACCEL Charter Schools	LEA Address, City, State, Zip Code:
School Name: Youngstown Academy of Excellence	School Address: 1408 Rigby Street Youngstown, Ohio 44506	1650 Tysons Boulevard, Suite 600 McLean, Virginia 22102
Date of Inspection: 4/2/2024 to 4/3/2024	Inspector Names: Michael Todd, Christina Saldivar and Brandon Brewster	Number of Photographs Taken: 67

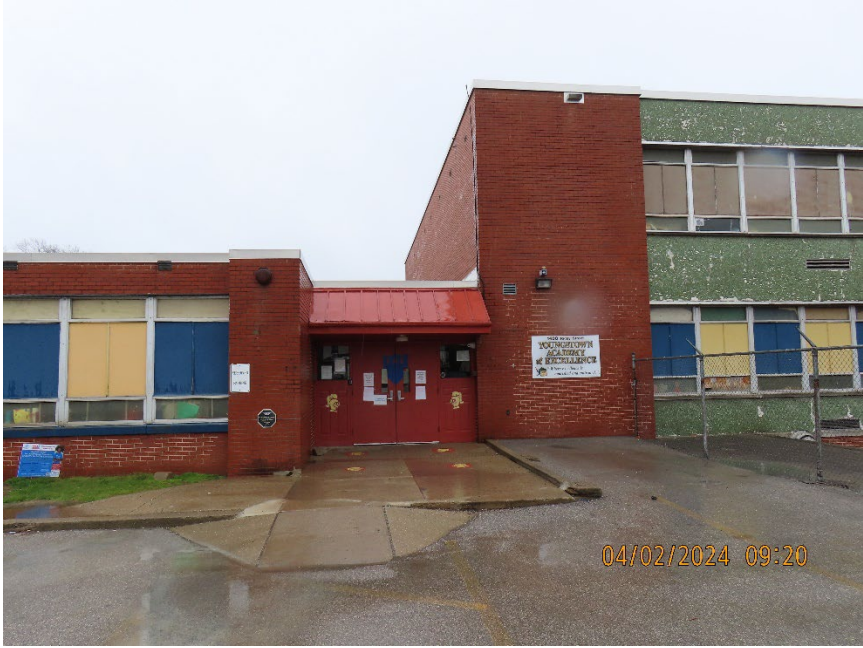
4.	Date Taken 4/2/24:	Time Taken: 9:20 AM EST

<p>04/02/2024 09:20</p>
	Sample No.: B-4 Description of Digital Image:  Exterior Entrance of YAE

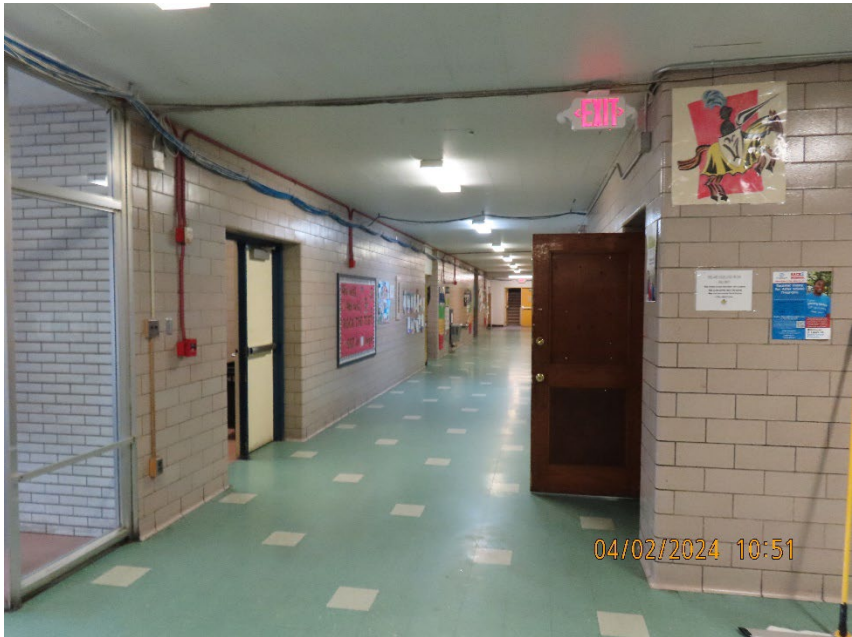
9.	Date Take: 4/2/24	Time Take: 10:51 AM EST

Sample No.: B-9 Description of Digital Image:  YAE 1 <sup>st</sup> Grade Hallway located on the 1 <sup>st</sup> Floor near the main entrances.

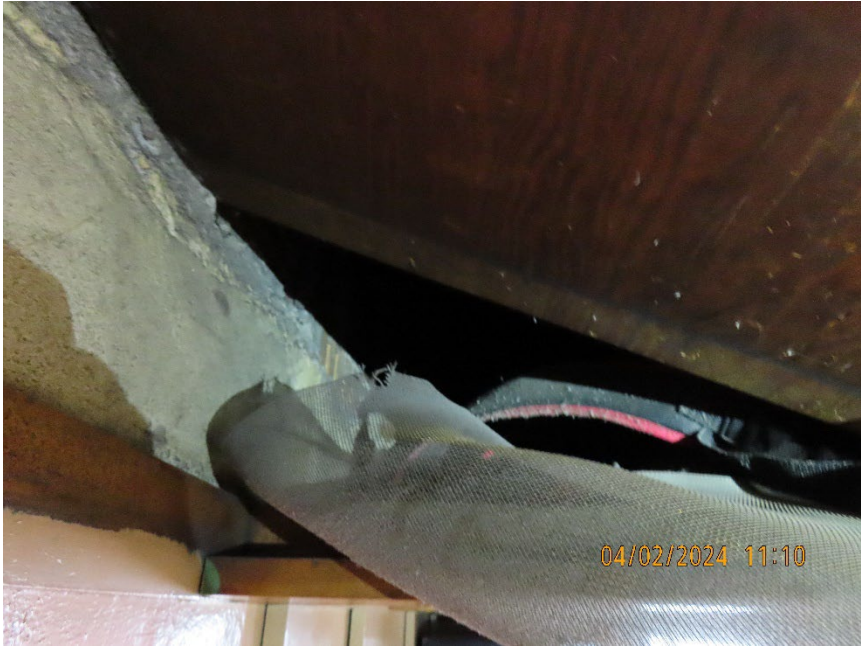
20.	Date Taken: 4/2/24	Time Taken: 11:10 AM EST

Sample No.: B-20		
	Description of Digital Image:  4 <sup>th</sup> Grade Classroom  Opening to closet and wall

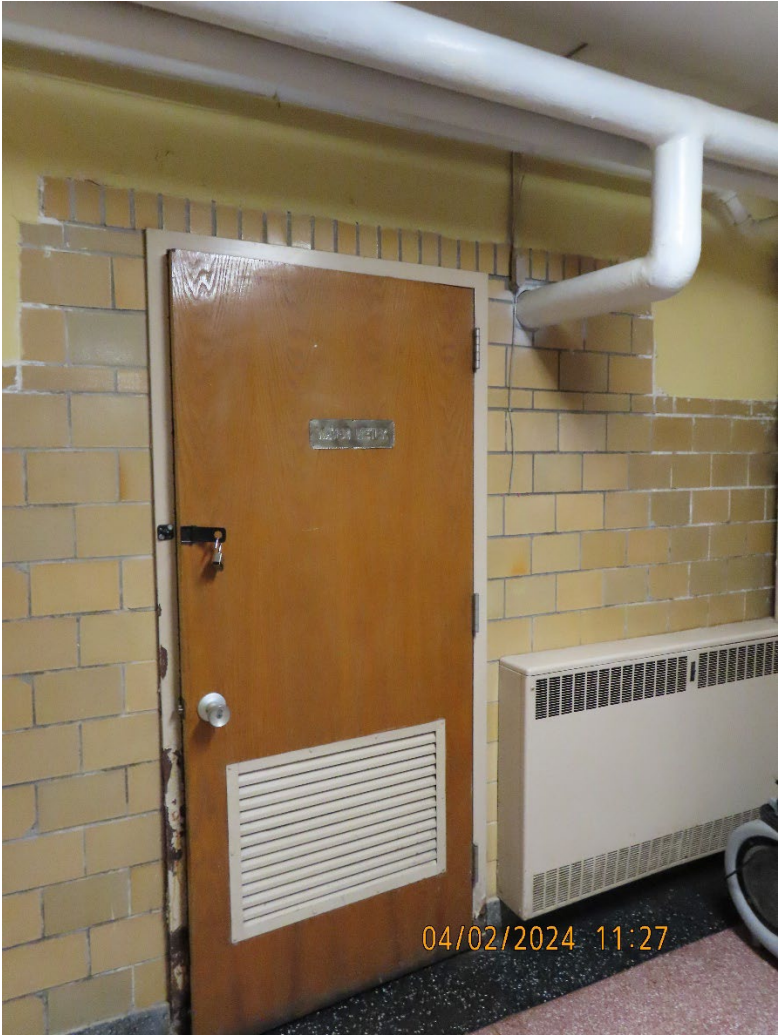
32.	Date Taken: 4/2/24	Time Take: 11:27 AM EST

Sample No.: B-32 Description of Digital Image:  YAE Basement Water Meter Room

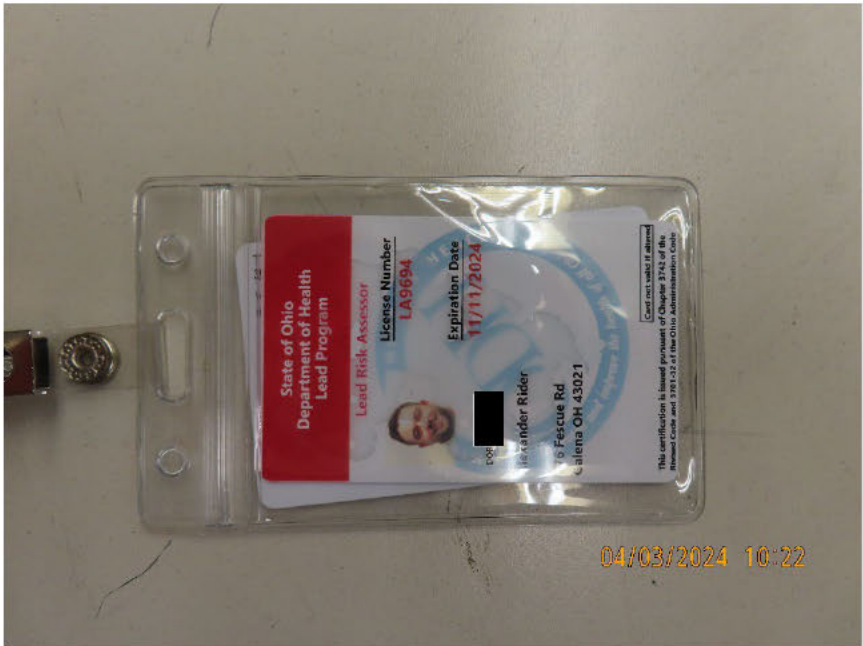
67.	Date Taken: 4/3/24	Time Taken: 11:10 AM EST

<p>Sample No.: B-20</p> <p>Description of Digital Image:</p> <p>Ohio Health Department Lead Risk Assessor License From Alexander Rider, who was conducting an AHERA Inspection at YAE</p>
