**SUBJECT: ADMINISTRATIVE ORDER ON CONSENT (AOC) STATEMENT OF WORK (SOW) SECTION 5
CORROSION AND METAL FATIGUE PRACTICES, DESTRUCTIVE TESTING PLAN, RED HILL
BULK FUEL STORAGE FACILITY (RED HILL), JOINT BASE PEARL HARBOR-HICKAM,
OAHU, HAWAII**

RED HILL BULK FUEL STORAGE FACILITY

SCOPE OF WORK FOR DESTRUCTIVE TESTING SUPPLEMENT

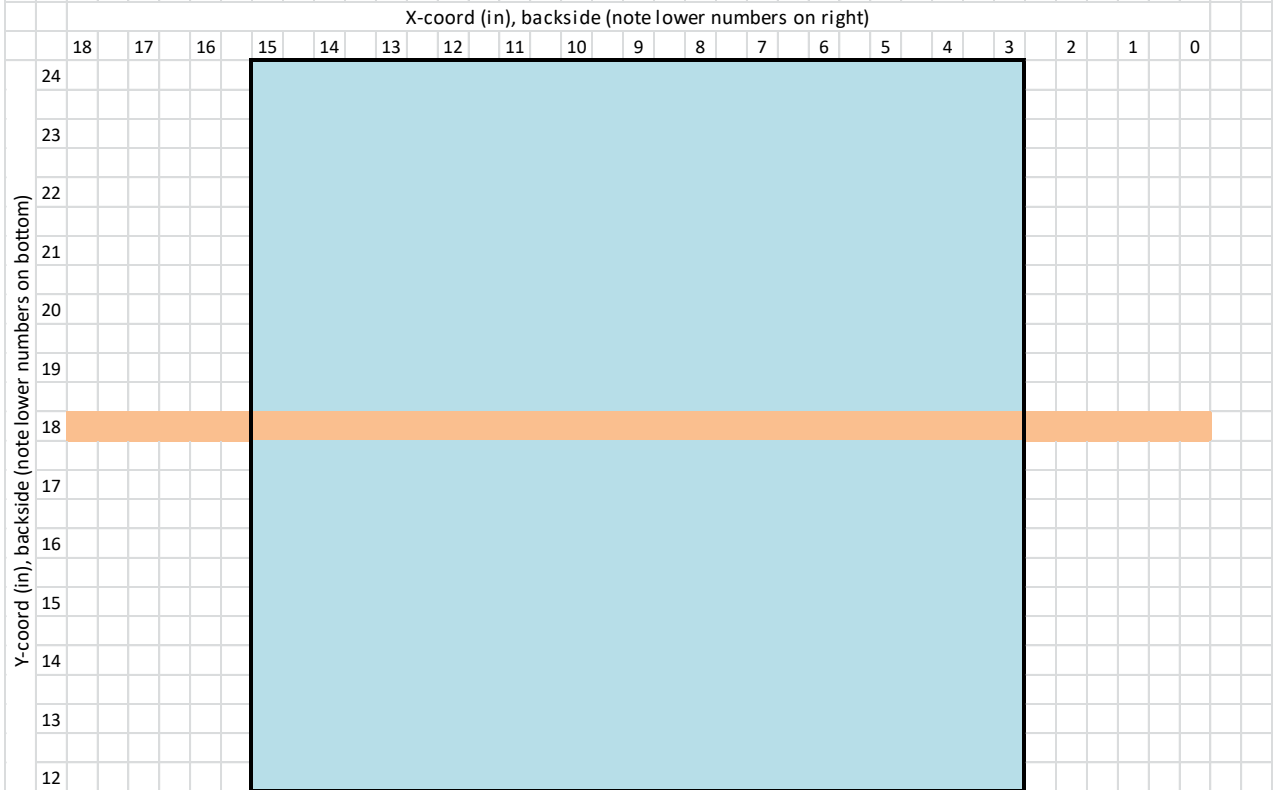
Coupon 3

Coupon for 14-ER-E3-13-9-18, 12"x12", Backside

- Border: Coupon area to be cut out
- Light Blue: Part of coupon with thickness below 0.200" not expected
- Light Brown: Area where an indication was found in the screening phase (x = 0" to 18", y = 18")
 This area is not backside corrosion
 Screening thickness (LFET): 0.033"; Prove-up thickness (PAUT): No indication noted, so no repair recommended
 Horizontal indication at y = 18" believed to be a plate manufacturing flaw; PAUT prove-up determined no repair

Coordinate origin is lower-left of plate, viewed from inside tank
 For backside sketches, coupon is flipped along vertical (y) axis
 So, in backside sketches, origin is lower-right

spreadsheet. The sketches also indicate if there are areas of general corrosion (between 20 -50 mils) expected. Any other pertinent information is added as a note on each sketch. The sketches documenting expected results for each coupon location are provided in **Appendix B**.

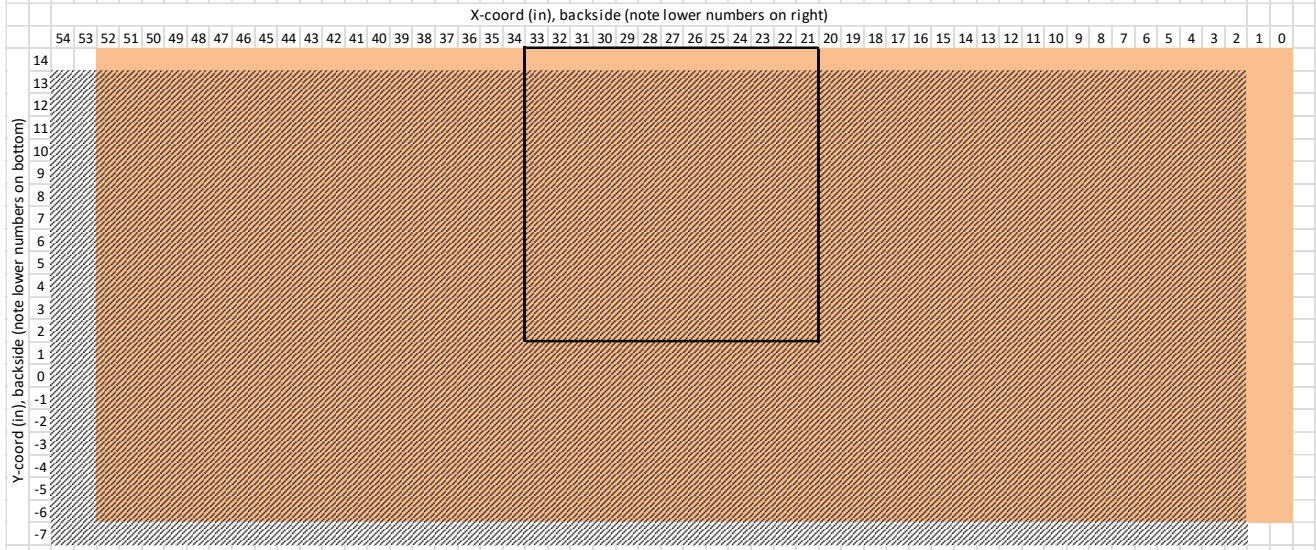
Coupon 5

Coupon for 14-BA-26-15-15-8, 12"x12", Backside

Shade: Patch plate for repair
