BOARD OF WATER SUPPLY

Subject: Board of Water Supply (BWS) Comments to the Work Plans Being Developed Under the Red Hill Bulk Fuel Storage Facility Administrative Order on Consent (AOC) Statement of Work (SOW) Sections 2 through 5 and 8

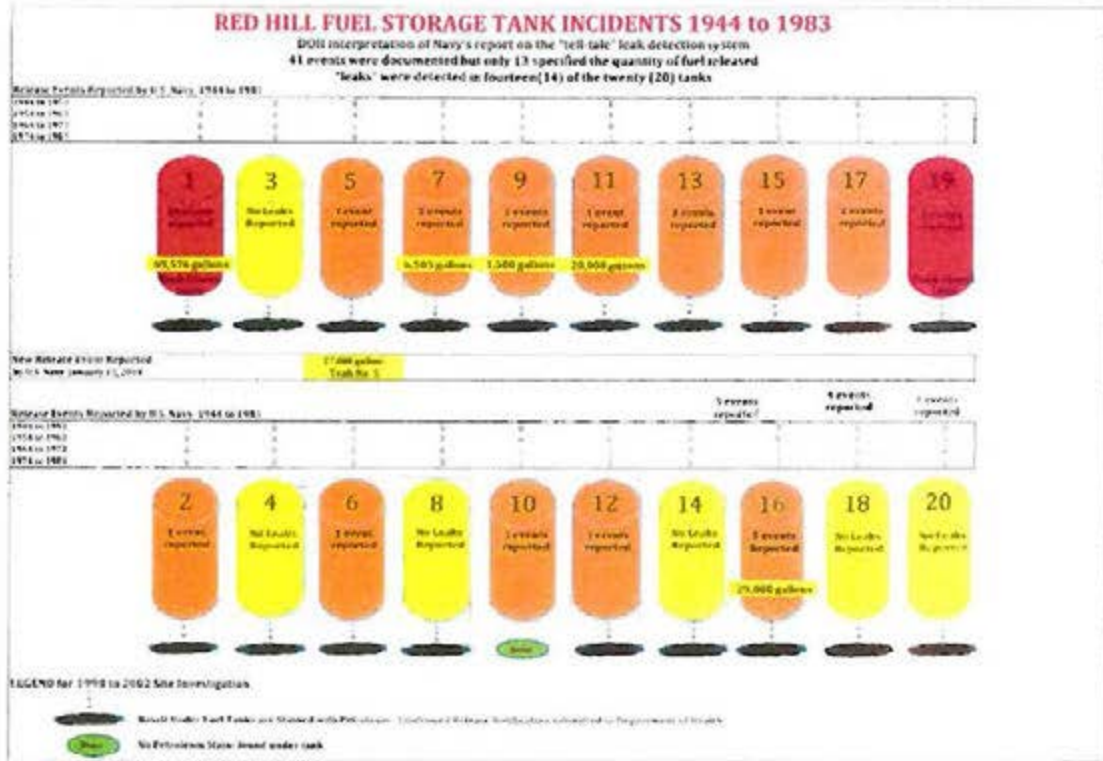
Provide a table that lists what is known about prior leaks. The Hawaii Department of Health's (DOH) chart shown below provides a basis for what should be included.

- For example, the Tank 5 loss of 27,000 gallons of JP-8 reported in January 2014.⁷
