# Rumney Marsh Restoration Areas

EPA Region 1 GIS Center  
 Map #11801, 1/19/2022

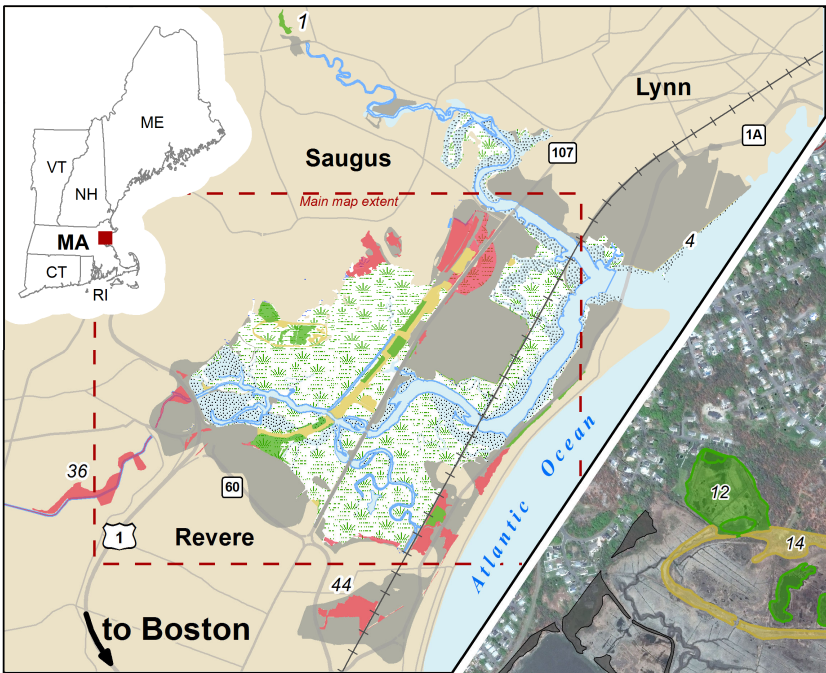
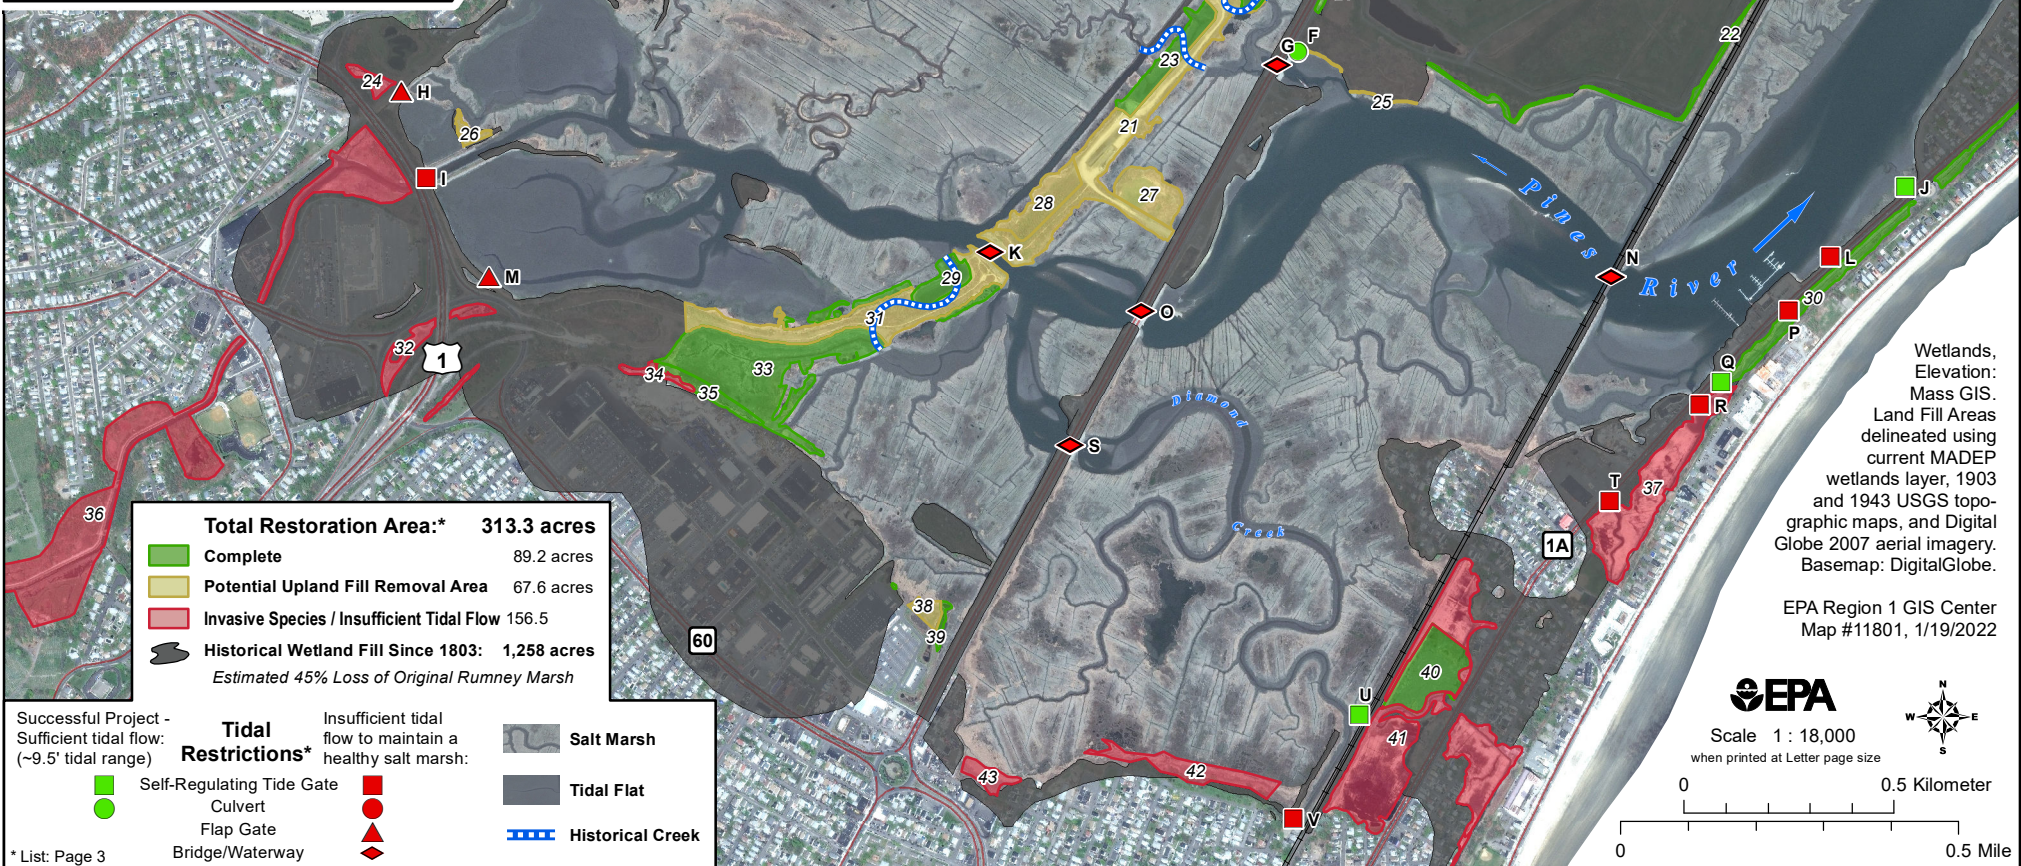
# Rumney Marsh Restoration Areas

**Total Restoration Area:\* 313.3 acres**

- Complete 89.2 acres
- Potential Upland Fill Removal Area 67.6 acres
- Invasive Species / Insufficient Tidal Flow 156.5
- Historical Wetland Fill Since 1803: 1,258 acres  
*Estimated 45% Loss of Original Rumney Marsh*

- Successful Project - Sufficient tidal flow: (~9.5' tidal range)
- Self-Regulating Tide Gate
  - Culvert
  - Flap Gate
  - Bridge/Waterway
- Tidal Restrictions\*
- Insufficient tidal flow to maintain a healthy salt marsh:
  - 
  -
- Salt Marsh
  - Tidal Flat
  - Historical Creek

Wetlands, Elevation: Mass GIS.  
Land Fill Areas delineated using current MADEP wetlands layer, 1903 and 1943 USGS topographic maps, and Digital Globe 2007 aerial imagery. Basemap: DigitalGlobe.

26	Pines River Channelization Upland Fill	0.6	Potential Upland Fill Removal Area		
27	DCR Salt Marsh Restoration Area	3.5	Potential Upland Fill Removal Area		Fill was found to be contaminated
28	I-95 Salt Marsh Restoration Area 1	3.5	Potential Upland Fill Removal Area		
29	Corps Roughan's Point Mitigation Area	2.2	Complete		
30	Route 1A Tide gates #1-4 Marsh	5.4	Complete		Maintenance needed to tide gates for proper function
31	I-95 Salt Marsh Restoration South	9.9	Potential Upland Fill Removal Area		
32	Copeland Circle Wetlands	2.4	Insufficient Tidal Flow	Yes	
33	Central Artery Marsh Restoration	16.0	Complete		
34	Caruso Marsh Restoration Phragmites Zone	0.7	Insufficient Tidal Flow	Yes	
35	Caruso Marsh Restoration	1.7	Complete		
36	Townline Brook Marsh Restoration	39.0	Insufficient tidal flow	Yes	
37	Route 1A Tide gates #5-6 Marsh	9.5	Insufficient Tidal Flow	Yes	
38	DCR Salt Marsh Restoration Area 2	0.8	Potential Upland Fill Removal Area	Yes

ID	Name	Type	Functioning	Status	Phragmites	Notes
A	Ballard St Tide gate	Flap Gate	Yes	Complete	Yes	
B	Seagirt Ave Marsh Tide gate	Culvert	No	Potential project	Yes	Obstructed 18-inch culvert and ditch
C	Crescent Marsh Culvert	Culvert	Yes	Complete	Yes	MA DOT culvert replacement
D	Bristow St Culvert #2	Culvert	No	Potential project	Yes	obstructed ditch; 18-inch culvert
E	Bristow St Culvert #1	Culvert	No	Potential project	Yes	Obstructed culvert and ditch
F	Route 107 Bridges Mitigation	Culvert	Yes	Functioning salt marsh		Failed culvert replaced to restore salt marsh
G	Route 107 E Branch Pines River	Bridge	Yes	Complete		Bridge was replaced, with higher and wider structure
H	Linden Brook Tide gate	Flap Gate	No	Potential project	Yes	Old wooden flap gate
I	Townline Brook Tide gates (3)	SRT	No	Repairs needed	Yes	Three SRTs are not being operated per permit conditions; three bottom floats missing
J	Route 1A Tide gate #1	SRT	Yes	Repairs needed		Missing top floats need replacement for flood control

K	I-95 Embankment	Waterway				Armored crossing of Pines River restricts flow and drainage across marsh
L	Route 1A Tide gate #2	SRT	No	Repairs needed		Missing top floats need replacement; obstructed culvert
M	Copeland Circle Tide gate	Flap Gate	No	Potential project	Yes	Cast iron flap gate only supports salt marsh from leakage
N	Pines River Railroad Crossing	Bridge				Limited vertical clearance at high tide - due to low bridge structure
O	Route 107 Pines River	Bridge	Yes	Complete		Bridge was replaced, with higher and wider structure
P	Route 1A Tide gate #3	SRT	No	Repairs needed		Crushed culvert outlet and stolen grated vault cover need replacement
Q	Route 1A Tide gate #4	SRT	Yes	Repairs needed		Stolen grated vault cover needs replacement
R	Route 1A Tide gate #5	SRT	No	Potential project	Yes	Replace 24" culvert with larger size. 48" SRT stolen grated vault cover needs replacement
S	Route 107 Diamond Creek	Bridge	Yes	Complete		Bridge was replaced, with higher and wider structure

T	Route 1A Tide gate #6	SRT	No	Repairs needed	Yes	Completely obstructed 600-foot-long culvert. Stolen grated vault cover needs replacement
U	Oak Island Tide gate	SRT	Yes	Under restoration		New combo gate (2013). Portions of salt marsh restored with muted tidal hydrology
V	Central County Ditch Tide gate	SRT	No	Repairs needed	Yes	Not being operated properly to maximize restoration; needs bottom float installation
